**Technical Data Sheet**

Bridge Identification:	1560210000000R01
Facility Carried:	M 20
Feature(s) Intersected:	Tittabawassee River and C & O Railway
Location:	City of Midland
County:	Midland
Region:	Bay
Year Built:	1955
Year(s) Reconstructed:	1985
Bridge Type:	Two-Girder System
No. of Spans:	10
Deck Area:	45,585 S.F.
Paint System:	Type 1 (Joint Area, Type 4)
Paint Area:	96,500 S.F.

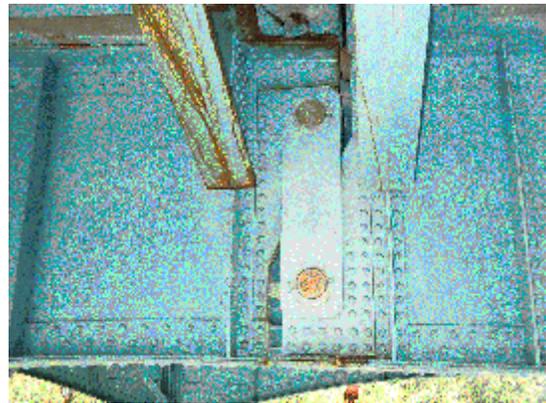
- ! **Pin and hanger assemblies.** The pins and hanger plates should be carefully inspected, and any wear or section loss should be measured and compared to that documented in previous inspections. The assemblies should be inspected to ensure they are free to move as intended.

Typical Pin and Hanger Assembly (5)

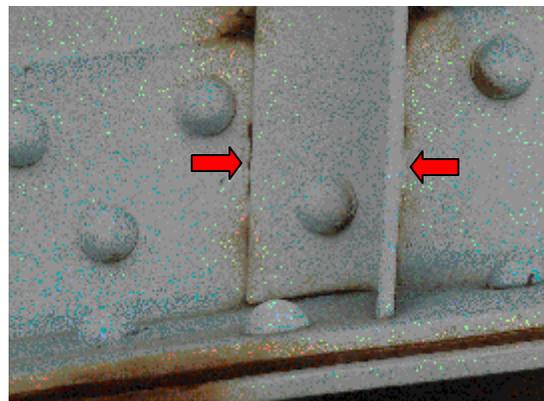
- Bottom of stiffener angles to bottom flange angles (Photo 6)

Typical Connection of Stiffener Angle to Girder Bottom Flange Angle (Note Cracked Tack Welds) (6)

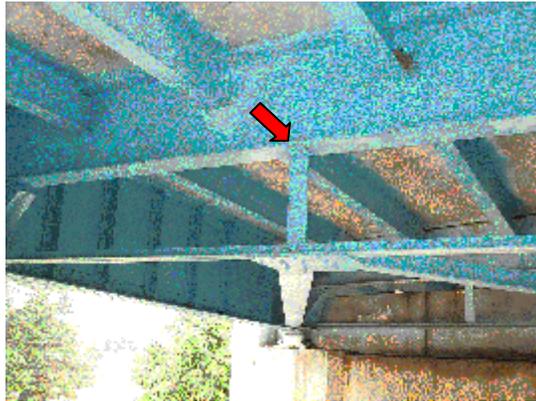
-- Lateral bracing hanger connections to floorbeam bottom flanges  
(Photos 7 and 8)

Lateral Brace Connection to Floorbeam (7)

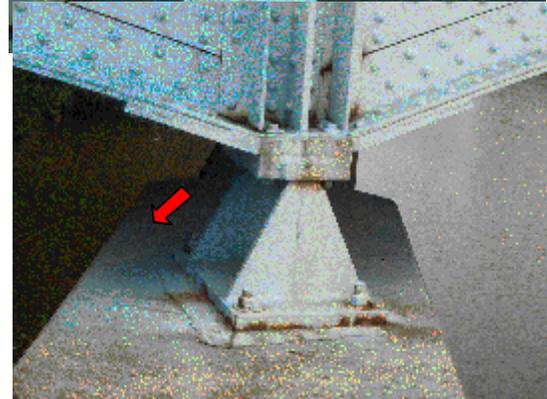
Girder Bearing at Pier (Note Spot Welds) (9)

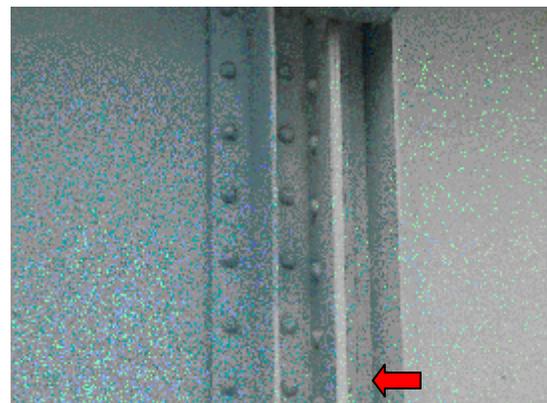
-- Stiffener angles to girder webs

Typical Connection of Bearing Stiffener Angle to Girder  
Web (Note Tack Welds) (10)

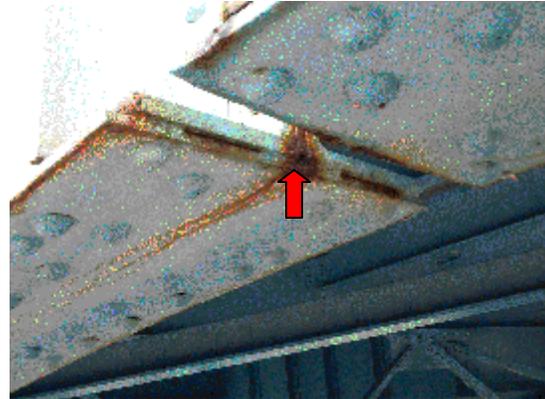
- Ends of bottom flange plates

Tack Welds at Bottom Flange Cover Plate (Below the Pin and Hanger Assembly) (11)

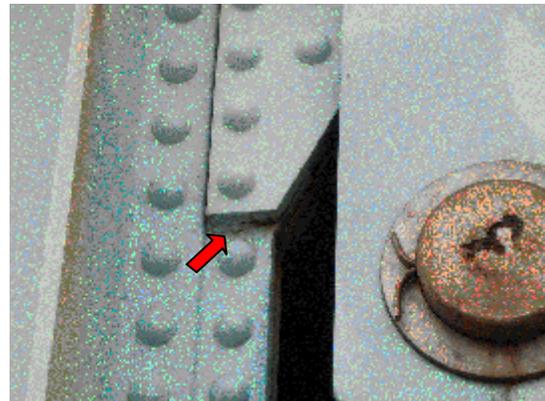
- Ends of girder webs at pin and hanger assemblies

Typical Tack Weld adjacent to Pin and Hanger Assembly (12)

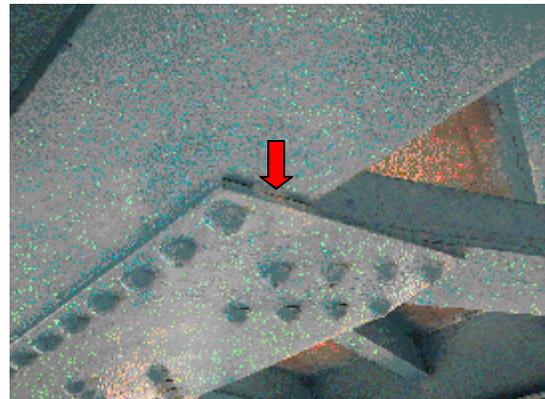
- Lateral bracing gusset plates to centerline floorbeam bottom flanges

Typical Connection of Lateral Bracing to Bottom Flange of Centerline Floorbeam (Note Cracked Tack Weld) (13)

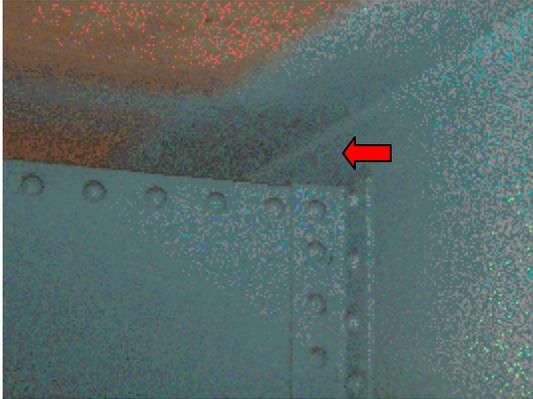
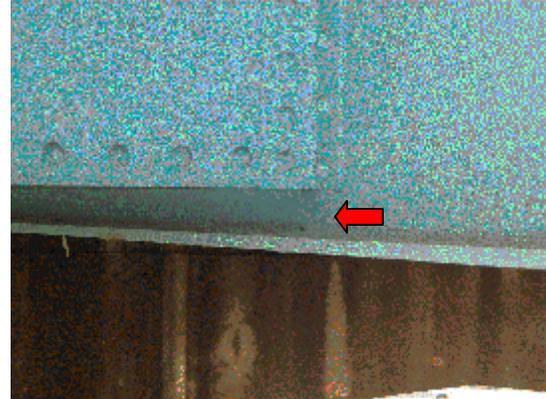
! **Small web gaps.**

Typical Web Gap in Multi-beam Approach Span (14)

Typical Web Gap in Multi-beam Approach Span (15)

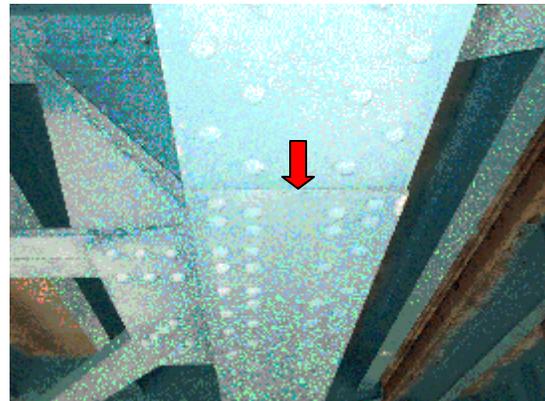
! **Ends of cover plates.** (Photo 16) The ends of the cover plates should be inspected for cracks, especially around the rivet or connector holes.

Typical End of Cover Plate (16)

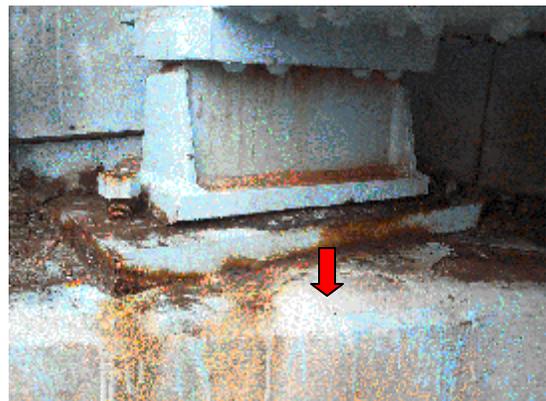
! **Bearings.** The fixed and rocker bearings can become frozen due to buildups of pack rust between the curved surfaces.

Rust Buildup at Rocker Bearing (17)

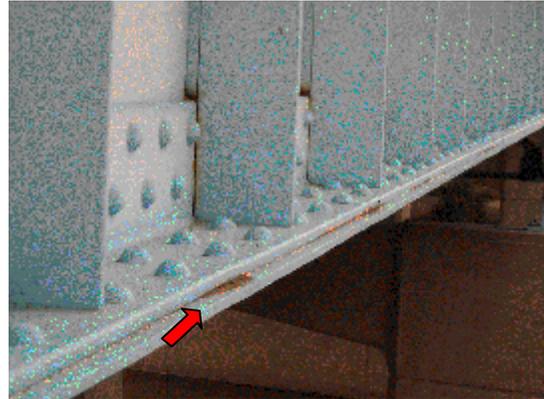
- ! **Bottom flanges of girders.** Development of pack rust can occur between the plates where sealant has not been applied.

Pack Rust between Girder Flange Angle and Cover Plate (18)

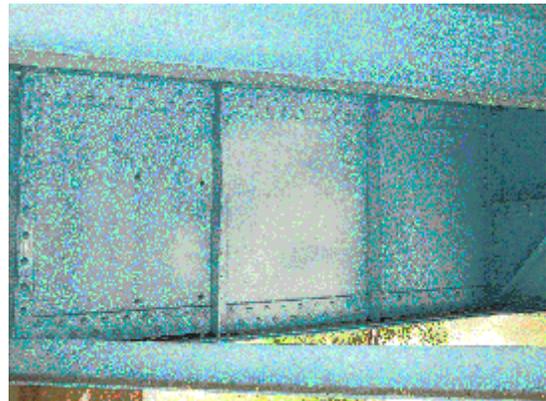
- ! **Paint system.** The finish coat is susceptible to chalking.

Typical Paint Chalking at Girder Web (19)

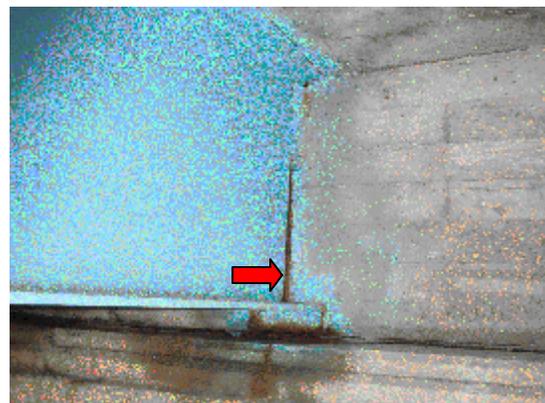
- ! **Beam ends at abutments.** The ends of the beams are encased by the concrete backwall at the abutments. The steel is susceptible to development of corrosion at the concrete interface.

Typical Beam Bearing Encased in Abutment Backwall (20)
