Technical Data Sheet

Bridge Identification:	1560440000000B043 1560440000000B044
Facility Carried:	US 10
Feature Intersected:	Sanford Lake
Location:	Sanford
County:	Midland
Region:	Bay
Year Built:	1962
Year Reconstructed:	1984, 1997
Bridge Type:	Two-Girder System
No. of Spans:	3
Deck Area:	12,547 S.F.
Paint System:	Red Lead
Paint Area:	31,500 S.F. (B04-3) 31,500 S.F. (B04-4)

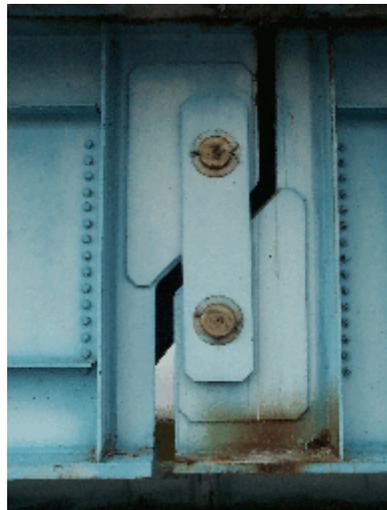
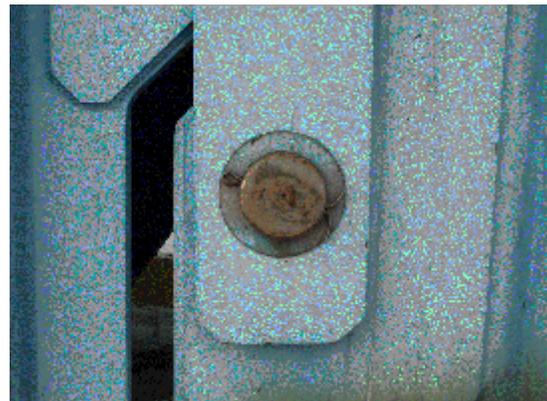
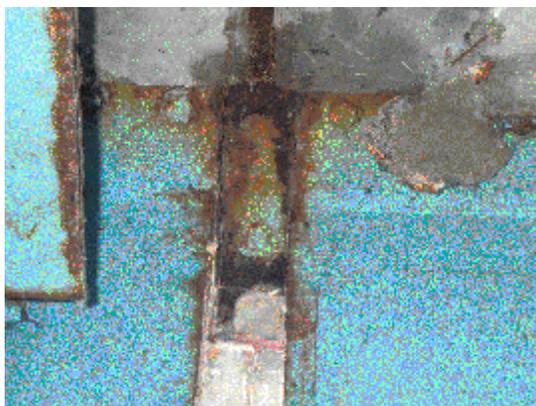
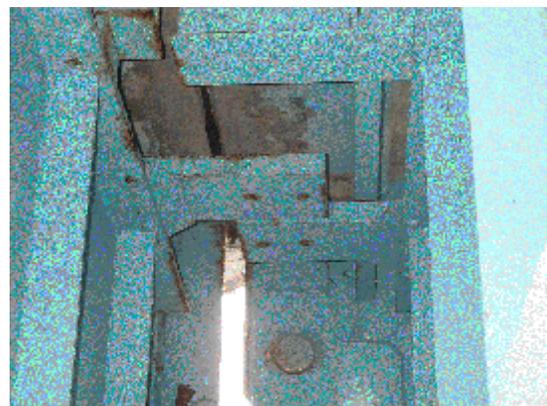
Corrosion on Tie Bar (7)

- ! **Pin and hanger assemblies.** (Photos 5 through 8) The tie bars installed to fix the pin and hanger assemblies are susceptible to corrosion.

Recommendation	Schedule
Clean bridge drainage system components (deck drains and downspouts).	6 to 12 months
Flush bridge deck joints and check for leaks.	12 months
Powerwash bridge superstructure.	12 months
Powerwash bearings and pin and hanger assemblies.	12 months

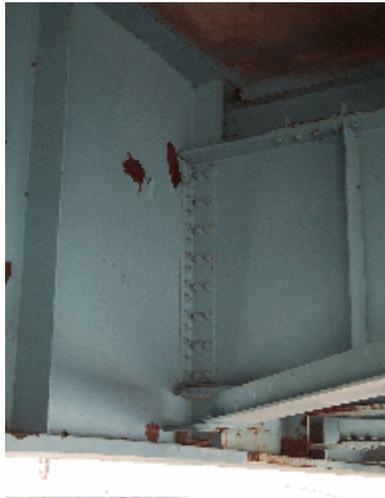
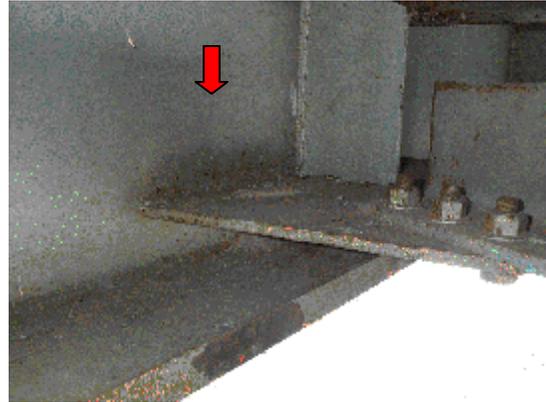
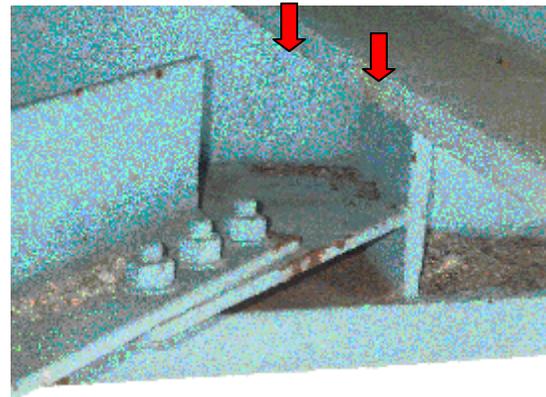
- ! **Tension areas of main girders.** See Figure 1 in the Inspection and Maintenance Program section of this manual for tension areas.
- ! **Girder webs and lateral bracing gusset plates at floorbeam connections.**
(Photos 9 through 11)

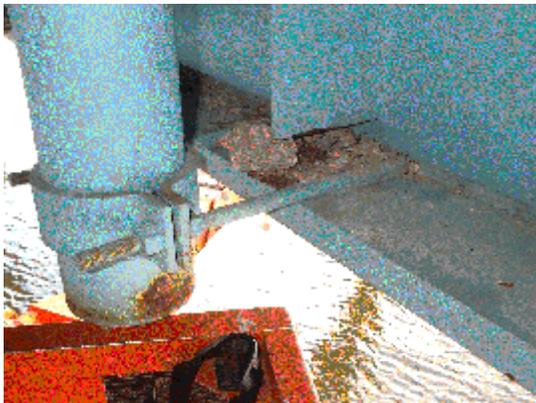
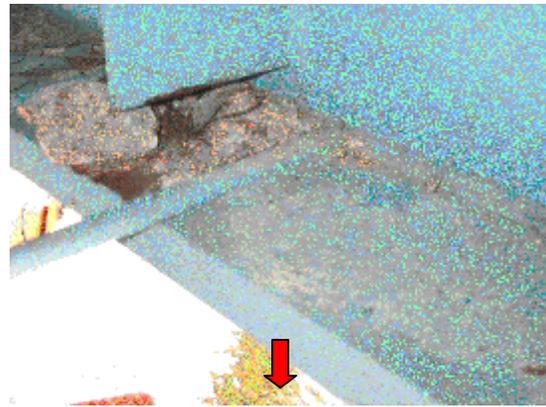
! Downspout support bracket welds to bottom flanges of main girders.

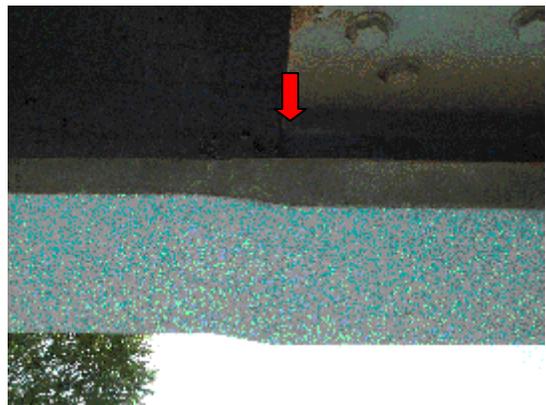
! Welded bottom flange splices/transitions.

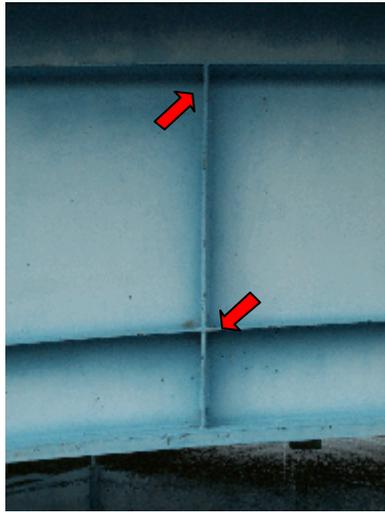
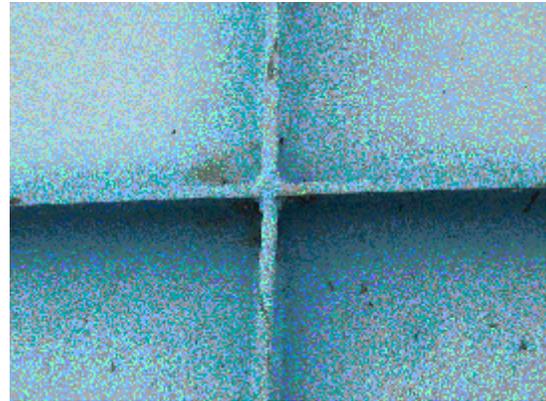
! Intersecting welds where transverse and longitudinal web stiffeners cross.

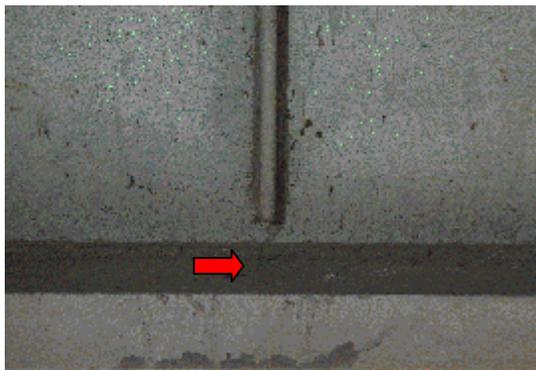
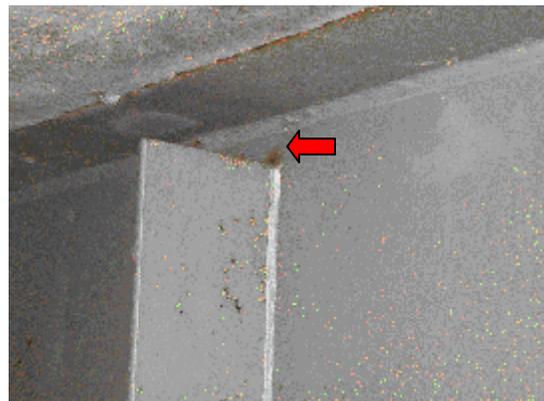
! Small web gaps. There are small web gaps at the transverse web stiffeners.

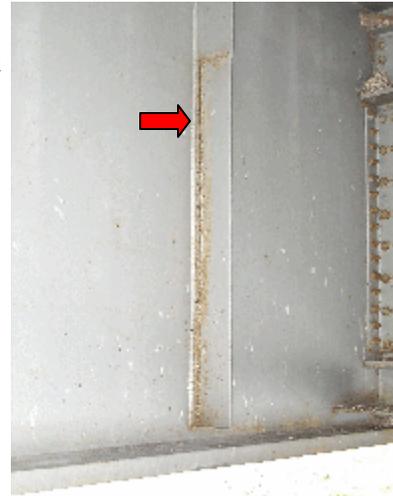
Typical Rewelded Stiffener (21)

! Transverse webstiffeners on interior faces of main girder. Several of these interior stiffeners were cut out during the original construction to facilitate installation of the floorbeams. These stiffeners were rewelded into place in the field. These field welds should be carefully inspected.

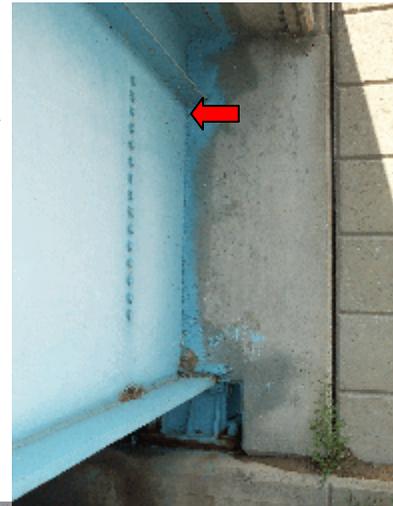
Typical Beam End Encasement in Abutment Backwall (22)

! Beam ends at abutments. The ends of the beams are encased by the concrete backwall at the abutments. The steel is susceptible to development of corrosion at the concrete interface.

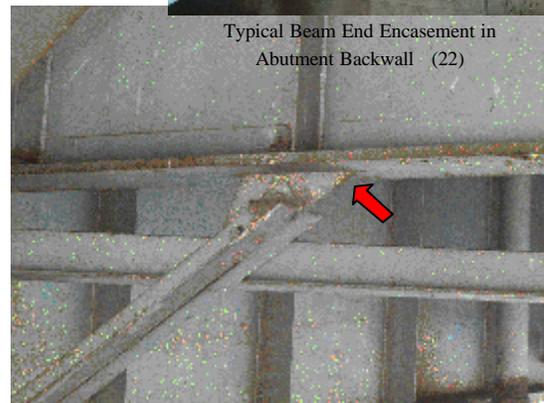
Weld of Knee Brace to Floorbeam (23)

! Floorbeams at knee brace connections. Knee braces are welded to the bottom flanges of the floorbeams and the bearing stiffeners at the piers.

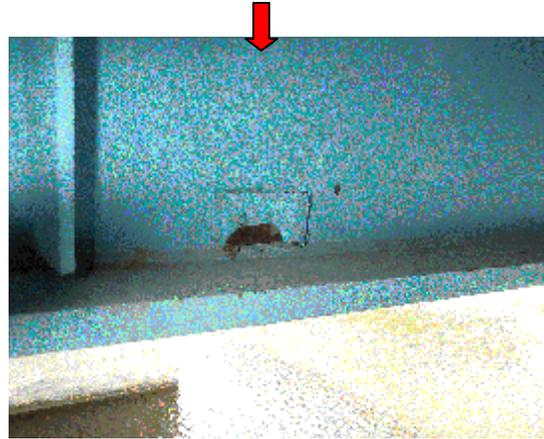
Typical Bracket Welded to Floorbeam Web (24)

- ! **Floorbeams at pin and hanger locations on eastbound bridge.** Brackets used during the replacement of the pin and hanger assemblies were welded to the floorbeam webs. These areas should be monitored for cracks.

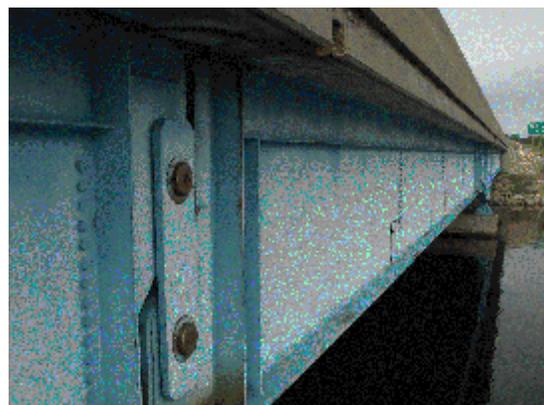
- ! **Paint system.** The paint system should be monitored for chalking, especially on the exterior surfaces of the main girders.

Typical Chalking on Paint System (26)
