Technical Data Sheet

Bridge Identification:	1640120000000B01
Facility Carried:	Relocated US 31
Feature Intersected:	Pentwater River
Location:	Hart
County:	Oceana
Region:	Grand
Year Built:	1954
Year Reconstructed:	1988
Bridge Type:	Two-Girder System
No. of Spans:	3
Deck Area:	17,030 S.F.
Paint System:	Type 4
Paint Area:	46,000 S.F.

General Bridge Description

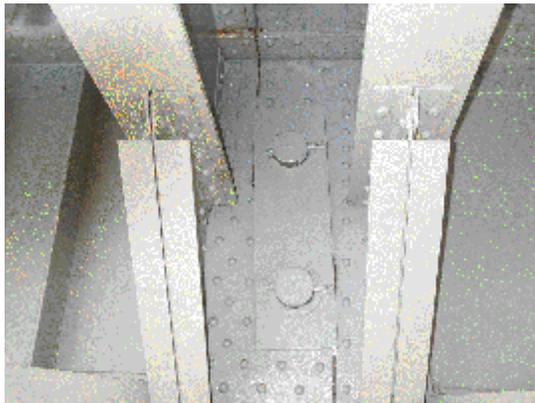
! Pin and hanger assemblies. (Photos 5 and 6)

Pin and Hanger Assembly at East Girder, S.B. Bridge (5)

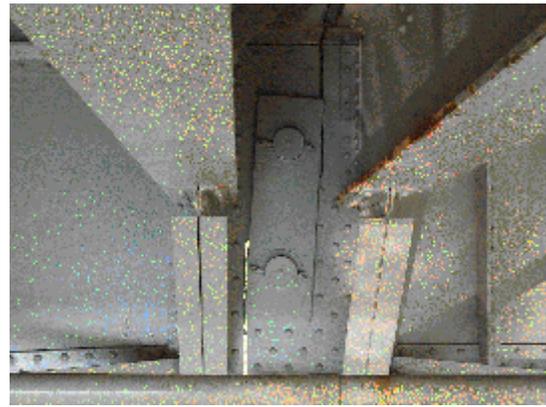
Pin and Hanger Assembly at West Girder, S.B. Bridge (6)

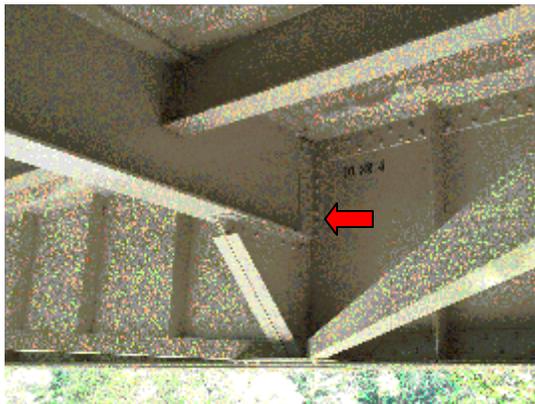
! Girder webs at floorbeam connections. (Photos 7 and 8)

Typical Connection of Floor Beam to Girder (7)

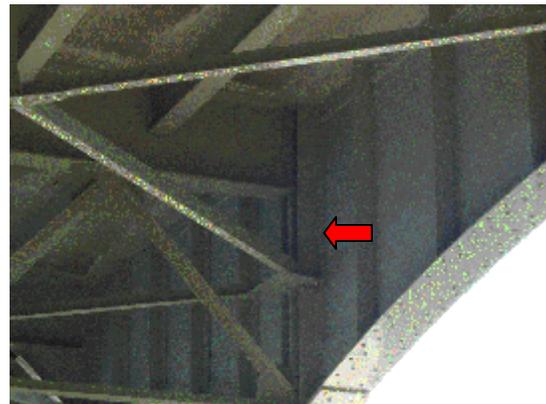
Connection of Floor Beam to Girder at Pier (8)

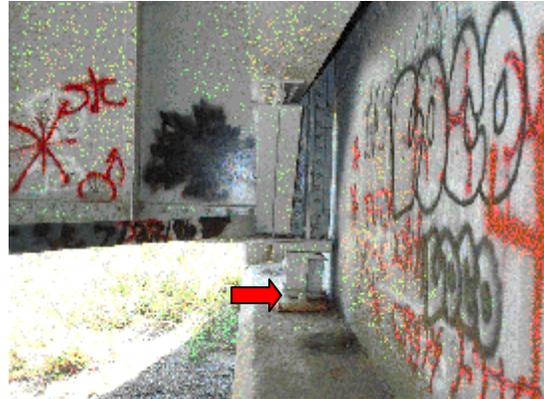
! **Bearing assemblies.** The bearings at the abutments appear to be excessively inclined for ambient temperature. Accumulations of pack rust can cause the bearings to become frozen.

Excessively Inclined and Frozen Rocker Bearing (9)

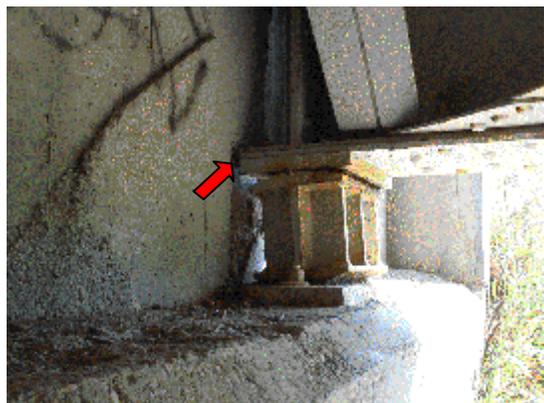
! **Substructure.** The abutments appear to be moving towards the channel. The beam and girder ends at one time had come into contact with the abutment backwalls. Notches were cut into the north abutment backwall to accommodate the beam ends. These areas should be checked carefully for structural distress.

Abutment Backwall Notched to Disengage it from Beam (10)
