Contribution to Michigan Geology Report - 90-4

PORT HURON STUDY
Historical Development of Hydrocarbons
and Subsequent Problems

Walter Danyluk,
Michigan Department of Natural Resources
Geological Survey Division

1990

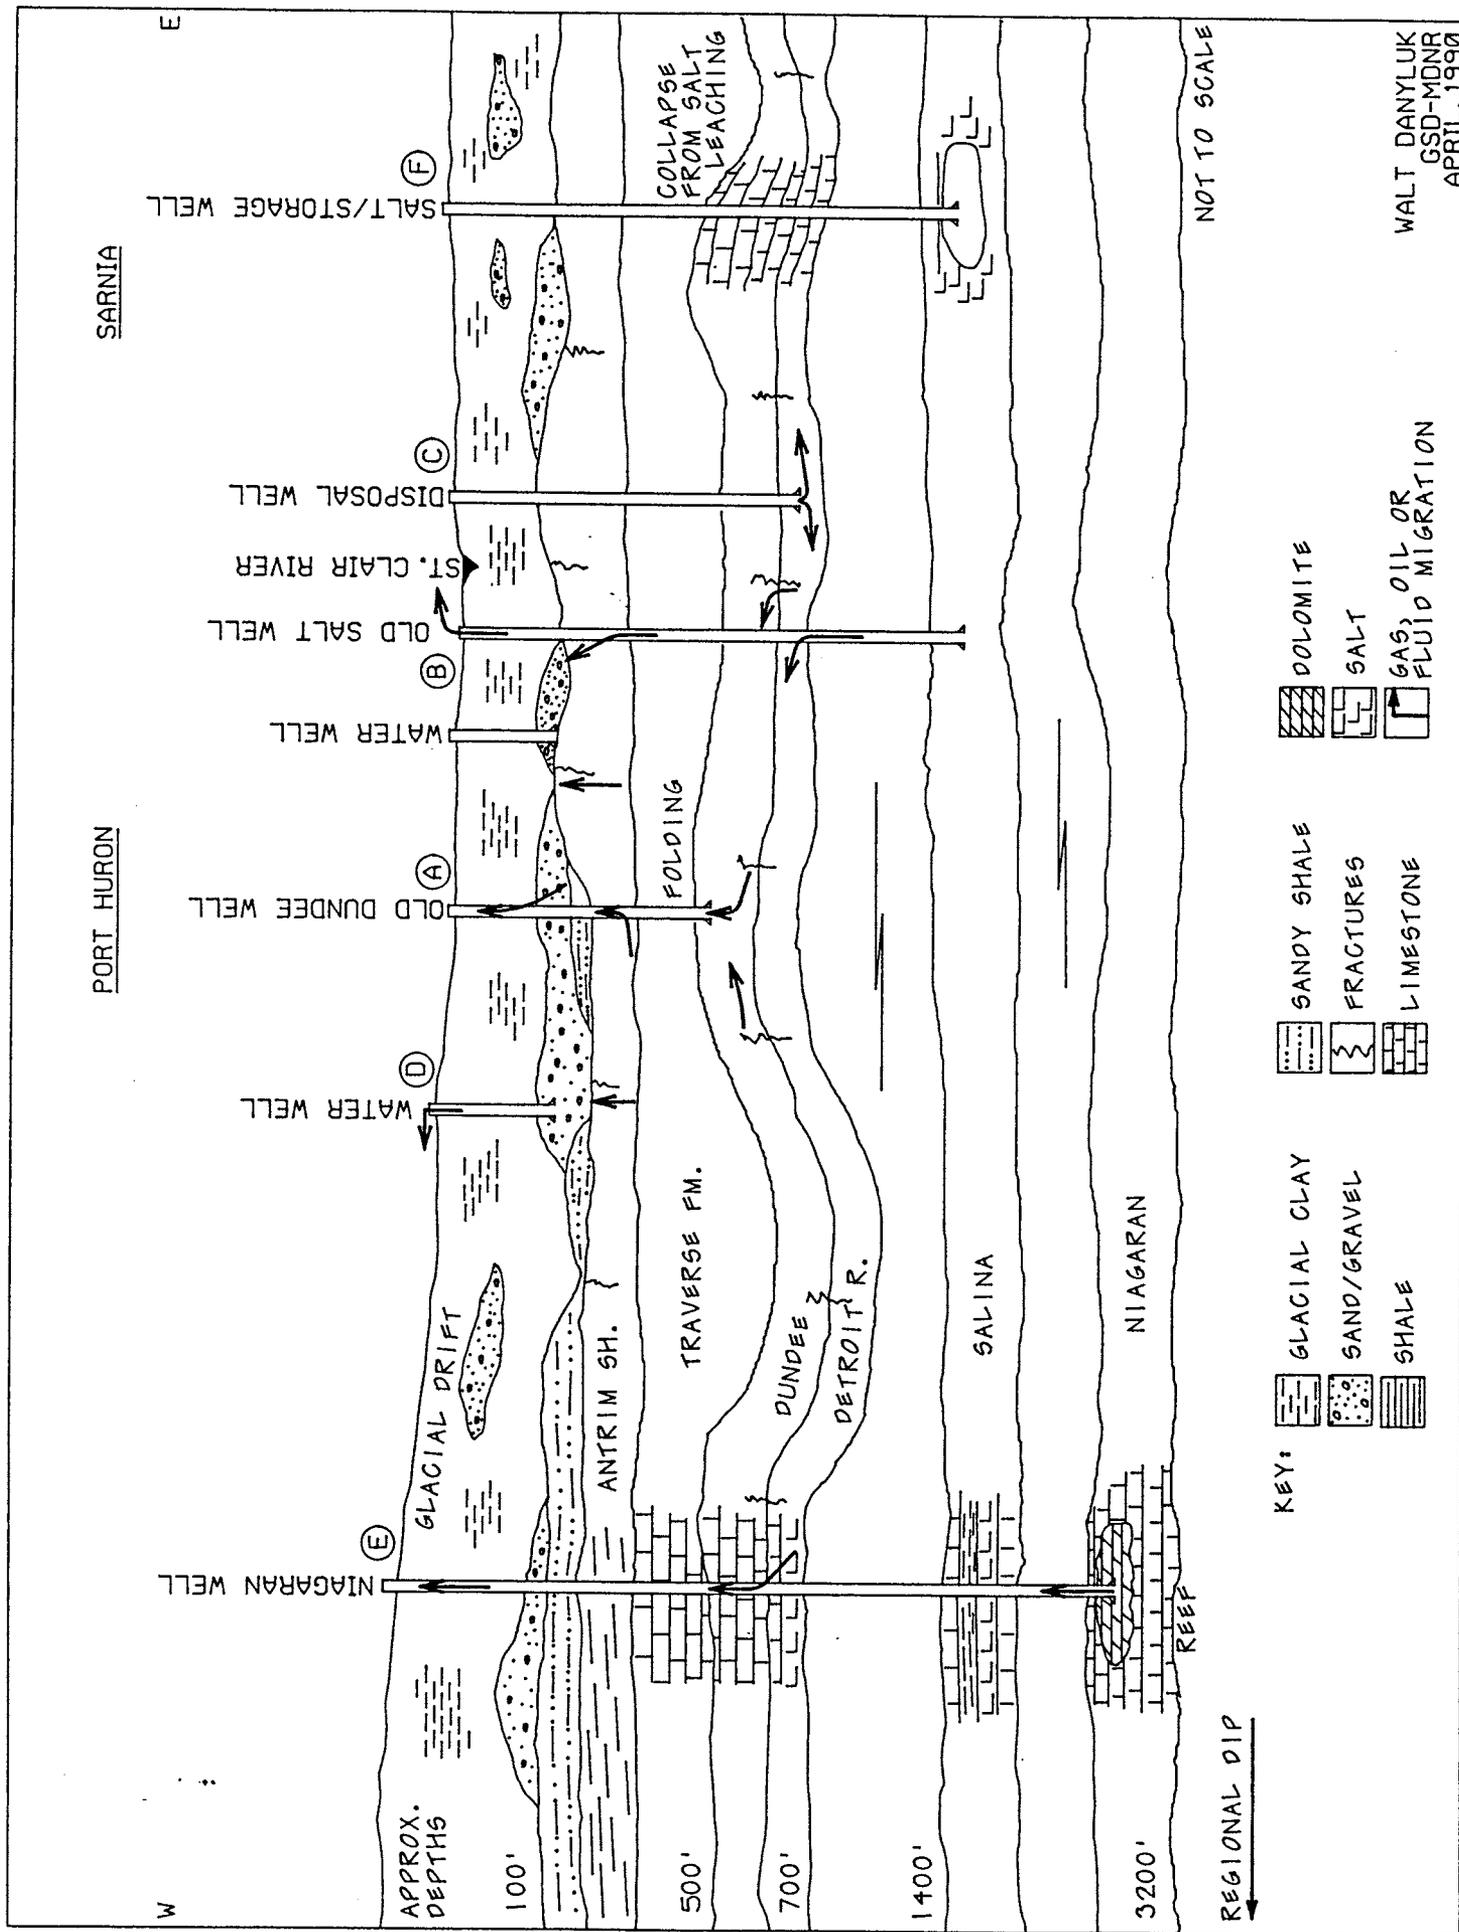
FIGURE 1. GENERALIZED SCHEMATIC OF SUBSURFACE OF PORT HURON

The schematic of the subsurface in Port Huron is a composite of the Case Histories depicting the various ways by which hydro- carbons and fluids (brines, brackish and fresh water) can migrate between different formations, and between formations and the surface.

Storage well (F) operations can also create potential for subsur- face/surface problems if there is leakage from the storage zone which may overpressurize surrounding rock formations and initiate or alter gas/fluid migration.

In all the cases above, migration can also occur via the annulus (space between wellbore and the casing) if it is not properly sealed.
