Management of Subsurface Landfill Fires at the Closed Kailua-Kona Landfill

Kailua-Kona, Island of Hawaii, Hawaii
By: Lindsay Mason, P.E.

County of Hawaii
Department of Environmental Management
345 Kekūanāoʻa St., Suite 41
Hilo, Hawaii 96720-4252

Element Environmental, LLC
98-030 Hekaha Street, Unit 9
Aiea, Hawaii 96701

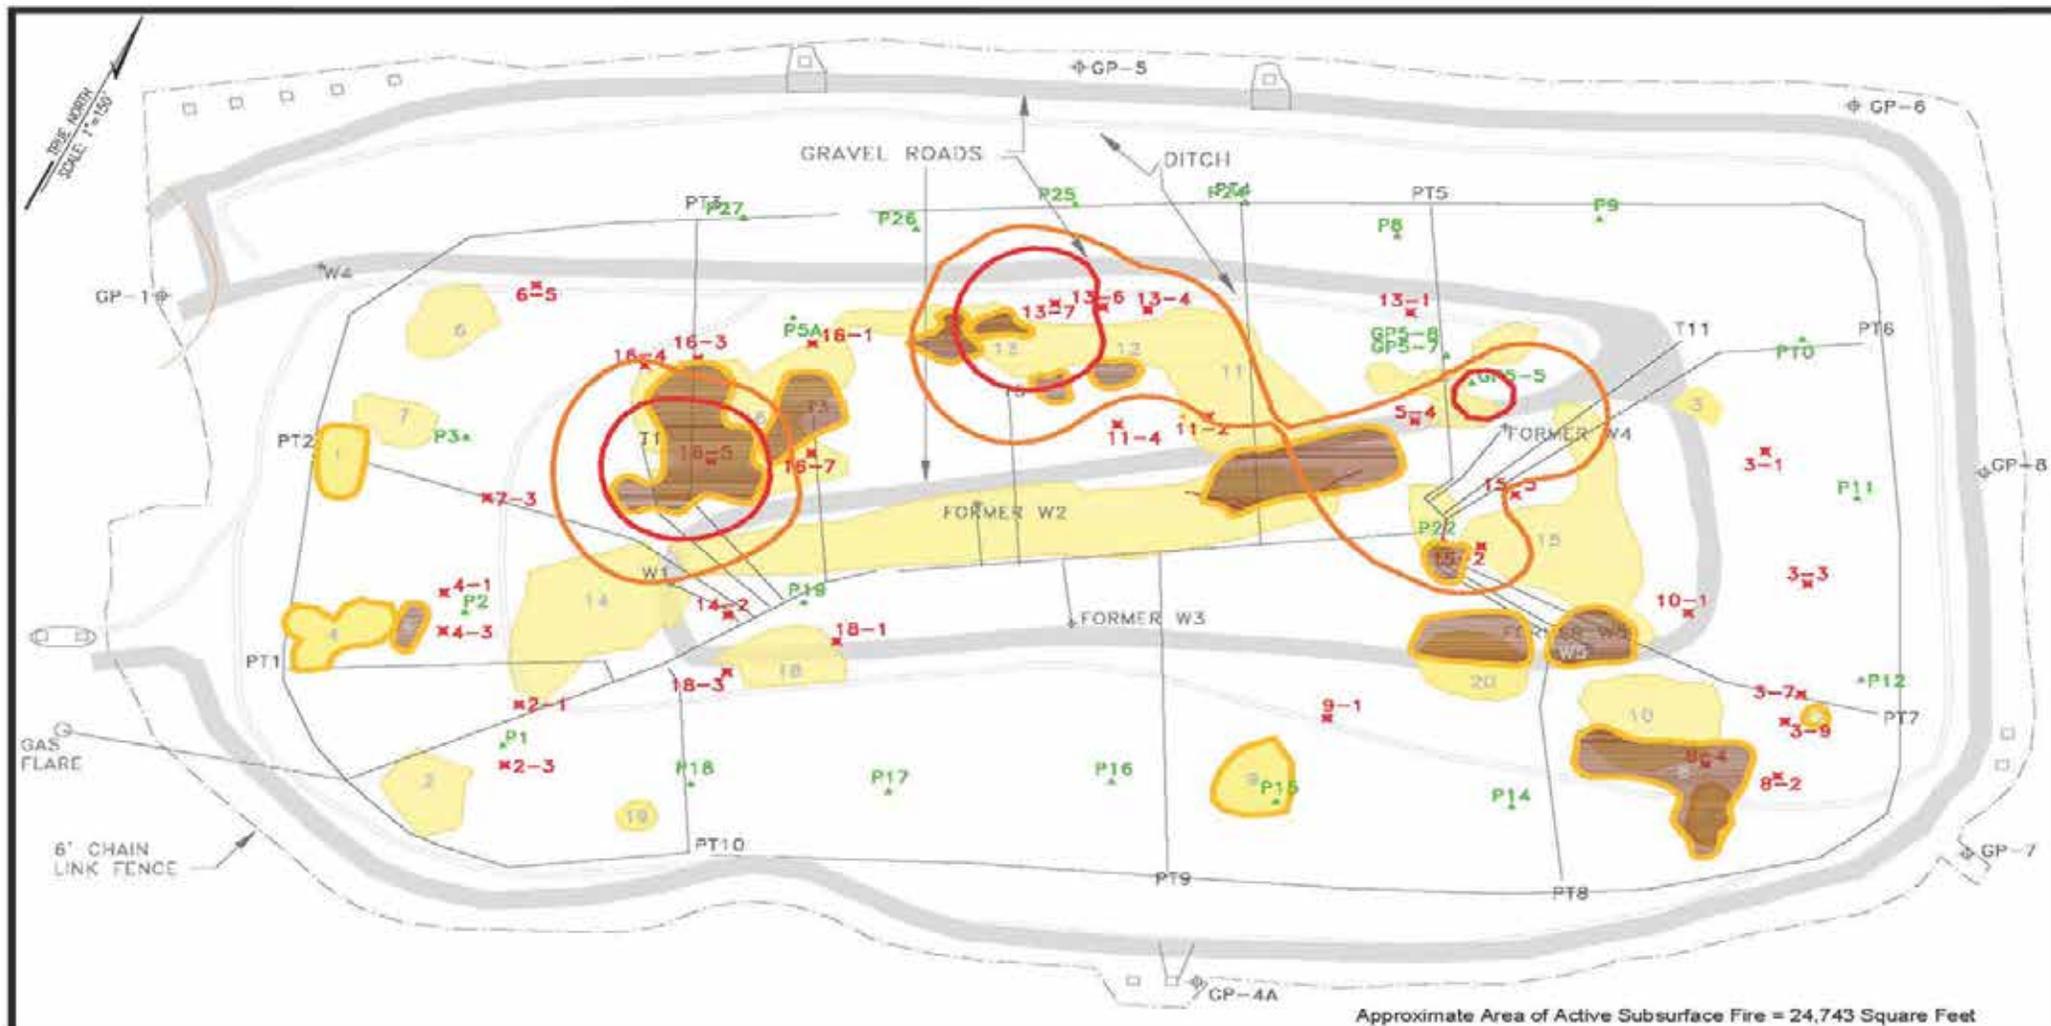
Figure 9
Approximate Fire Boundary as of June 2015
 County of Hawaii
 Kailua-Kona Landfill
 2nd Quarter 2015 Fire Monitoring Report
 Kona, Hawaii, Hawaii

- Landfill gas monitoring: Steel probes were inserted around the landfill to monitor landfill gasses. We primarily monitor for carbon monoxide, oxygen, methane, and carbon dioxide.
- Landfill gas concentrations are contoured to identify areas of concern and gauge whether subsurface landfill fire conditions are worsening.
- Temperature is no longer monitored at the landfill because the thermocouple probes burn out easily. Temperatures are too hot in areas of concern.
- Infrared surveys are conducted via helicopter one to two times per year. Flyovers are conducted early in the morning before the sun comes up for best results.
- Biweekly Site Inspection: The field team looks for visual and olfactory indications of subsurface fires (i.e. smoke, cracks, fissures, black staining, strong odors, sinkholes or depressions etc.)

- **Application of Cover Material:** Cover material is applied and compacted where erosion has occurred, large sinkholes are forming, and/or cracks or fissures are observed. This has been the most effective way to mitigate the subsurface fires at the landfill. Conditions have improved since implemented.
- **Closure of Vertical Landfill Gas Extraction Well:** The gas wells were always hot and burning. The wells were grouted and covered with fill material.
- **Vegetation Control:** Cattle graze on the site to keep the vegetation under control. Thick vegetation can become a surface fire hazard and make it difficult to conduct site inspections.
- **Carbon Dioxide Injection:** Carbon dioxide was regularly injected in the areas where active combustion was occurring, but is no longer conducted because application of cover is a better use of limited funds.
