Improving Seismic Safety of Dams in California

Donald H. Babbitt, M.ASCE ¹

Abstract

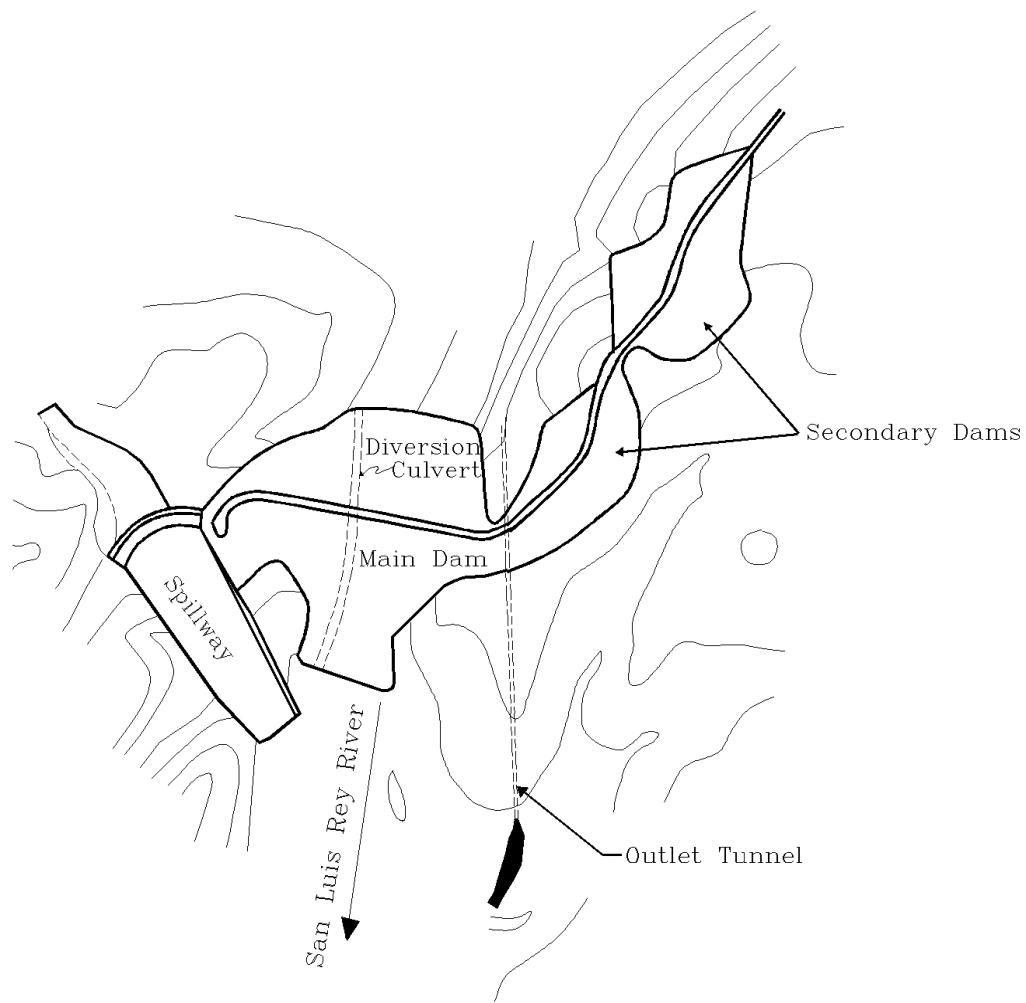
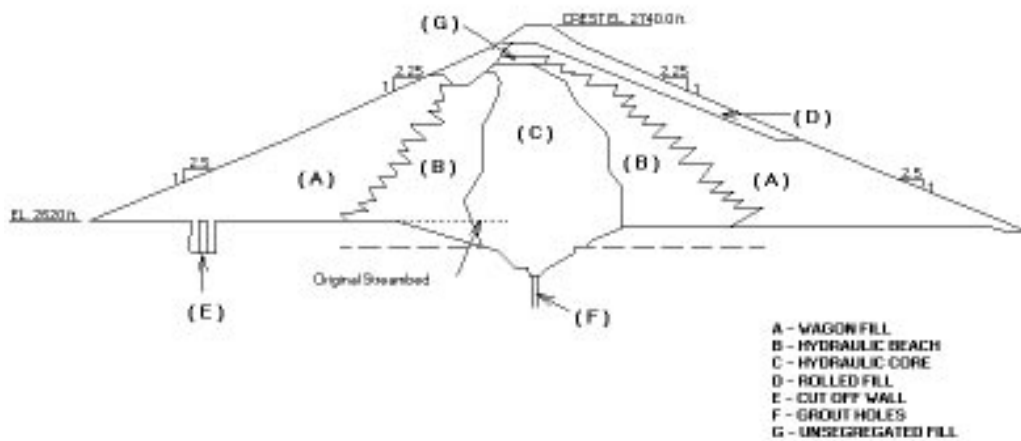
FIGURE 2 - HENSHAW DAM BEFORE MODIFICATION

Henshaw Dam, a hydraulic fill, (Fig.2) had another serious problem. It is located in the 8 to 12 mile wide active Elsinore fault zone. Traces of the fault trend diagonally under the main dam embankment (Bischoff 1985). The fault is deemed capable of producing a Magnitude 7.0 earthquake with potential fault rupture displacements, at the dam, of up to 5 feet in either the vertical or horizontal direction and or up to 7 feet in an oblique direction.

This 120-foot high dam, constructed in the 1920s, created a 204,000 acre-foot irrigation and municipal water supply reservoir on the San Luis Rey River in San Diego County. Preliminary studies showed the relative densities of the shell materials were low enough that liquefaction could lead to failure of the dam. They also disclosed the dam would be subject to piping should movement occur on the fault traces under the embankment. Later, concern developed that fault movement could raise a significant part of the reservoir relative to the dam and lead to reservoir release should the embankment severely slump.

Alternate reservoir sites were not available on the river and the choice of construction materials was limited in the broad fault zone. Operation studies showed that a 50,000 acre-foot reservoir would meet the owner's needs. The improvements selected were to permanently reduce the reservoir capacity to 50,000 acre-feet by constructing a 37-foot deep notch, 12-feet wide at its invert, in the spillway and to strengthen

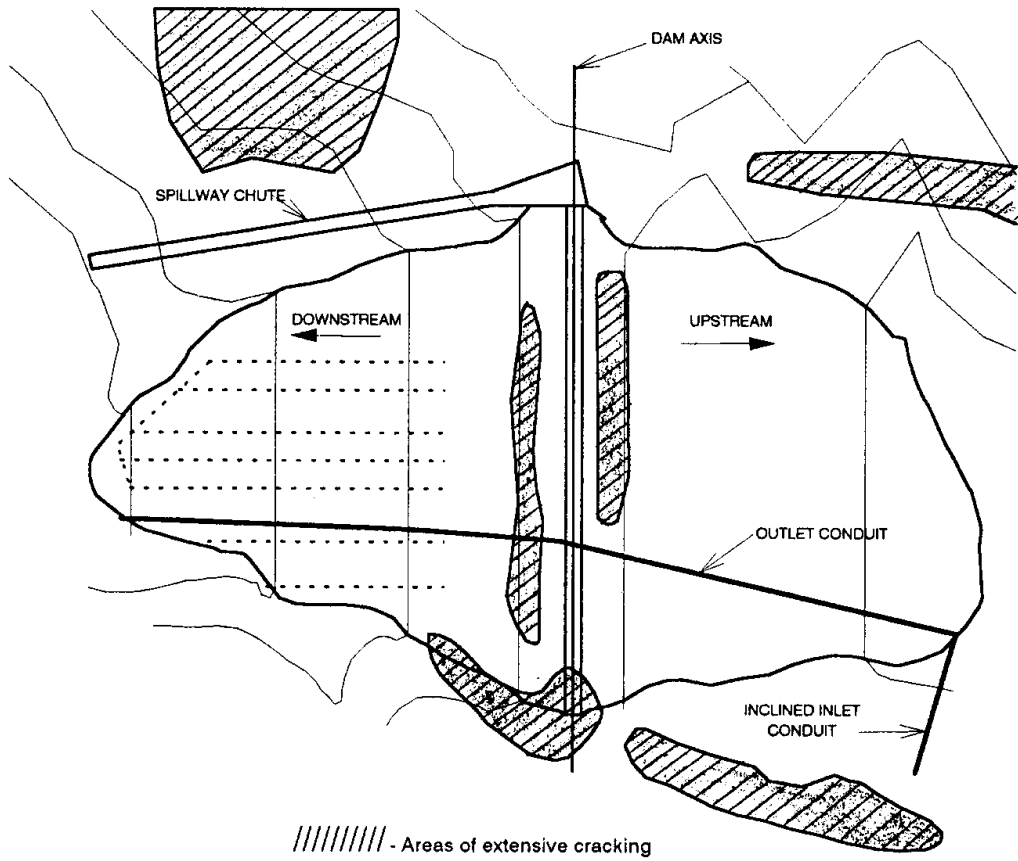
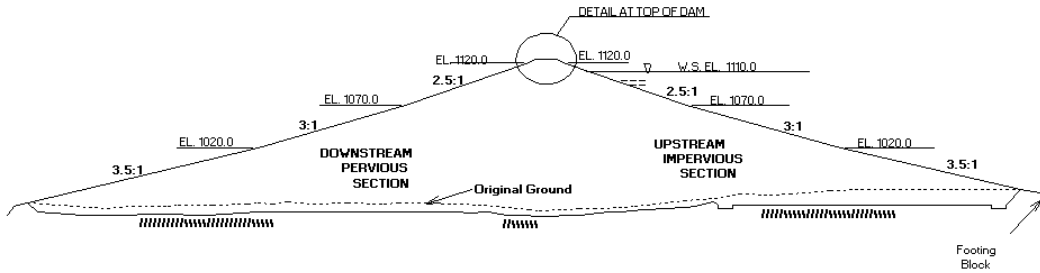
FIGURE 4 - AUSTRIAN DAM

The earthquake caused a maximum settlement of 2.8 feet, with significant settlement occurring over the right three-quarters of the dam (Rodda et al 1990). Maximum downstream movement was 1.1 feet near the spillway wall on the right abutment, and maximum upstream movement was 0.4 feet at the left quarter point of the embankment. Longitudinal cracks up to 1 foot wide and 14 feet deep occurred within the upper 25 percent of the upstream and downstream faces. Shallower longitudinal cracks were found on much of the downstream face. Crest cracking was confined to the abutment contact areas. Transverse cracking and embankment separation from the spillway structure occurred to a depth of 23 feet and a maximum width of 10 inches. The separation was apparently due to a combination of soil structure interaction, embankment settlement along the very steep abutment and permanent wall deflection. A transverse crack was traced 30 feet down the left abutment, where the dam had been constructed on weathered, highly fractured rock.

The settlement and cracking at both ends of the dam crest was partially the result of low density embankment that was rapidly placed to top out the dam after the start of the 1950 rainy season. The difficulty of compacting between the spillway wing and return walls is also a probable cause of the settlement and cracking next to the spillway. Embankment construction on the poor rock on the upper left abutment was an acknowledged expedient to prevent the dam from over topping. An attempt was made to grout the foundation in this area immediately after the dam was completed.

Spillway damage consisted primarily of numerous transverse tension cracks. The structure appears to have elongated about one foot, toppling the end walls in the process. Some cutoff walls were damaged. Voids up to 6 inches wide were observed upstream from other cutoff walls. The walls of the "U" shaped section flexed inward, lifting the base of walls and adjacent portions of the floor slab up to one inch. The only damage to the outlet works consisted of the tipping of a valve actuator steel tank, located at the top of the inclined facility. Ground cracking occurred in and above the reservoir area and on the abutments.

Repairs to Austrian Dam began within days following the earthquake, so that the dam would not be over topped during the rainy season and could store water for use in 1990. Cracked embankment on the upstream face and embankment and foundation materials at the abutments were excavated and replaced with compacted embankment (Rodda and Pardini 1990). Crack stopper zones were included near the abutments (Fig.5). The grout curtain at the left abutment contact was regouted. A toe drain was installed to improve drainage from the finger drains and provide seepage monitoring during reservoir filling. The cracks in the spillway were epoxy grouted to allow immediate use if needed. The spillway and earthwork repairs were essentially complete in about an 8-week period.

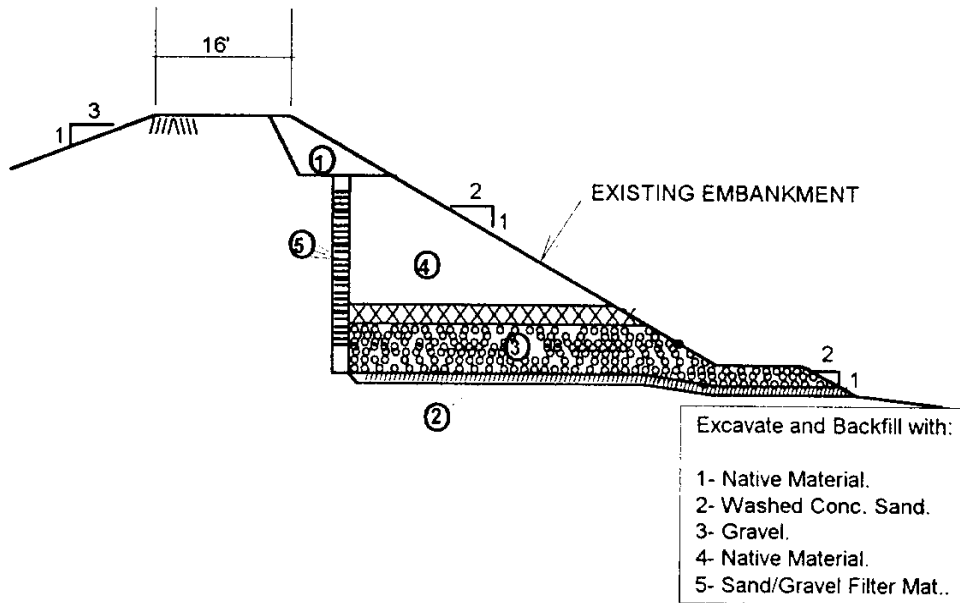
FIGURE 6 - PIGEON PASS DAM, CHIMNEY DRAIN INSTALLATION

In December 1978, transverse cracks were discovered in the embankment. The causes of the cracks were determined to be a combination of embankment shrinkage and differential foundation settlement due to hydrocompaction and possibly seismic shaking. The largest crack was repaired by excavating and placing compacted embankment. The proximity of a nearby active fault, the San Jacinto at 4 miles, dictated that

repairs include more than treating identified cracks. Cracks could rapidly reopen or new ones form in the rather brittle embankment during an earthquake, particularly where the dam is founded on cohesionless soils. A chimney drain was placed in a trench in the downstream slope to act as a crack stopper. Gallery drains were provided as outfalls from the chimney (Fig.6).

The work was safely accomplished in a short time without the aid of trench supports. The chimney material is a well graded minus 1-1/2 inch concrete mix. It was dumped in place, wet, from ready mix trucks. The gallery material is 3/8 inch pea gravel; it is filtered by concrete sand.

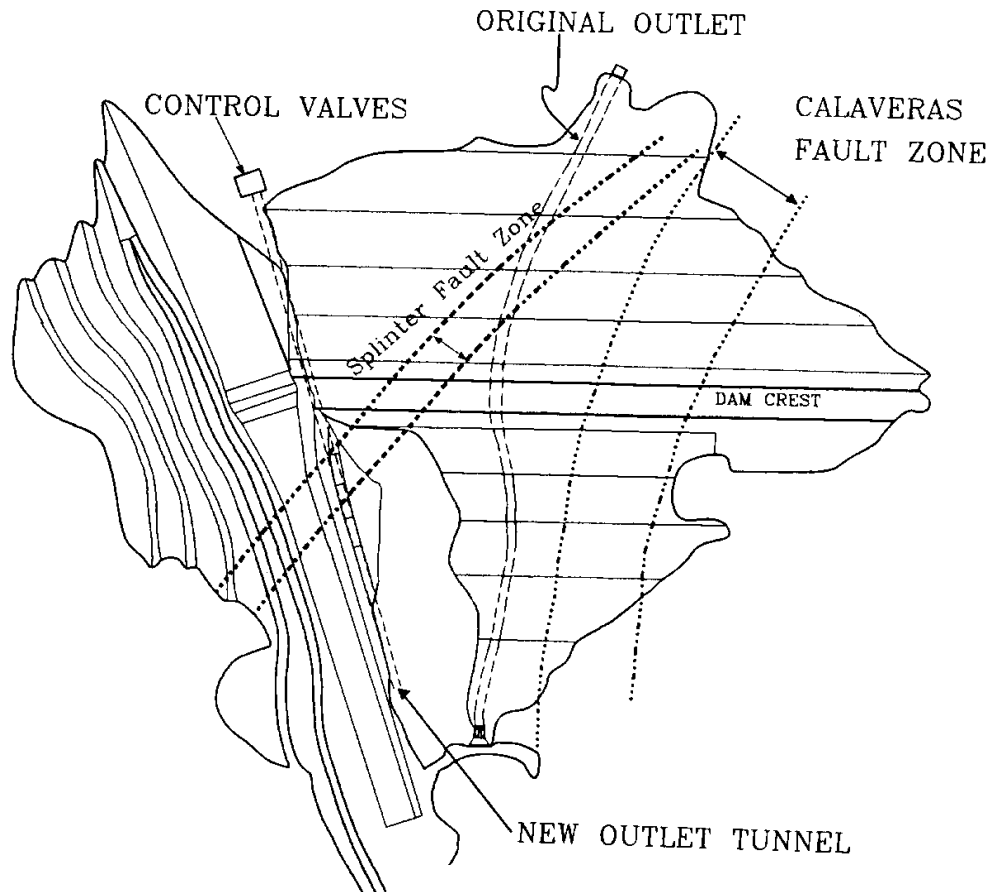
FIGURE 7 - COYOTE DAM, PLAN VIEW

Coyote Dam is a 140-foot high zoned embankment dam completed in 1936 across the known active Calaveras fault in southern Santa Clara County. The apparent active fault trace was mapped on the excavated foundation surface and a 50-inch diameter outlet conduit was aligned to avoid it. A control valve was installed at the upstream end so that the steel-lined reinforced concrete conduit would not be under pressure if it was ruptured by splinter faulting or a slight shift in the active fault trace.

While the new outlet virtually eliminates the conduit rupture hazard, DSOD is concerned about piping occurring through upper abutment and/or embankment cracking caused by fault movement. A reservoir

for regulation, a valve was installed on the downstream end of the conduit. However, pressurization of the conduit was restricted to times when the contents of the reservoir could be captured by Leroy Anderson Reservoir located 3 miles downstream. When, in the late 1980s, continued accumulation of sediments necessitated another outlet modification, an outlet tunnel was constructed through the right abutment just above the level of the sediments. The new outlet tunnel is 200 to 300 feet farther from the active fault trace (Fig.7). The control valves are located upstream of a splinter fault crossing the tunnel alignment so that the tunnel is free flowing when crossing this feature. The tunnel is articulated into 10-foot long segments connected by water stops through the splinter fault zone.
