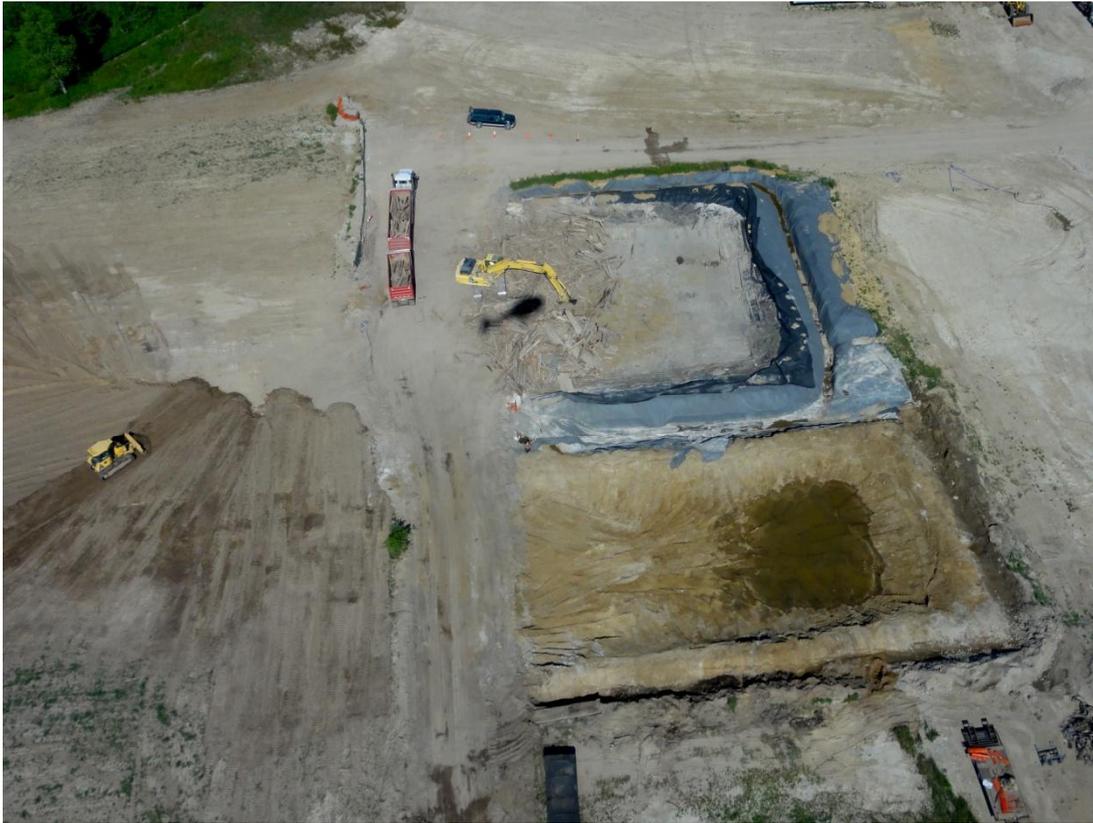
1. Division A, excavator loading timbers into trucks in Cell 4.

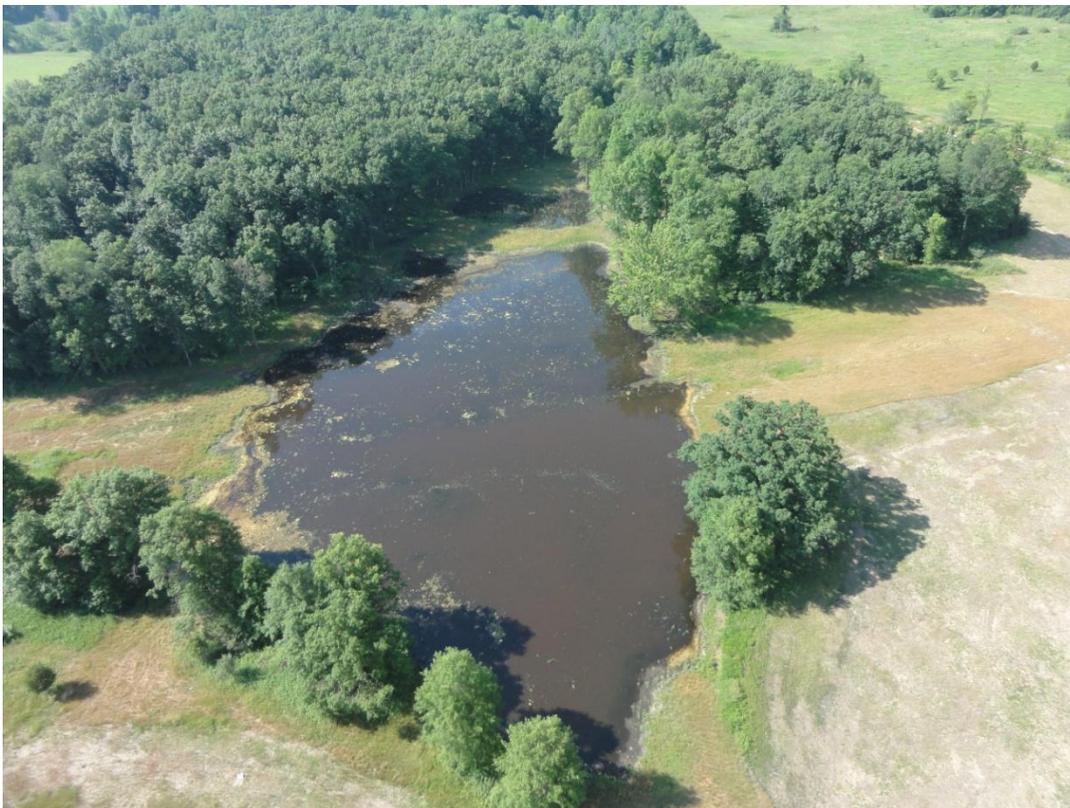
2. Release point, no sheen noted today.

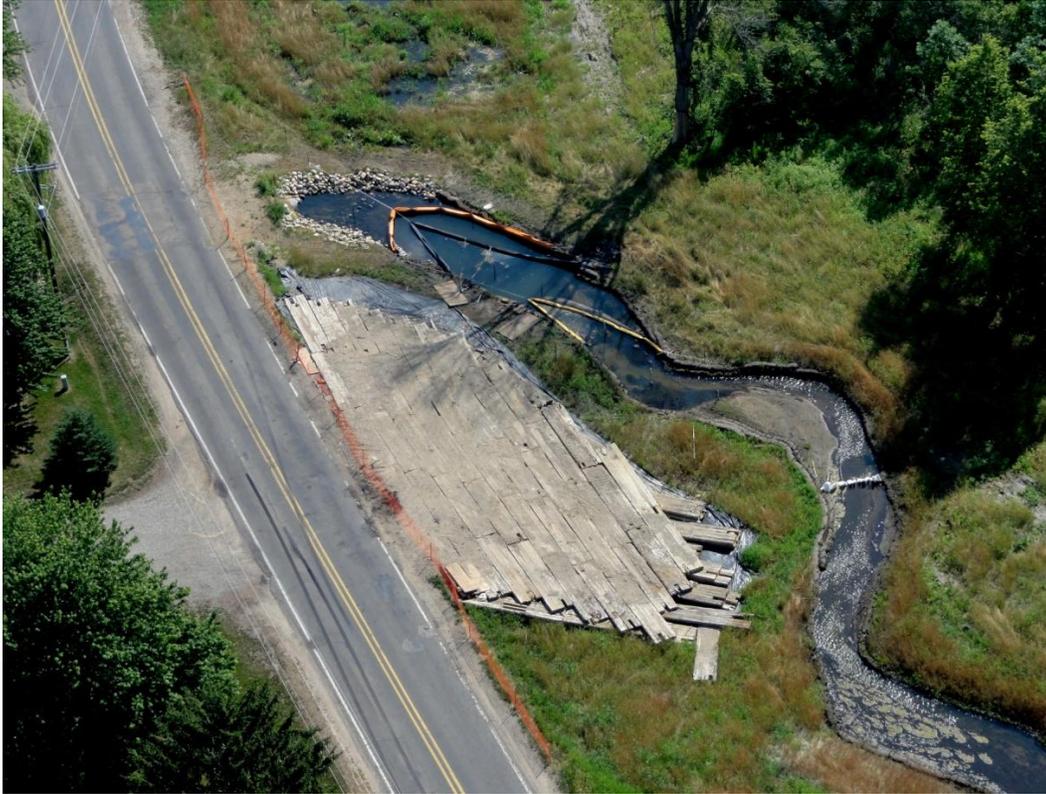
**3. B5 Sediment Trap, no activity noted at time of overflight.**

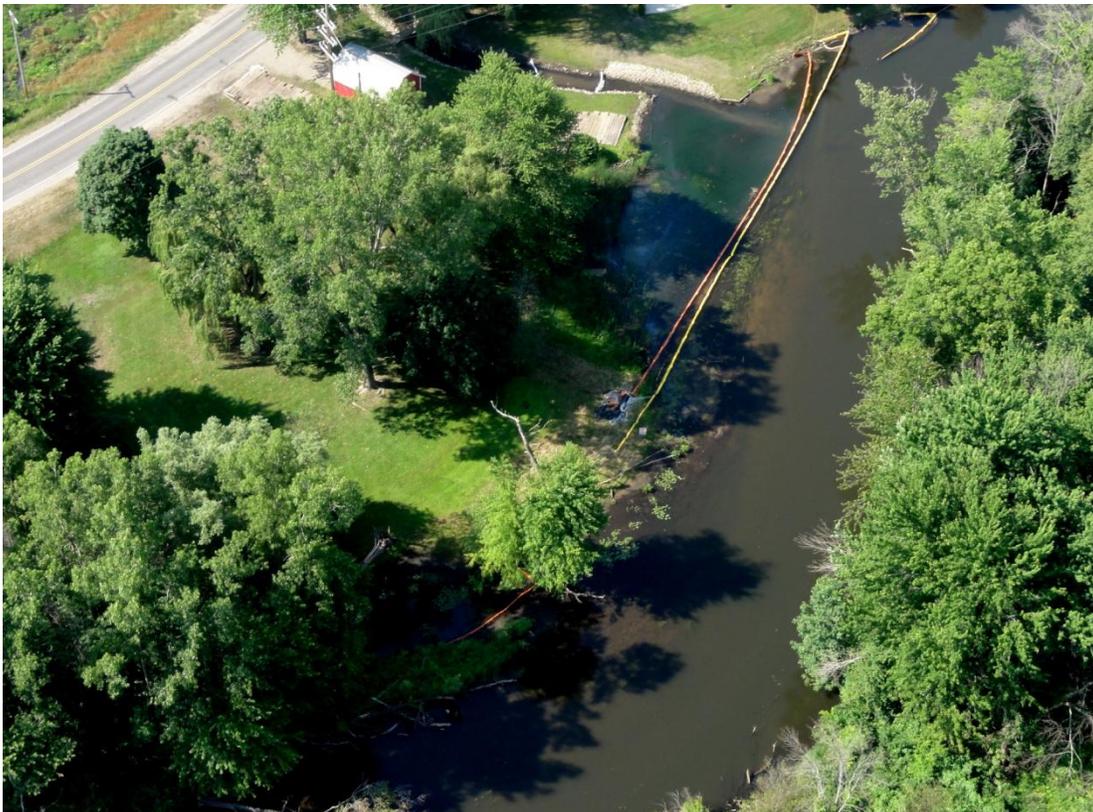
**4. Confluence and pond north of confluence, seen observed at both locations.**

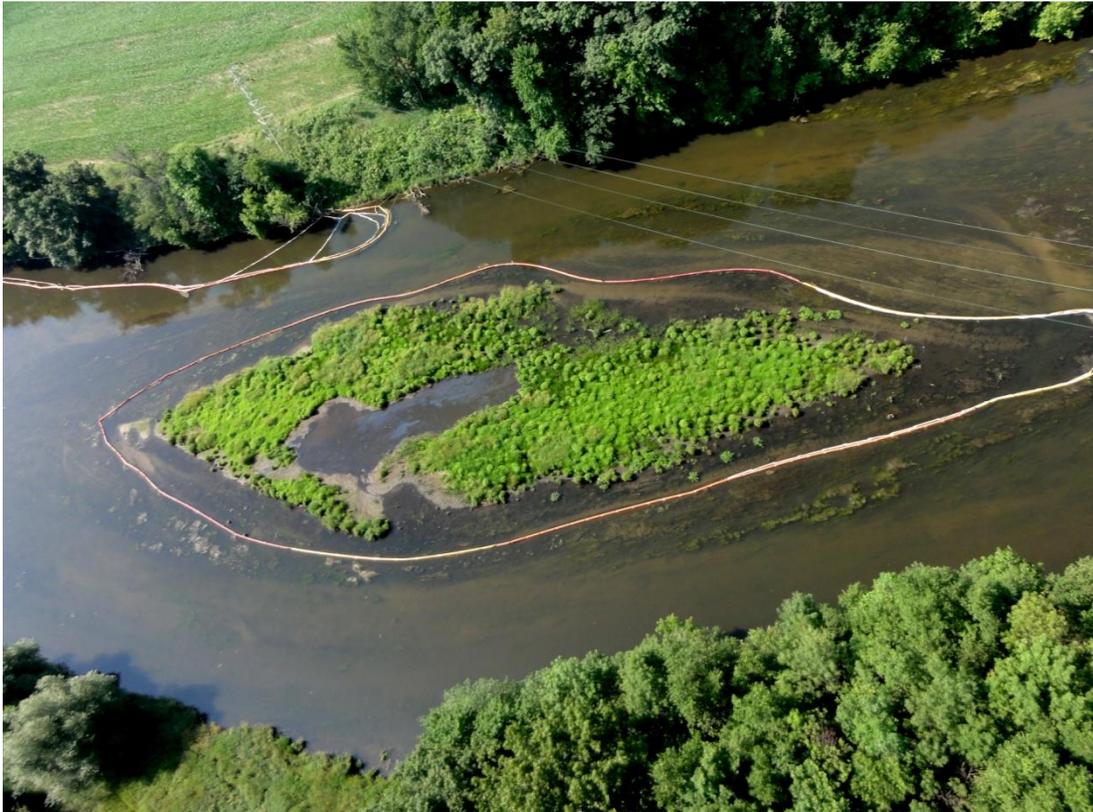
**5. MP4.0 and Island E, no activity noted today, sheen observed on island.**

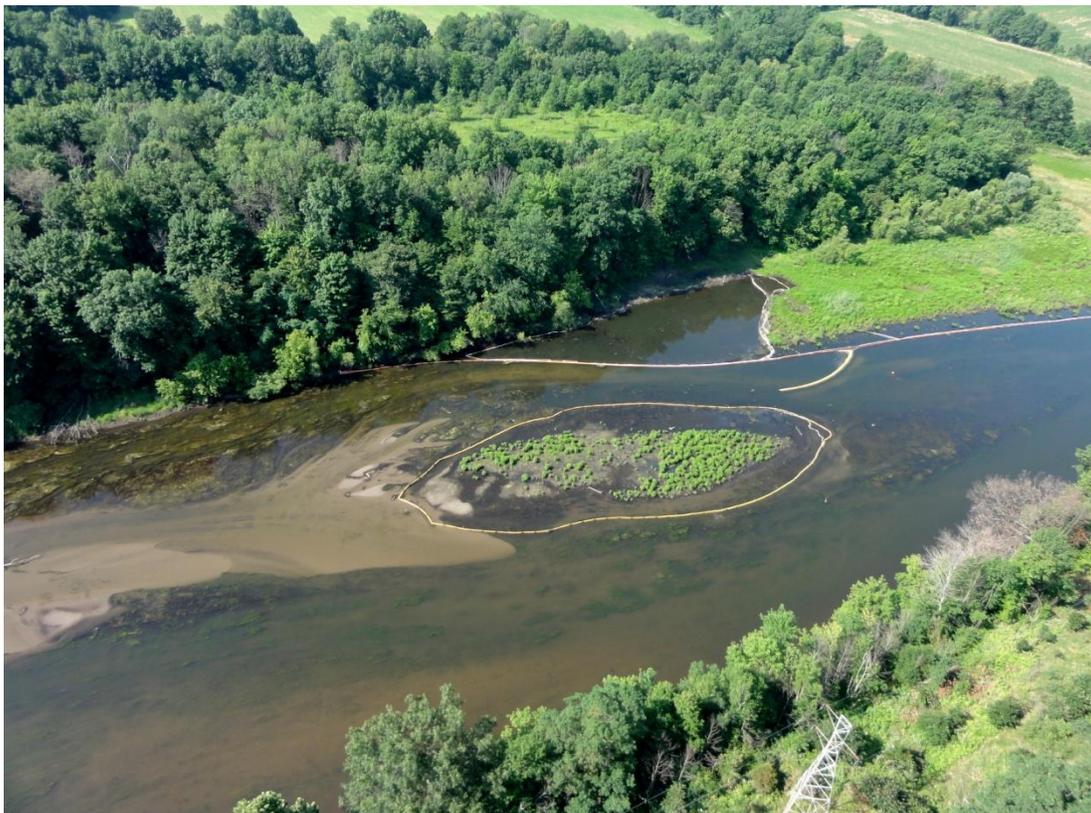
**6. MP4.5 and Island F, minor sheen observed.**

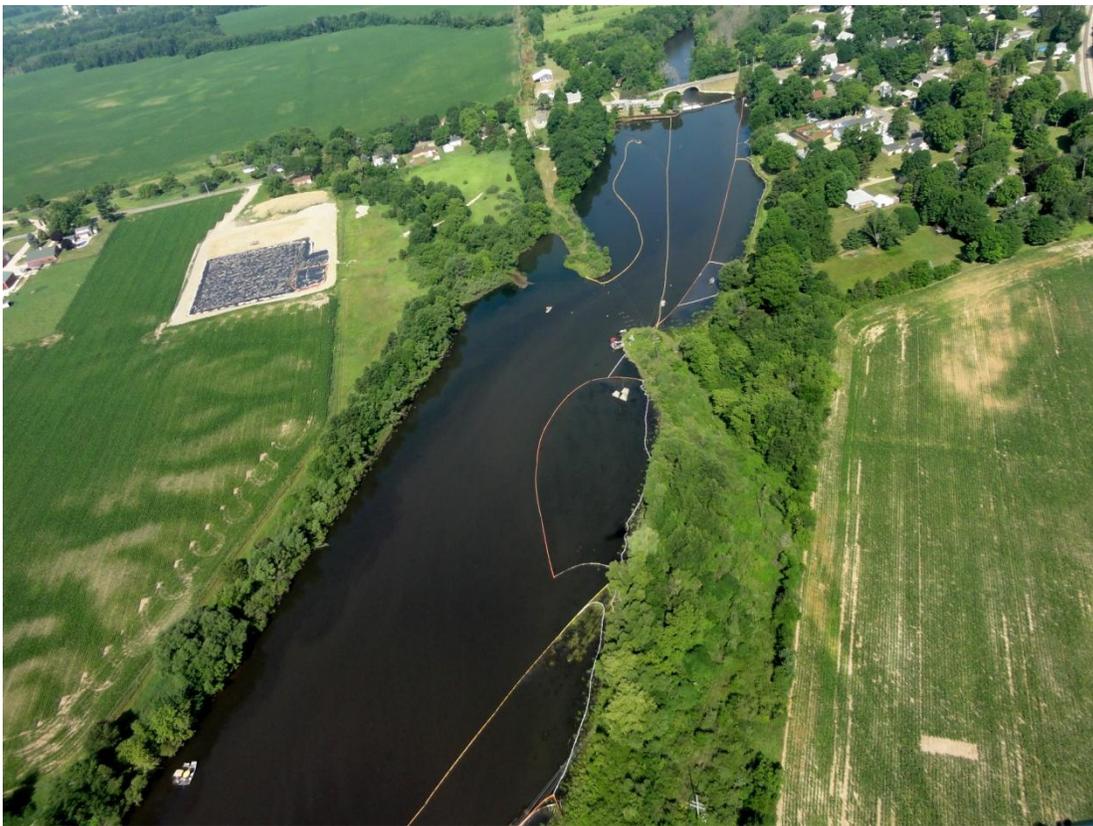
**8. Boom configuration above Ceresco Dam.**

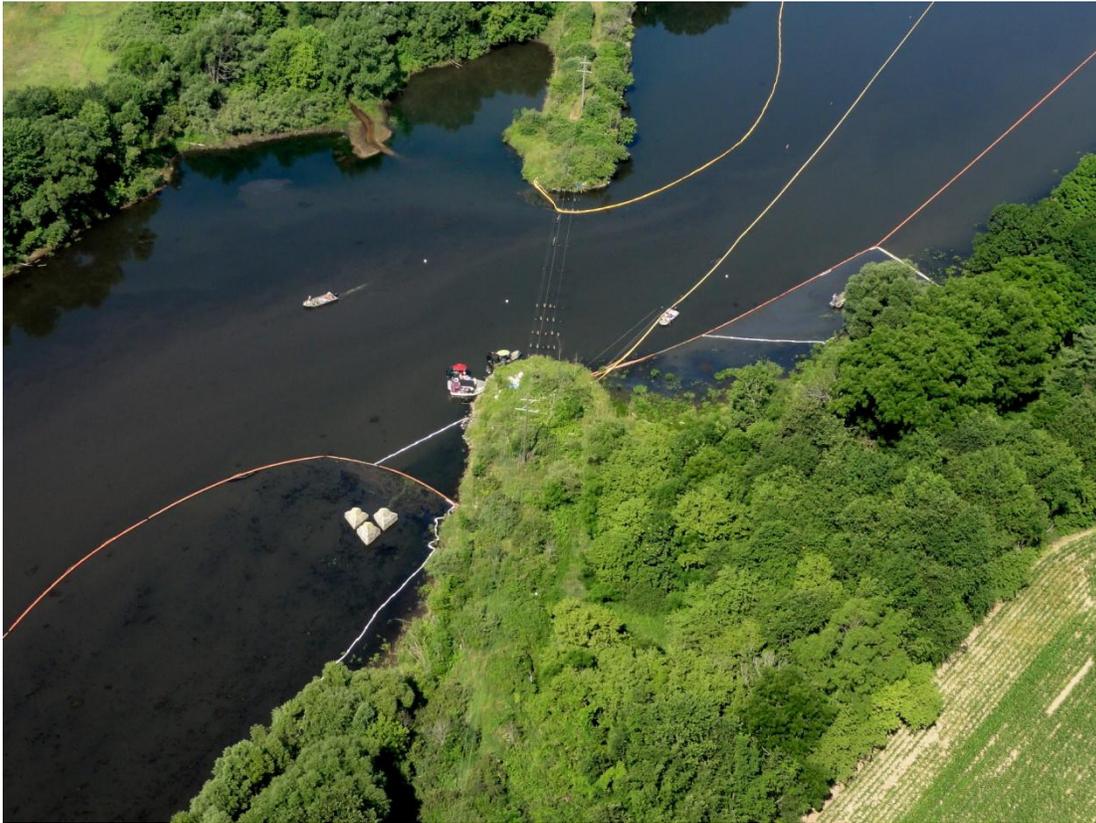
**9. MP5.55, sheen observed within boom.**

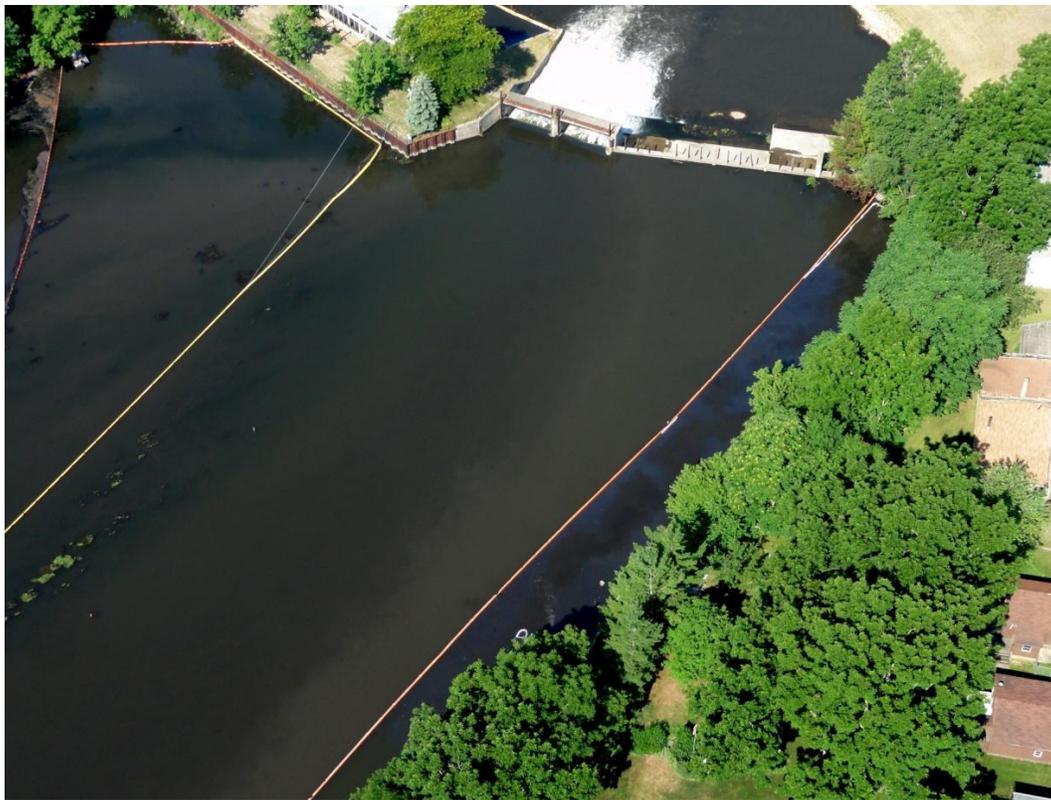
**10. MP5.75 RDB, sheen observed within the boom.**

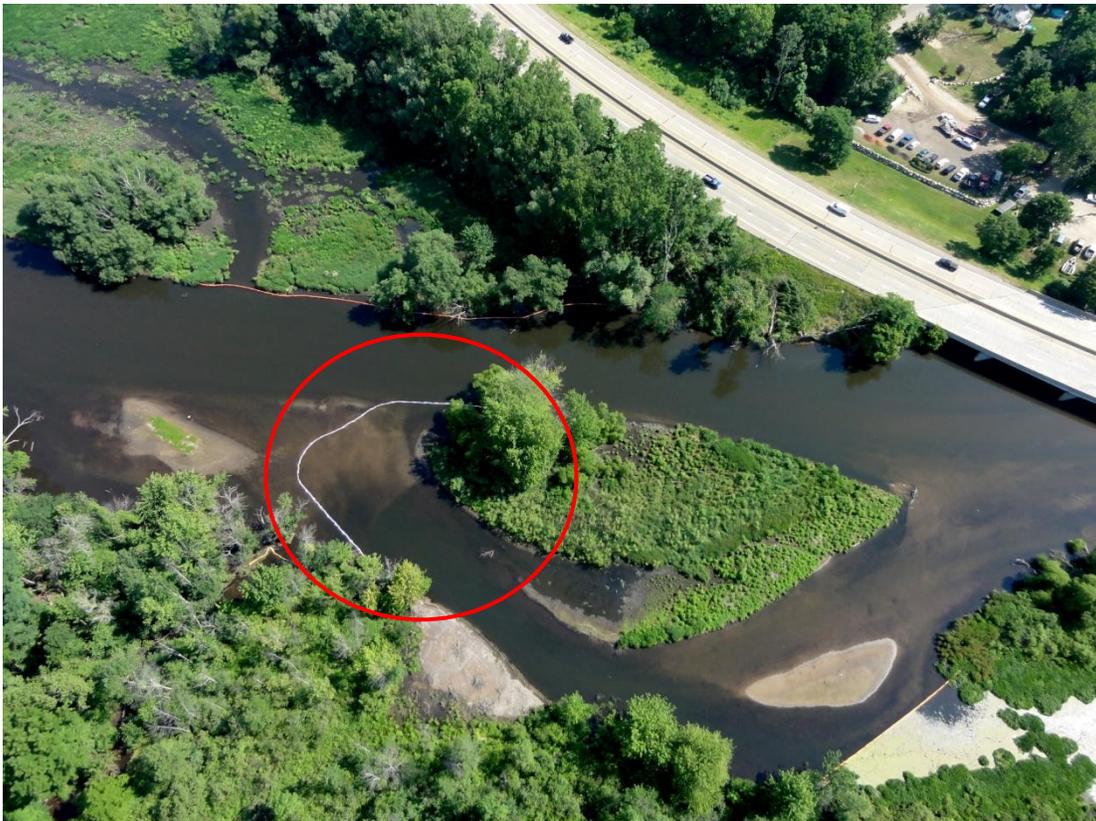
**12. MP15.0 Island, new boom installed, no significant sheen observed.**

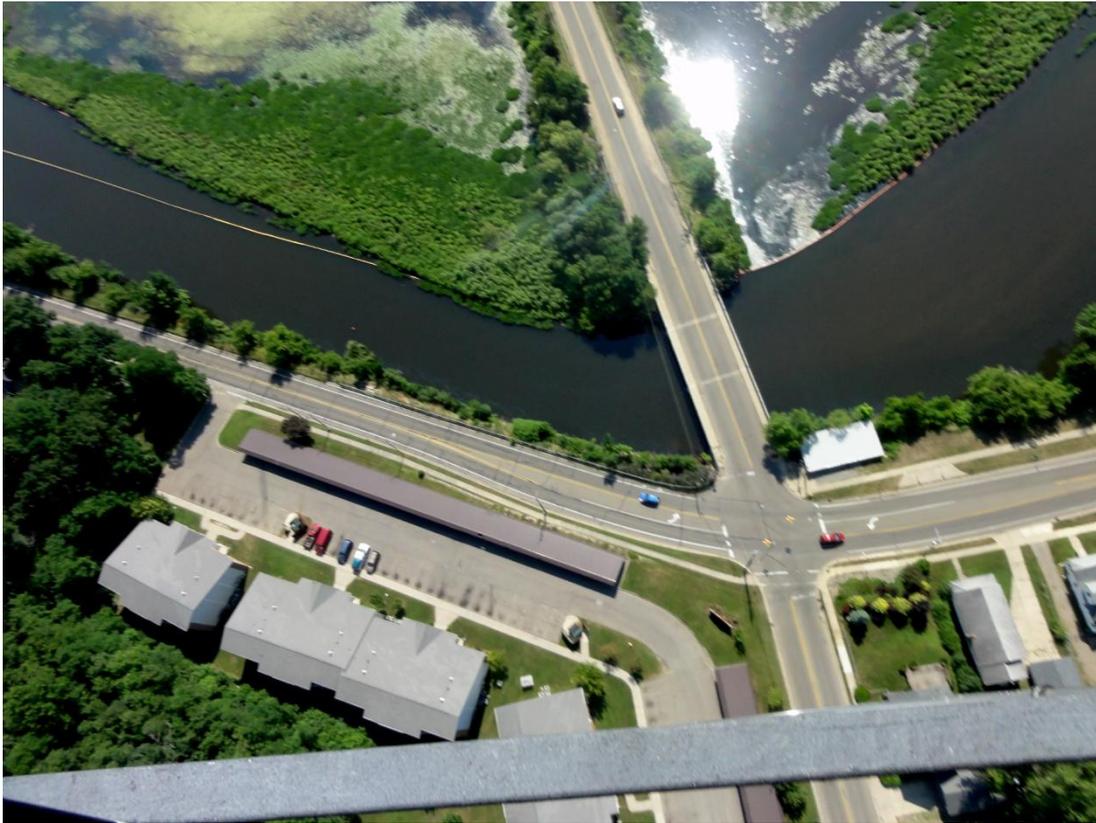
**13. MP15.25 Mill Pond, minor sheen noted along LDB.**

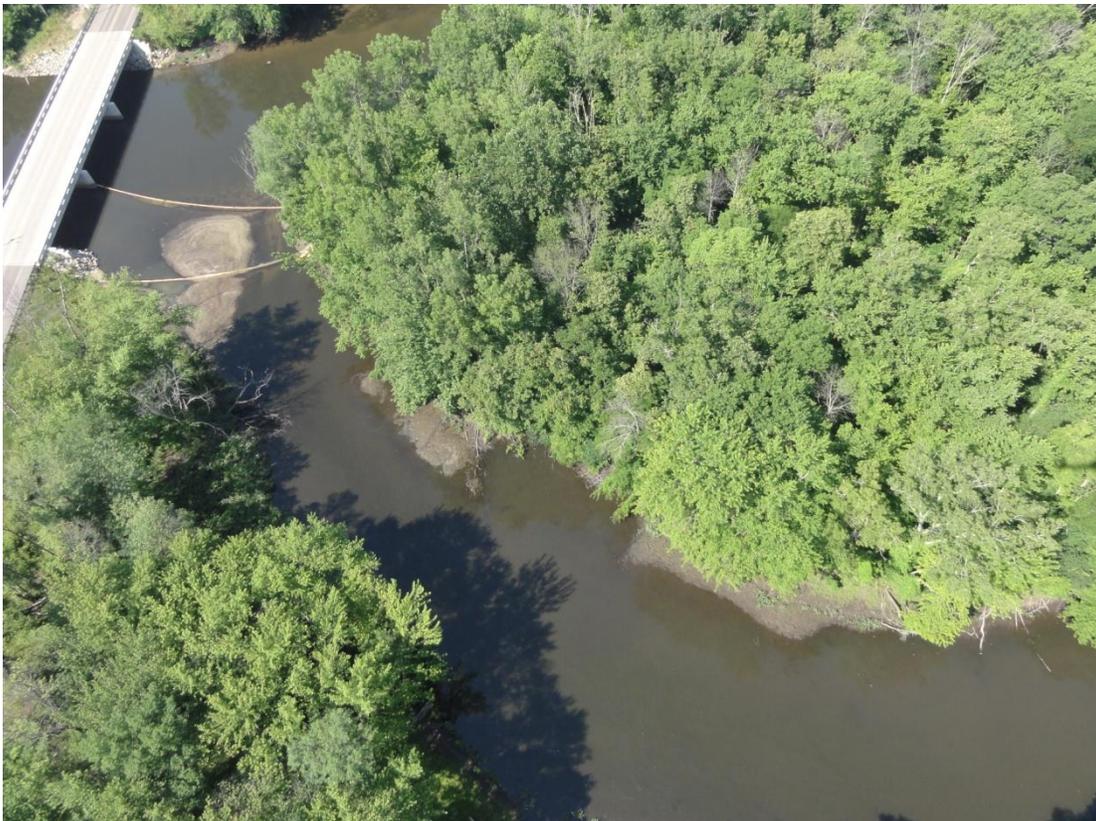
**14. MP21.5 Oxbow, sheen observed within boom.**

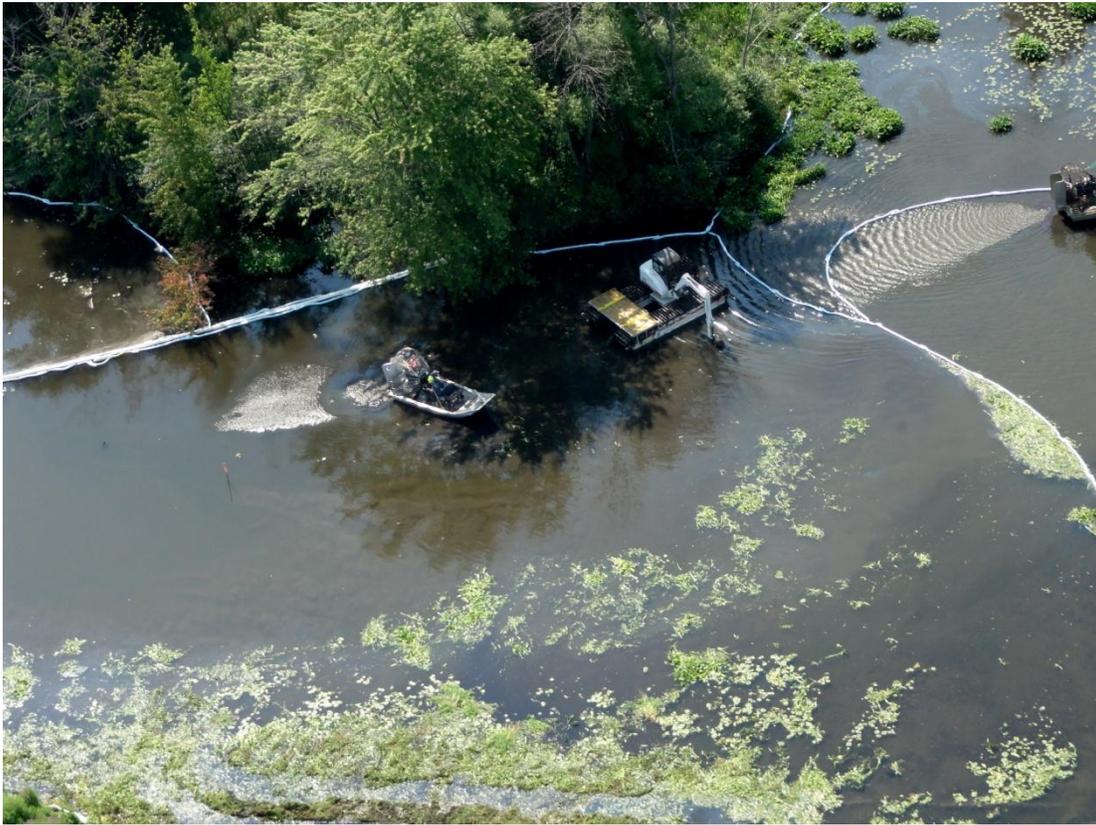
**15. Delta A, vegetation cutter in operation.**

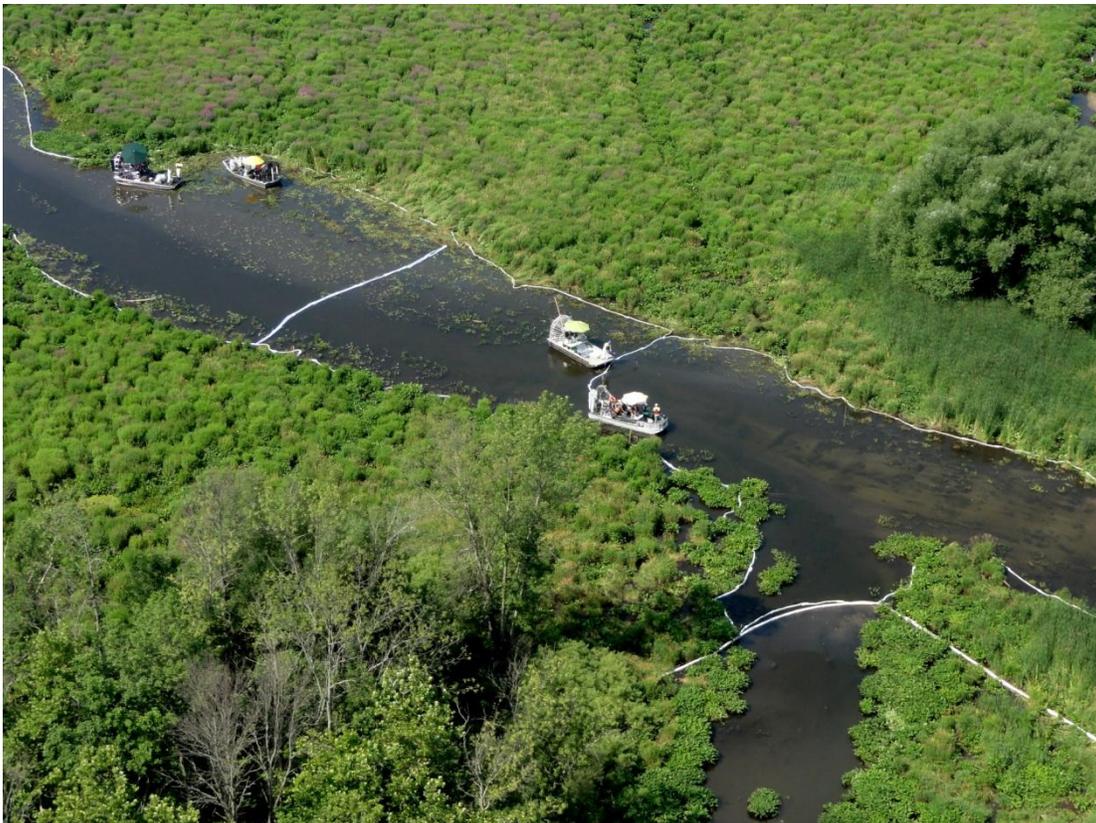
**16. Morrow Lake Delta, submerged oil recovery.**

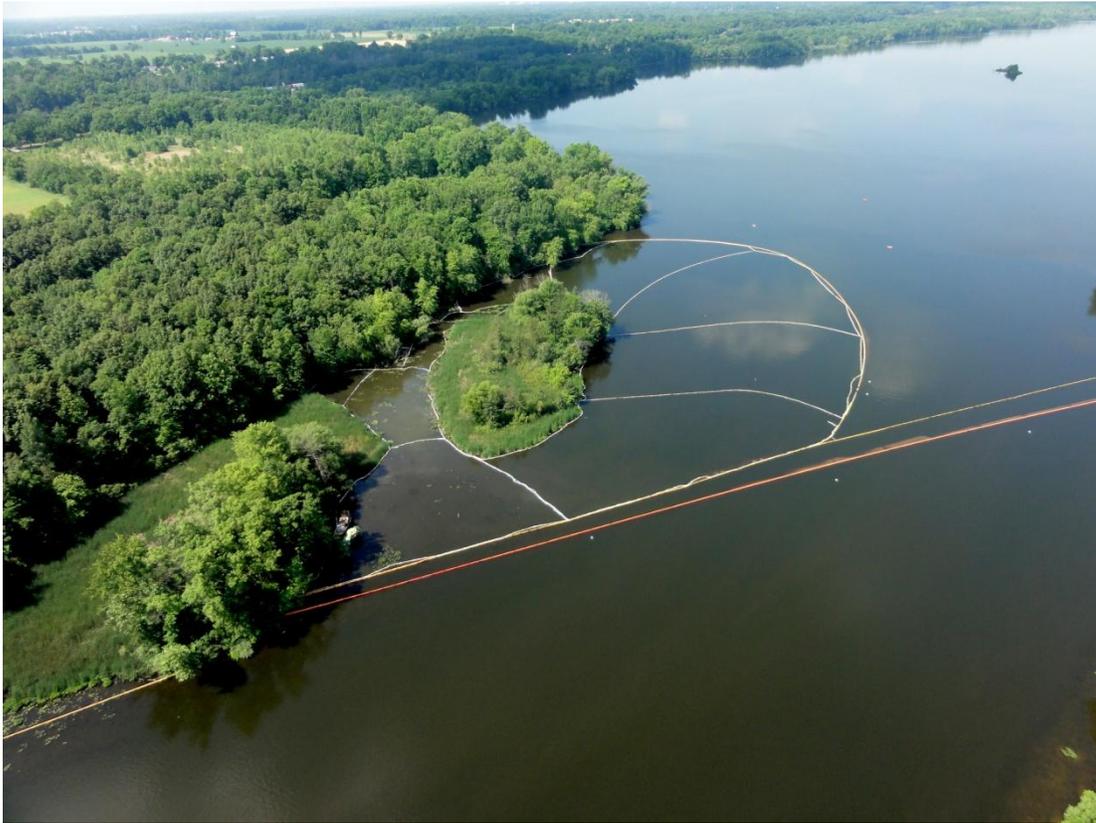
**17. MP37.75, submerged oil work continues.**

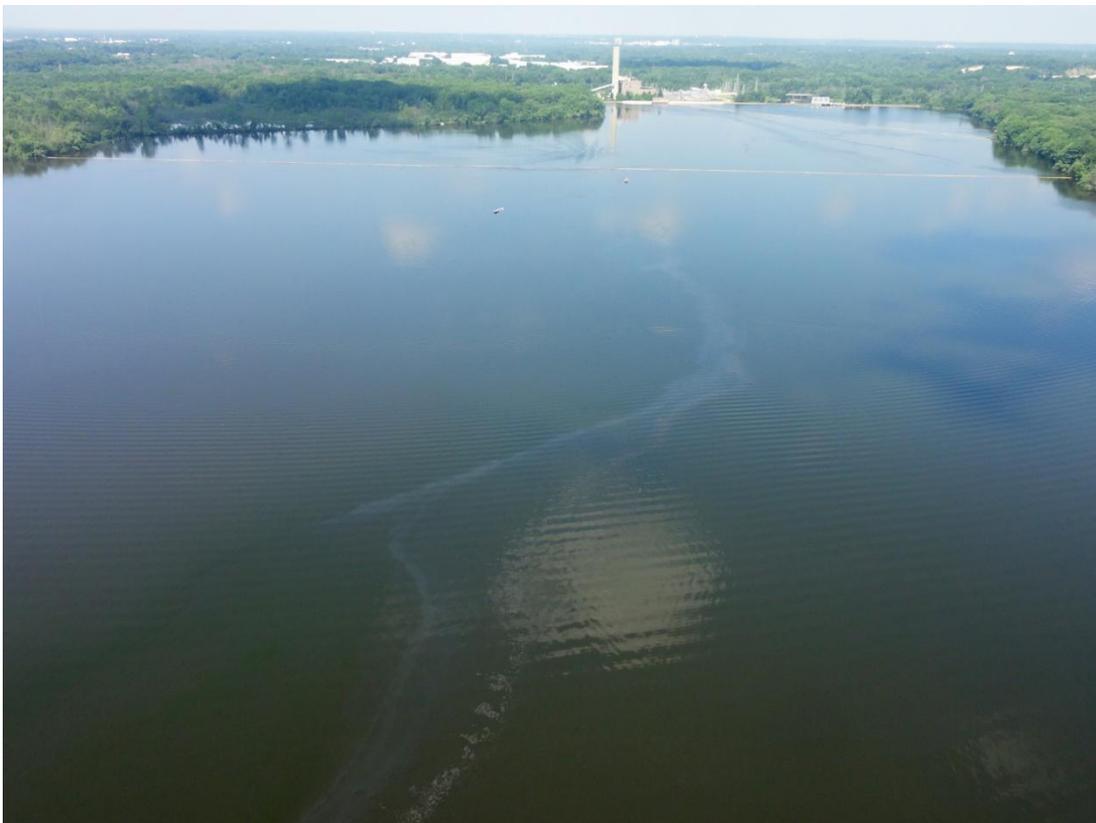
**18. Sheen trail on Morrow Lake, looking west toward E5.**

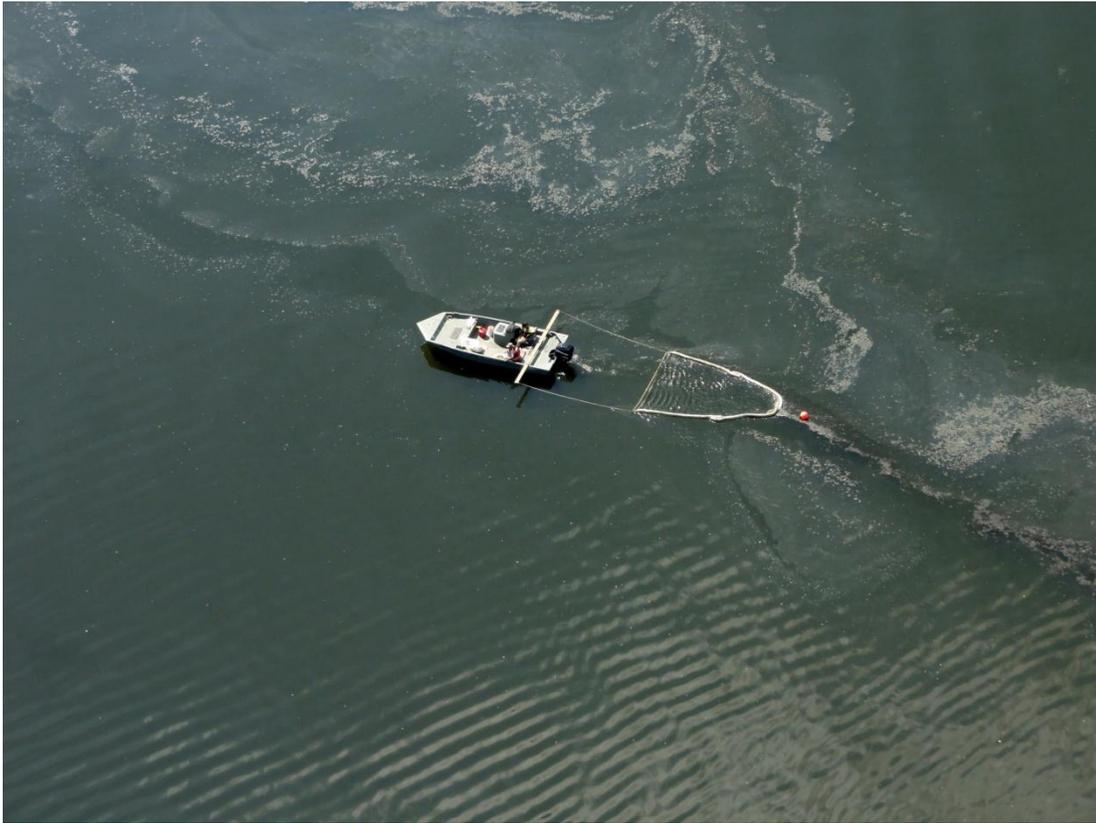
**19. Close up of skimmer boat.**

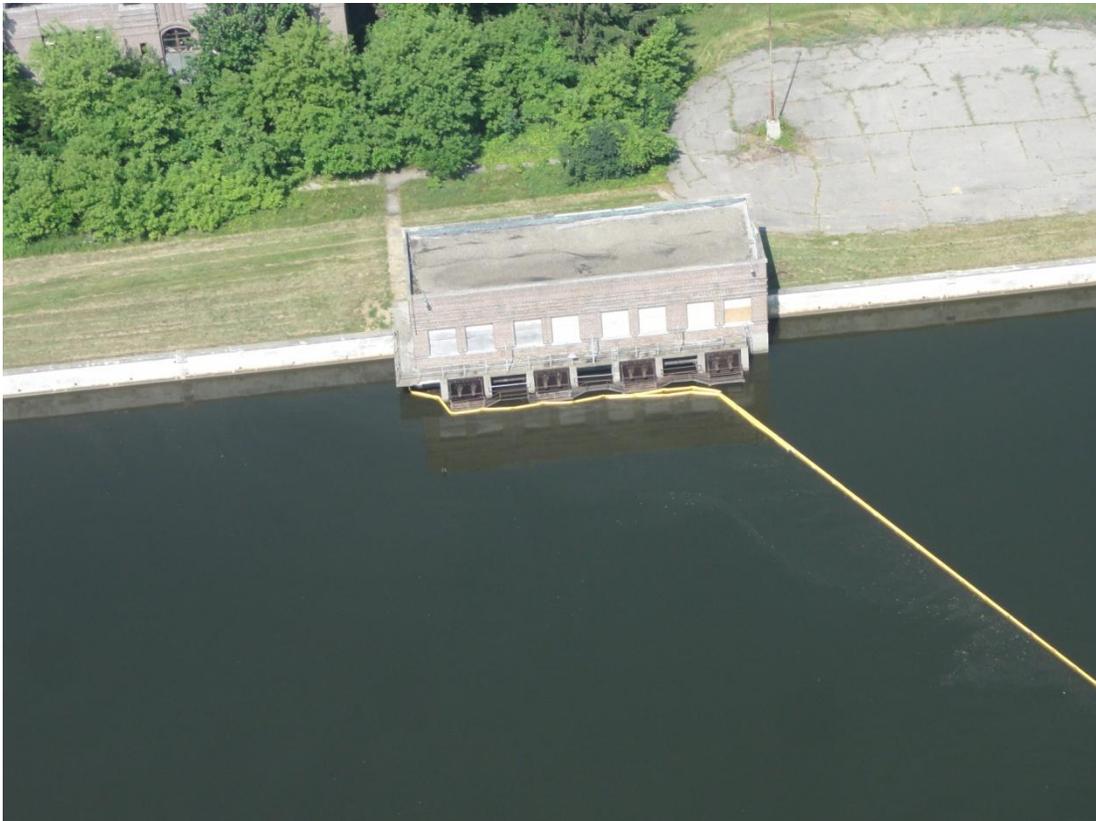
**20. Control Point E6, no sheen, some minor debris observed.**
