July 20-22, 2011 Overflight Photo Log

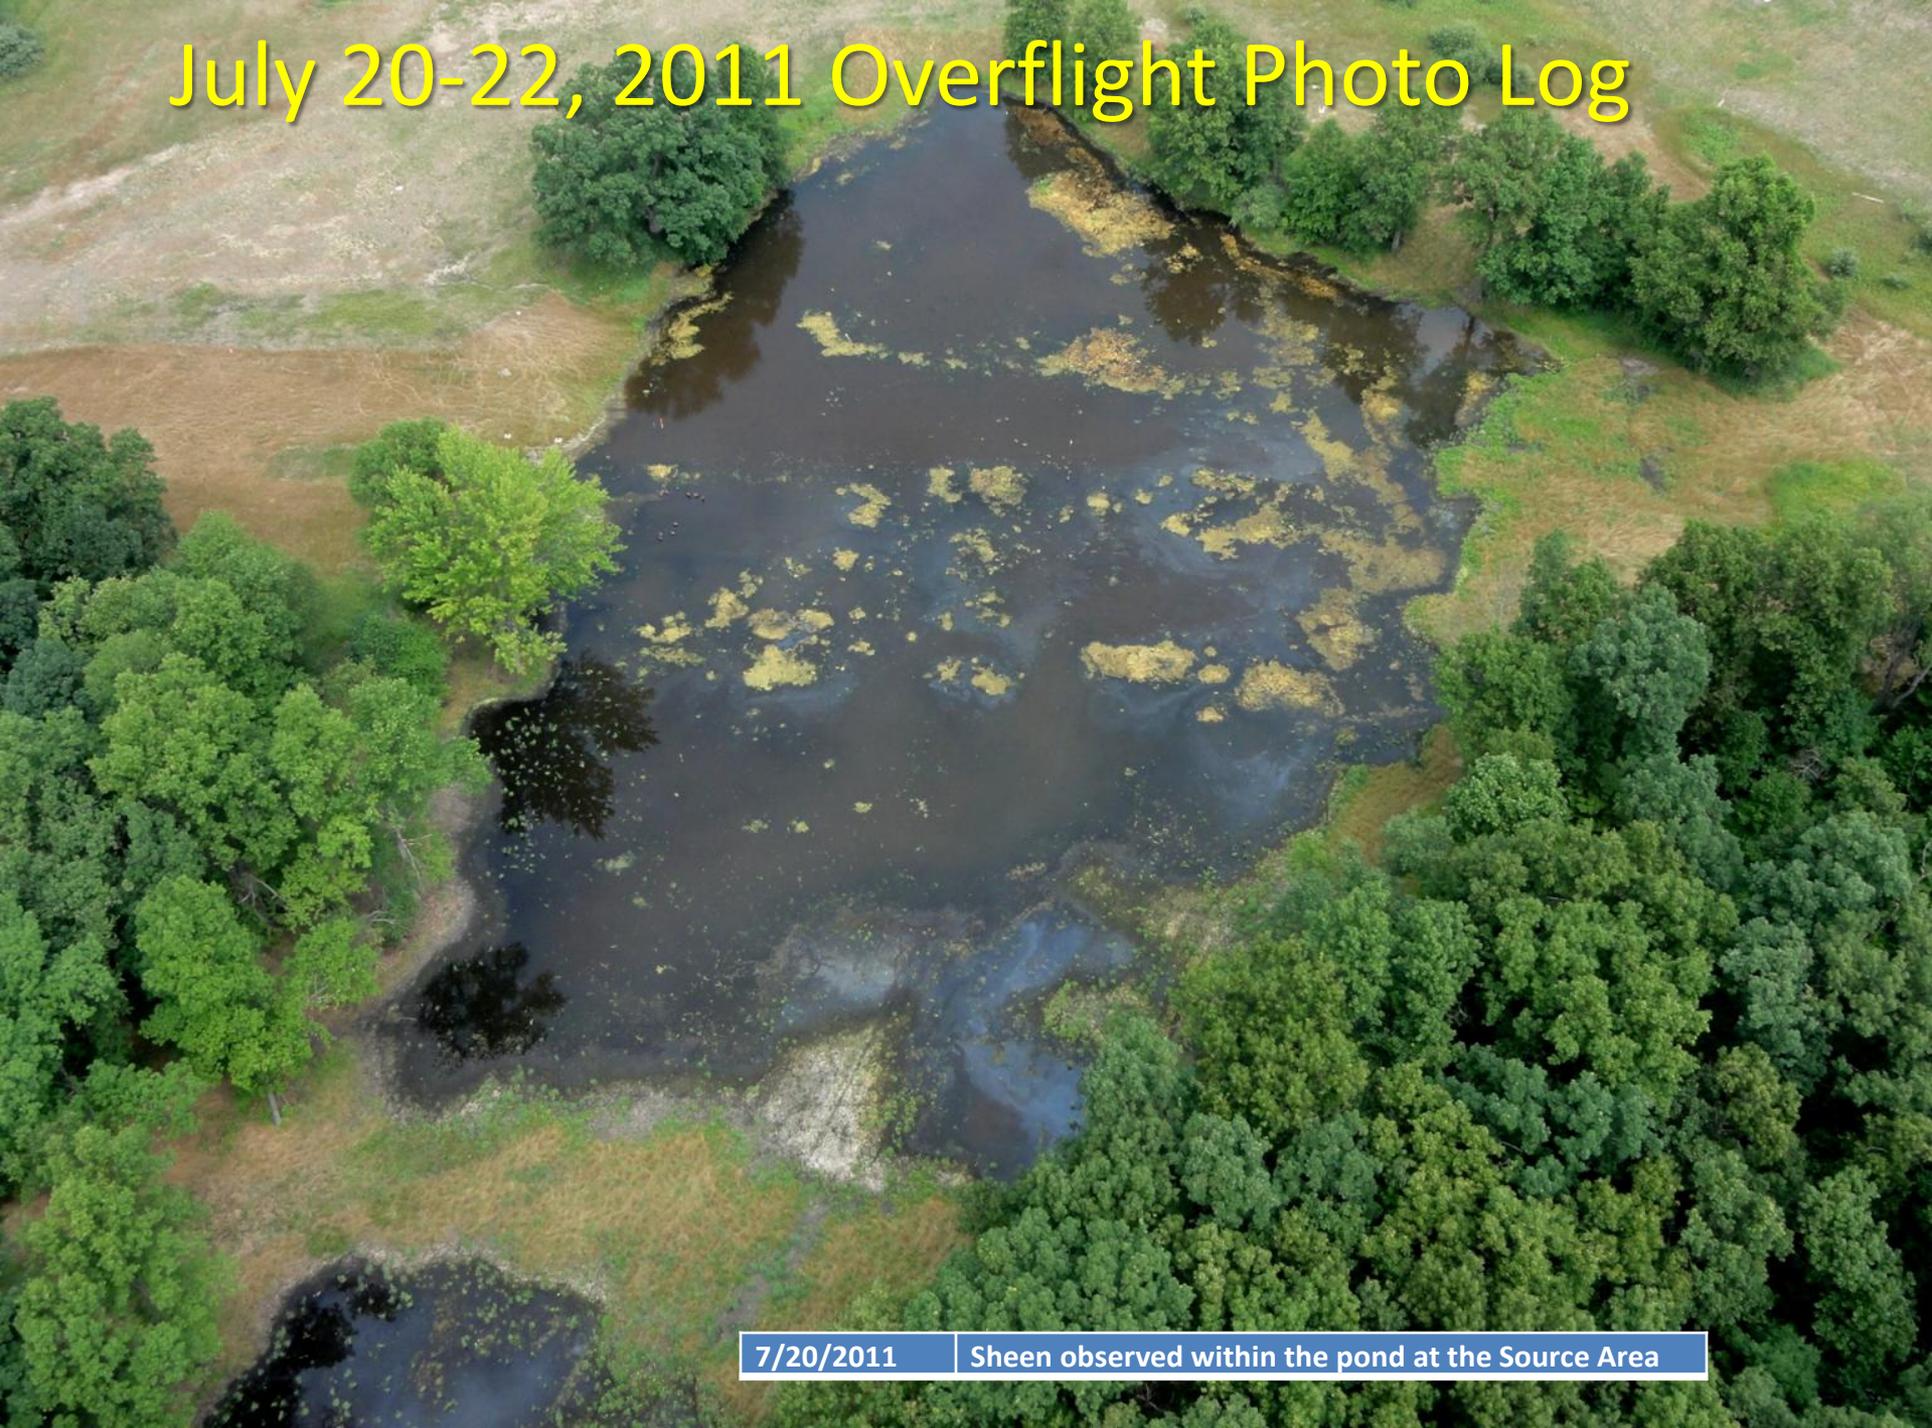
7/20/2011

Sheen observed within the pond at the Source Area

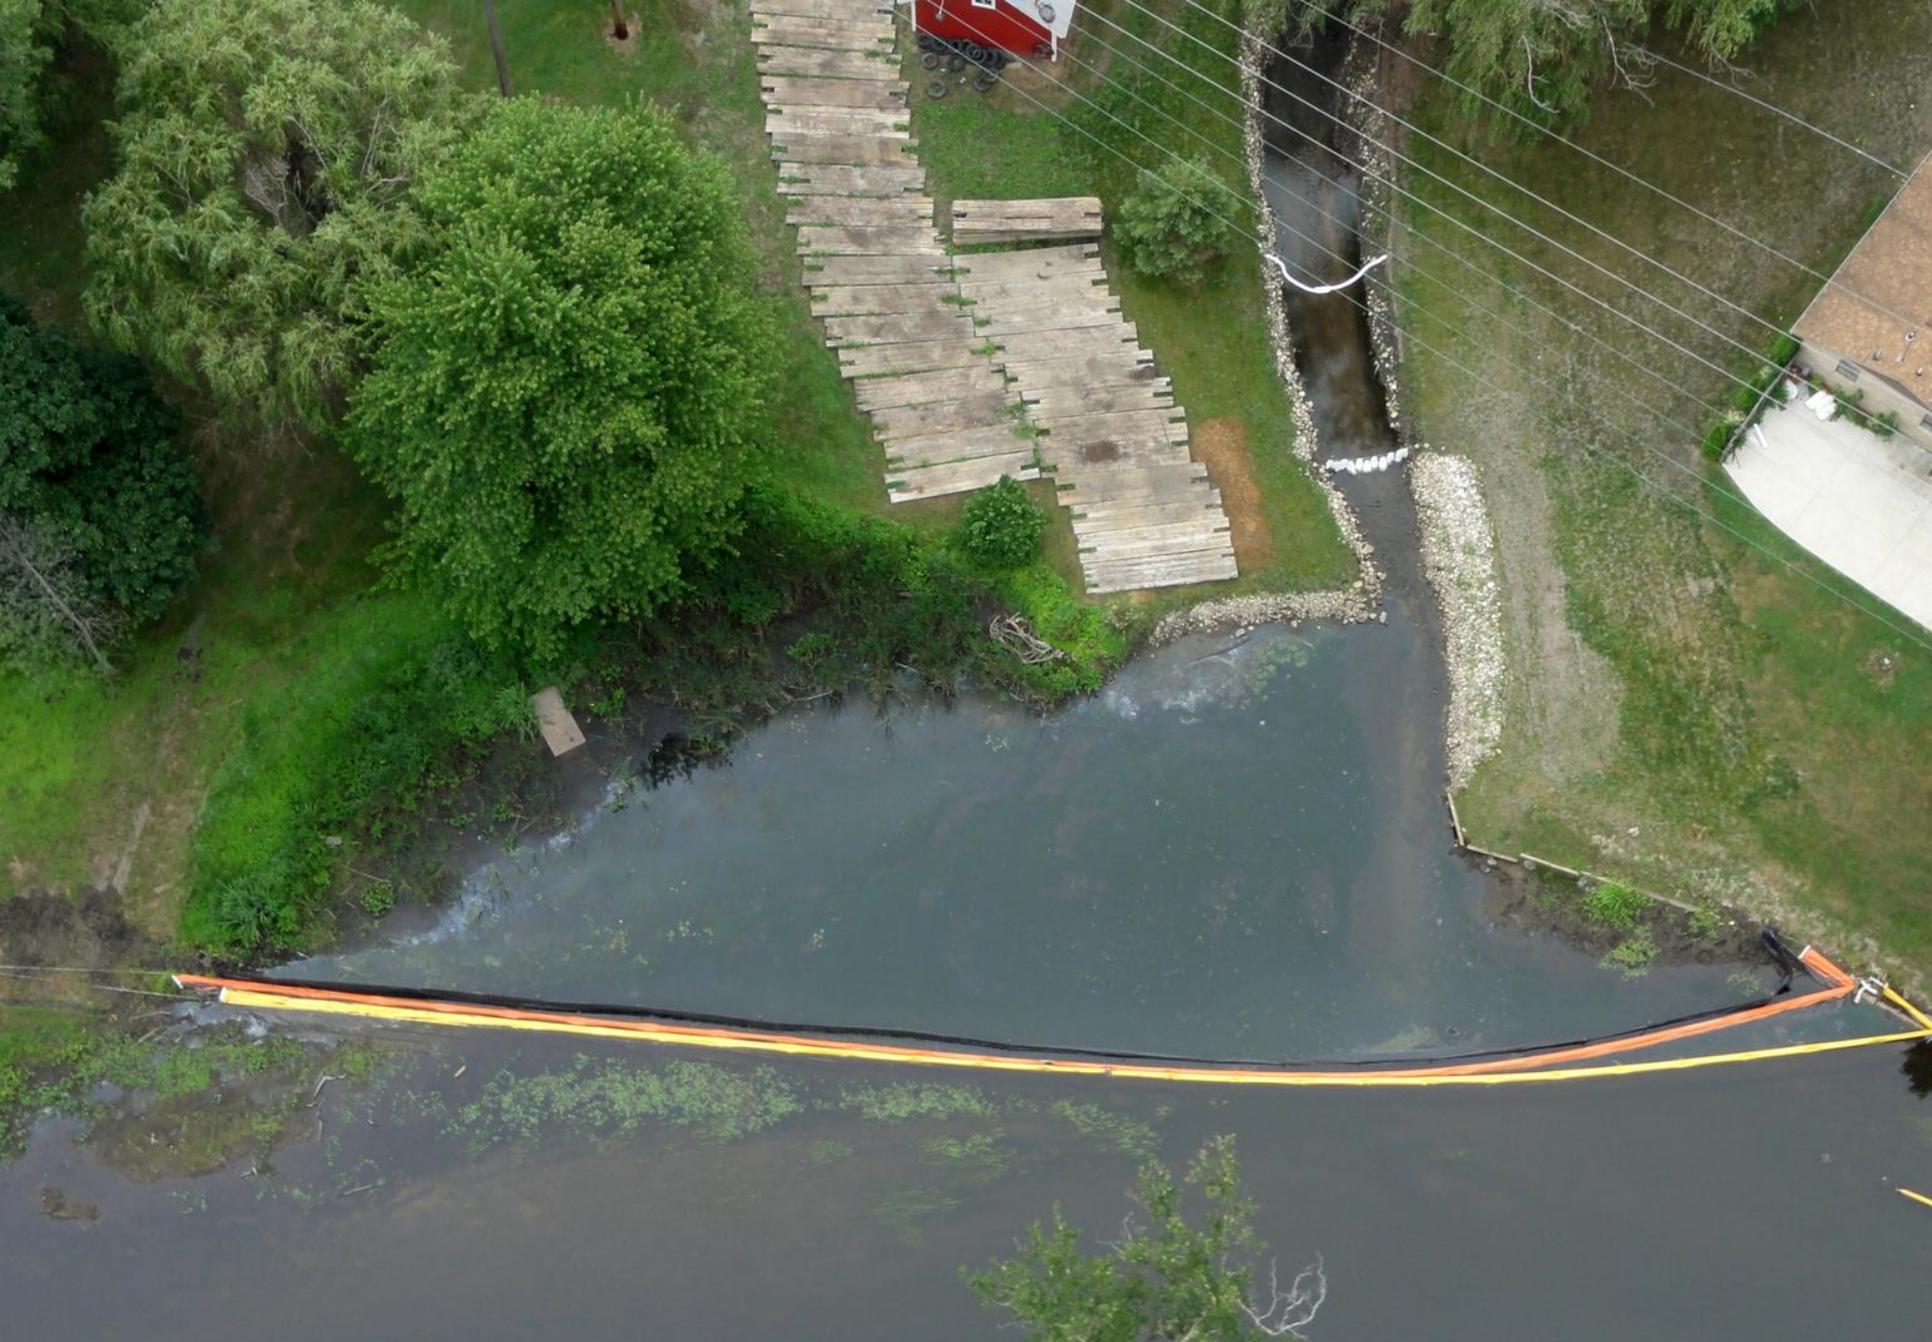
7/22/2011

Slight sheen observed at the confluence of Talmadge Creek and the Kalamazoo River

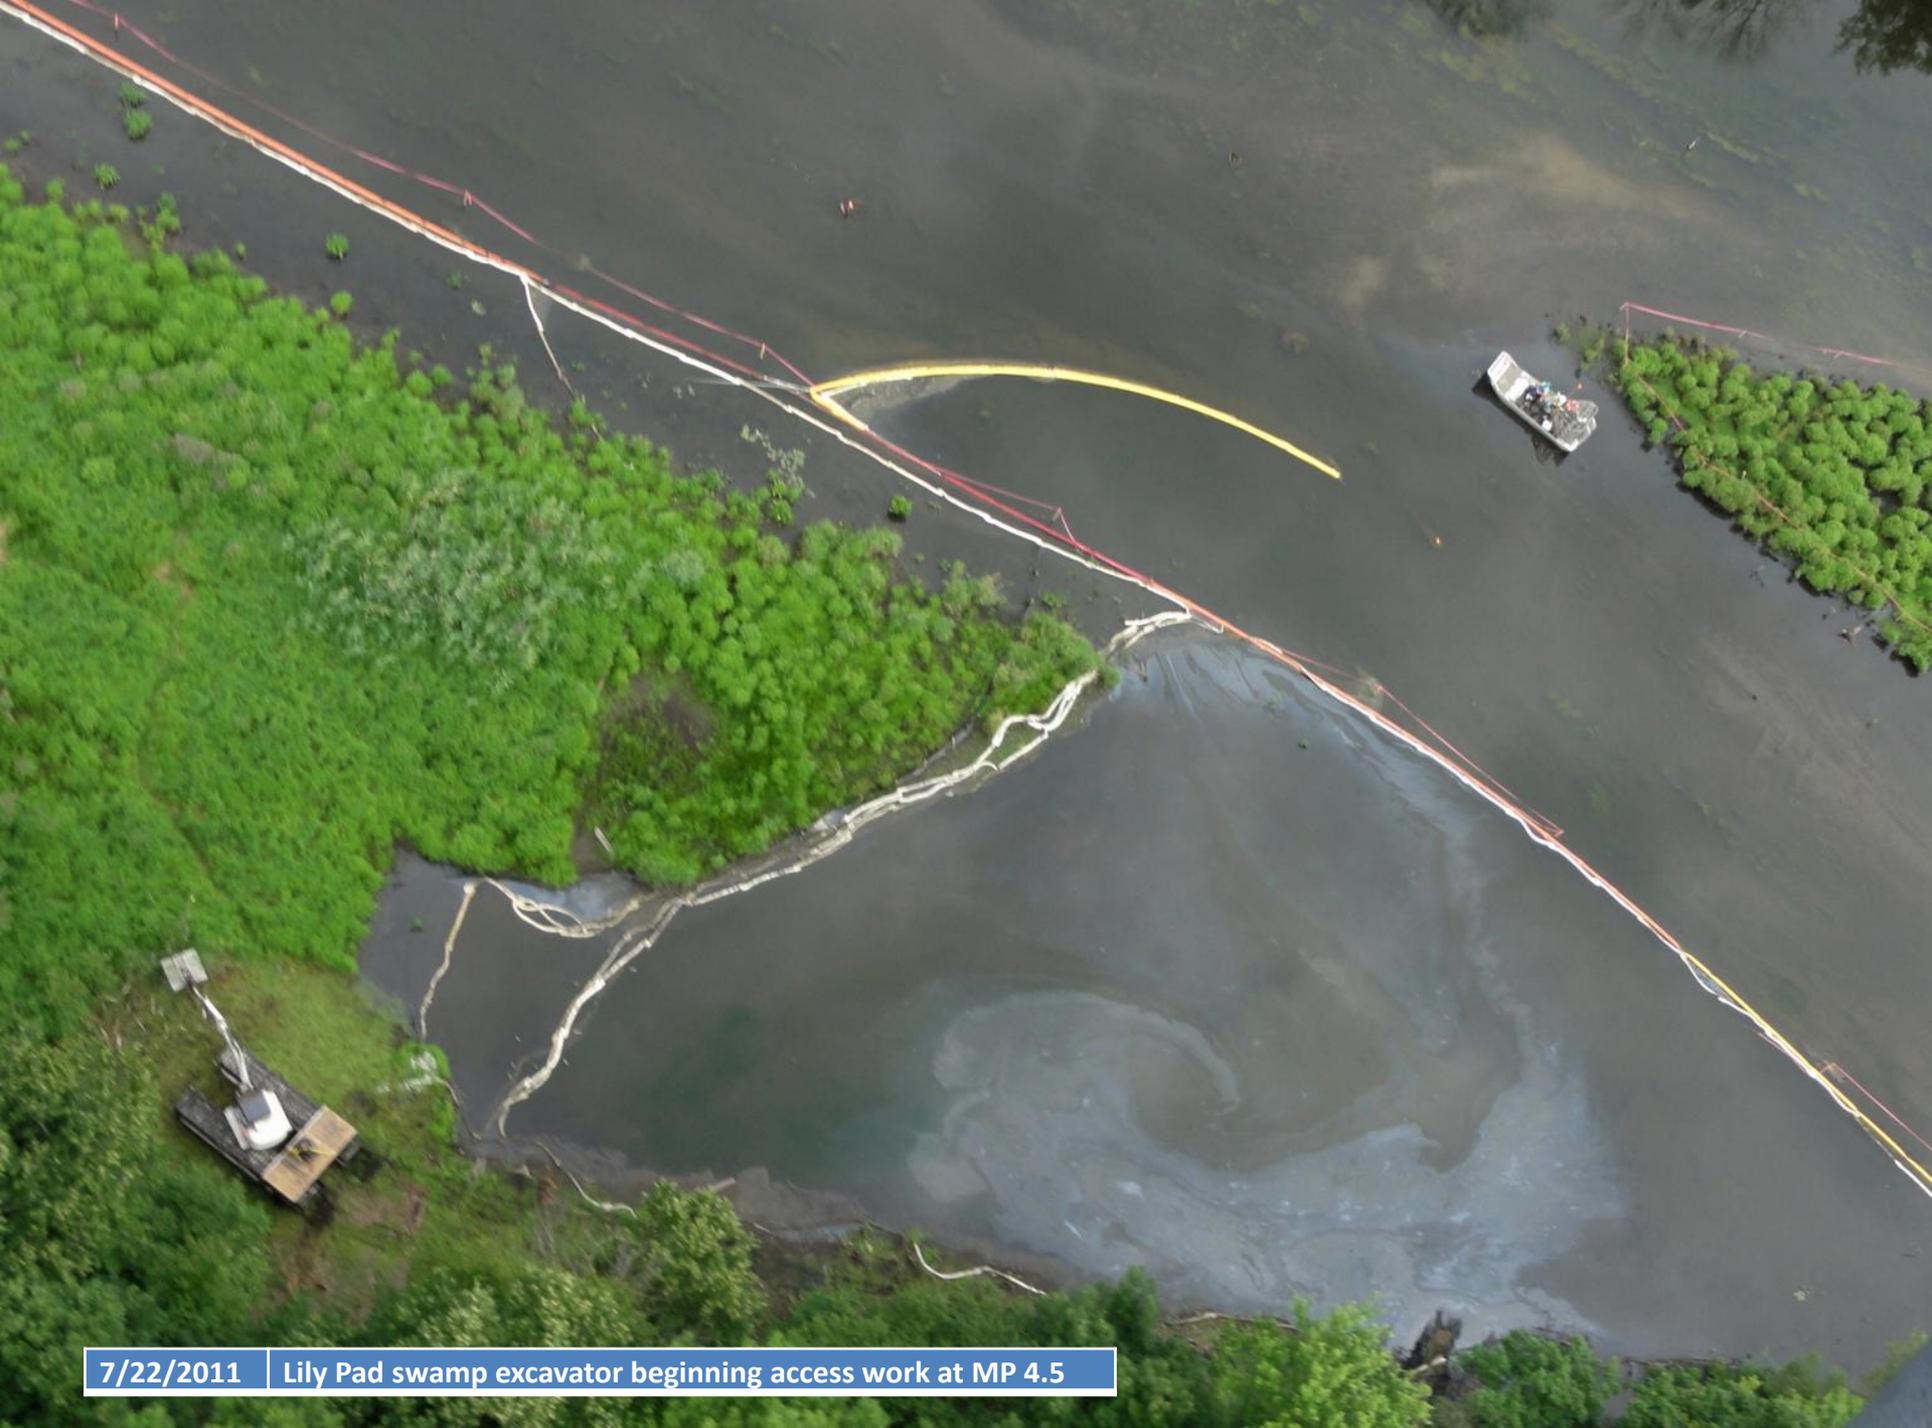
7/22/2011 | Lily Pad swamp excavator beginning access work at MP 4.5

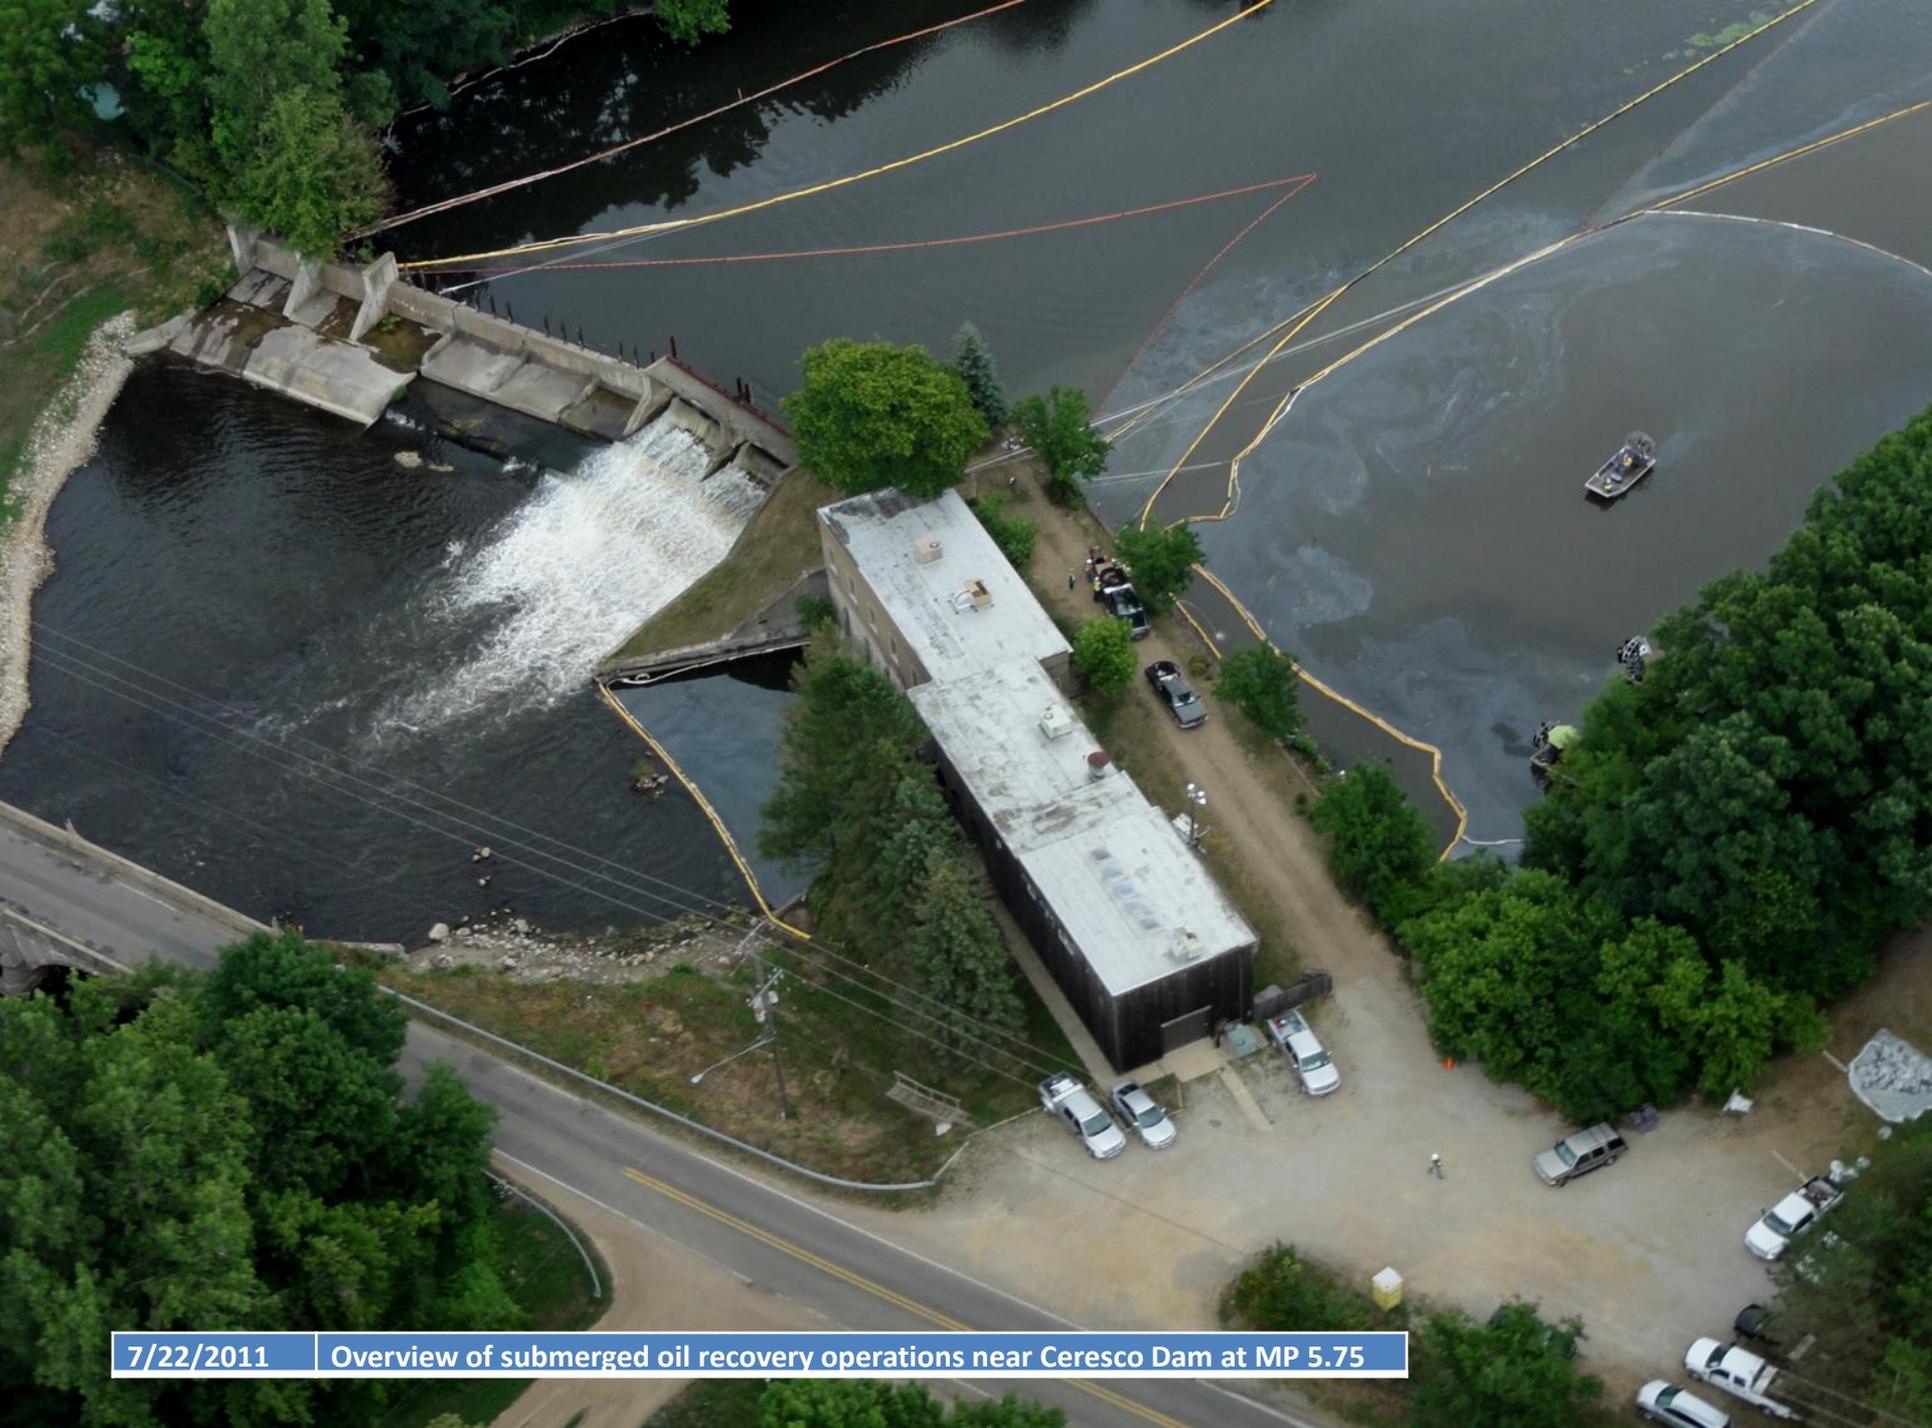
7/22/2011 | Overview of submerged oil recovery operations near Ceresco Dam at MP 5.75

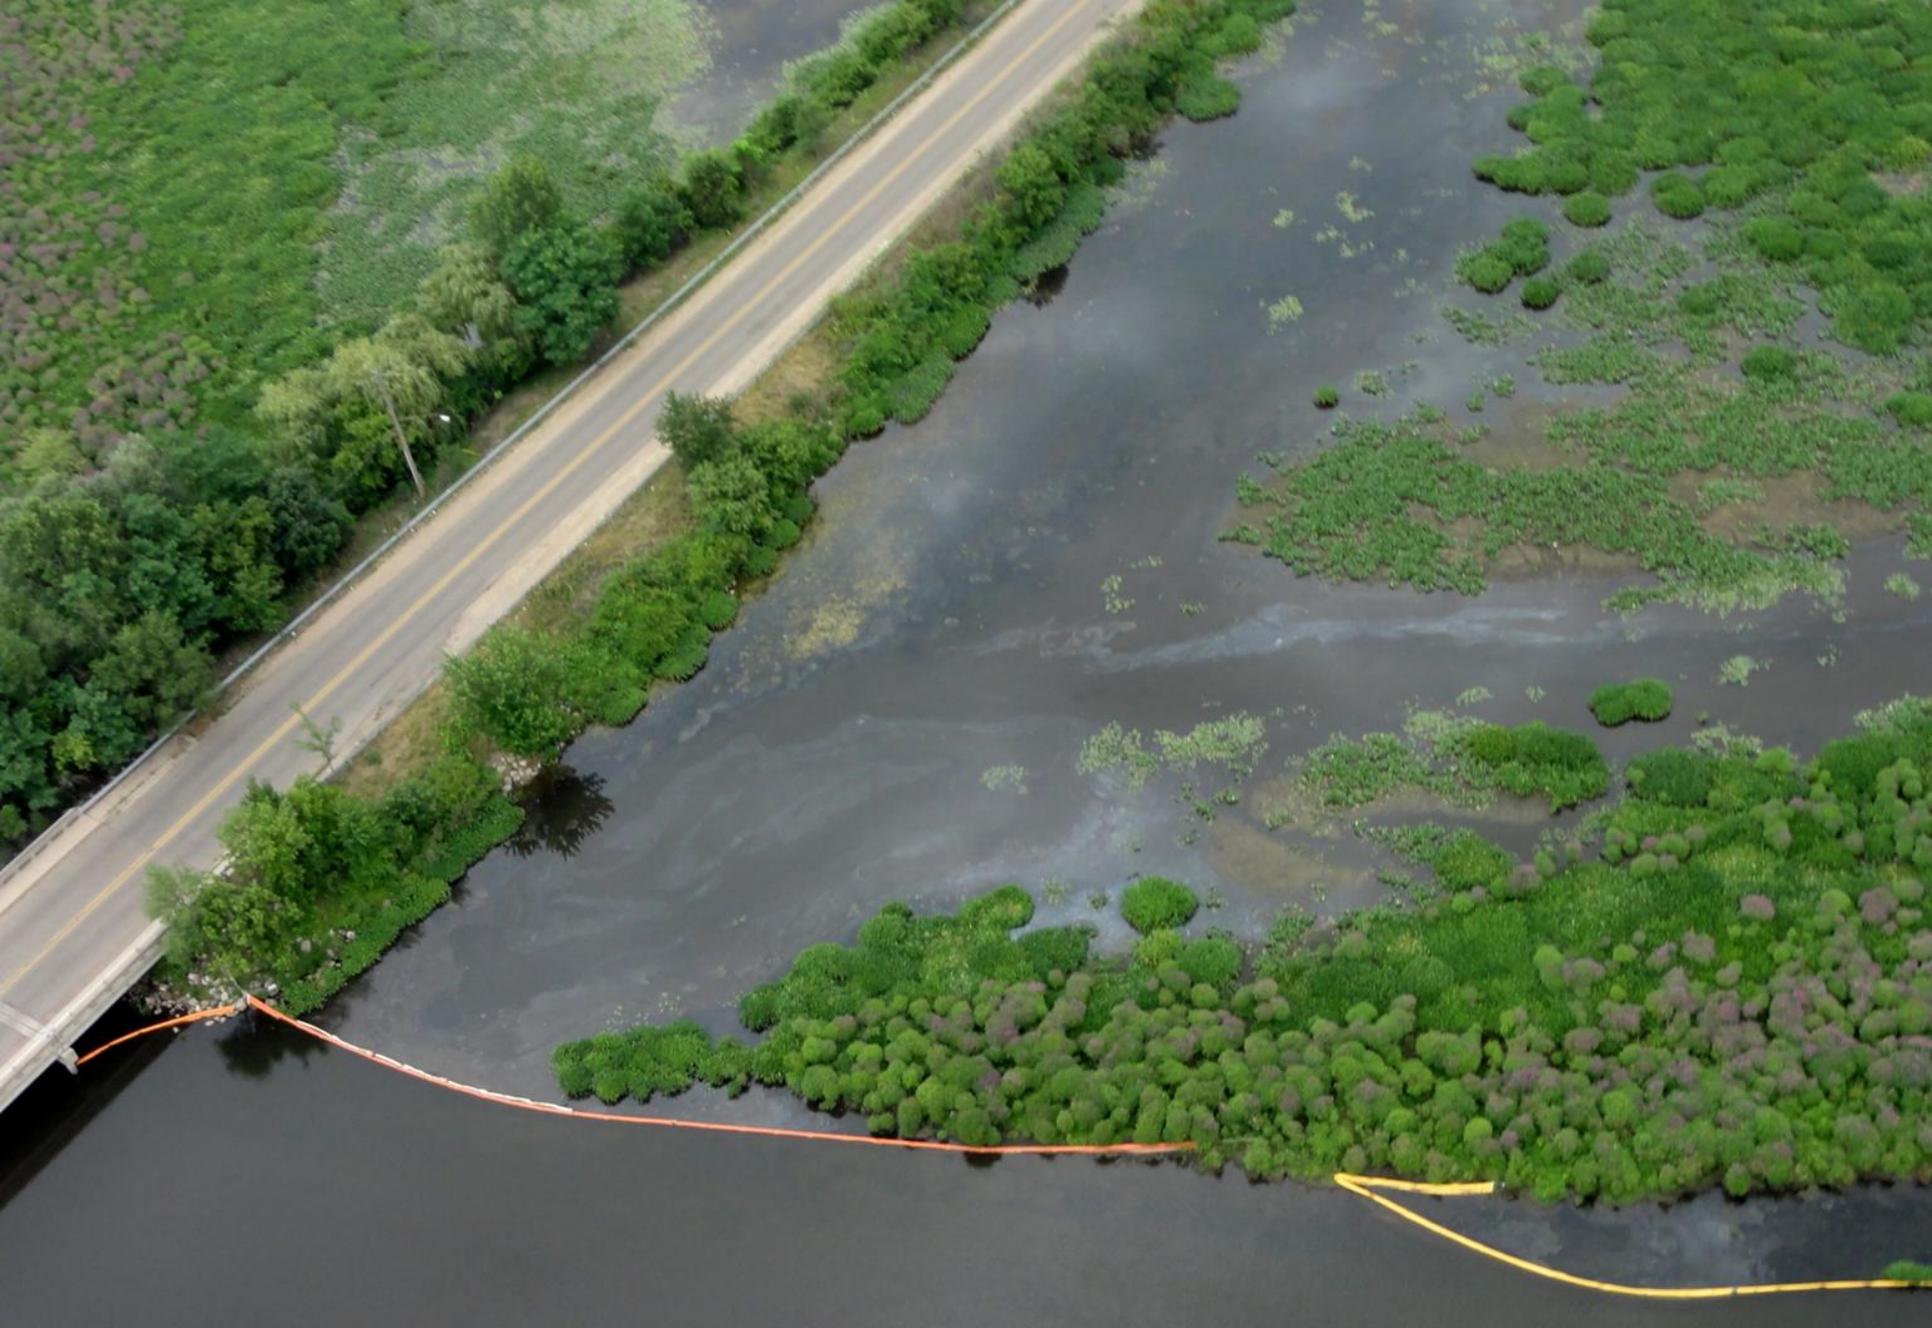
7/22/2011

Sheen observed within Mill Pond at MP 15.5

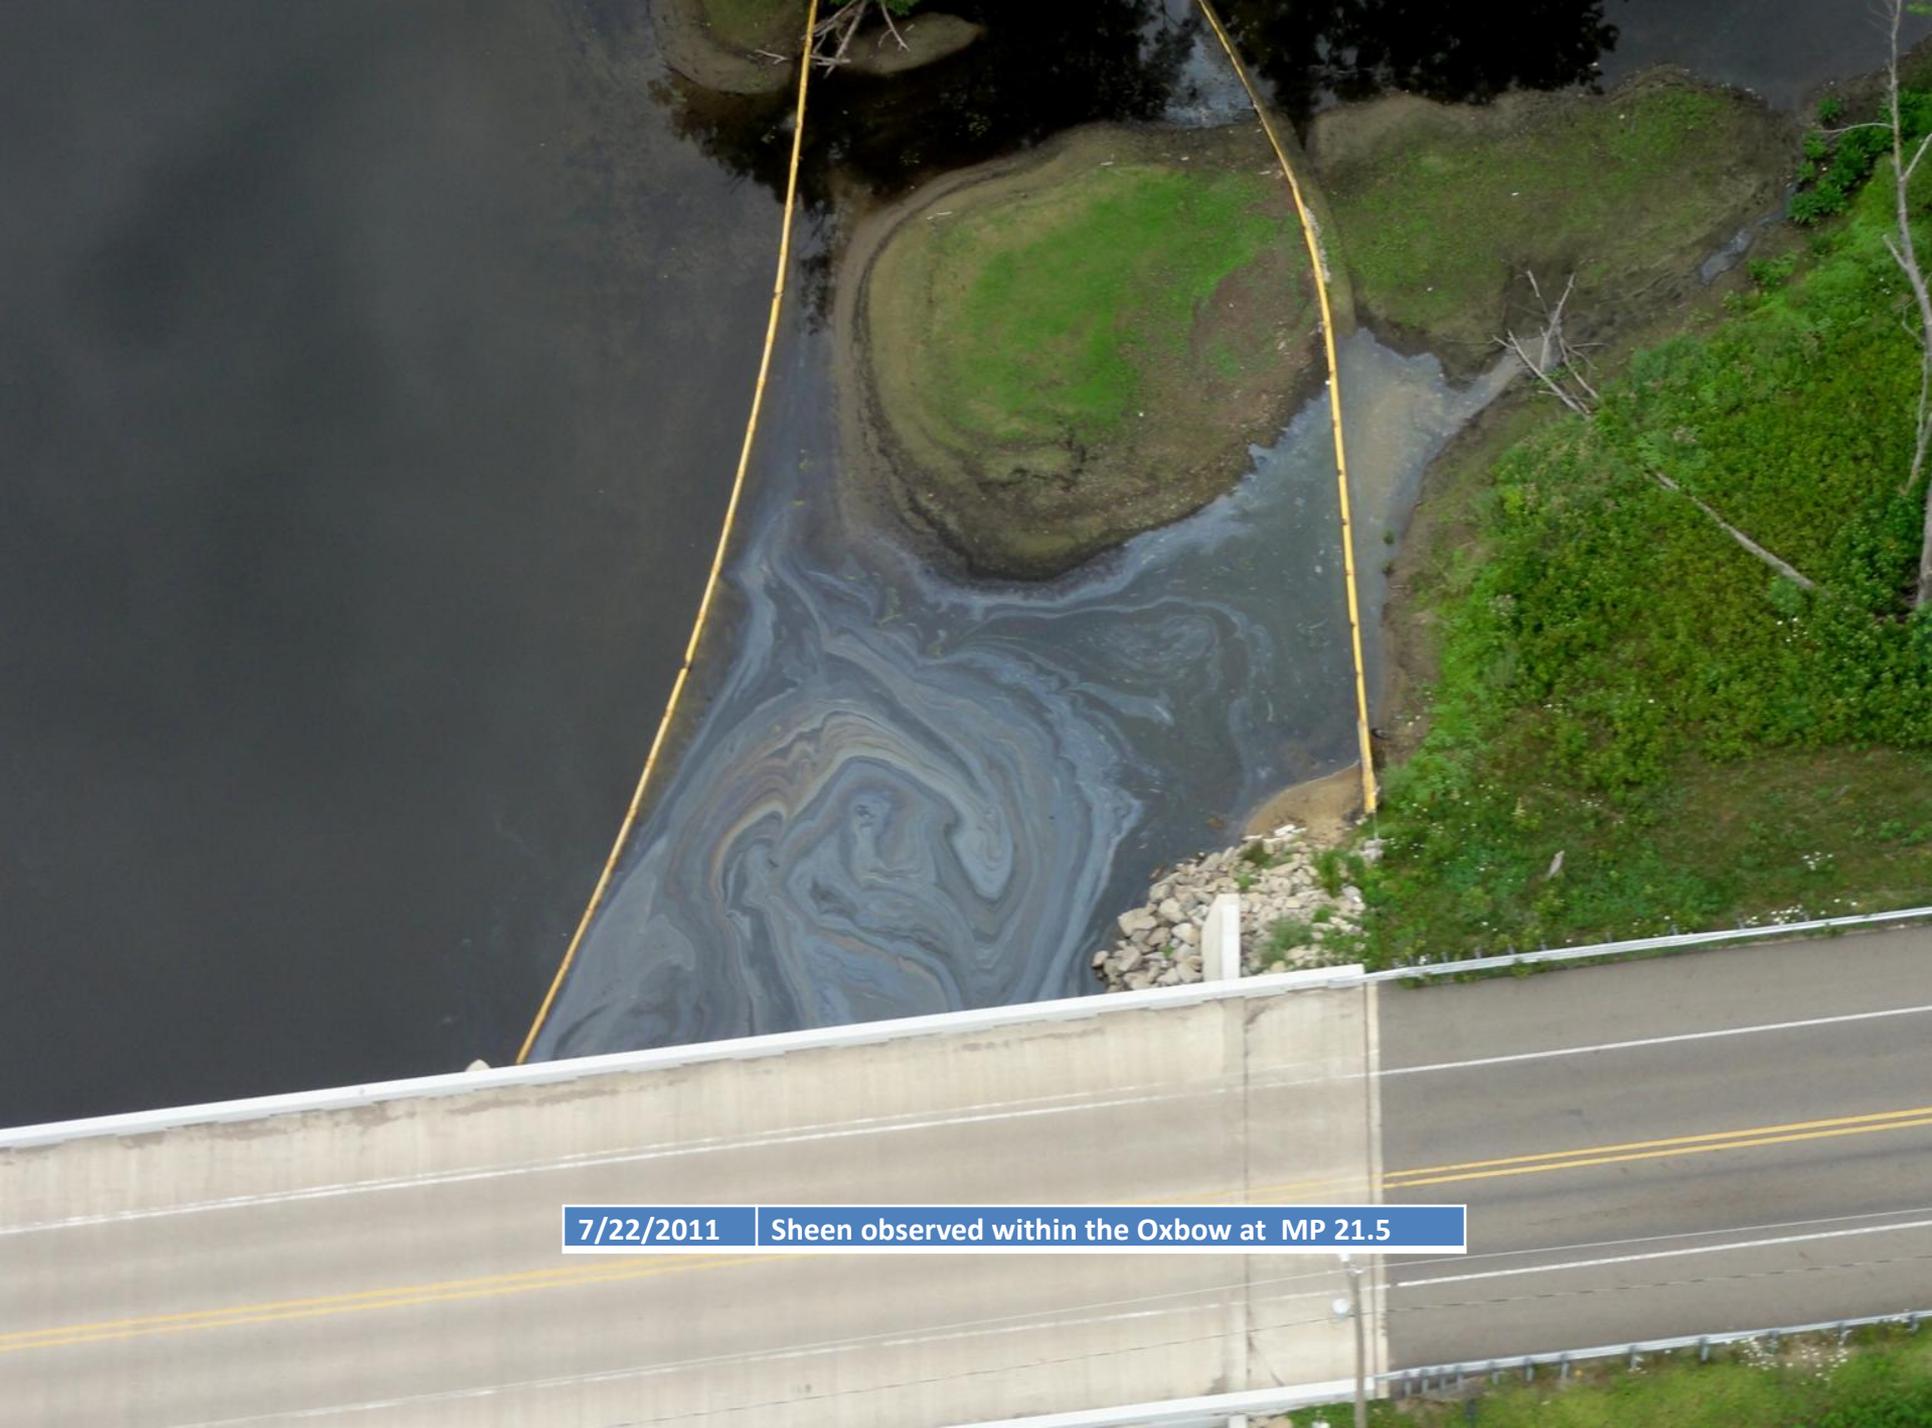
7/22/2011 | Sheen observed within the Oxbow at MP 21.5

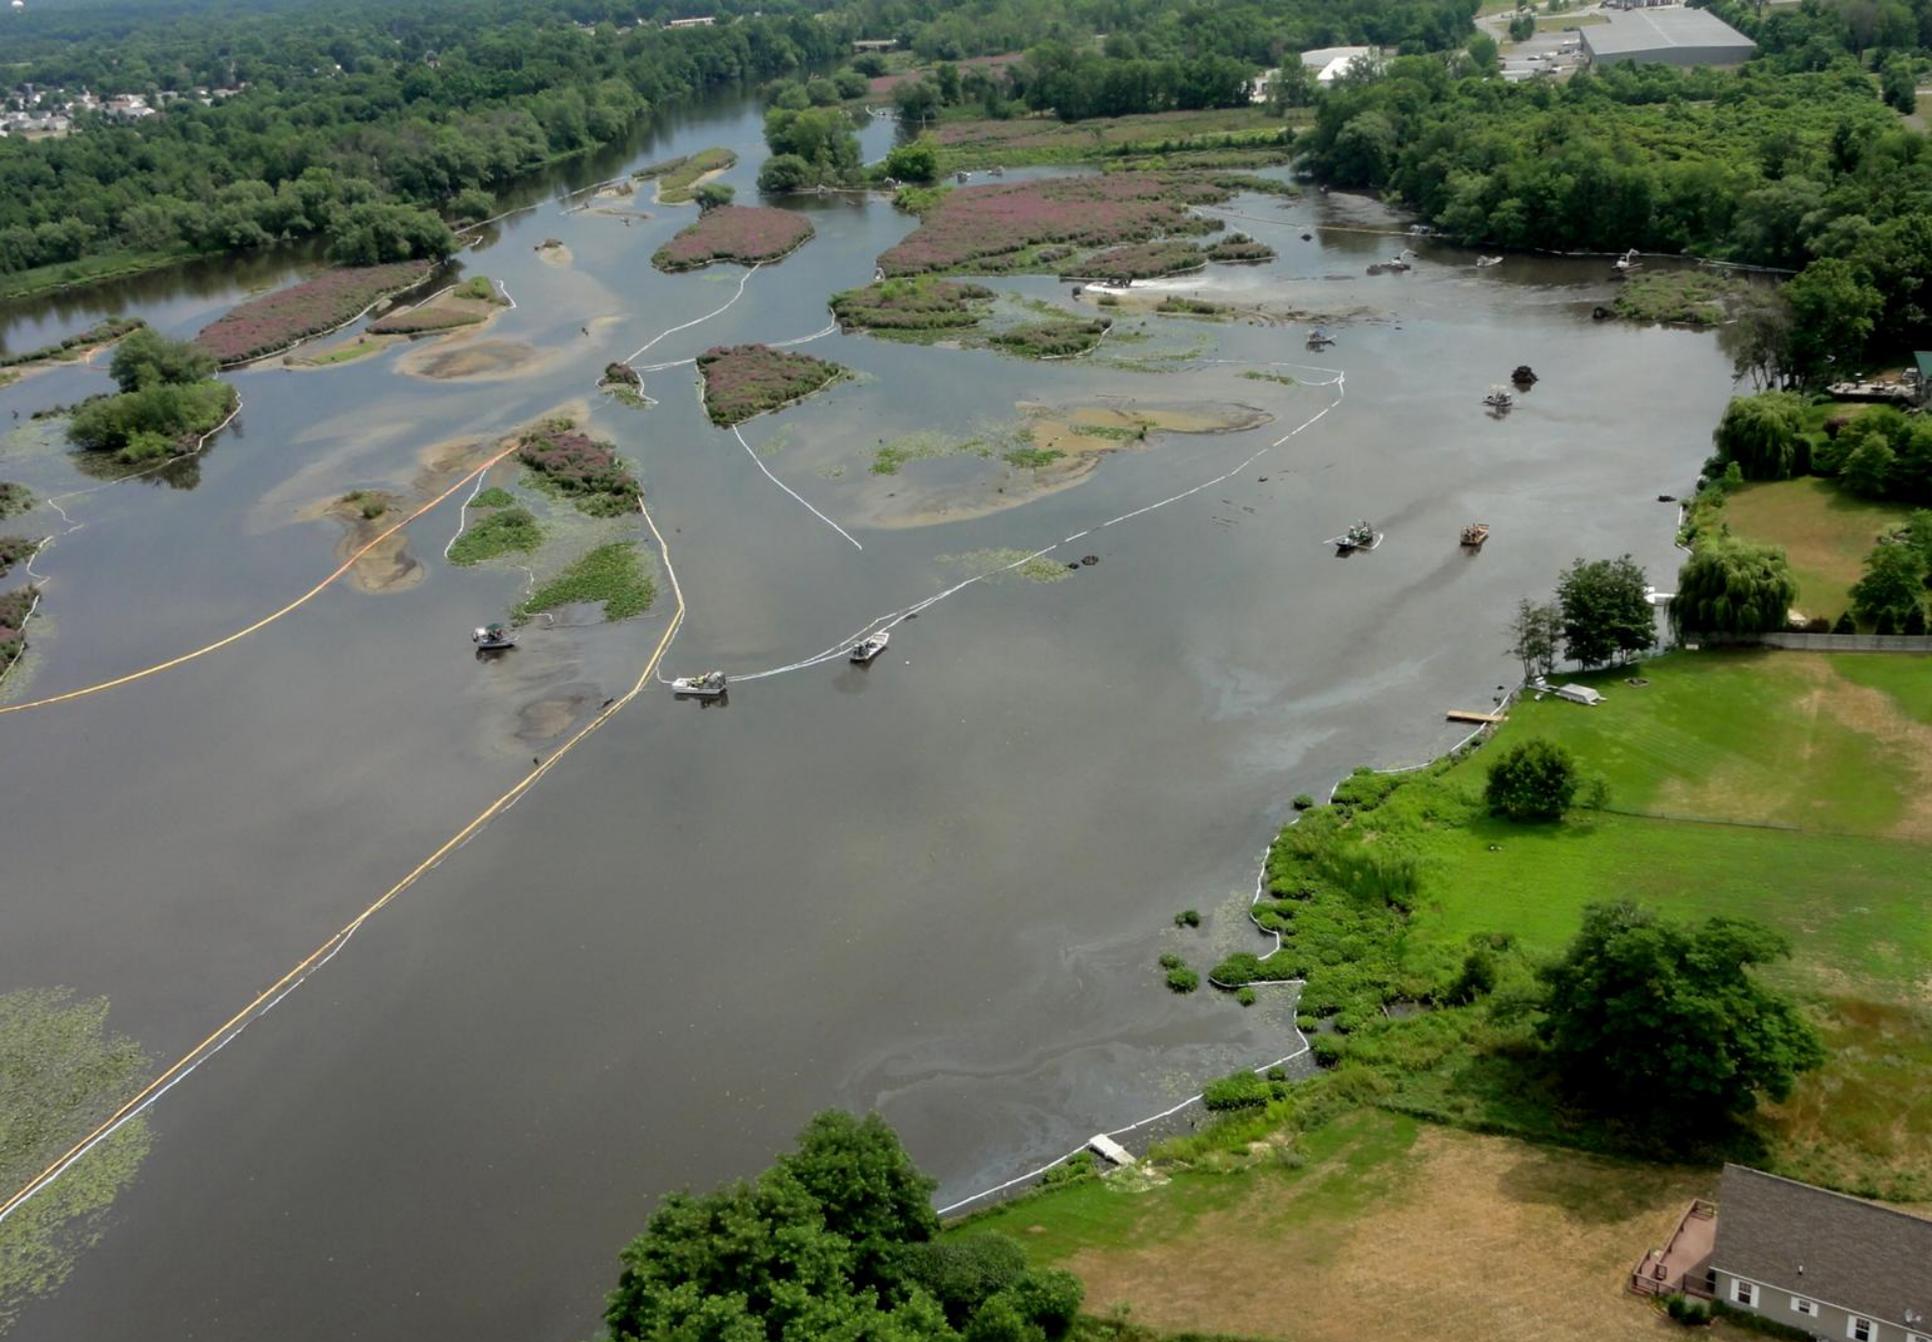
7/22/2011 | Overview of submerged oil recovery operations in the Morrow Lake Delta

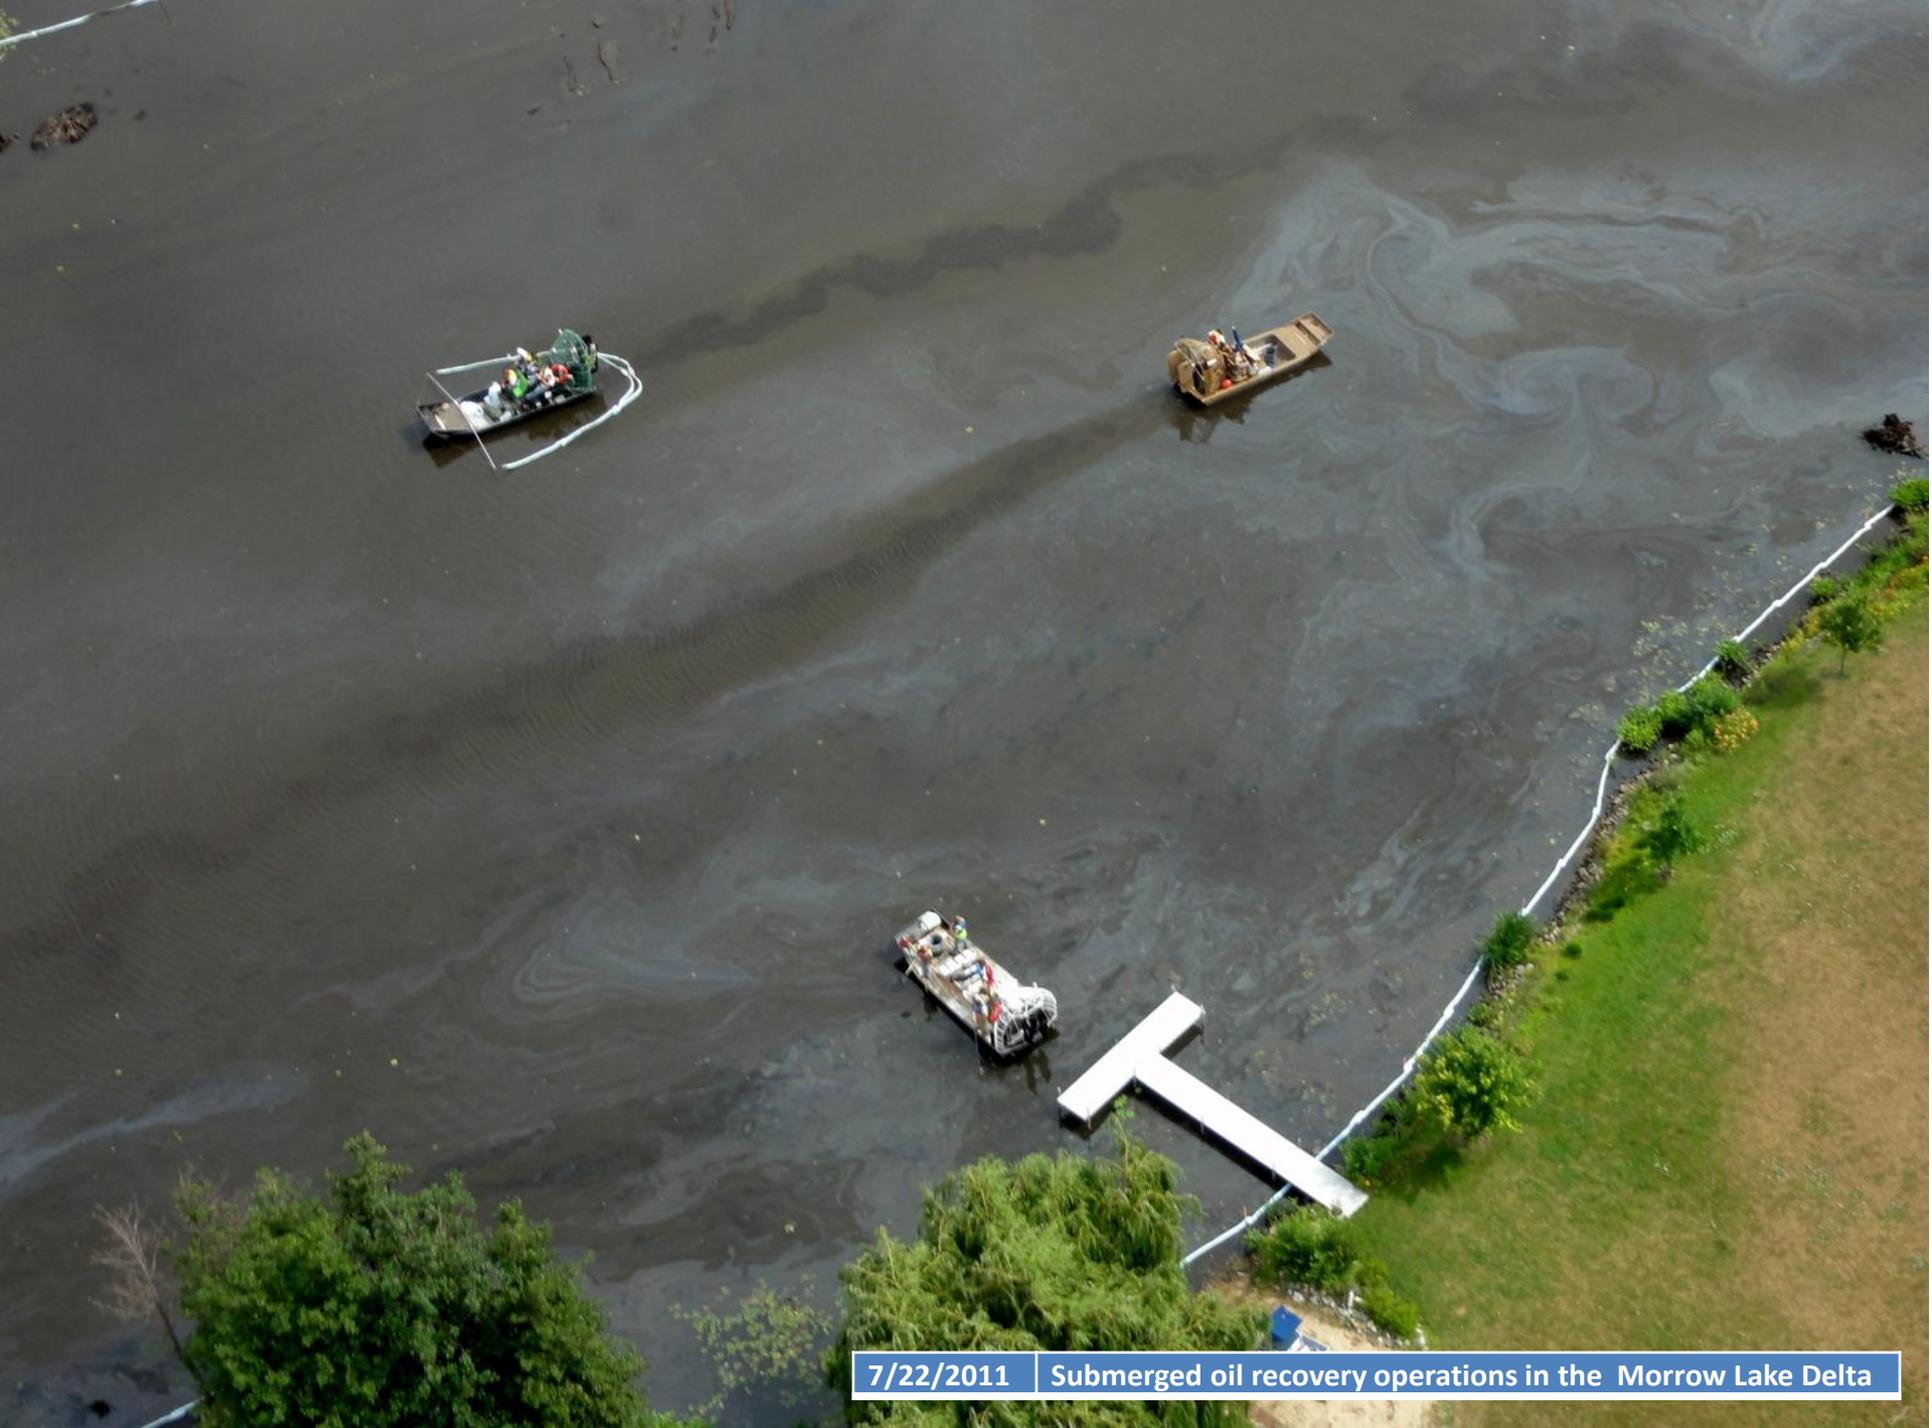
7/22/2011

Submerged oil recovery operations in the Morrow Lake Delta
