July 20-22, 2011 Overflight Photo Log

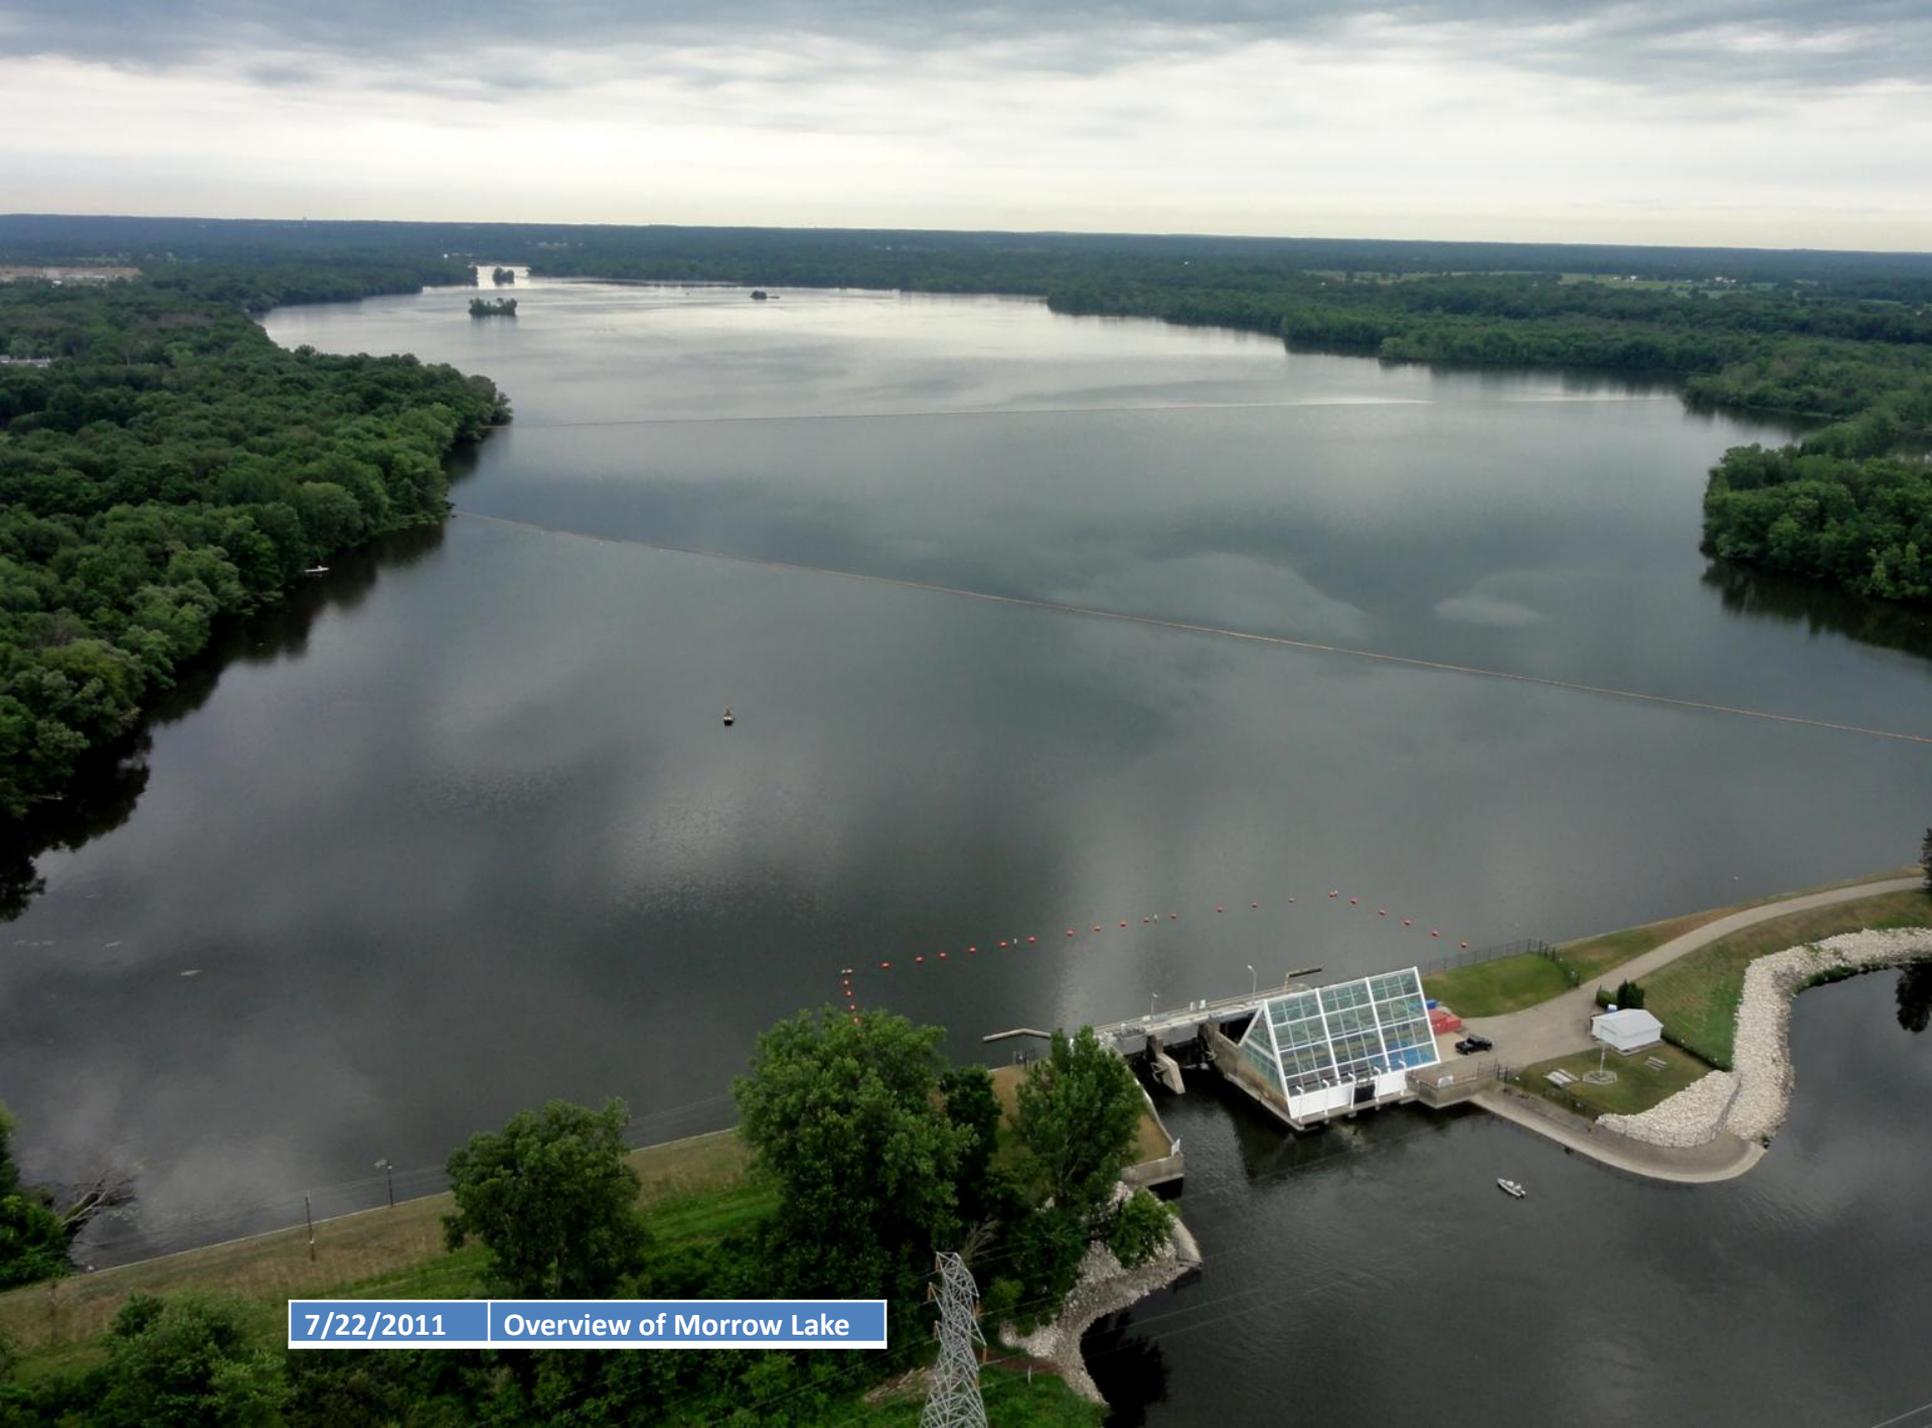
7/22/2011 | Overview of Morrow Lake
