**Clean Michigan Initiative  
Nonpoint Source Grant**  
1999-0026

## City of Novi Outfall And Stream Bank Stabilization

July 15<sup>th</sup> 2002 - June 30<sup>th</sup> 2004

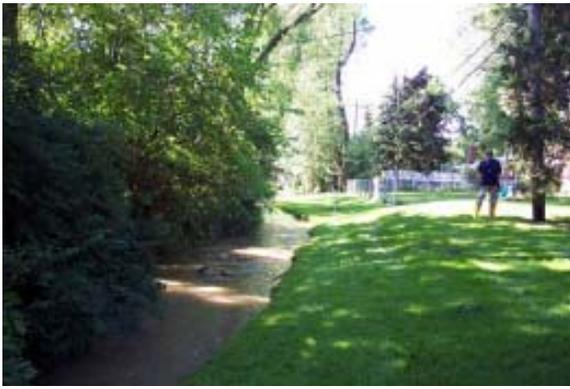
**Site SS1 Before: Looking downstream from Upstream of Site (7-03).**

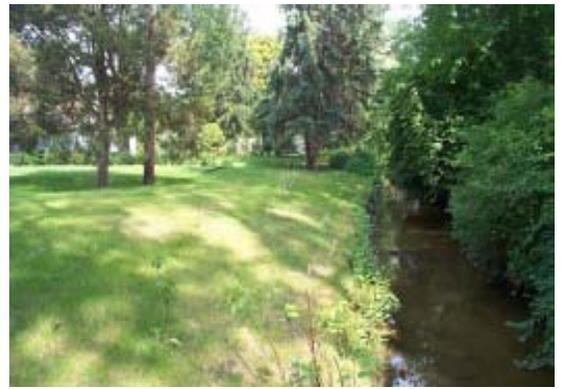
**Site SS1 After: Looking upstream from Downstream end of Site (5/04).**

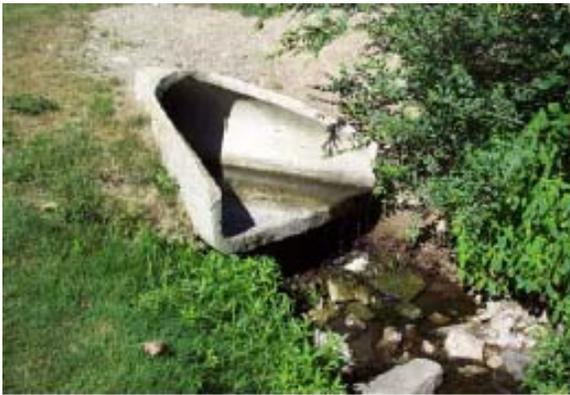
**Site OS4 Before: View of outfall showing Undercutting and Erosion (7/03).**

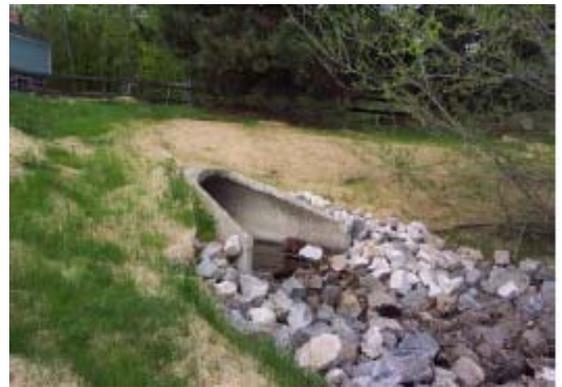
**Site OS4 After: Similar view showing installed Riprap apron and slope revegetation (5/04).**

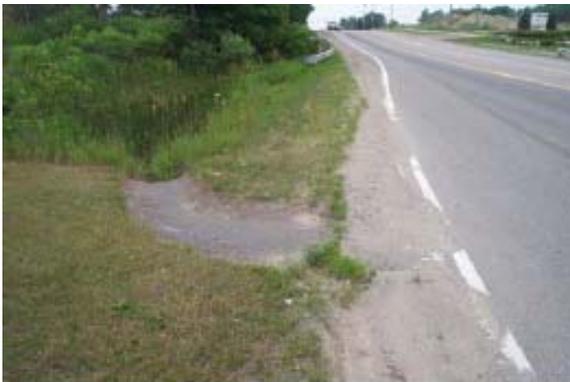
**Site OS2 Before: Looking south toward Road-side ditch and asphalt spillway (8/03).**

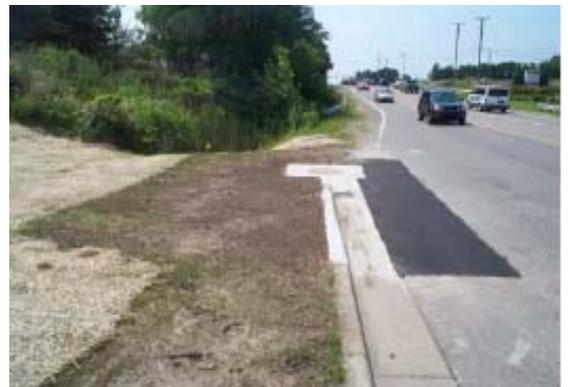
**Site OS2 After: Looking south, showing new curb, and sediment chamber that traps sediment.**
