Title: Macatawa River Bank Erosion Improvements

Michigan AUID Numbers: 040500020401-01, 040500020402-02, 040500020403-01, 040500020404-01, 040500020405-01, 040500020406-01, 040500020407-01

GRTS Number: 975474080, Project 08

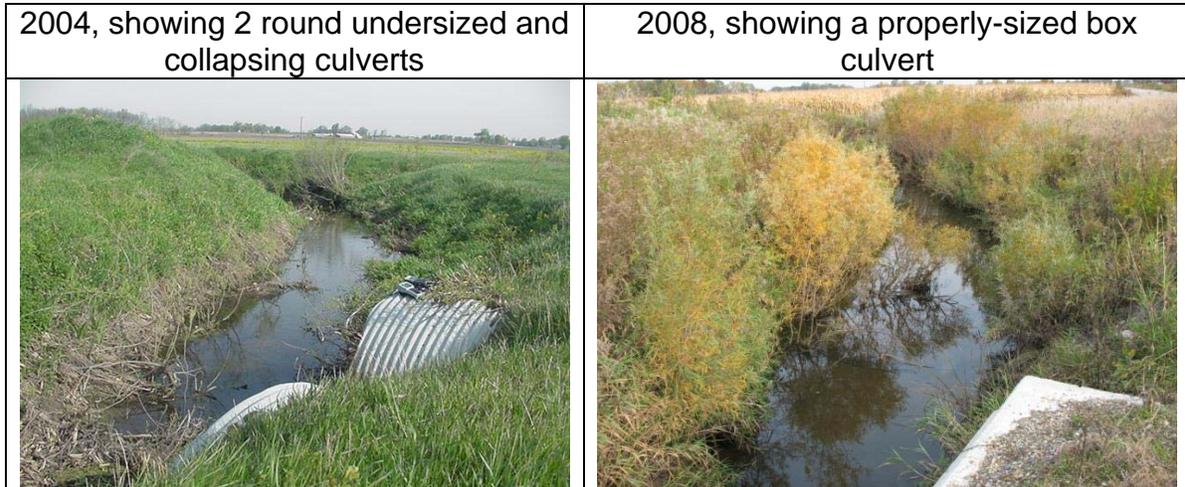
Figure 1. 104th Avenue north of Van Buren Street, before and after culvert replacement.

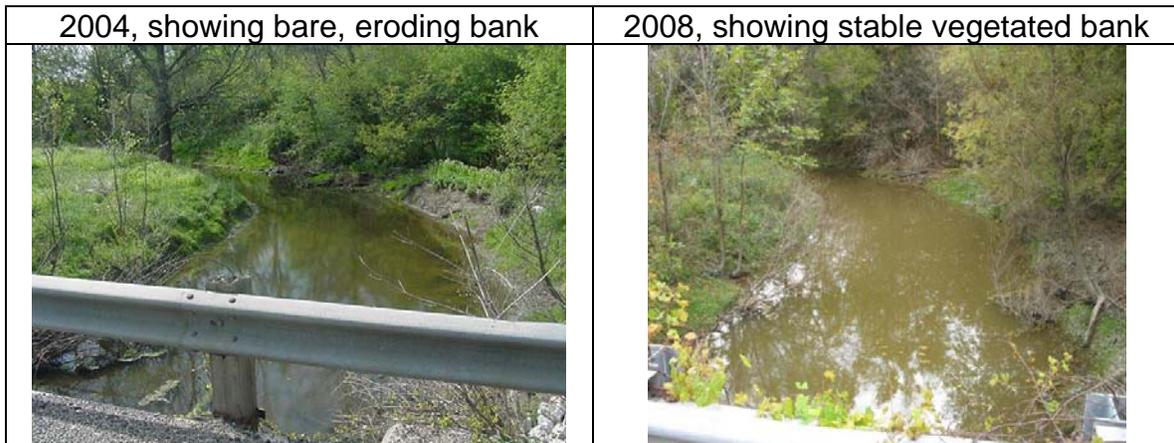
Figure 2. Quincy Street east of 112th Avenue, before and after road resurfacing and bridge replacement.

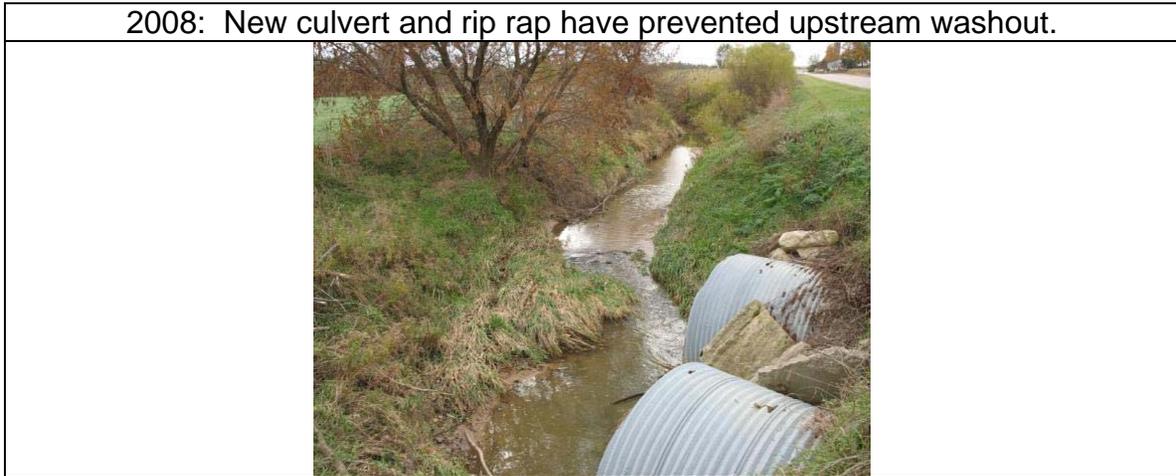
Figure 3. 43rd Street north of 144th Avenue, after culvert replacement and rip rap addition.

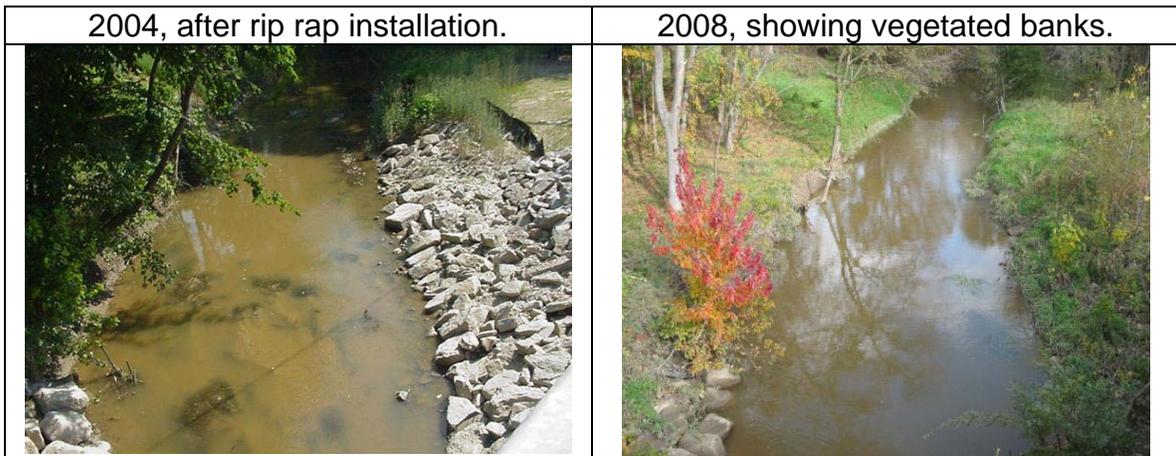
Figure 4. 42nd Street north of 147th Avenue, showing affects of stabilized streambanks.

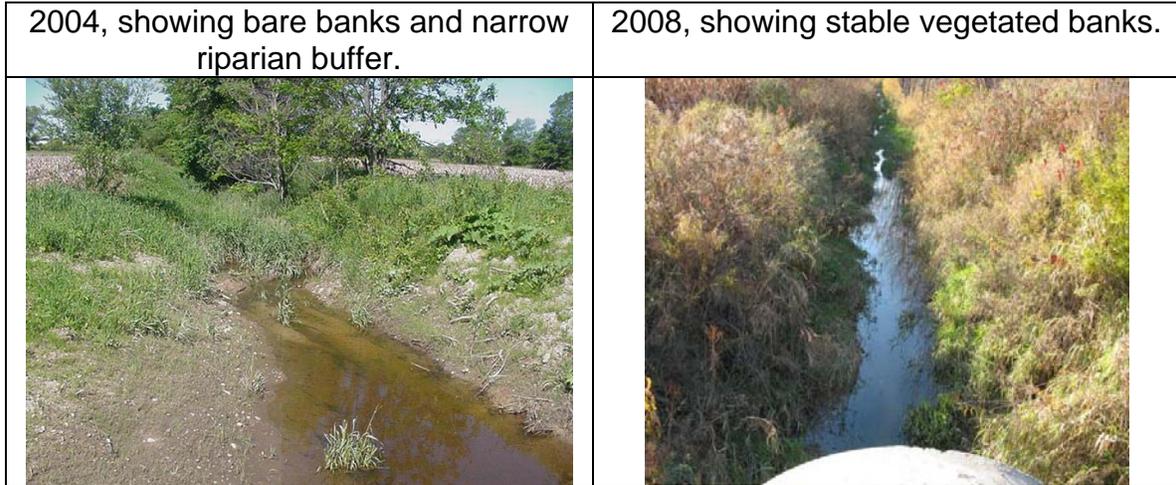
Figure 5. 56th Street north of 141st Avenue, before and after bank stabilization.

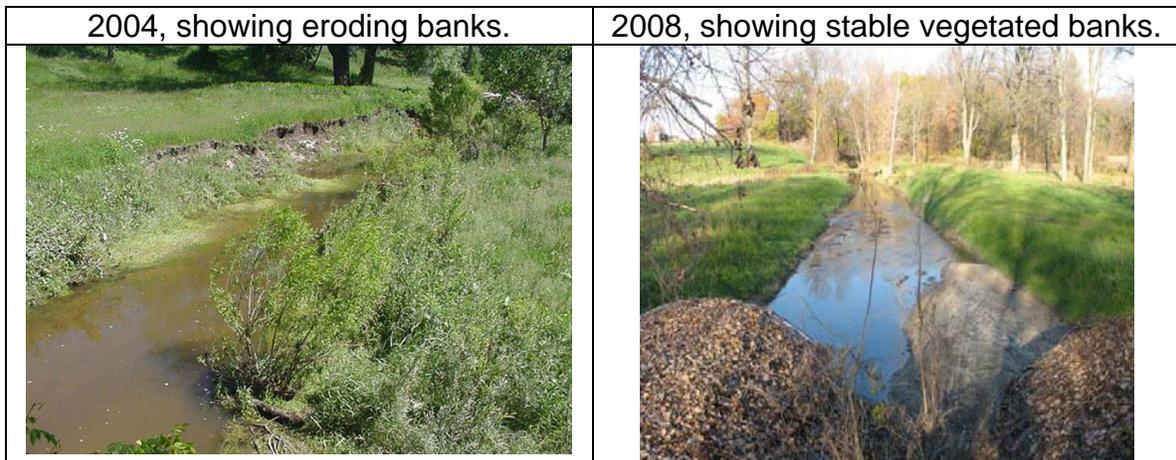
Figure 6. Russcher Road south of 144th Avenue, before and after bank stabilization.
