APPENDIX B

Photos – Example Erosion Areas

ENBRIDGE LINE 6B INCIDENT KALAMAZOO RIVER BANK STABILIZATION DESIGN PRIORITY AREAS

OCTOBER 26, 2010

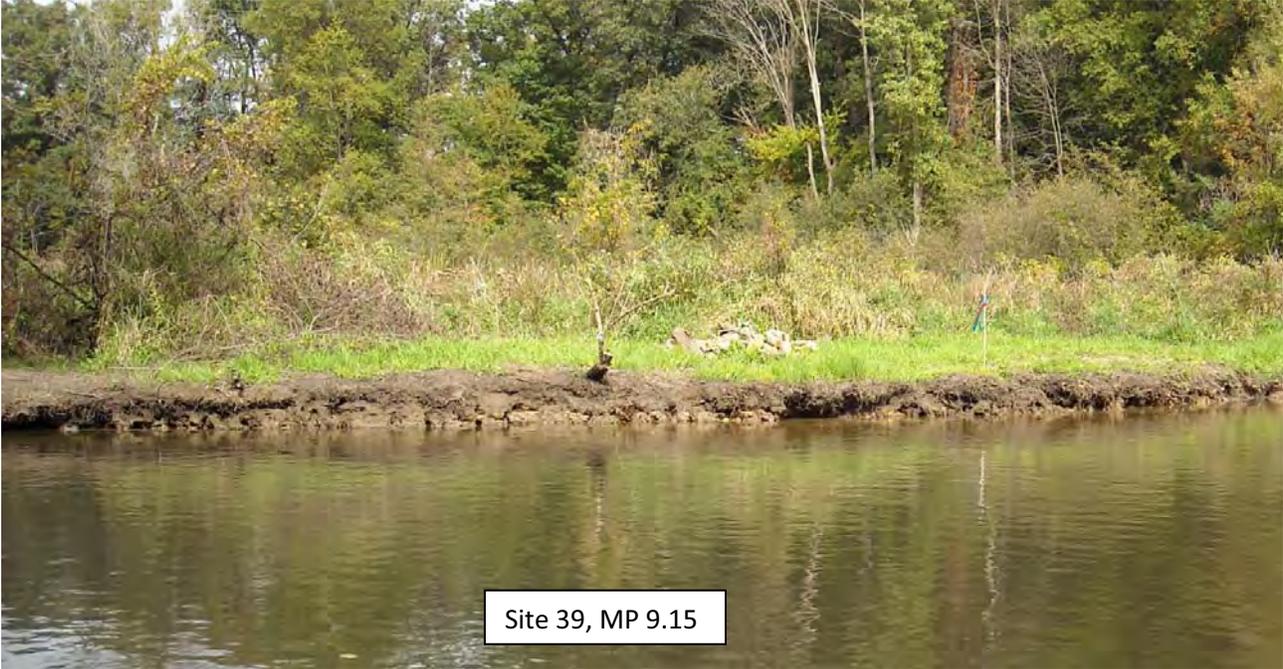
Site 39, MP 9.15

EXAMPLE LEVEL 4 SITES

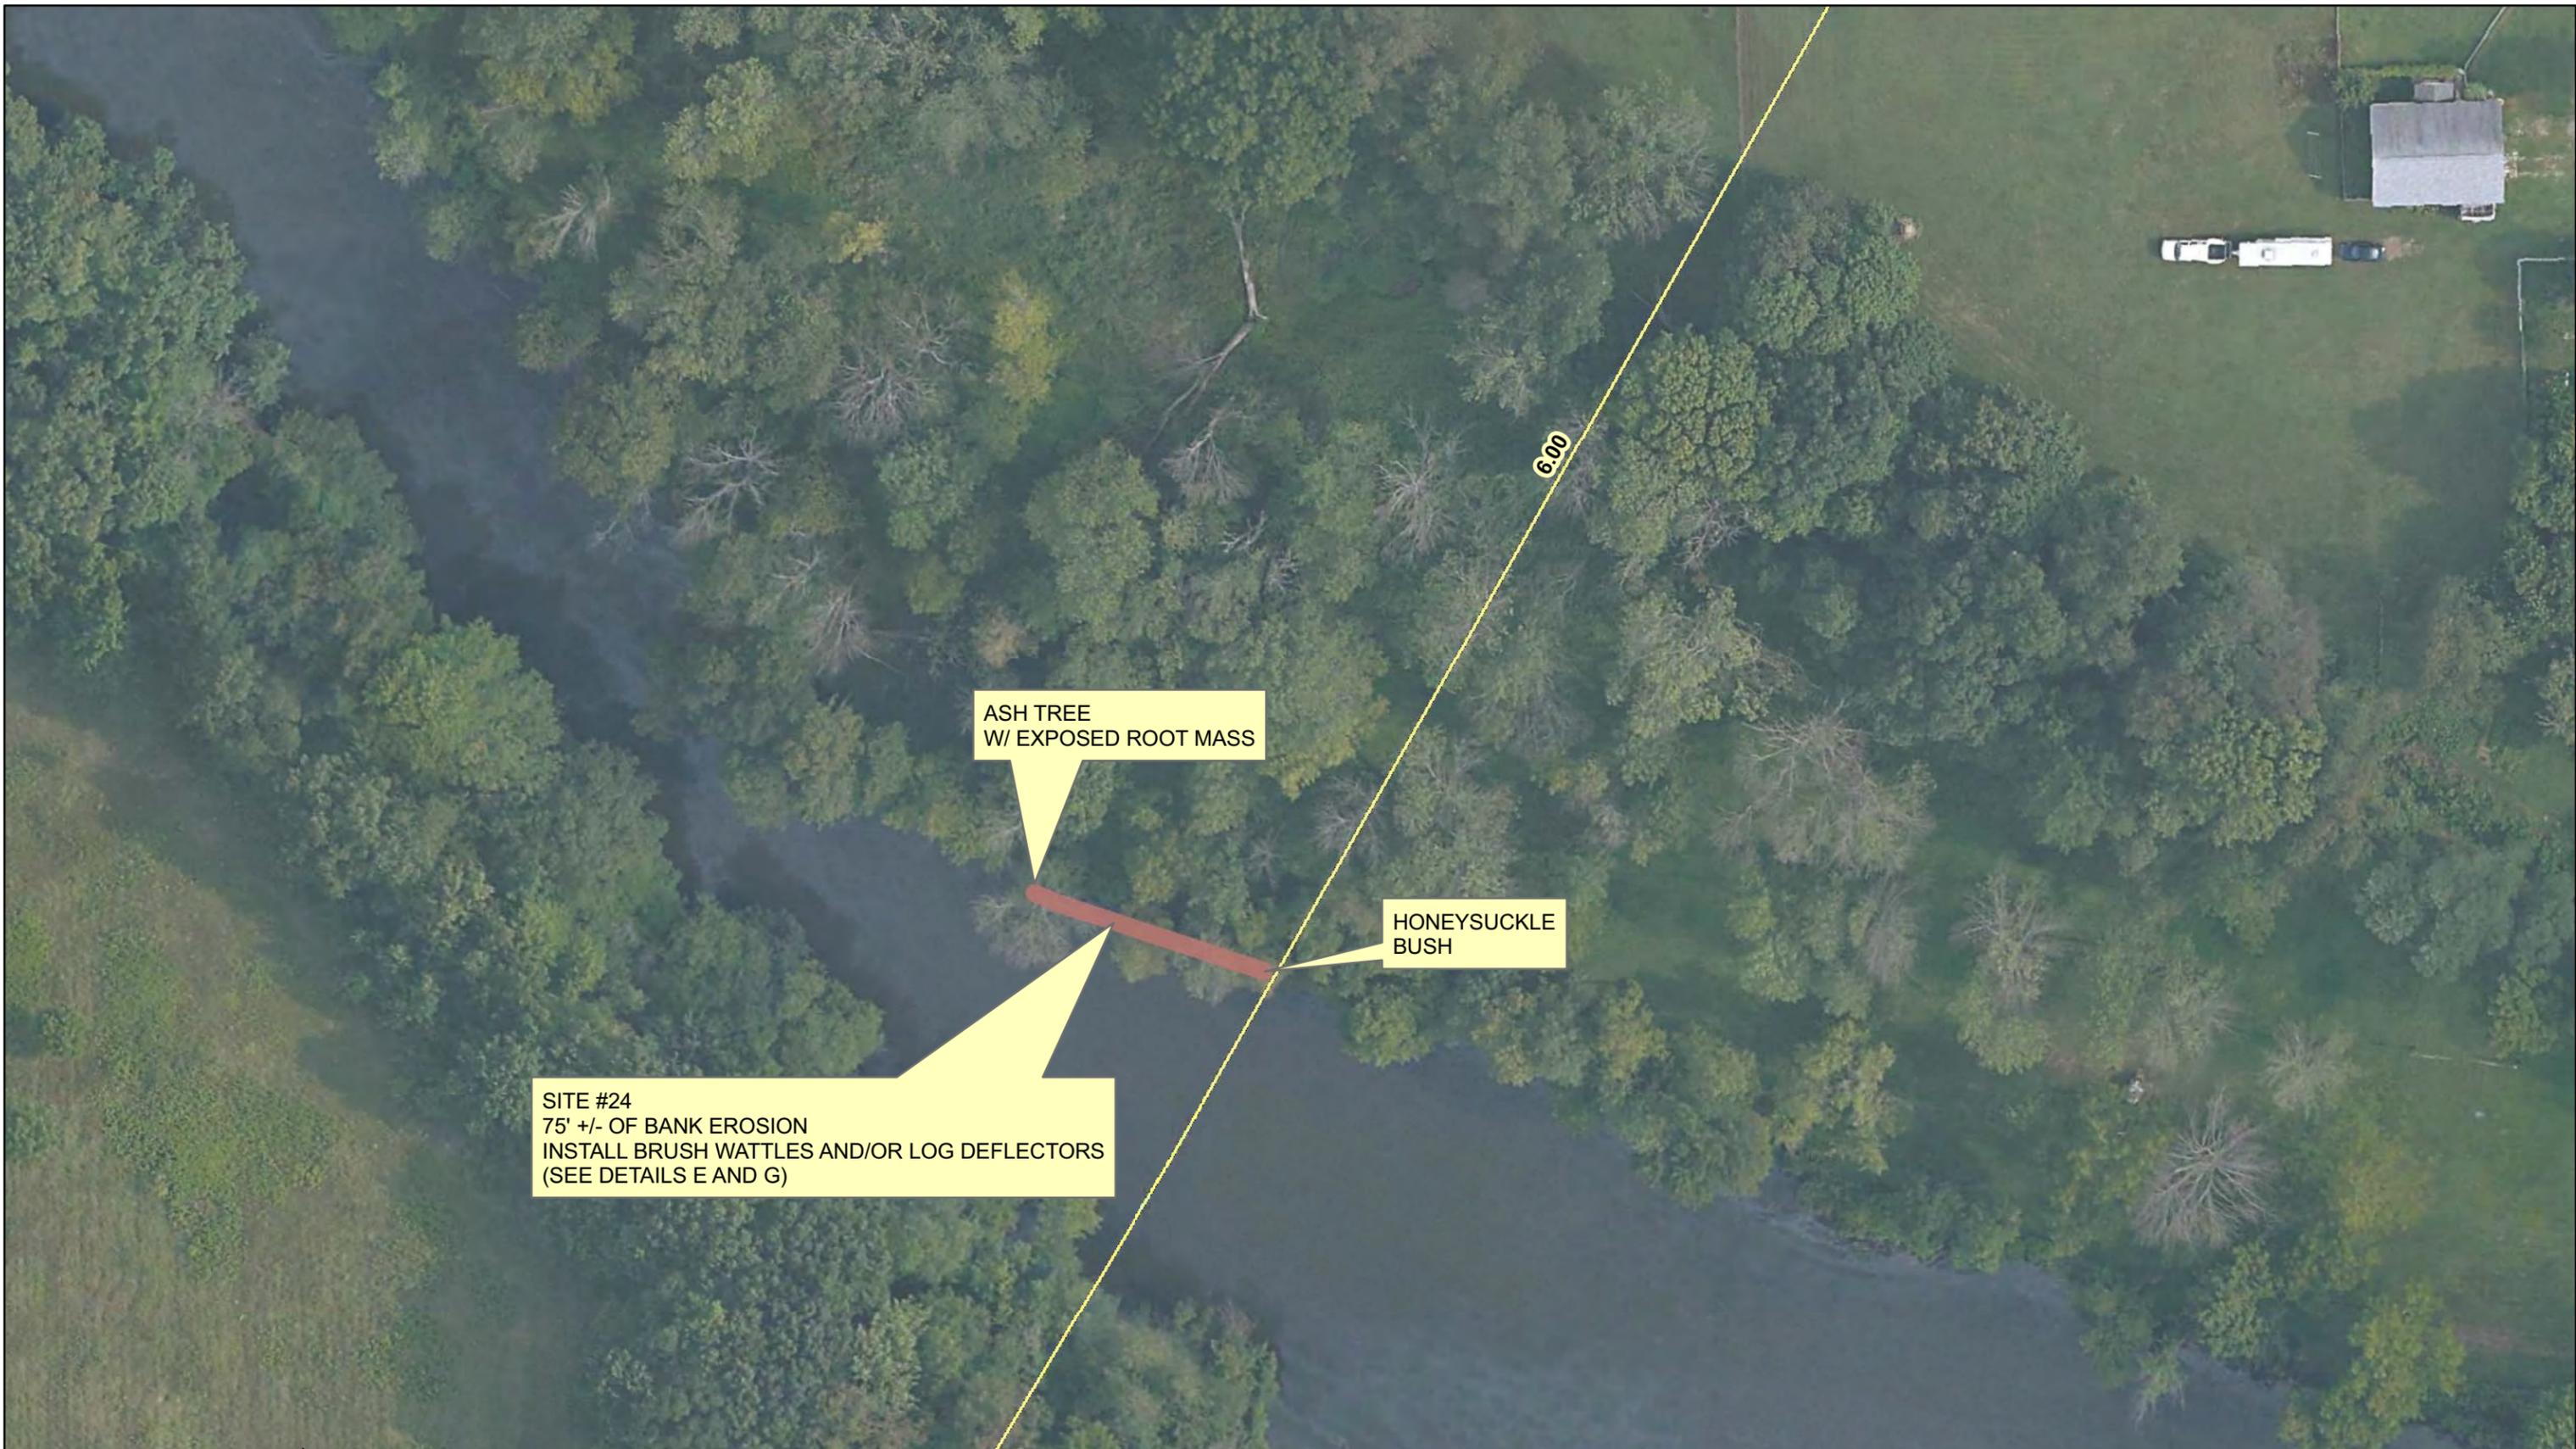
FIGURE 1
SITE #24
BANK EROSION STABILIZATION DESIGN

ASH TREE
W/ EXPOSED ROOT MASS

SITE #24
75' +/- OF BANK EROSION
INSTALL BRUSH WATTLES AND/OR LOG DEFLECTORS
(SEE DETAILS E AND G)

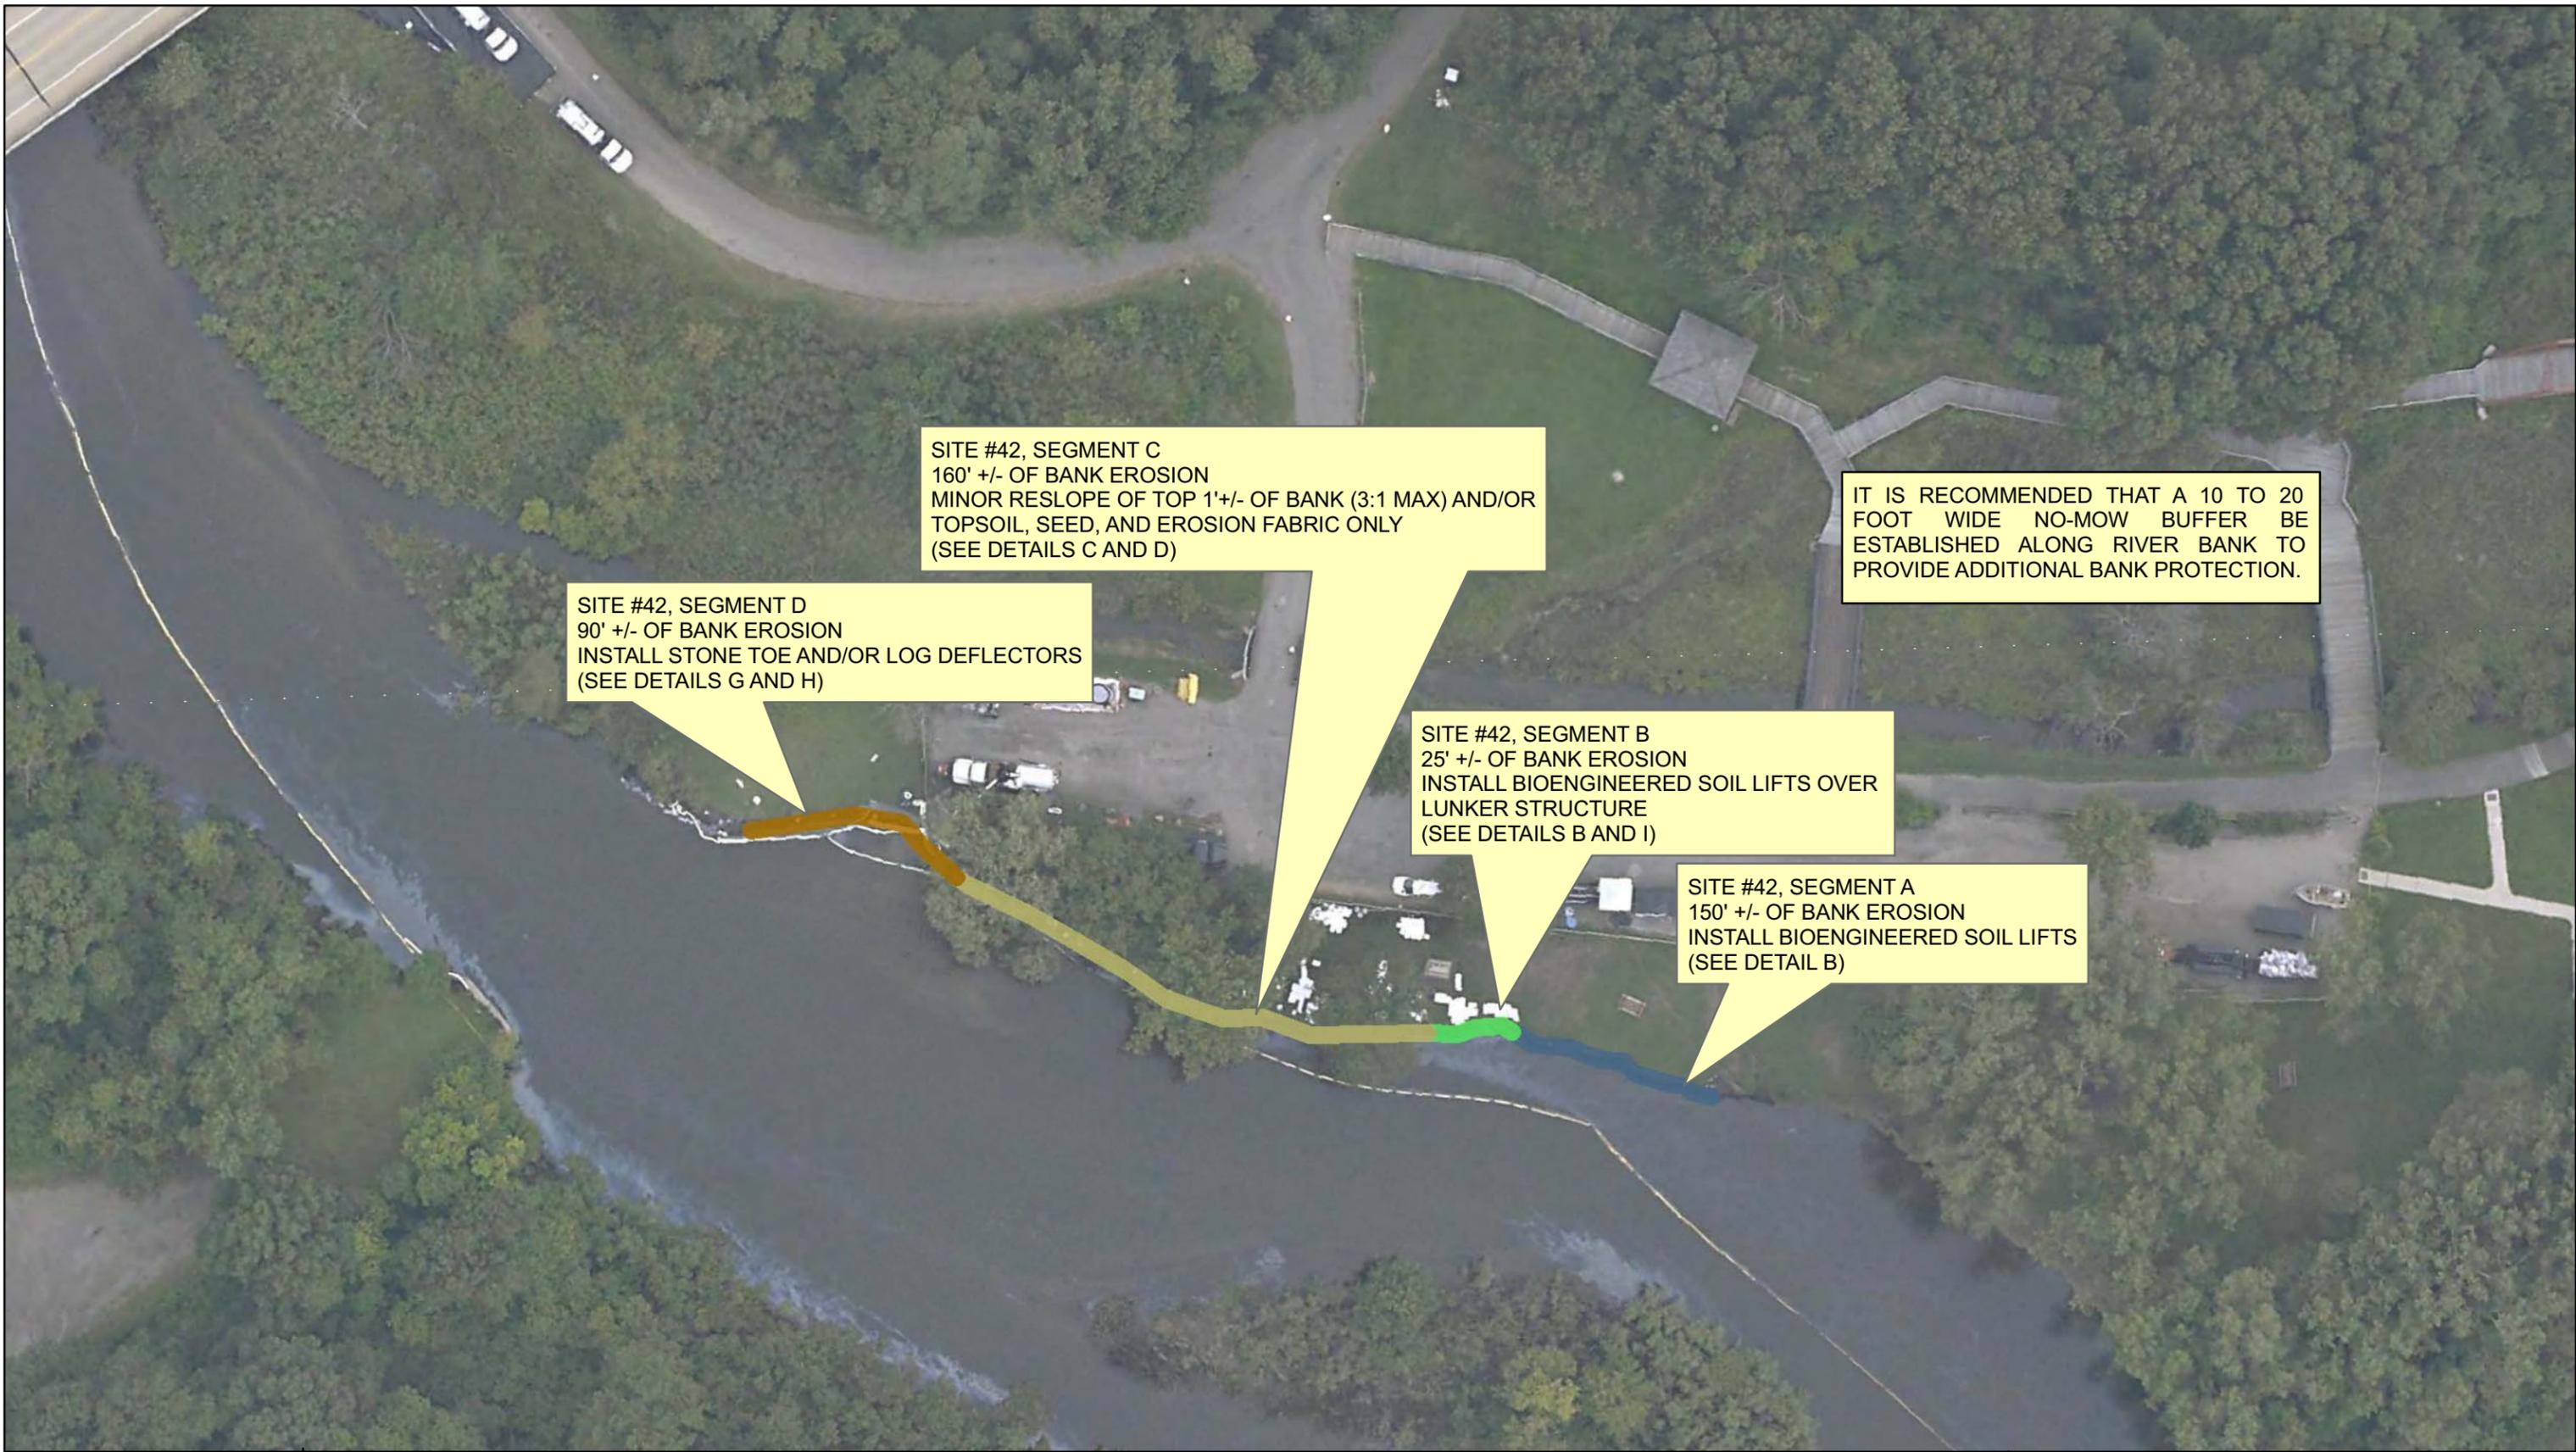
FIGURE 3
SITE #42
 BANK EROSION STABILIZATION DESIGN

SITE #42, SEGMENT C
 160' +/- OF BANK EROSION
 MINOR RESLOPE OF TOP 1'+/- OF BANK (3:1 MAX) AND/OR
 TOPSOIL, SEED, AND EROSION FABRIC ONLY
 (SEE DETAILS C AND D)

SITE #42, SEGMENT D
 90' +/- OF BANK EROSION
 INSTALL STONE TOE AND/OR LOG DEFLECTORS
 (SEE DETAILS G AND H)

SITE #42, SEGMENT B
 25' +/- OF BANK EROSION
 INSTALL BIOENGINEERED SOIL LIFTS OVER
 LUNKER STRUCTURE
 (SEE DETAILS B AND I)

SITE #42, SEGMENT A
 150' +/- OF BANK EROSION
 INSTALL BIOENGINEERED SOIL LIFTS
 (SEE DETAIL B)

IT IS RECOMMENDED THAT A 10 TO 20
 FOOT WIDE NO-MOW BUFFER BE
 ESTABLISHED ALONG RIVER BANK TO
 PROVIDE ADDITIONAL BANK PROTECTION.

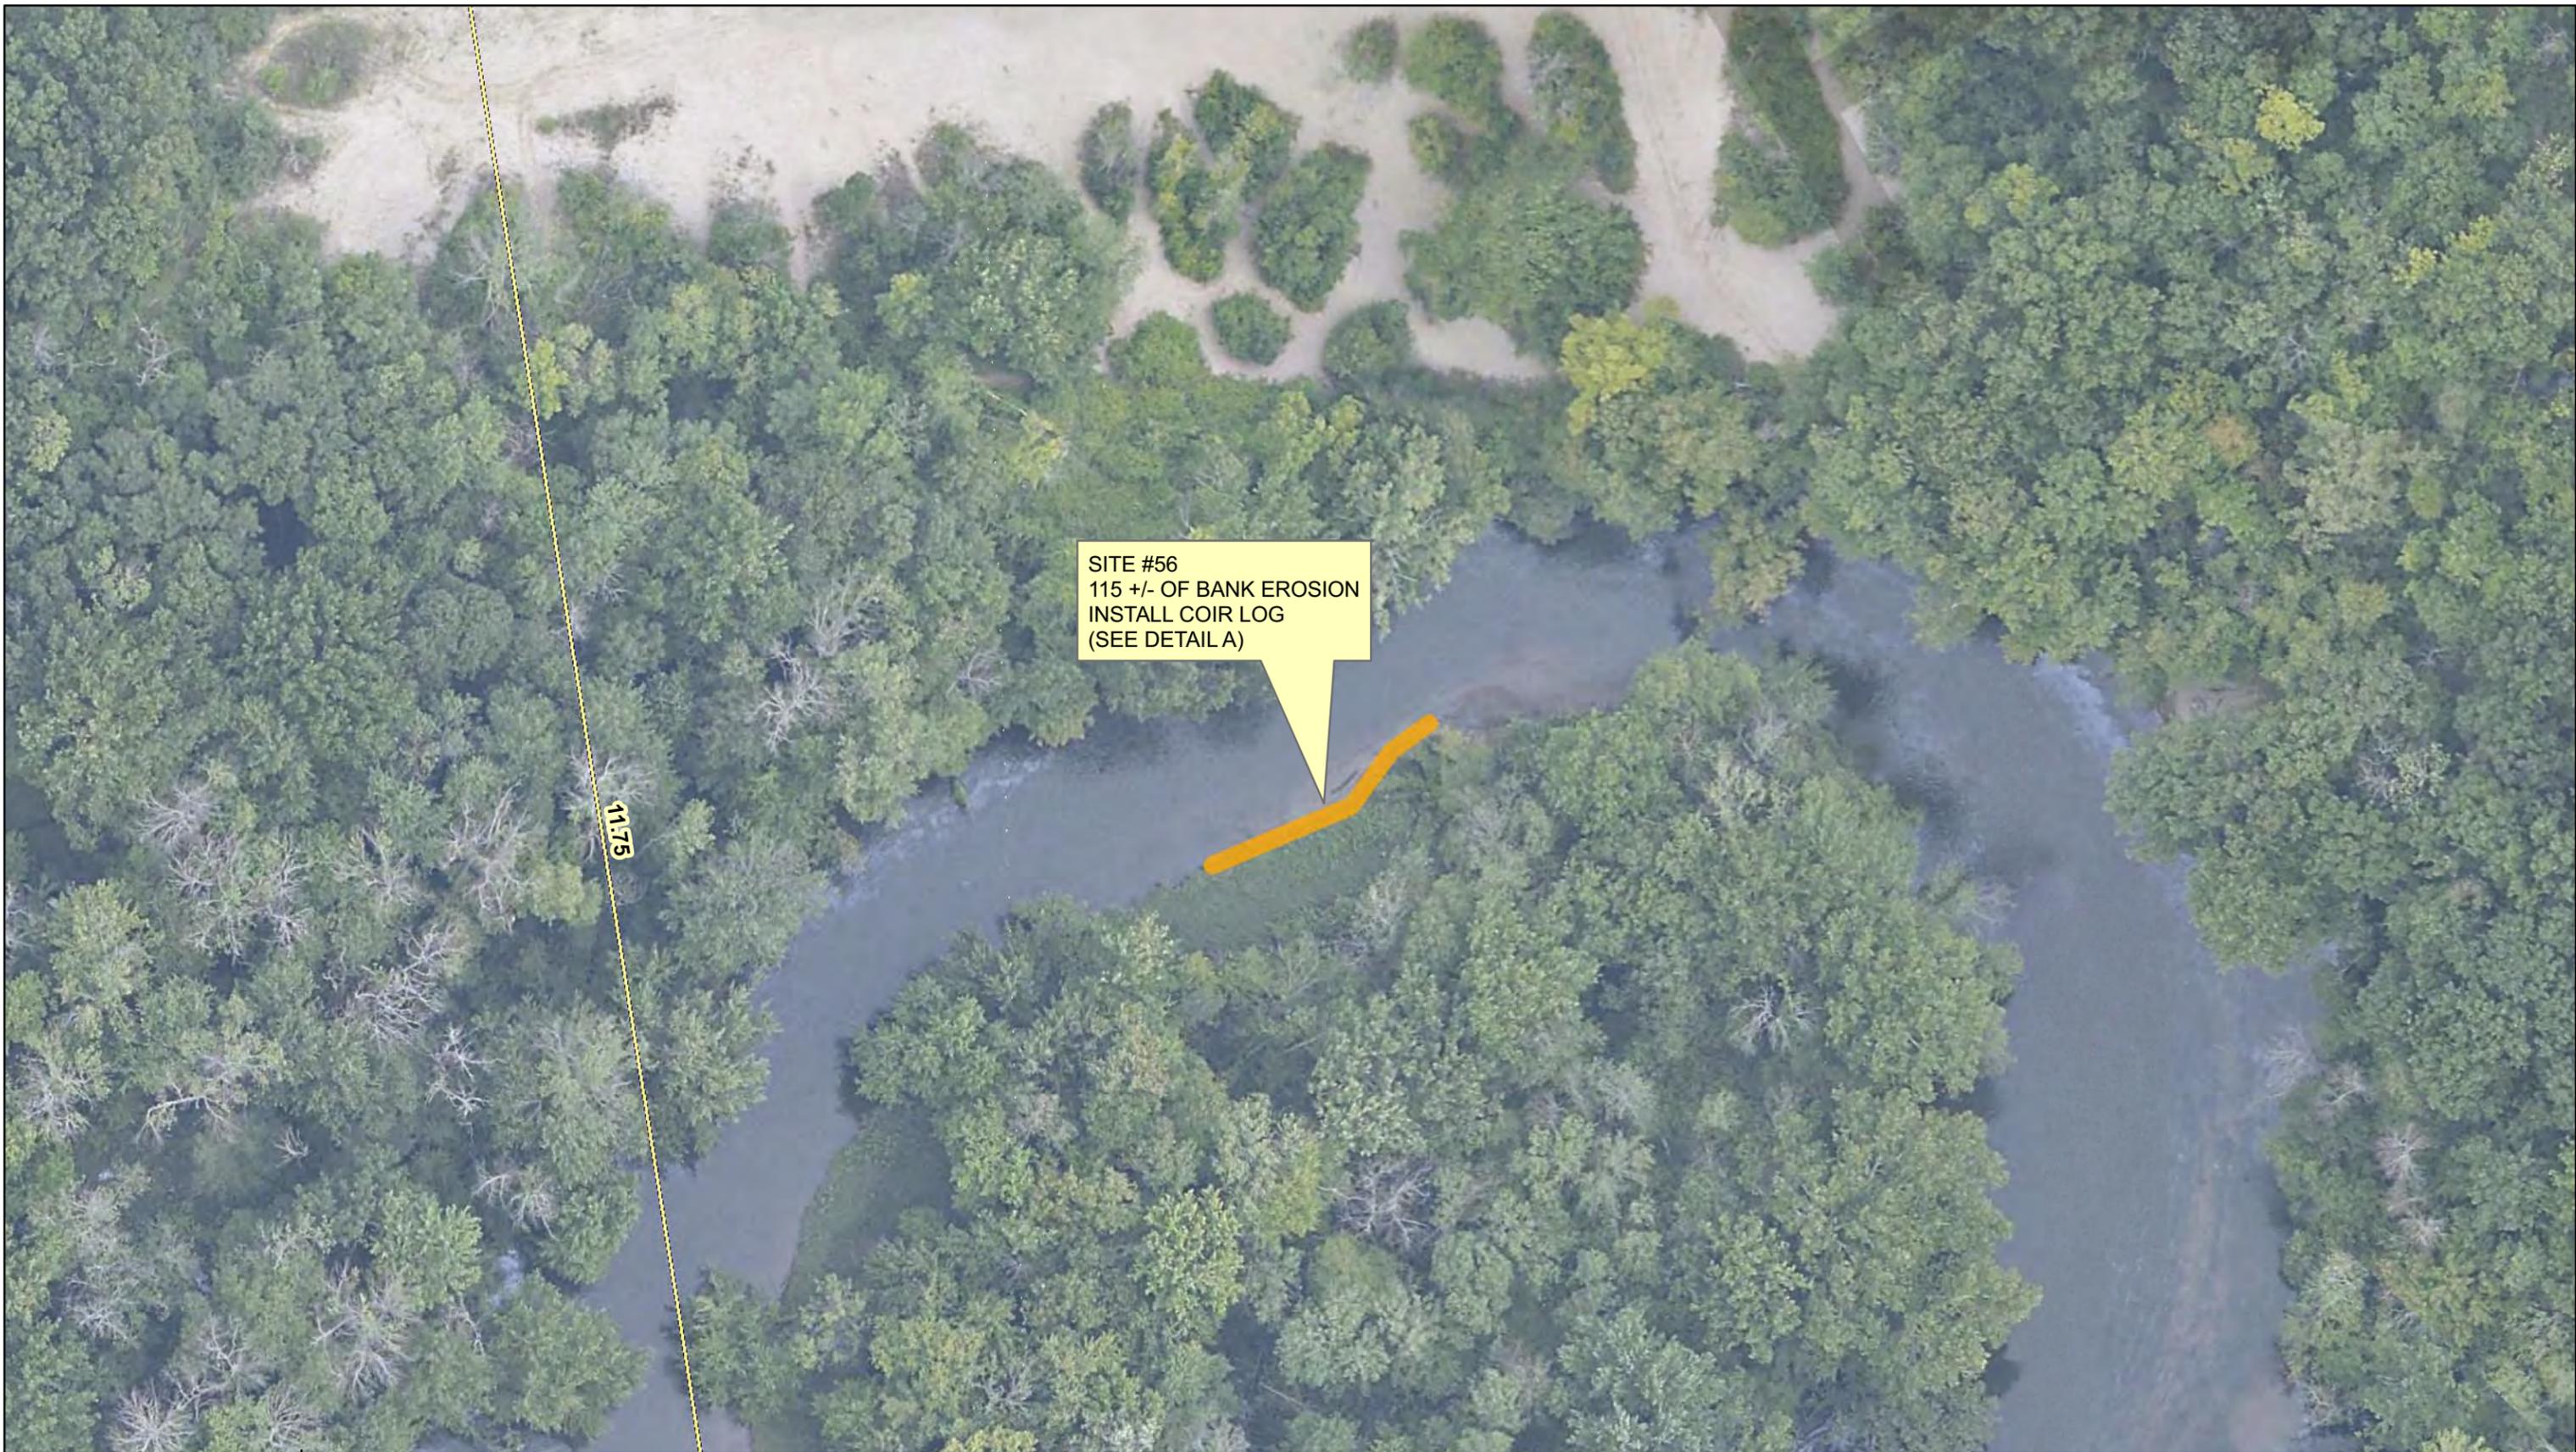
FIGURE 6
SITE #56
BANK EROSION STABILIZATION DESIGN

SITE #56
115 +/- OF BANK EROSION
INSTALL COIR LOG
(SEE DETAIL A)

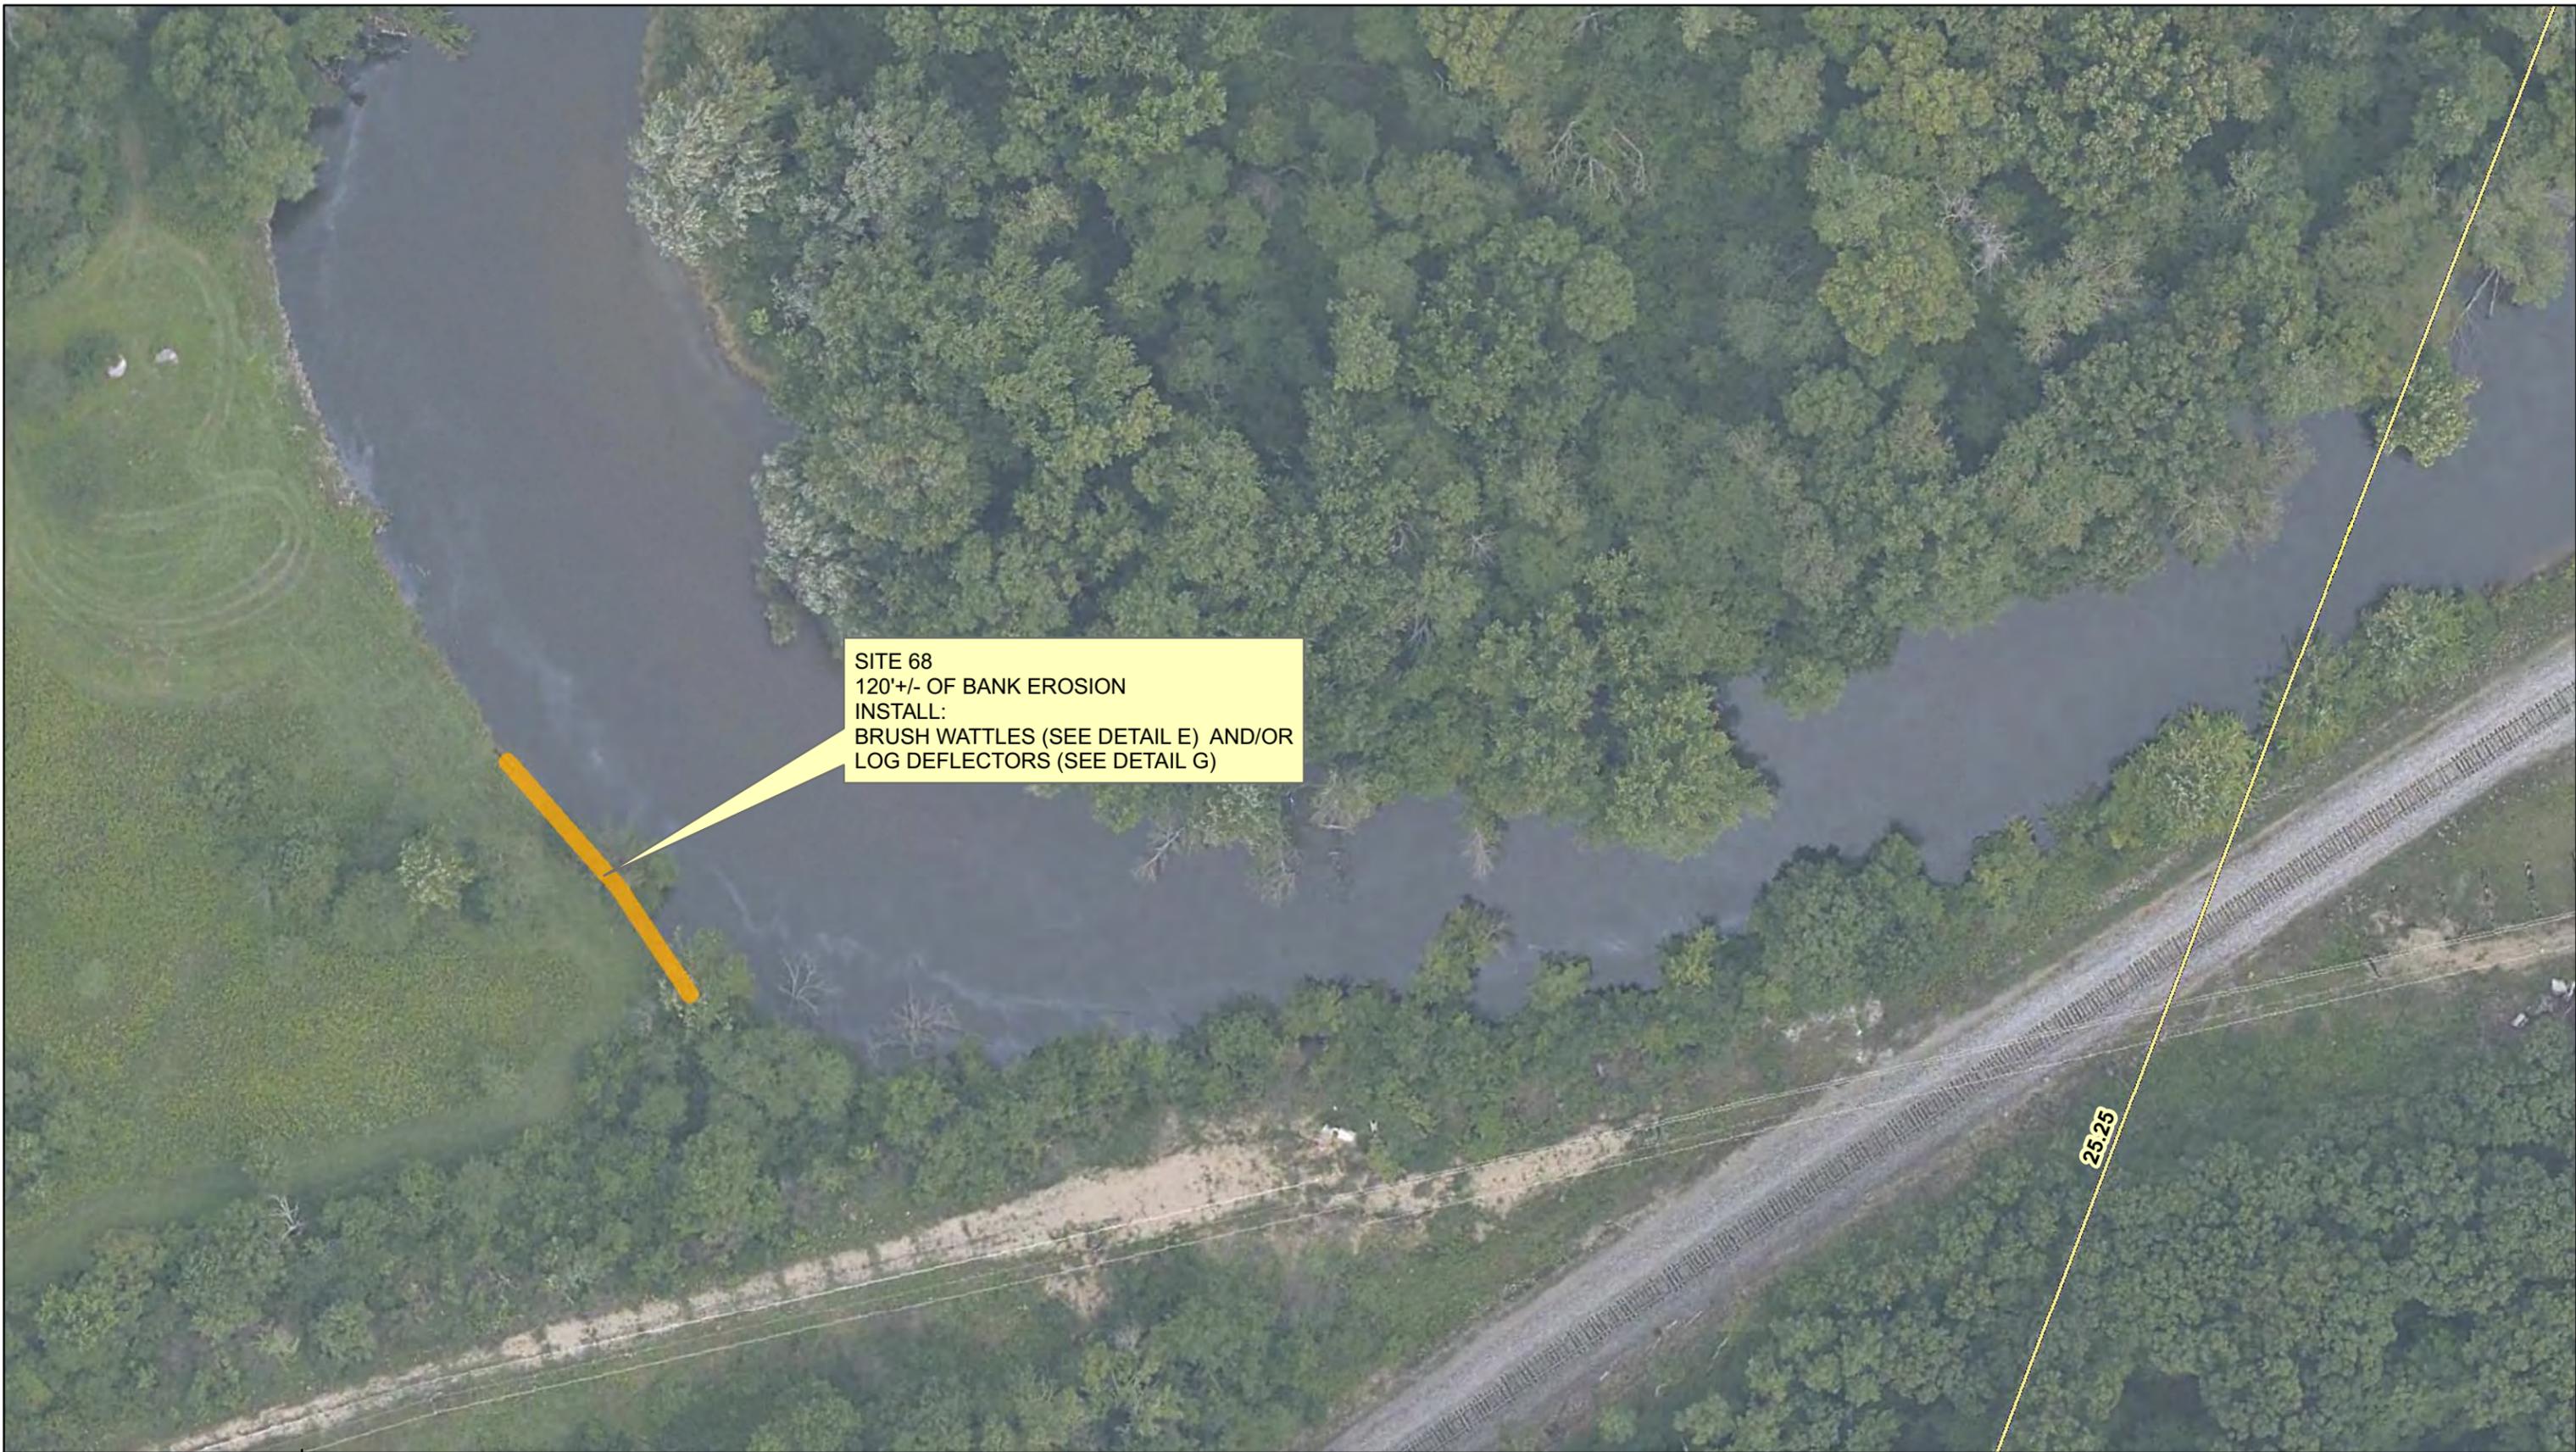
FIGURE 7
SITE #68

SITE 68
120'+/- OF BANK EROSION
INSTALL:
BRUSH WATTLES (SEE DETAIL E) AND/OR
LOG DEFLECTORS (SEE DETAIL G)

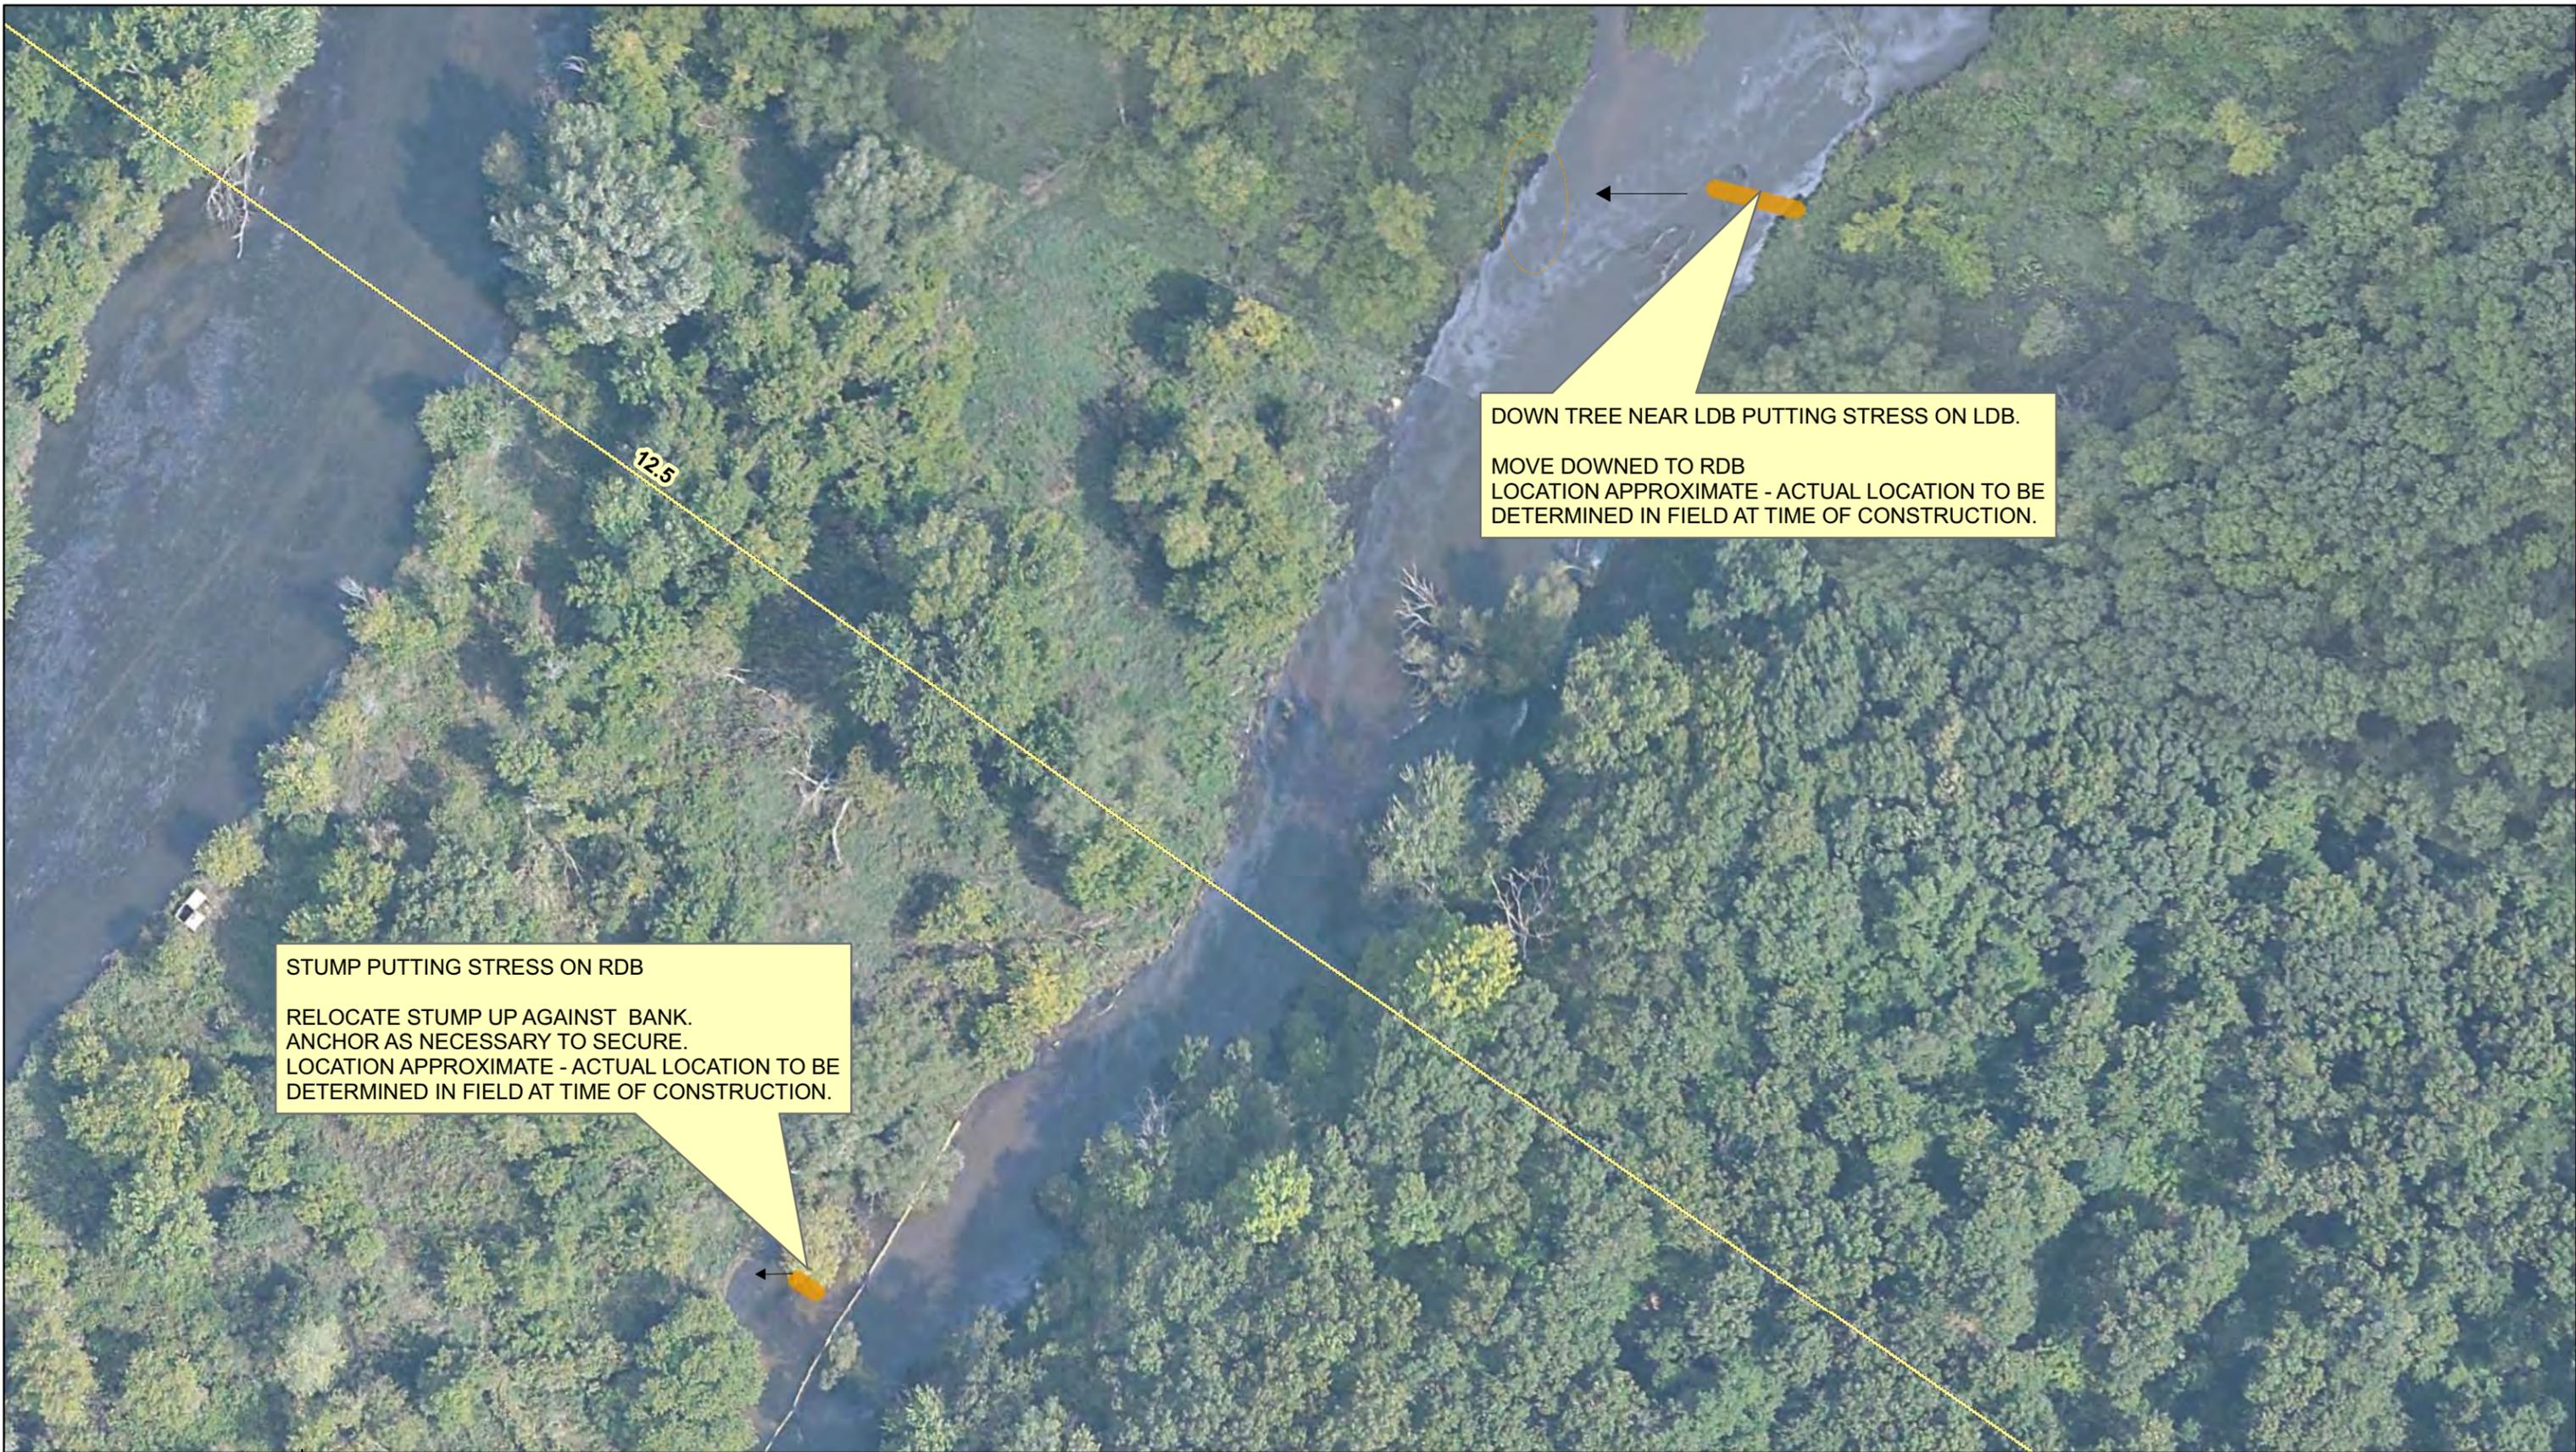
FIGURE 8
SITE #160
BANK EROSION STABILIZATION DESIGN

DOWN TREE NEAR LDB PUTTING STRESS ON LDB.
MOVE DOWNED TO RDB
LOCATION APPROXIMATE - ACTUAL LOCATION TO BE DETERMINED IN FIELD AT TIME OF CONSTRUCTION.

STUMP PUTTING STRESS ON RDB
RELOCATE STUMP UP AGAINST BANK.
ANCHOR AS NECESSARY TO SECURE.
LOCATION APPROXIMATE - ACTUAL LOCATION TO BE DETERMINED IN FIELD AT TIME OF CONSTRUCTION.

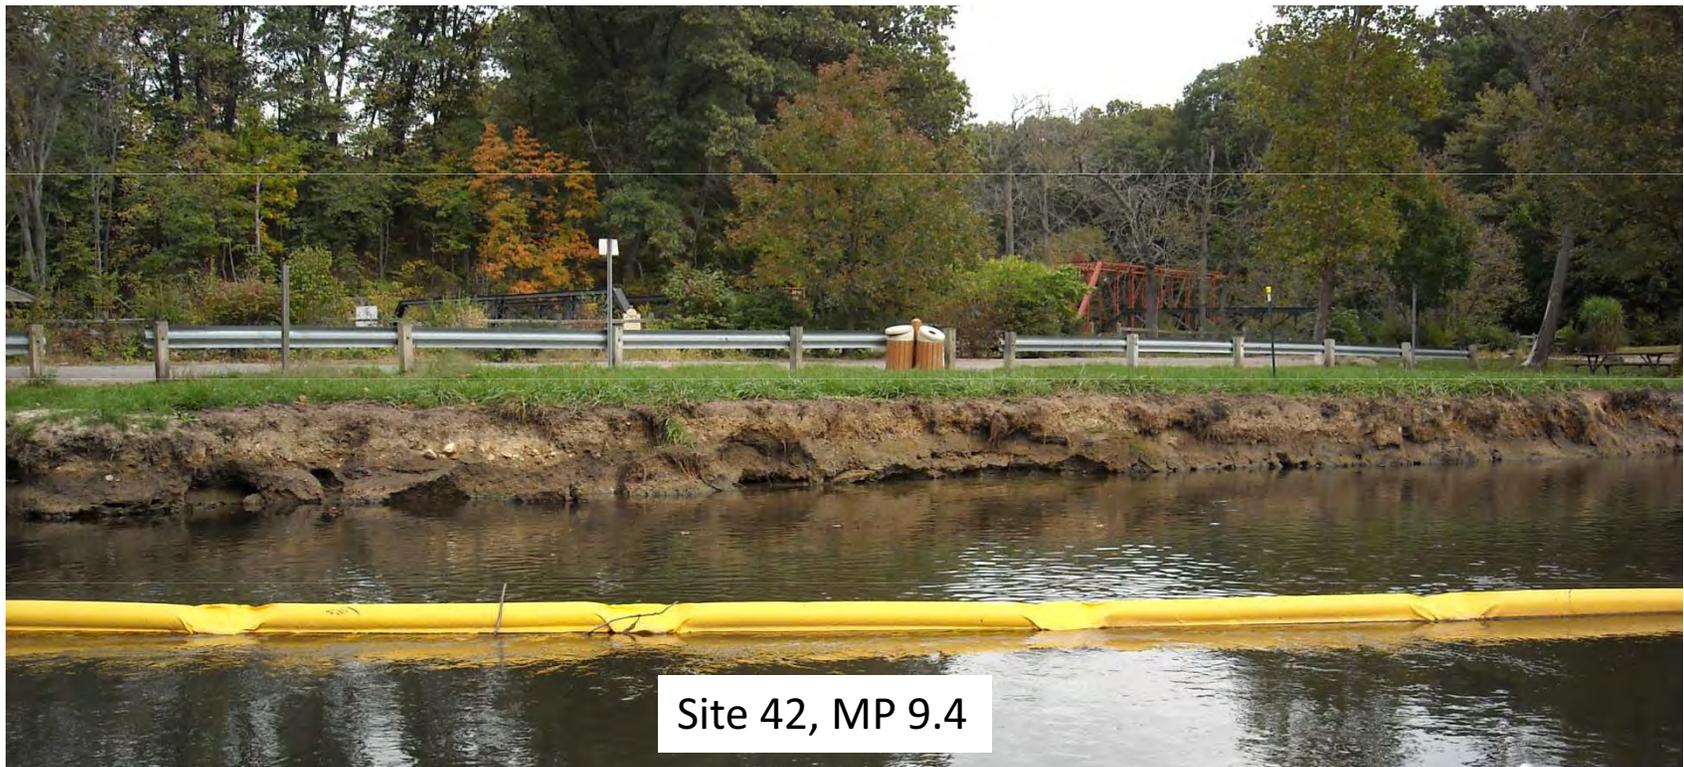
Site 42, MP 9.4

- Before Construction

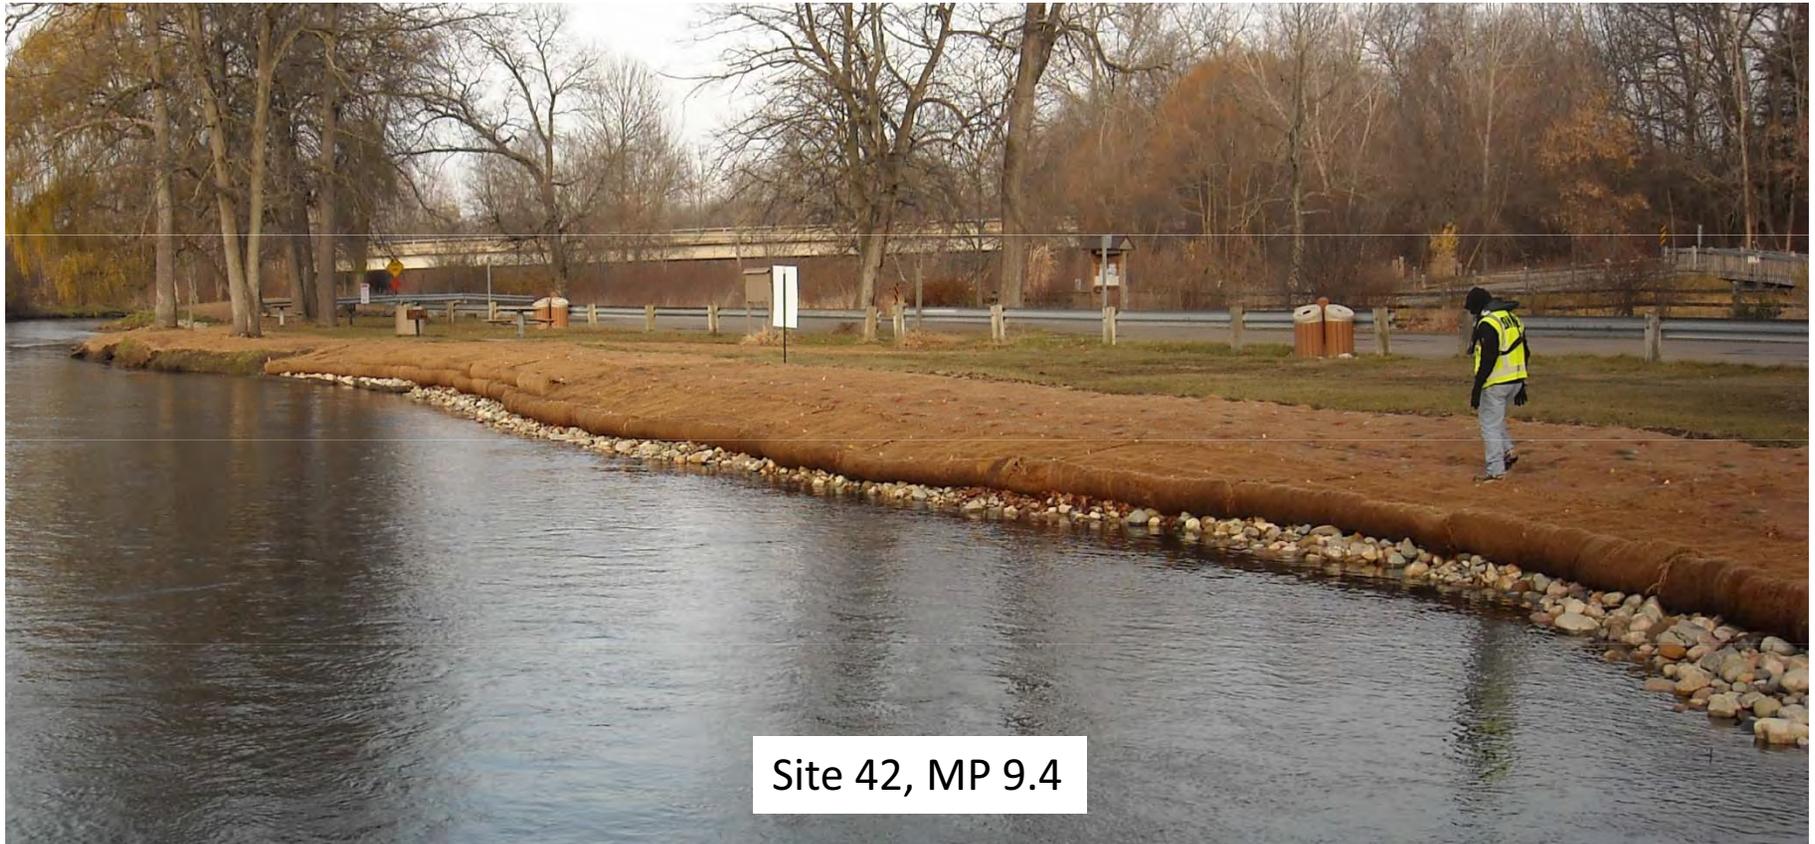
Site 42, MP 9.4

- After Construction
