APPENDIX B

Photos – Example Erosion Areas

ENBRIDGE LINE 6B INCIDENT KALAMAZOO RIVER BANK STABILIZATION DESIGN PRIORITY AREAS

OCTOBER 26, 2010

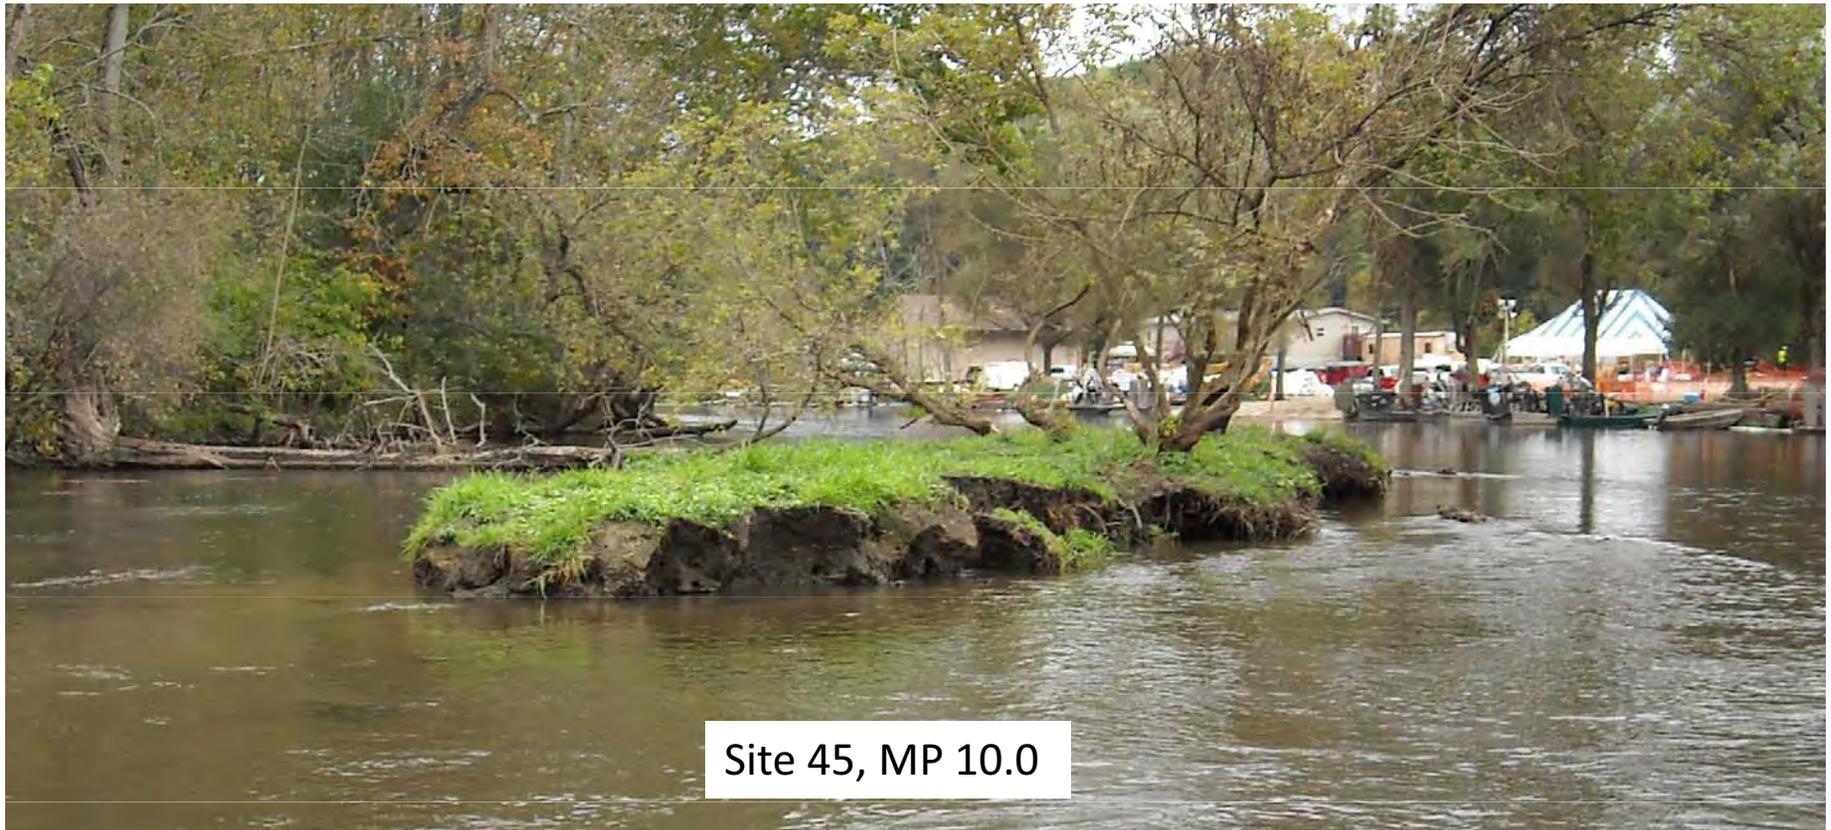
Site 45, MP 10.0

- Before Construction

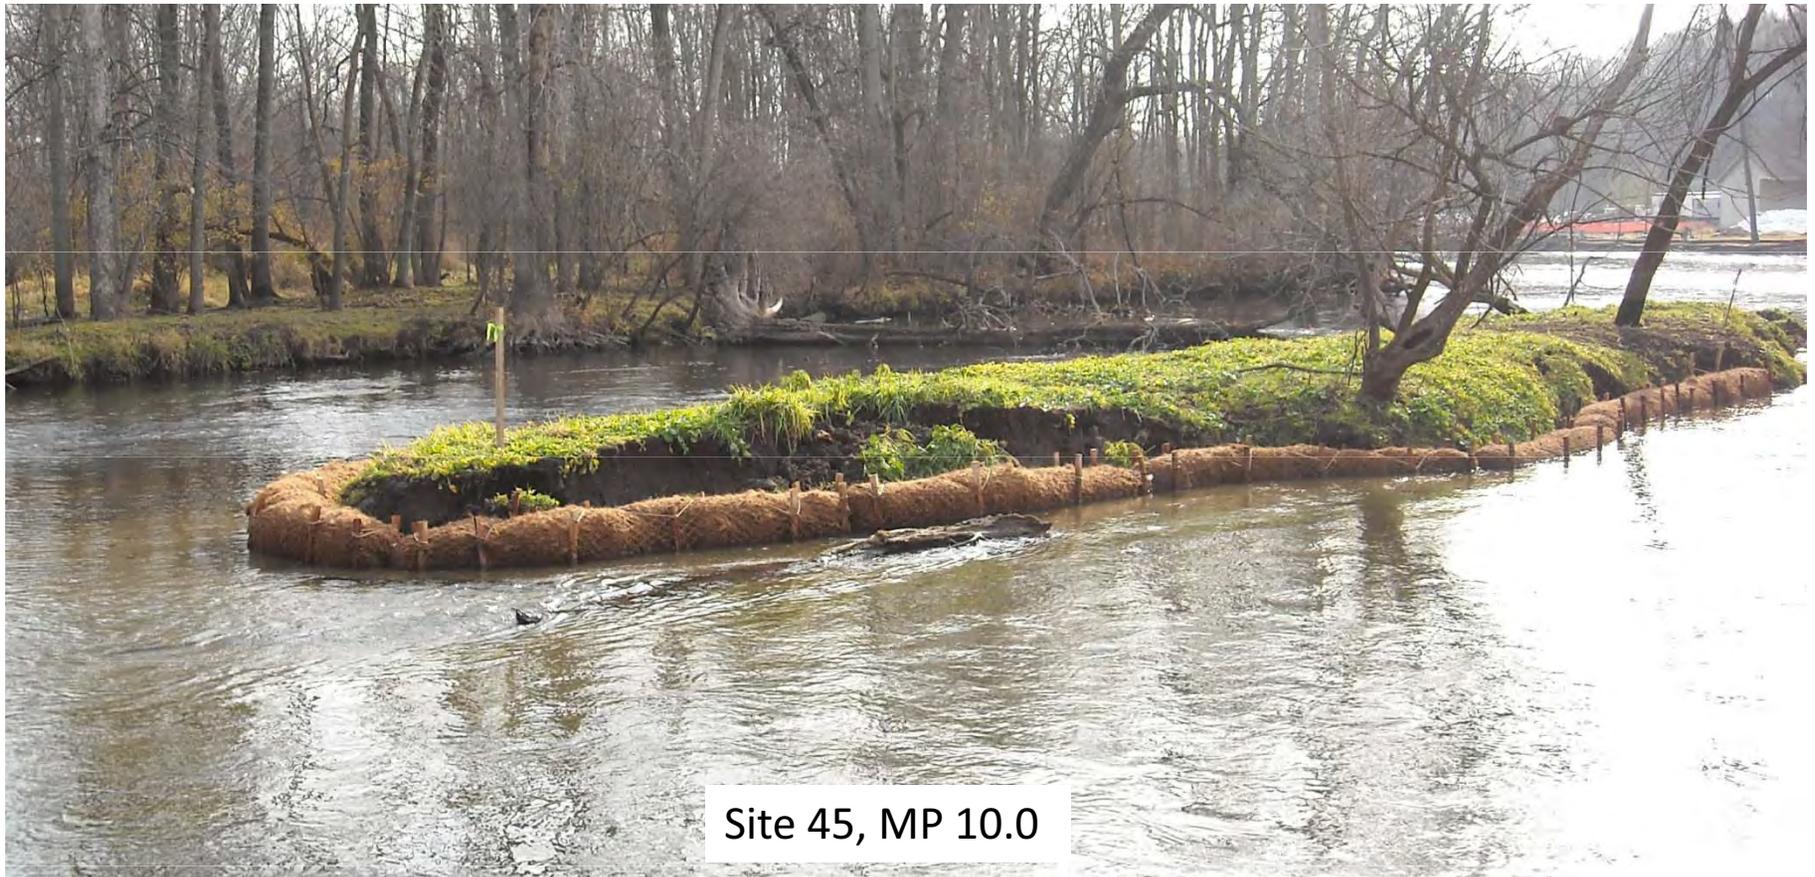
Site 45, MP 10.0

- After Construction

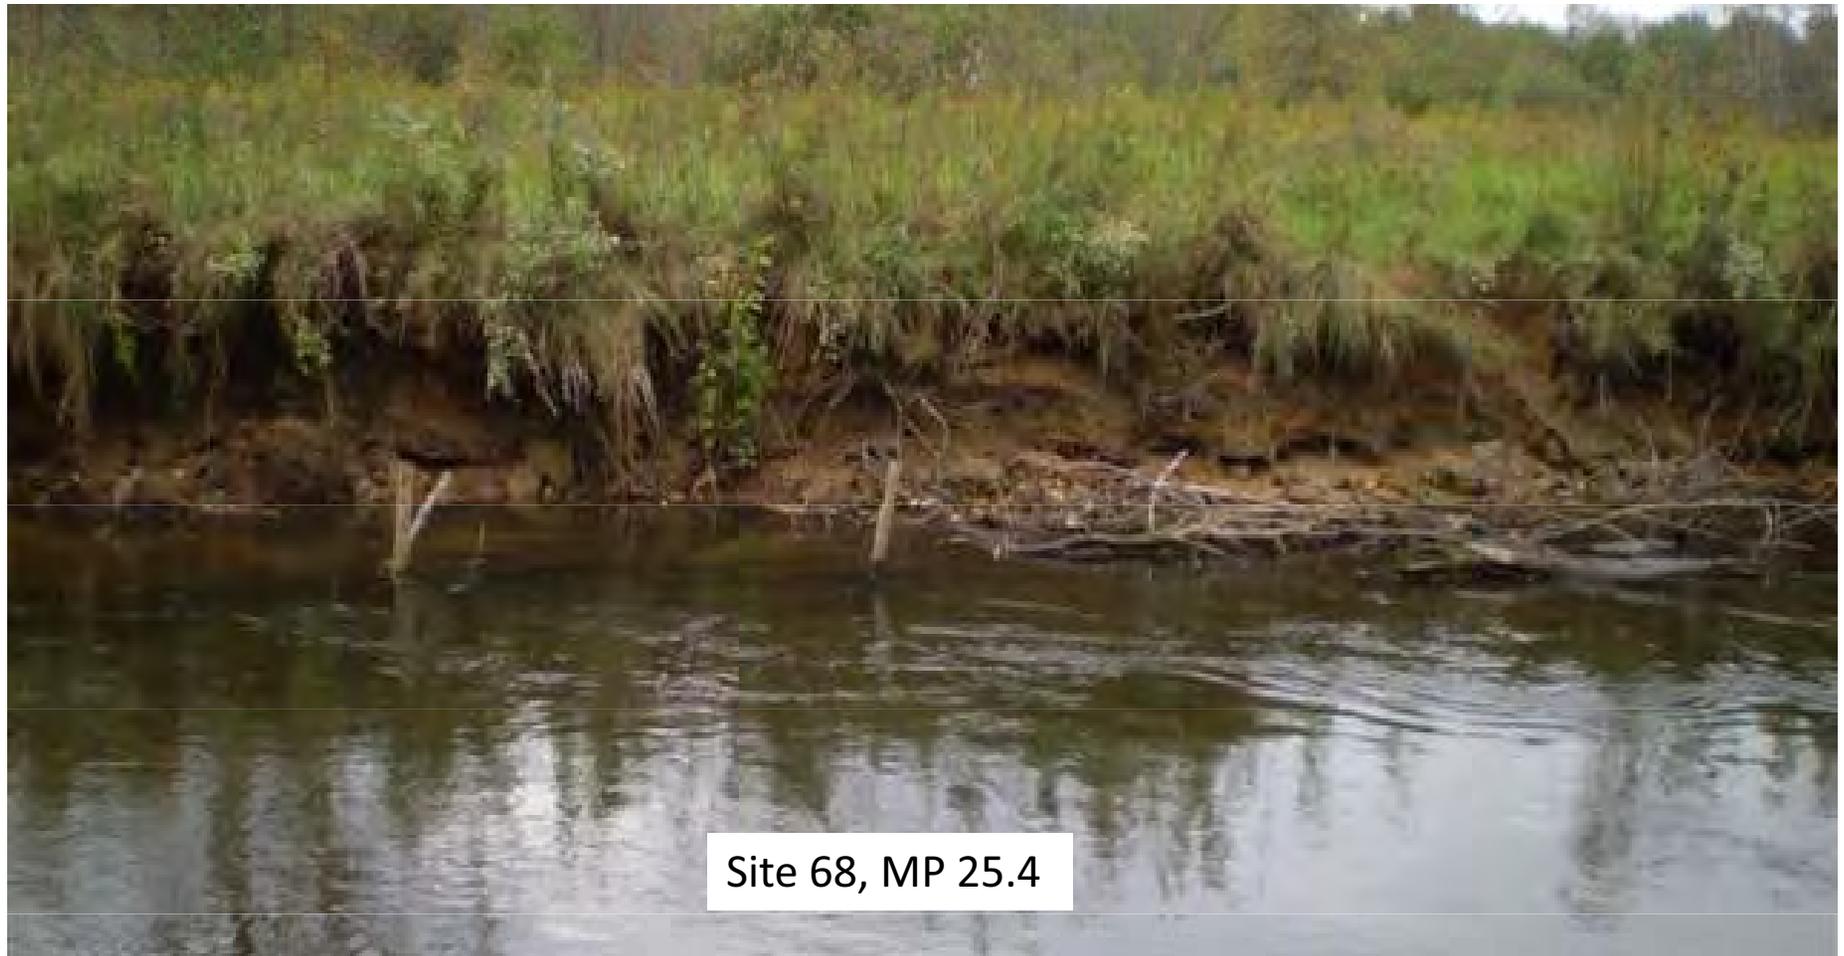
Site 68, MP 25.4

- Before Construction

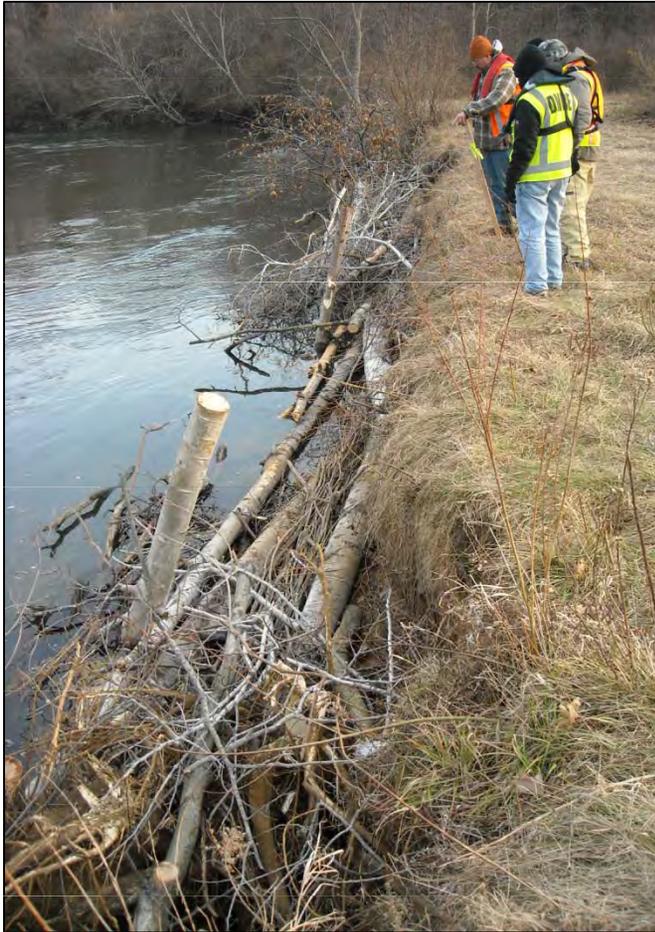
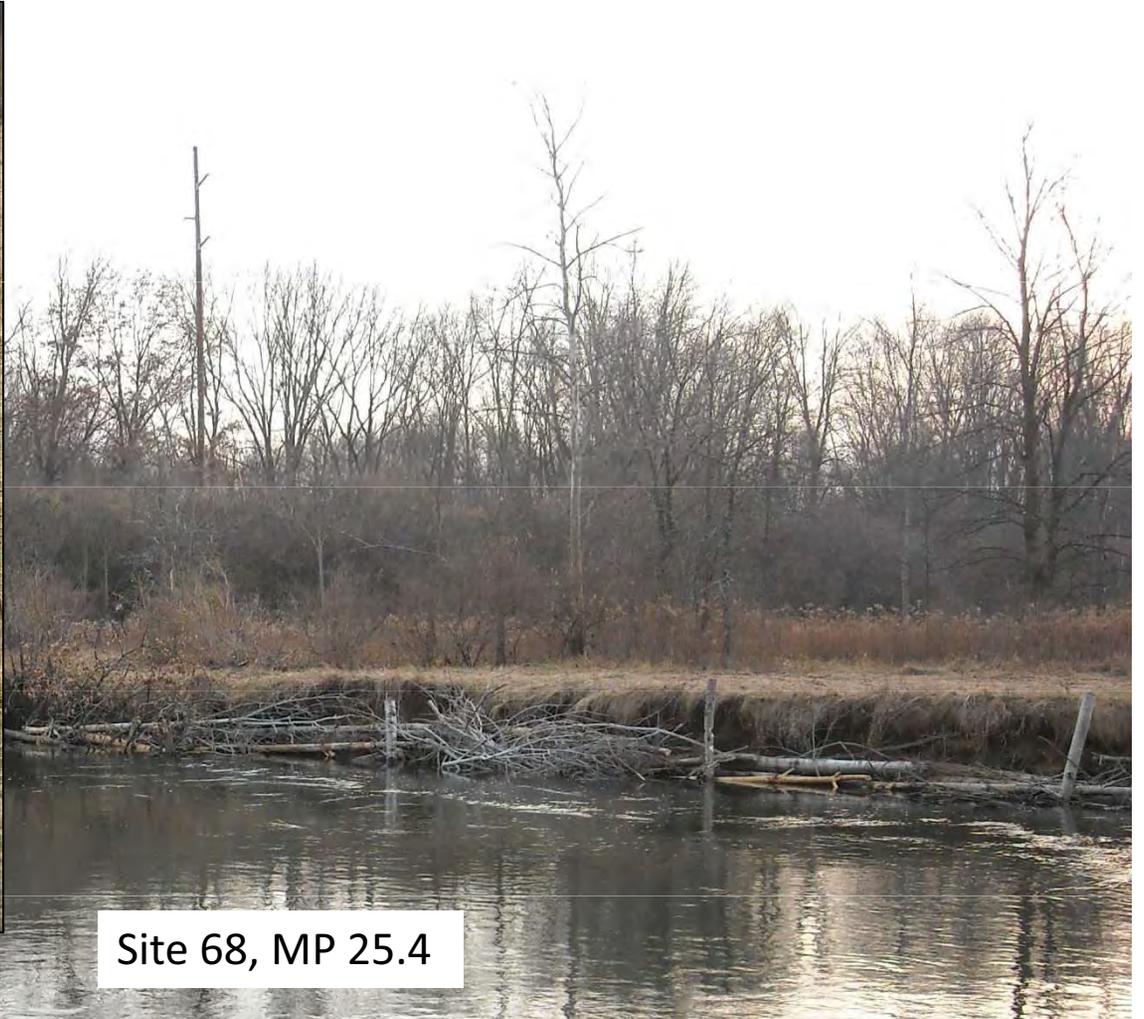
Site 68, MP 25.4

- After Construction
