Situation Photo Log

Friday, November 18, 2011

Kalamazoo River / Enbridge Spill

Larry Rader
START-USEPA
Situation Unit Leader

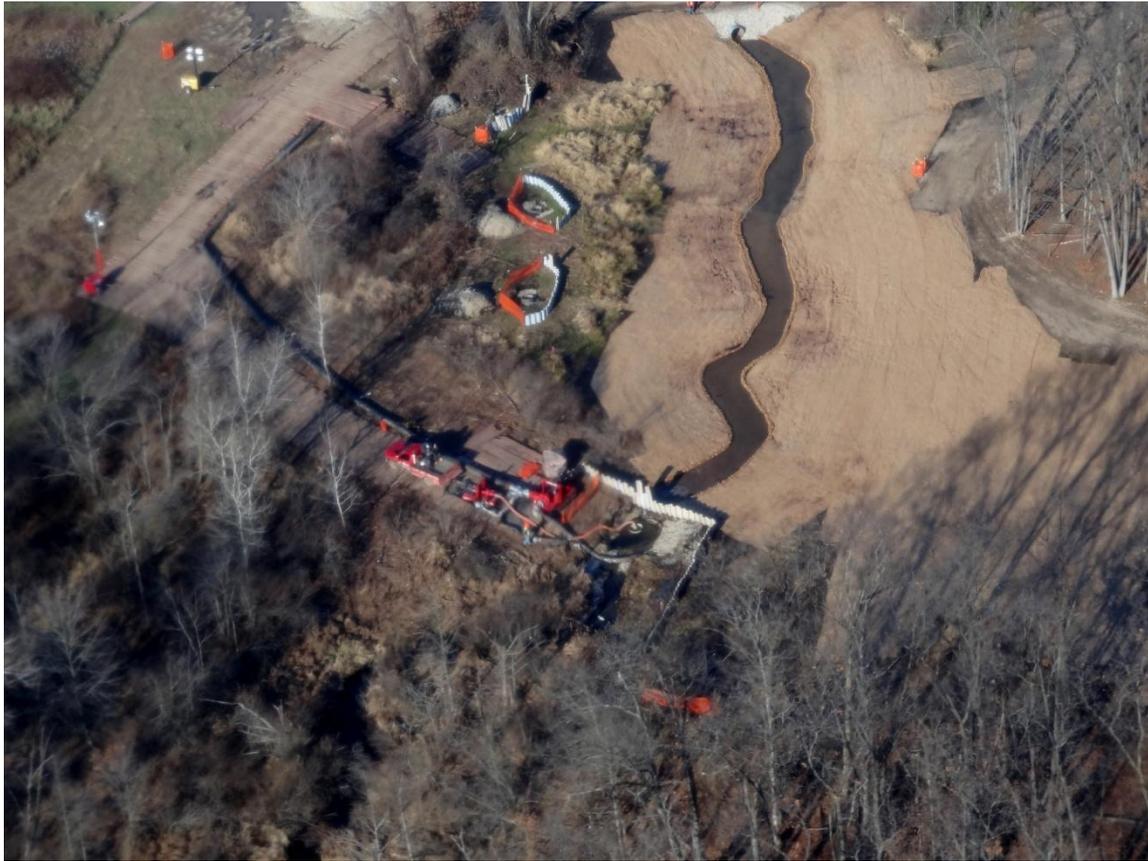
1. Talmadge Creek, pump-around system near Release Point.

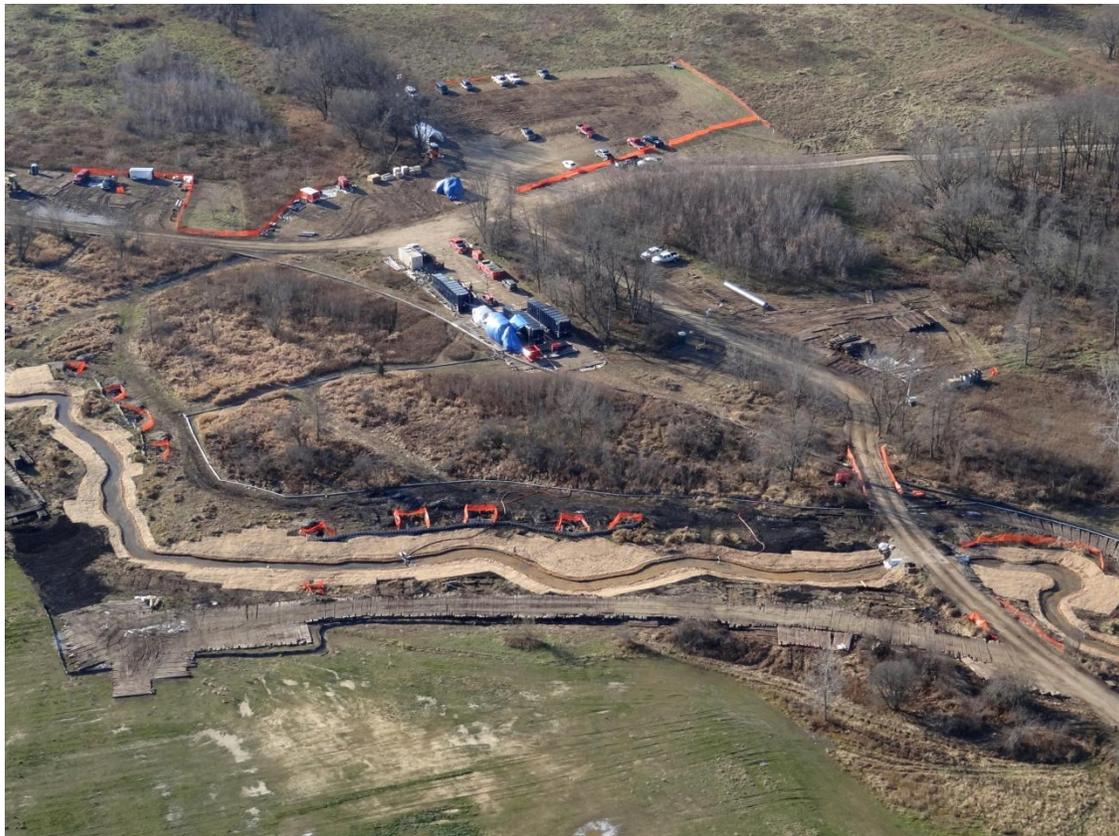
2. Talmadge Creek, restoration work near MP0.25.

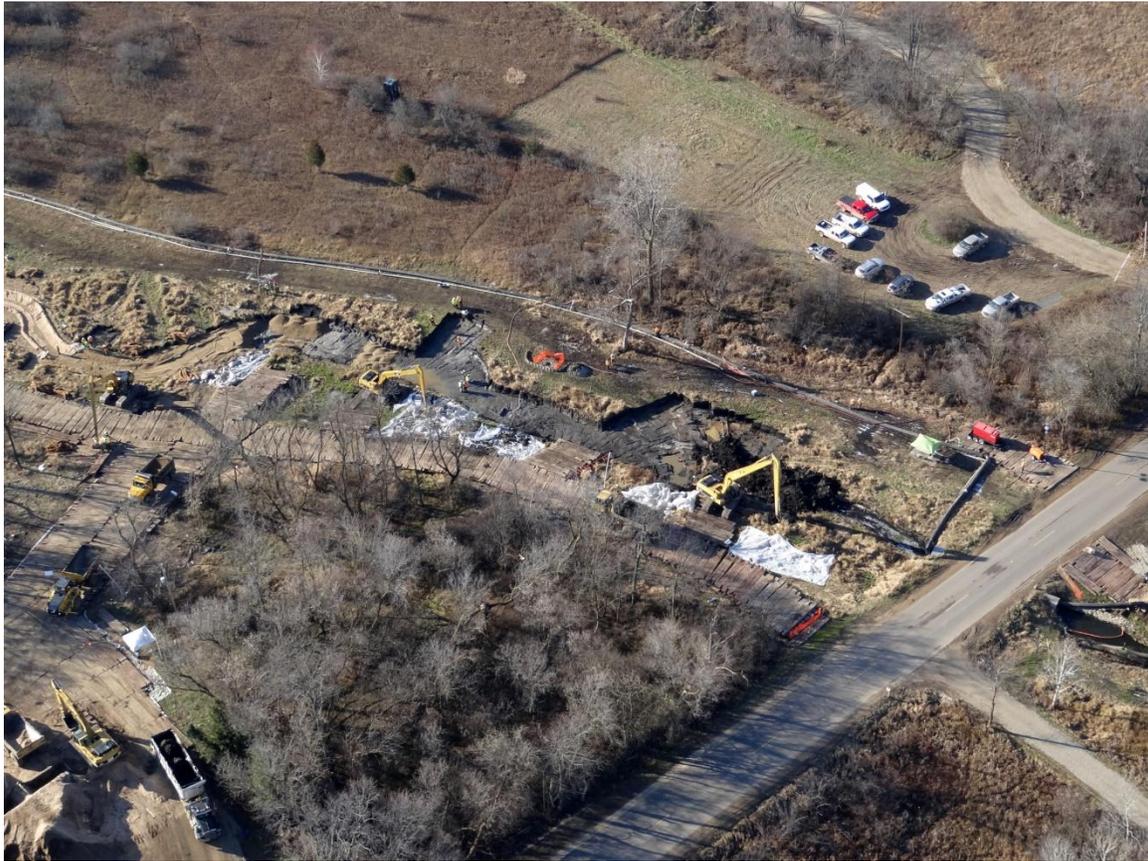
3. Talmadge Creek, excavation continues just south of Division Drive.

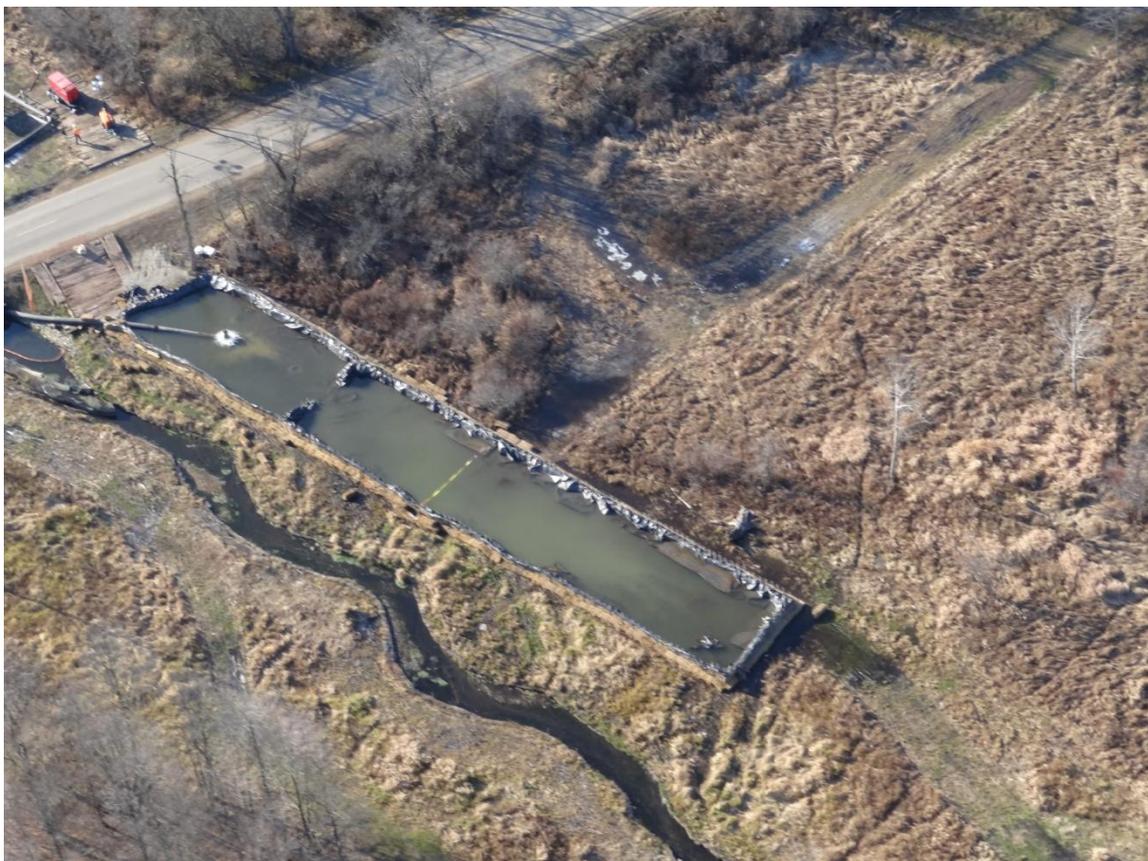
4. Talmadge Creek, discharge point just north of Division Drive.

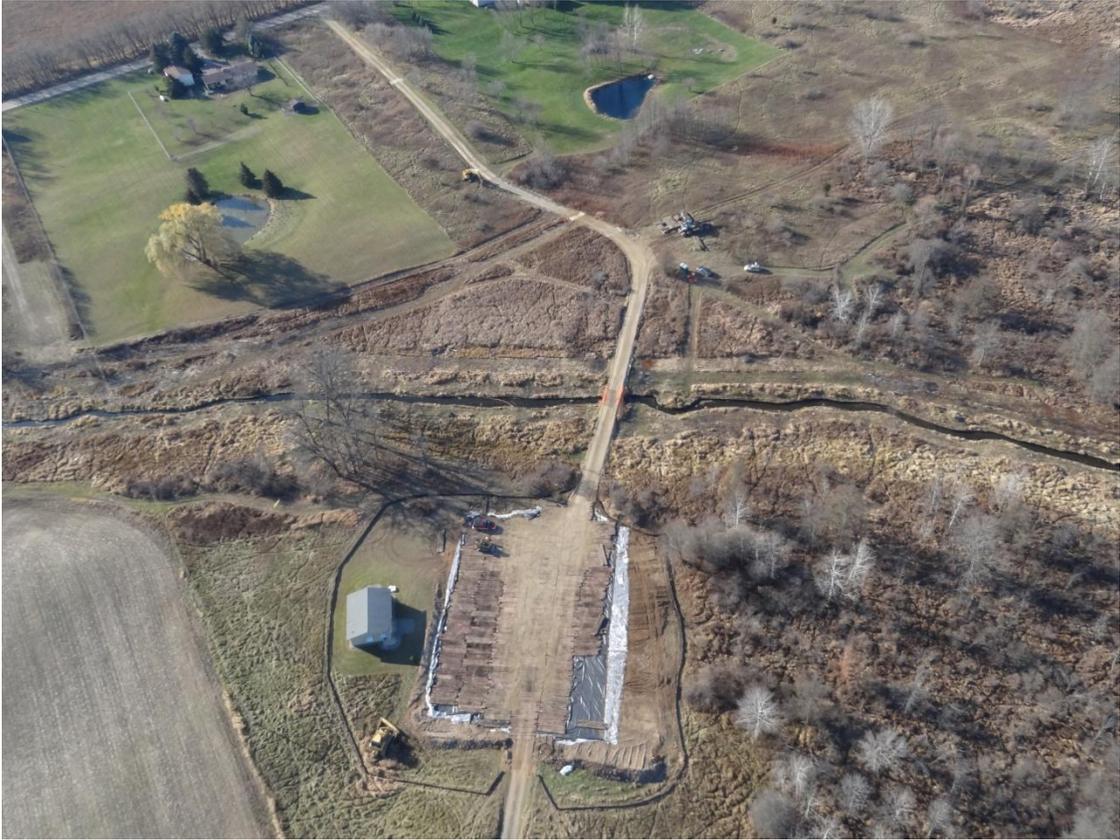
5. Preparation of soil staging area on Talmadge Creek for next phase of excavation.

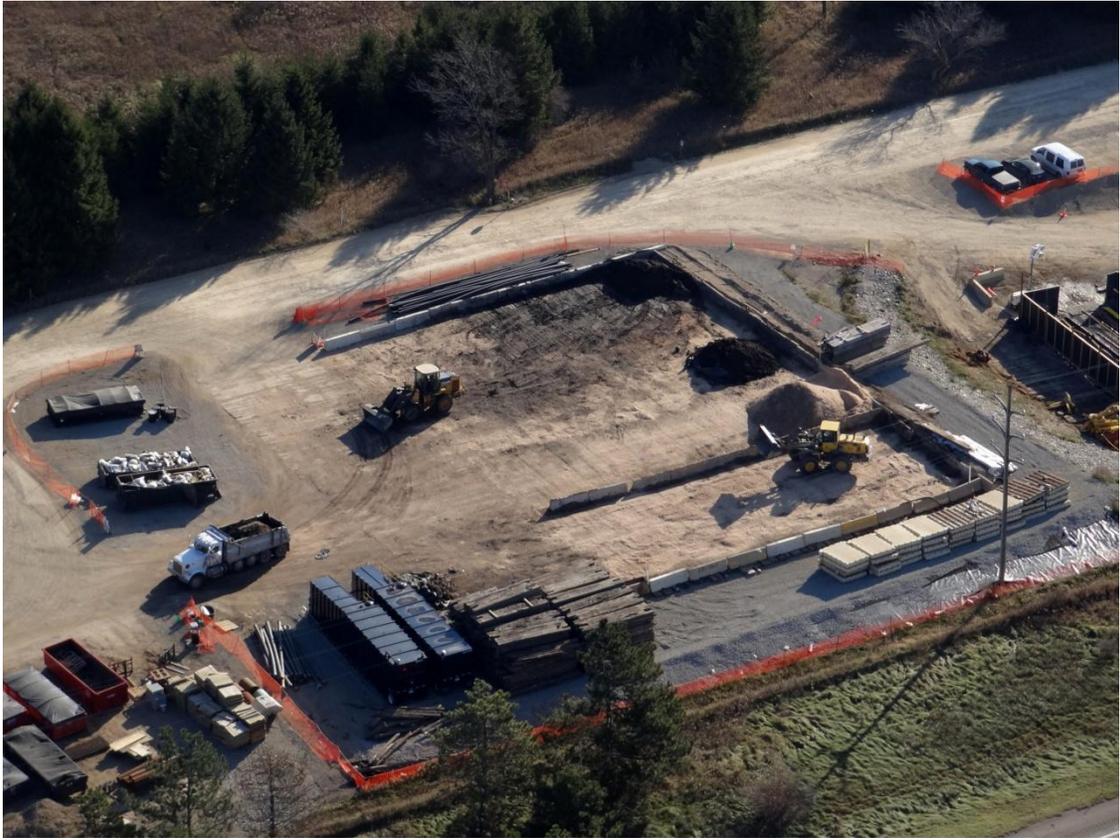
6. Frac-City Soil Cells A & B. Cell A contains two small piles of soil, Cell B is empty.

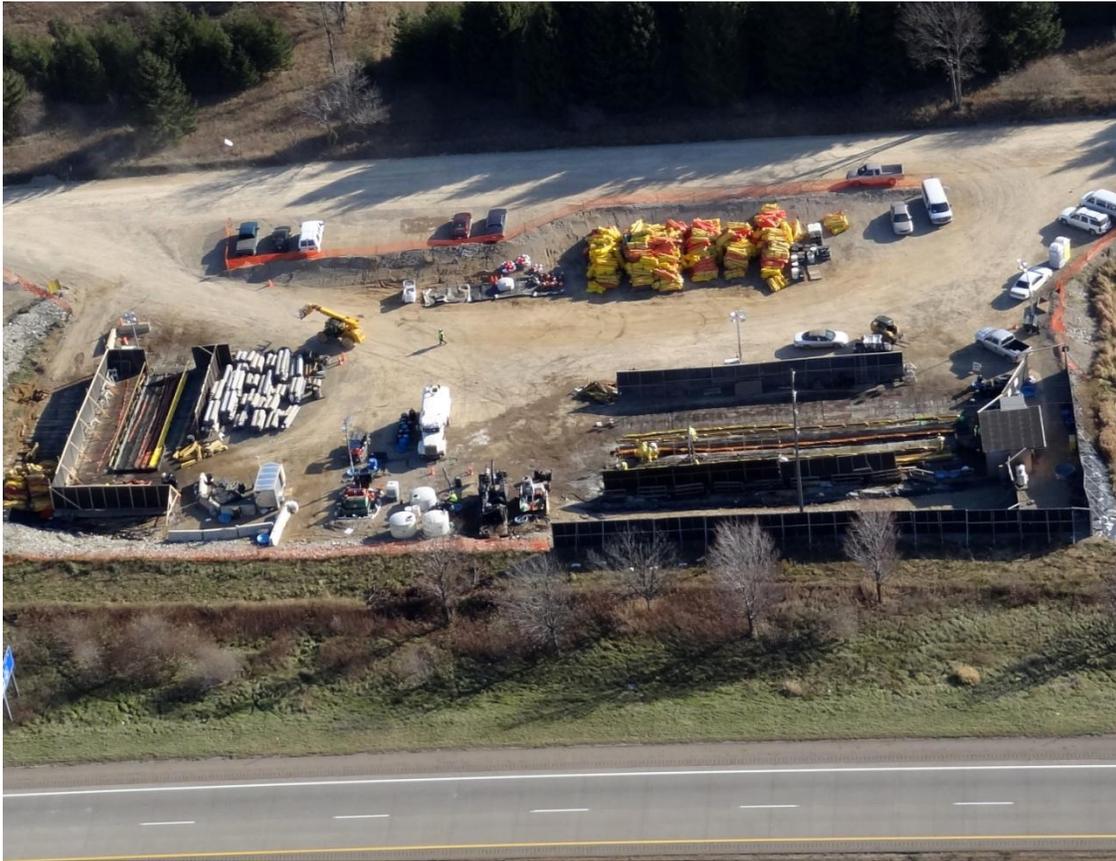
7. Frac-City decon area, boom observed being decon'd in both decon pads.

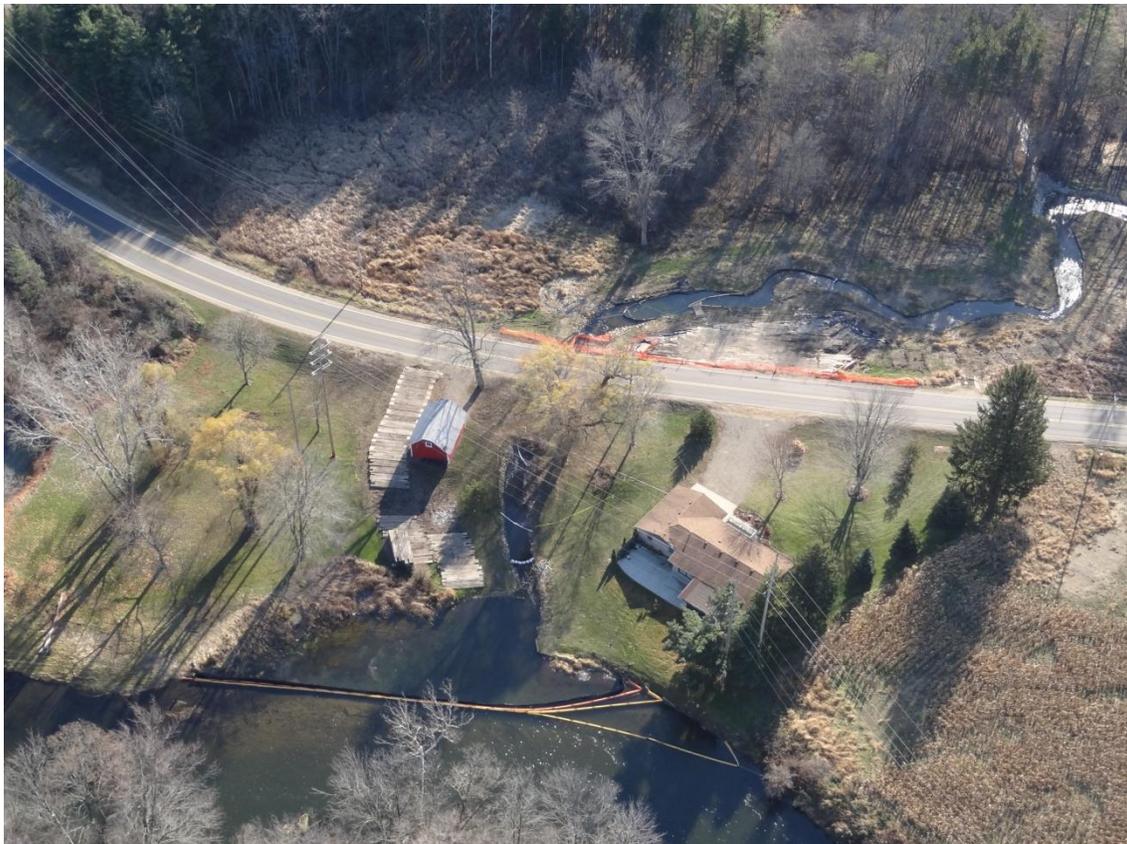
8. Sediment trap and Confluence, no activity or sheen observed.

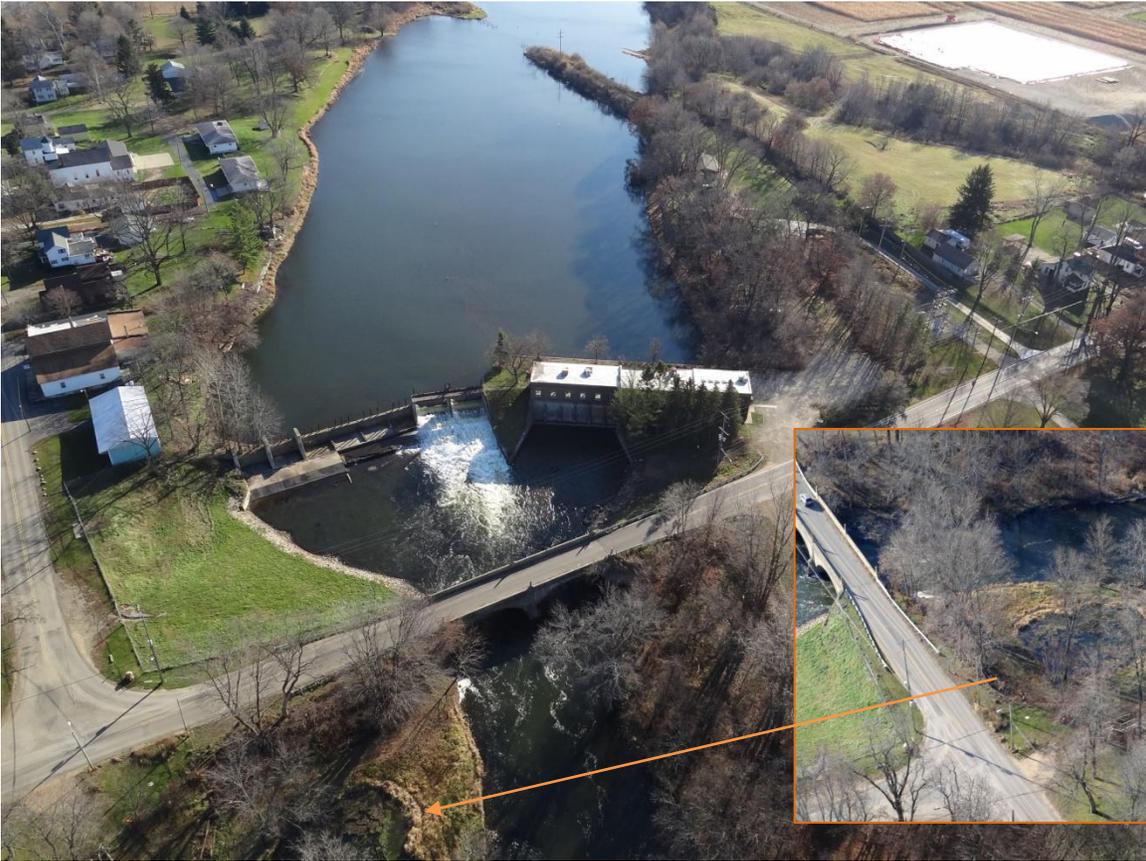
9. Ceresco Dam, chevron boom is gone. No sheen or activity observed at dam or pond at OB 5.92 RDB.

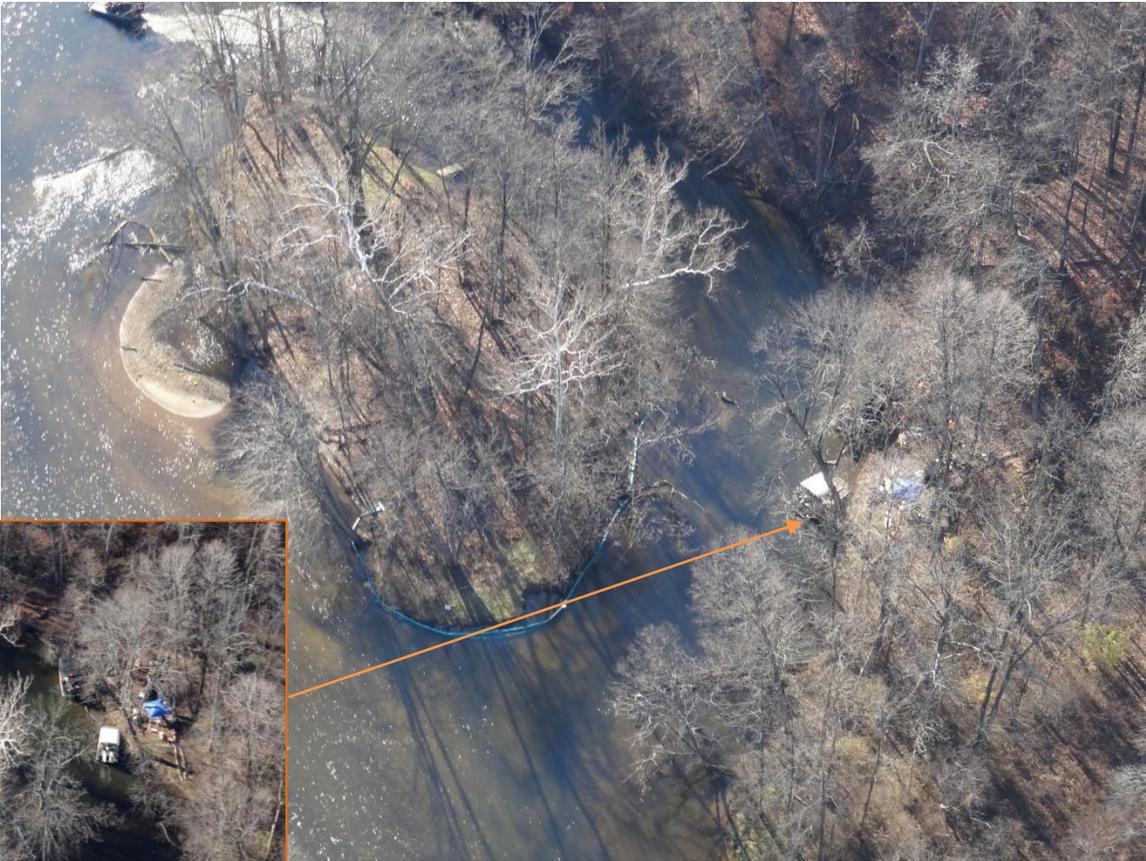
10. OB 9.10 LDB, expedited RI work continues at this location.

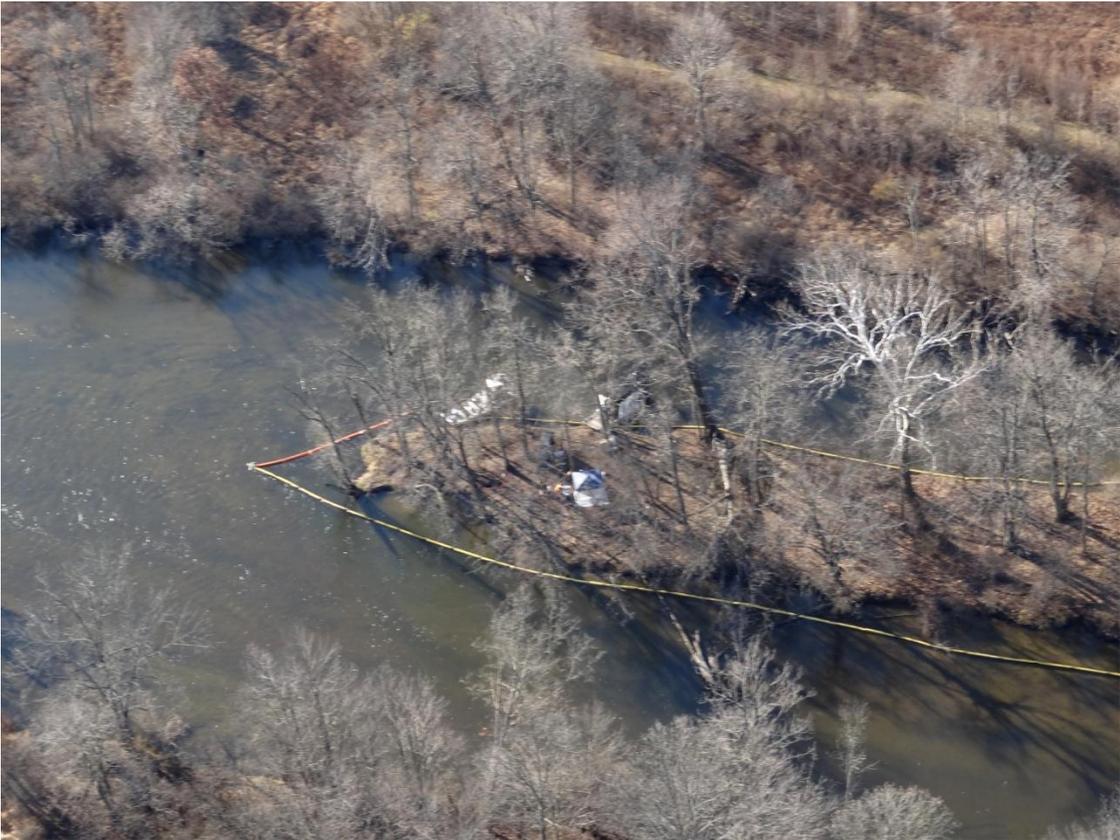
11. RI work on OB 9.78I continues.

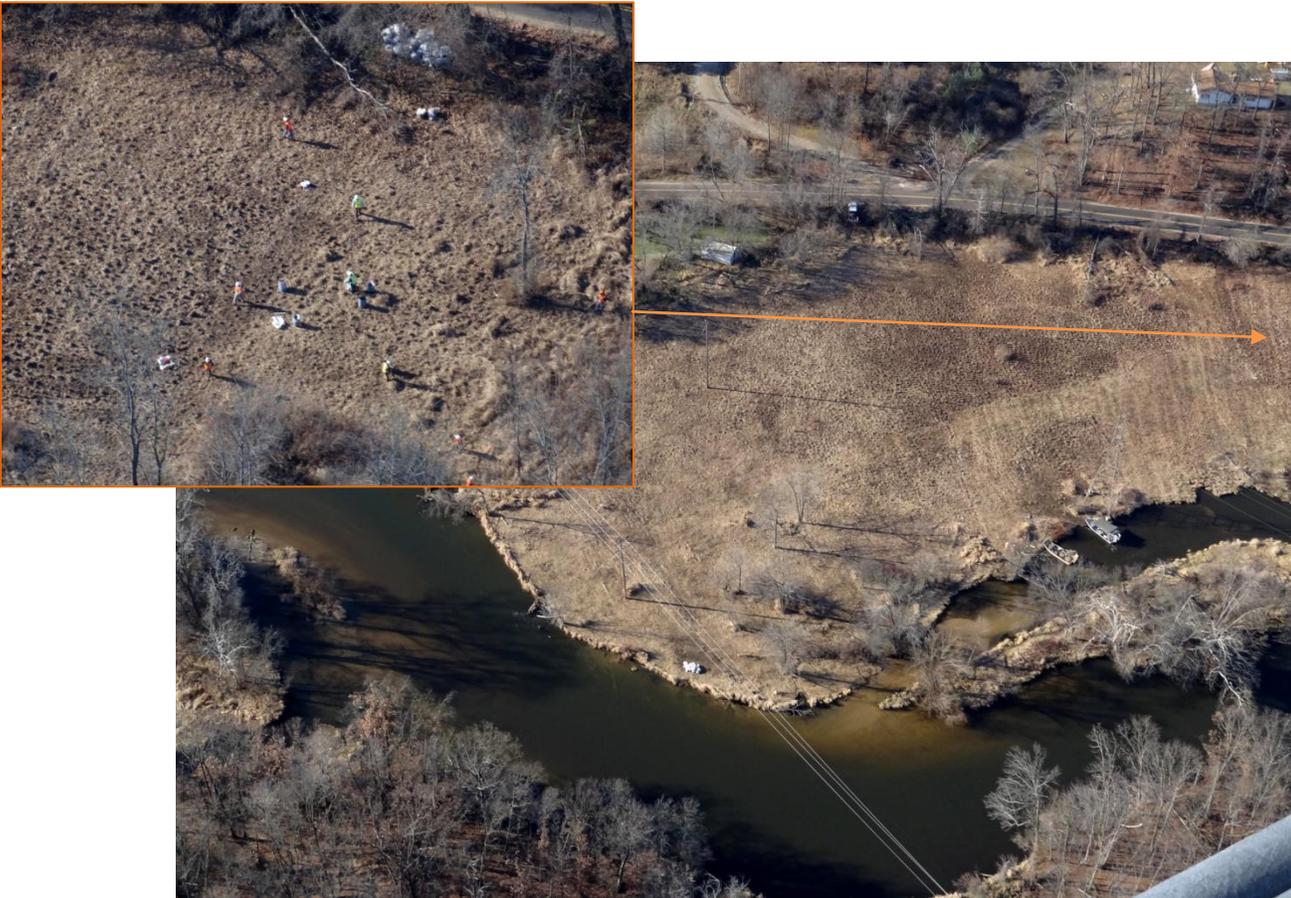
12. MP10.75 ERO work continues.

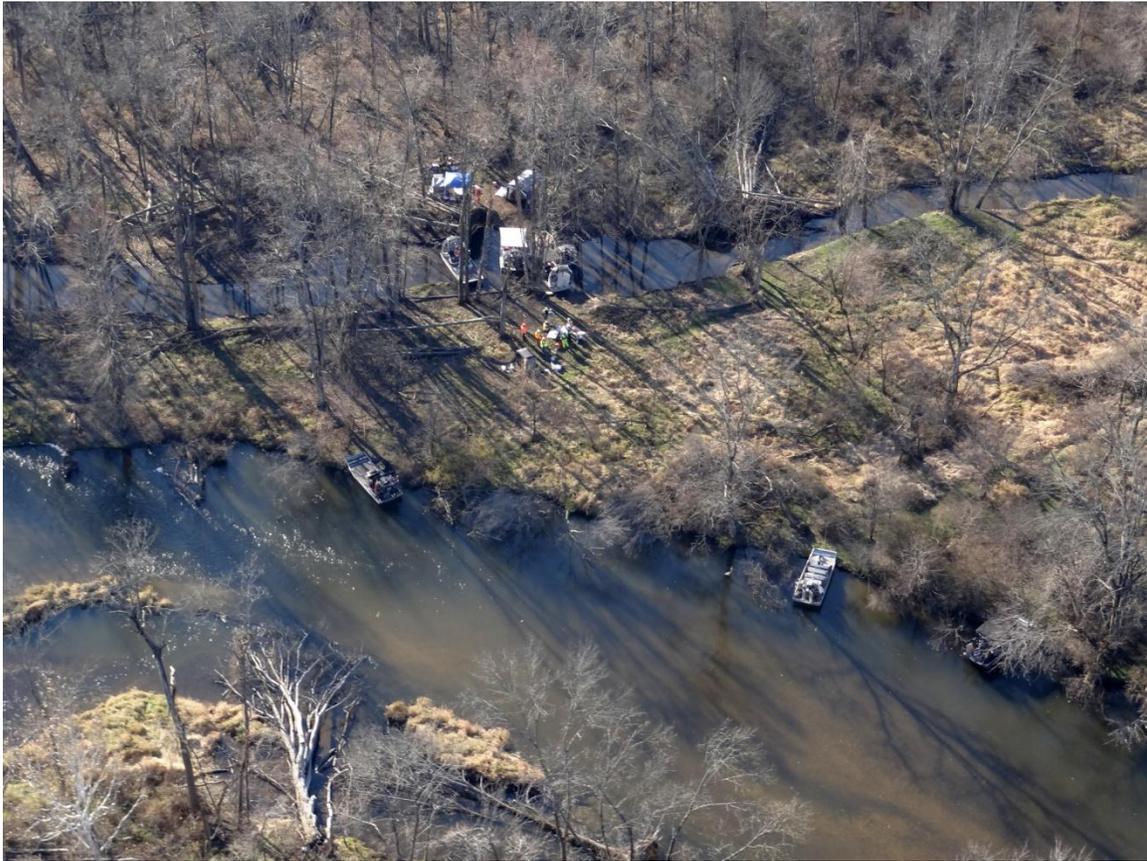
13. OB 11.79 LDB, RI crews observed south of river.

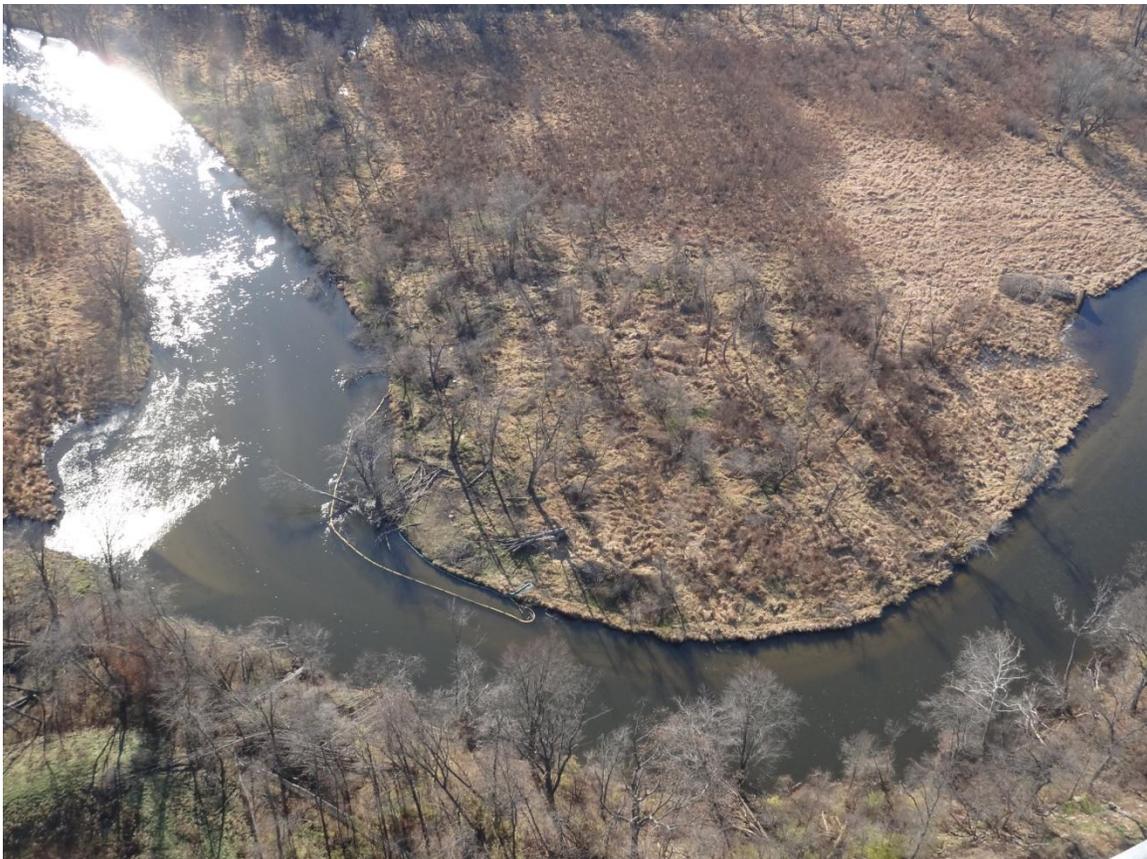
14. OB 13.40 LDB, no activity observed.

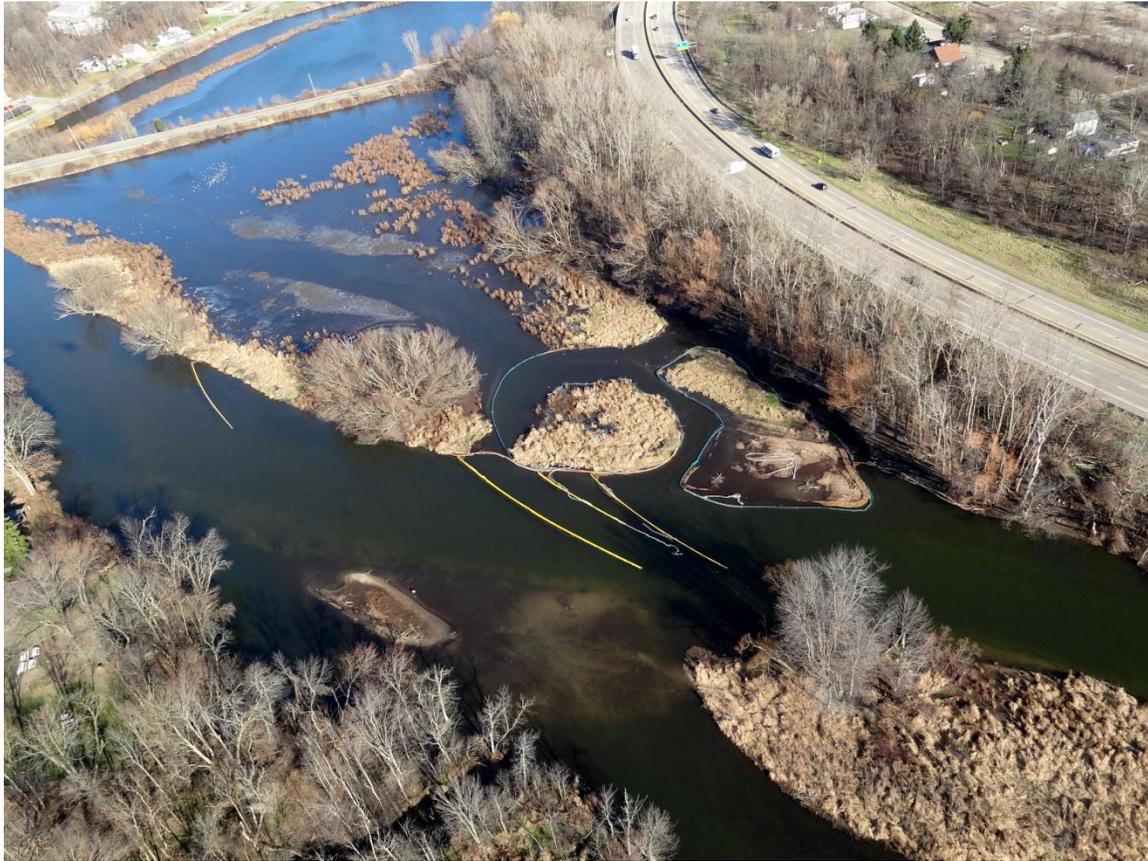
15. OB 14.97 I, sheet pile has been removed. No activity observed.

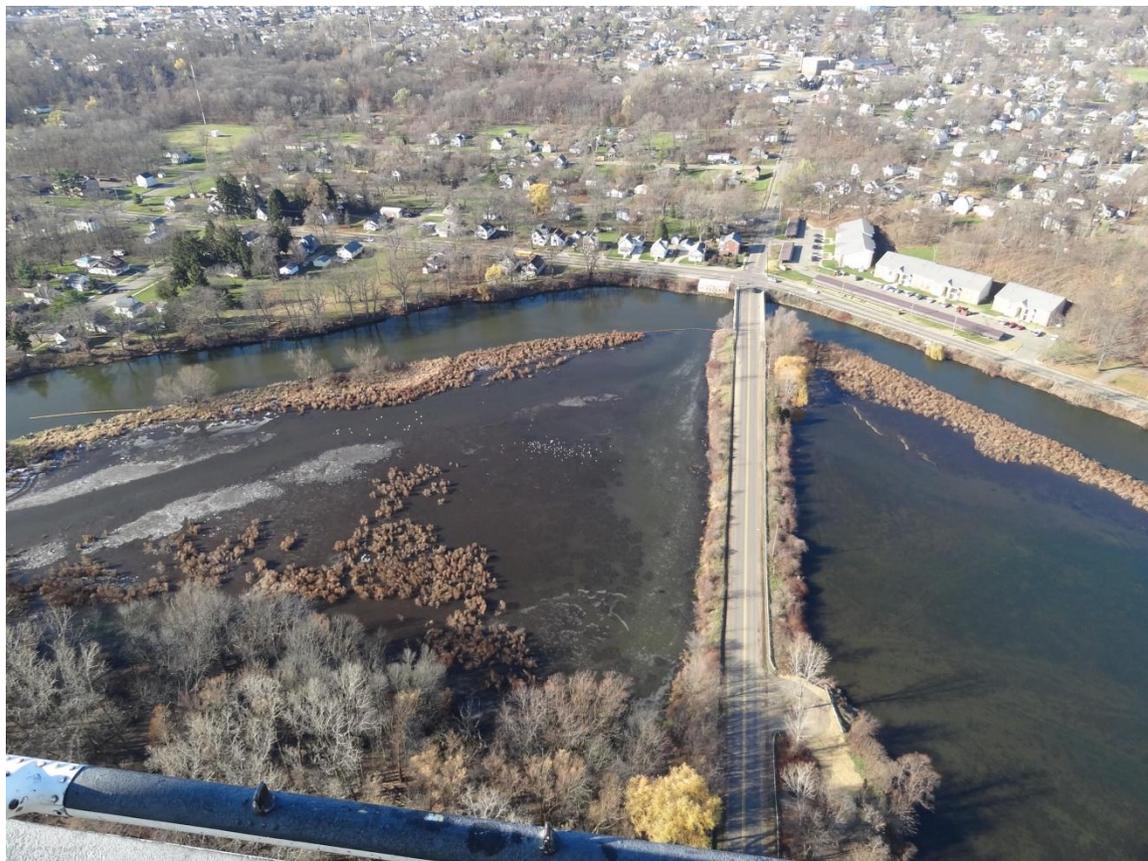
16. MP15.5, Mill Pond, ice observed in eastern portion of pond. No activity noted.

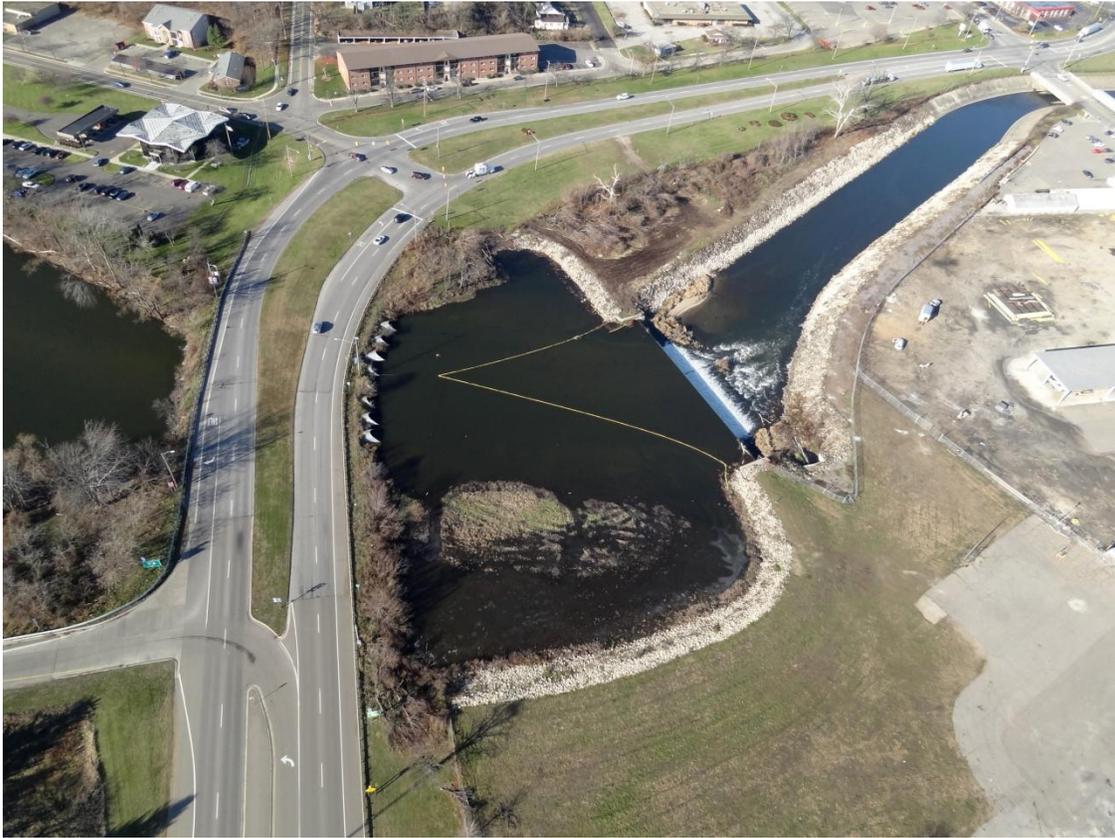
17. MP15.75 chevron boom, no sheen or activity noted.

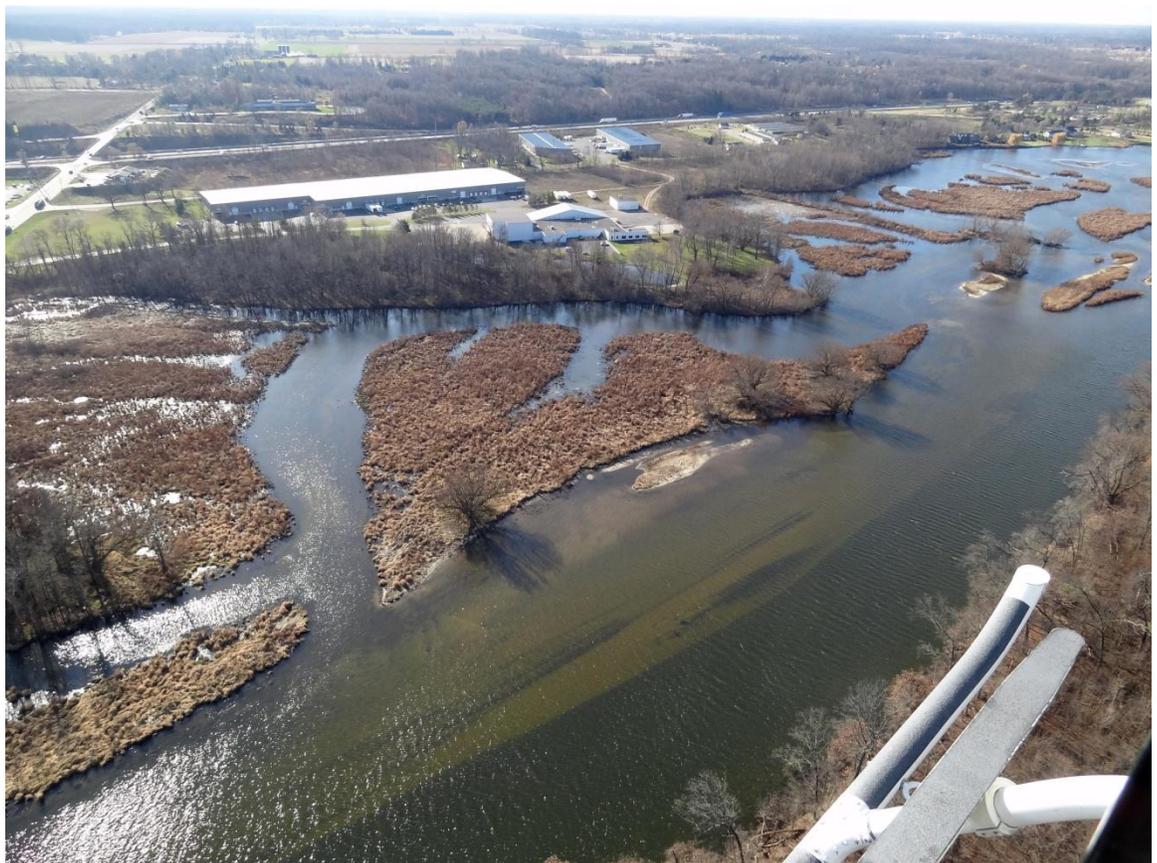
18. Morrow Lake Delta, no sheen or activity observed.

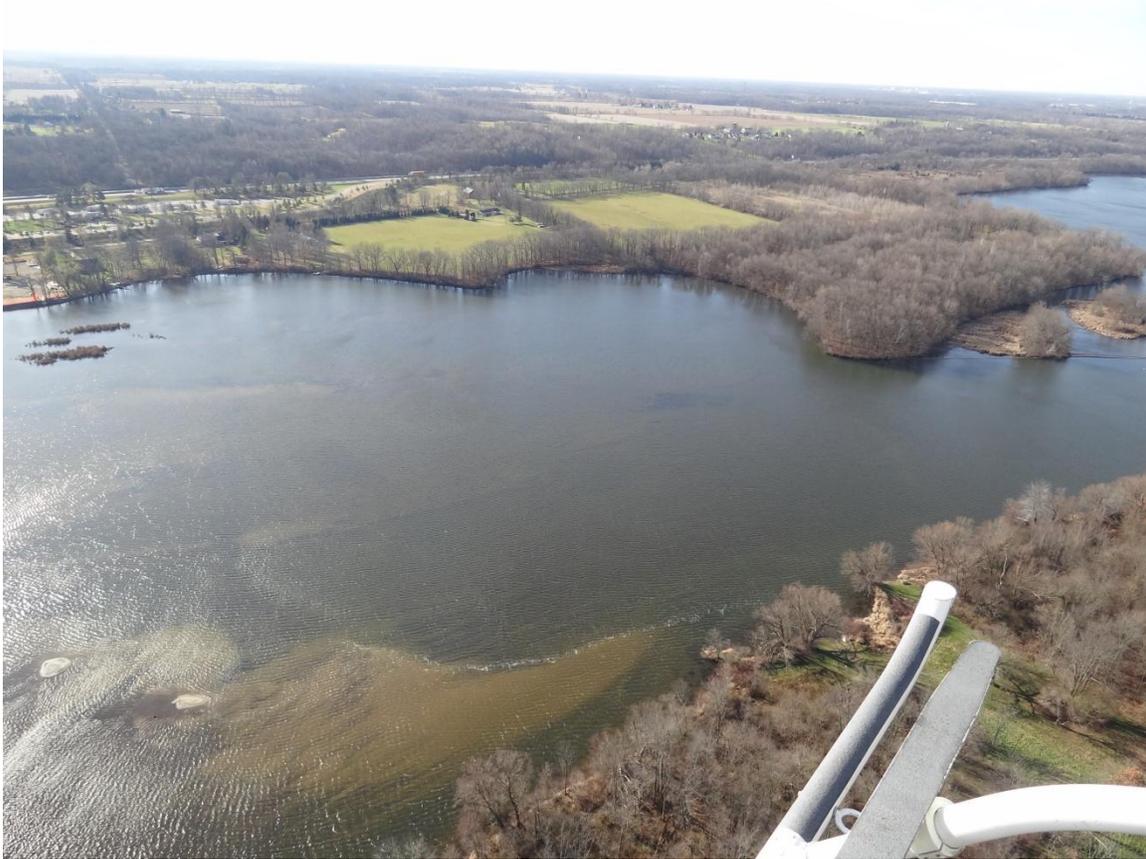
19. West end of Morrow Lake Delta, no activity observed.

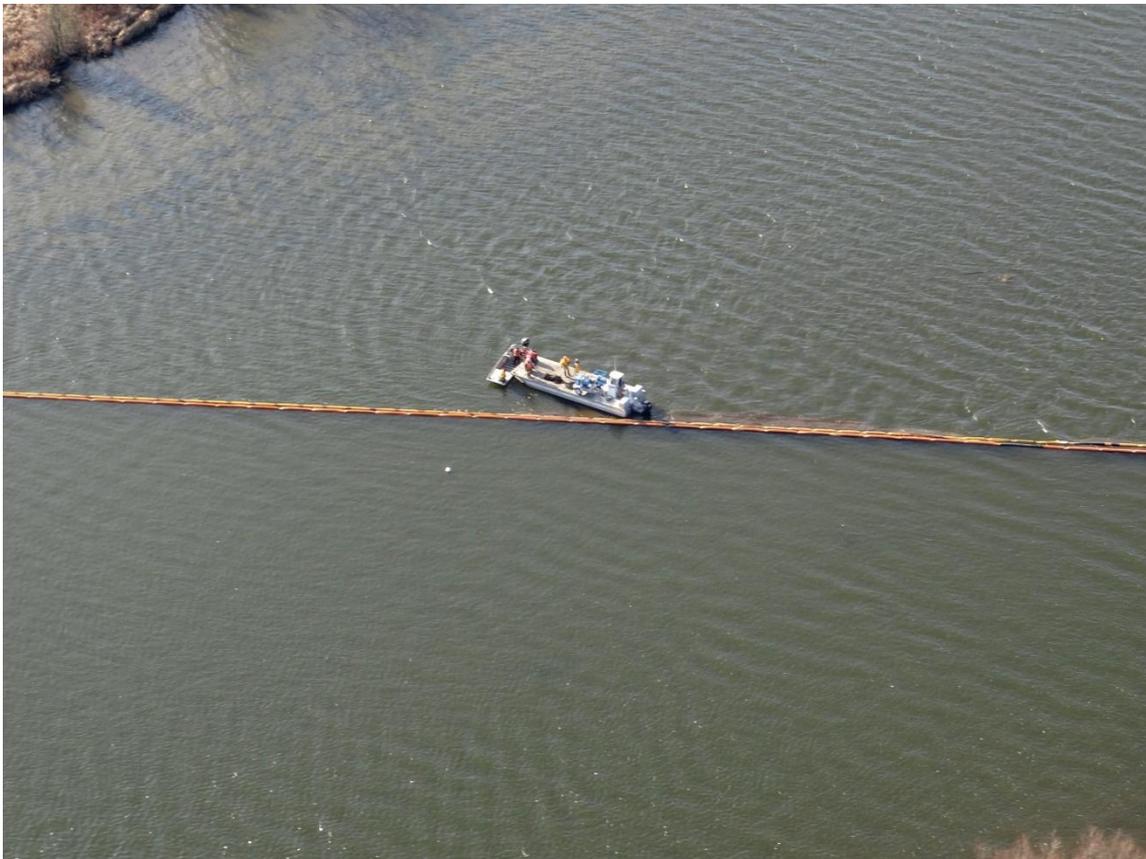
20. Morrow Lake Delta Control Point E 4.0, crews pulling sediment curtain.
