Situation Photo Log

Saturday, November 19, 2011

Kalamazoo River / Enbridge Spill

Larry Rader
START-USEPA
Situation Unit Leader

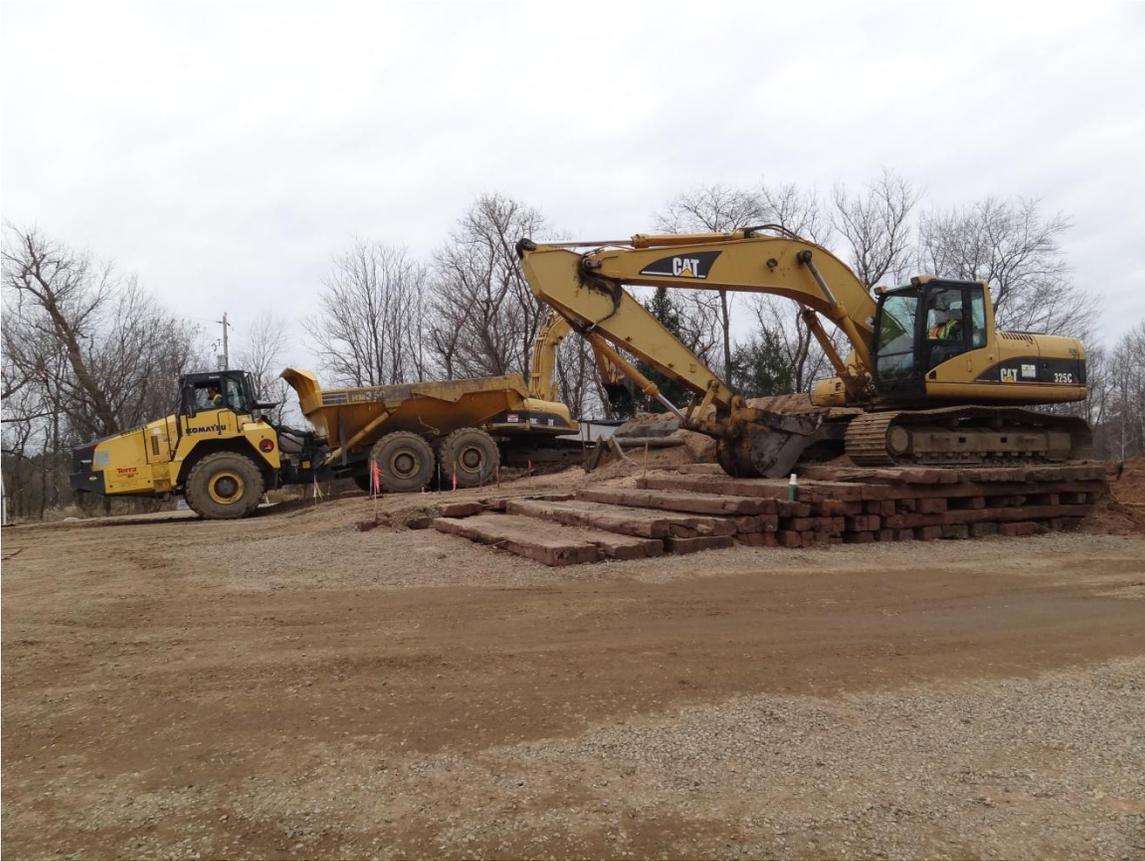
1. Talmadge Creek, soil solidification and loading station just south of Division Drive.

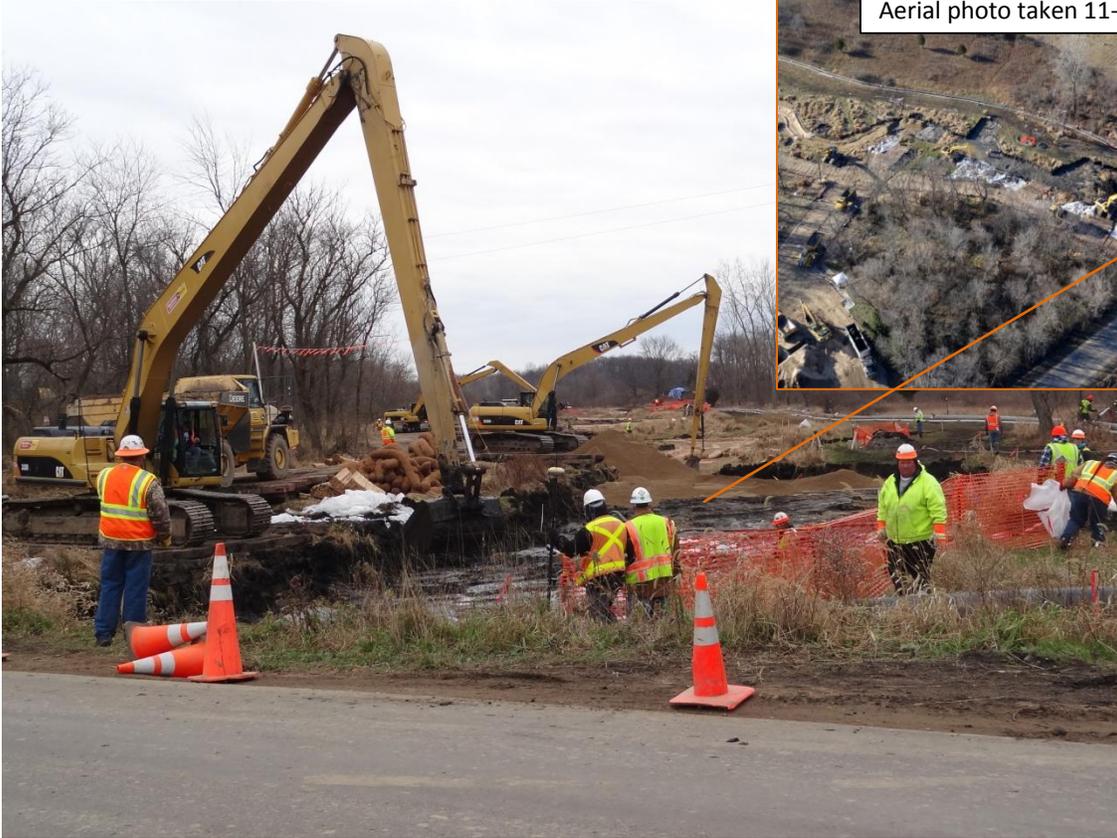
2. Talmadge Creek, excavation and restoration just south of Division Drive.

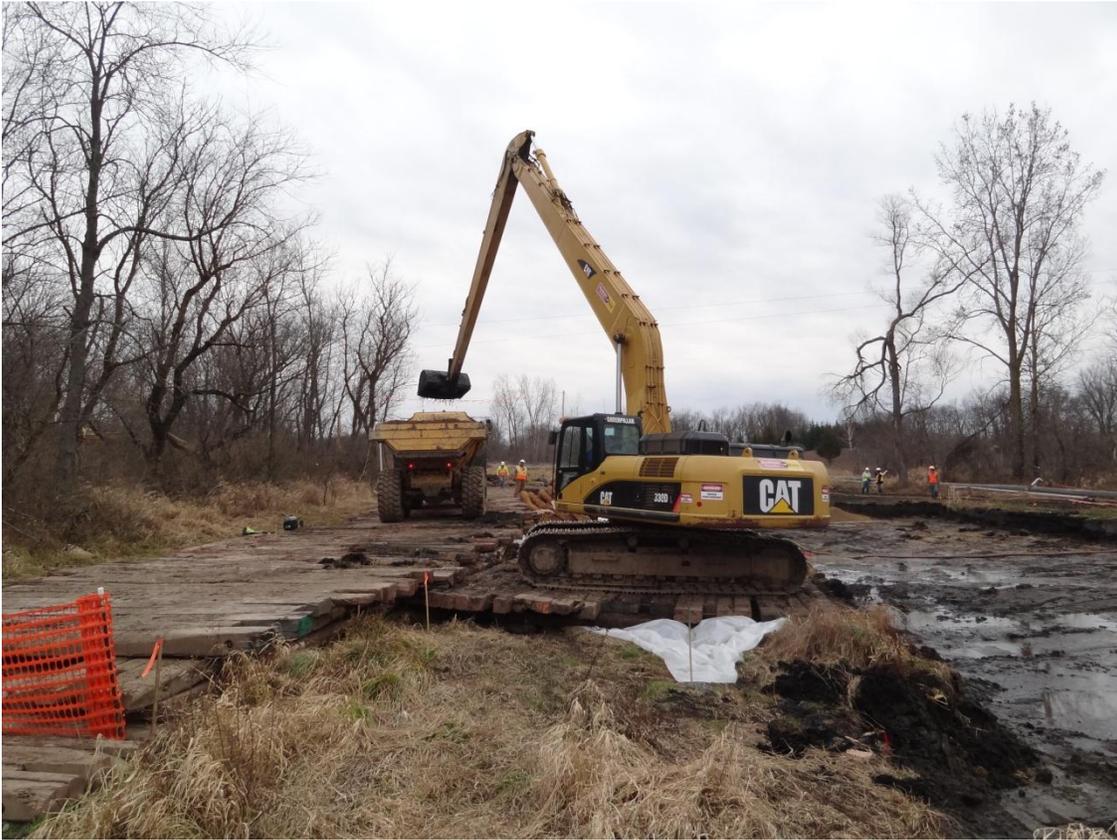
3. Talmadge Creek, loading excavated sediment into dump truck.

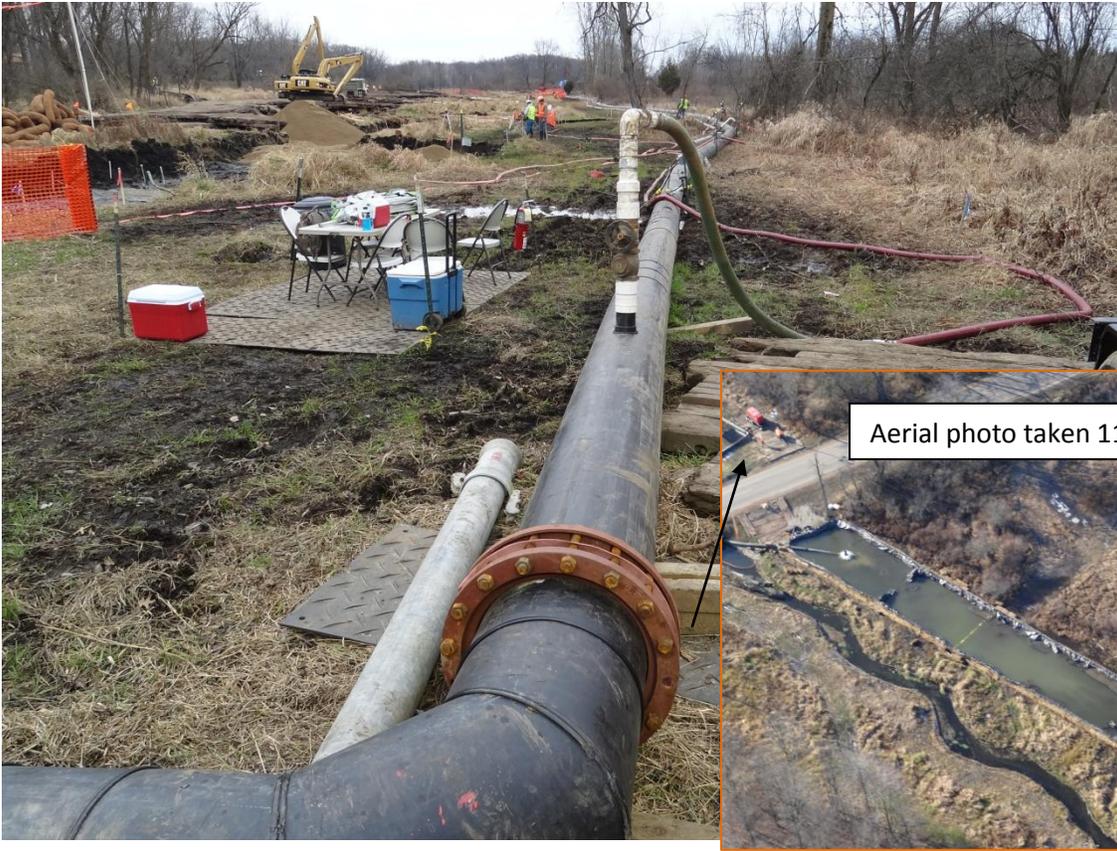
4. Talmadge Creek, piping for creek diversion system just south of Division Drive.

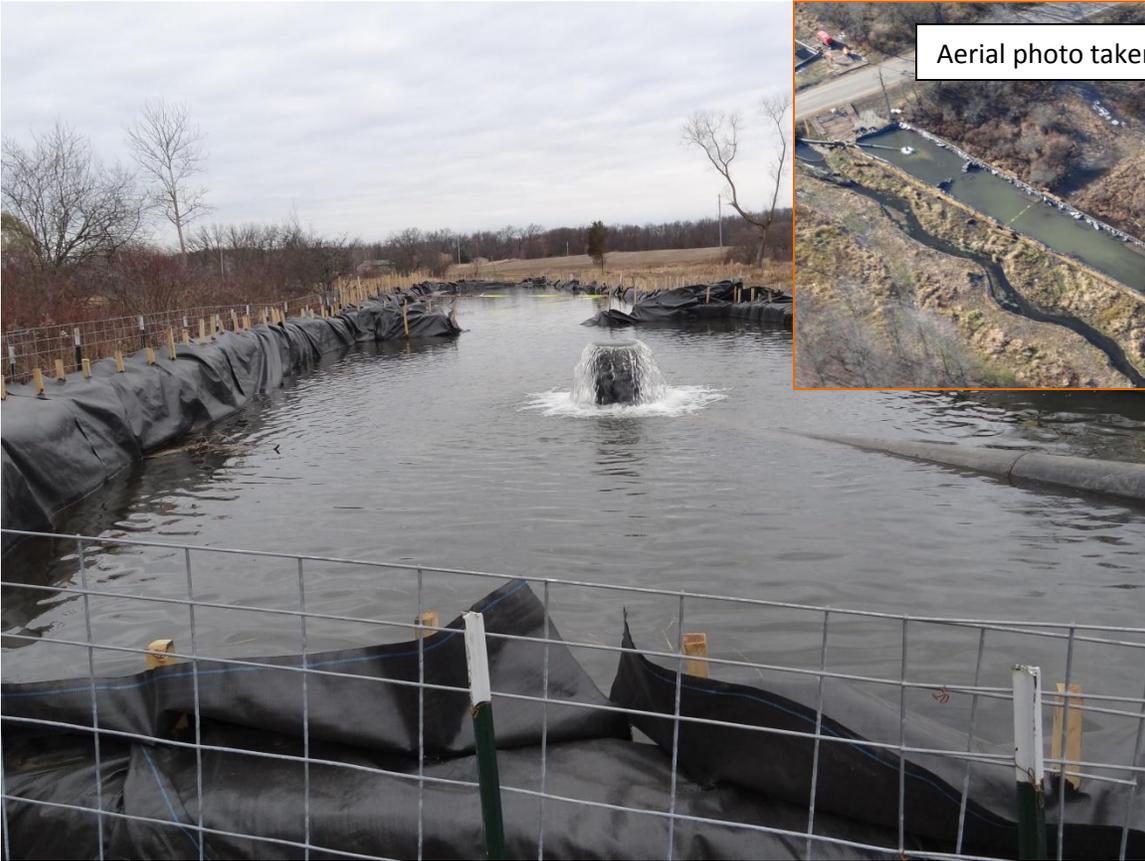
5. Talmadge Creek, discharge point of creek diversion system, just north of Division Drive.

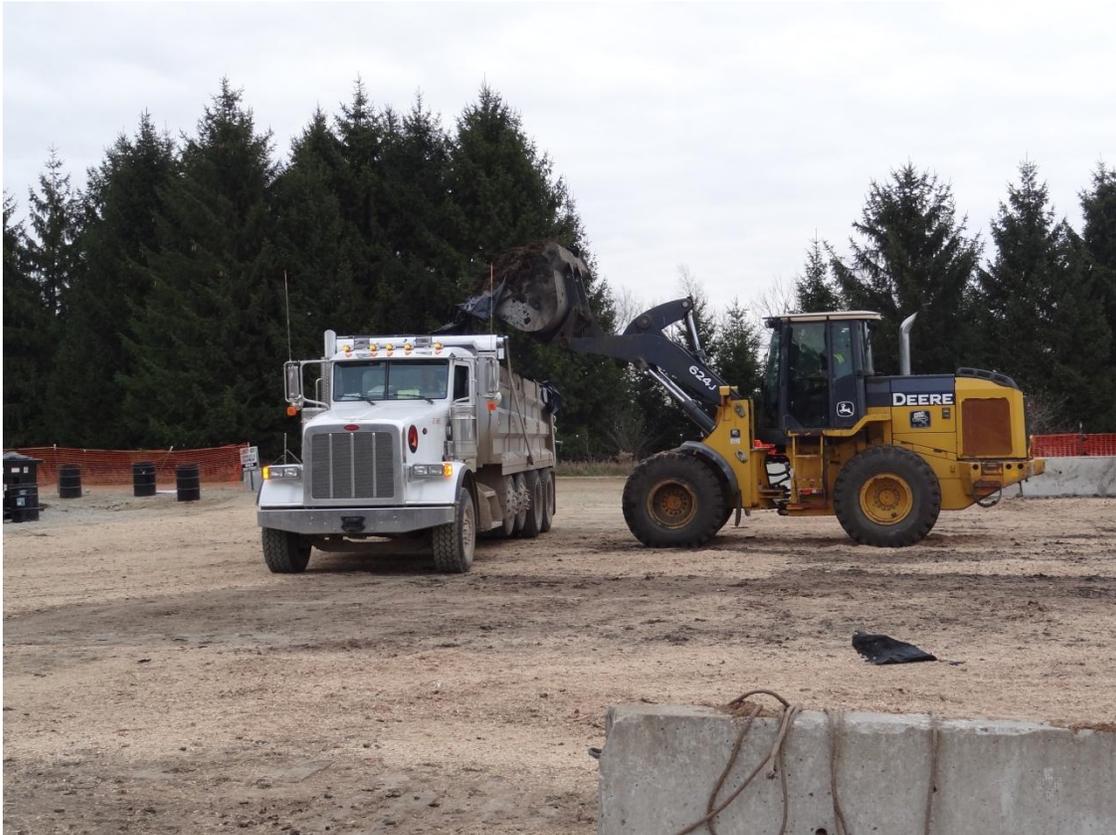
7. Frac-City Soil Cell A. End loader loading truck with soil from Cell A.

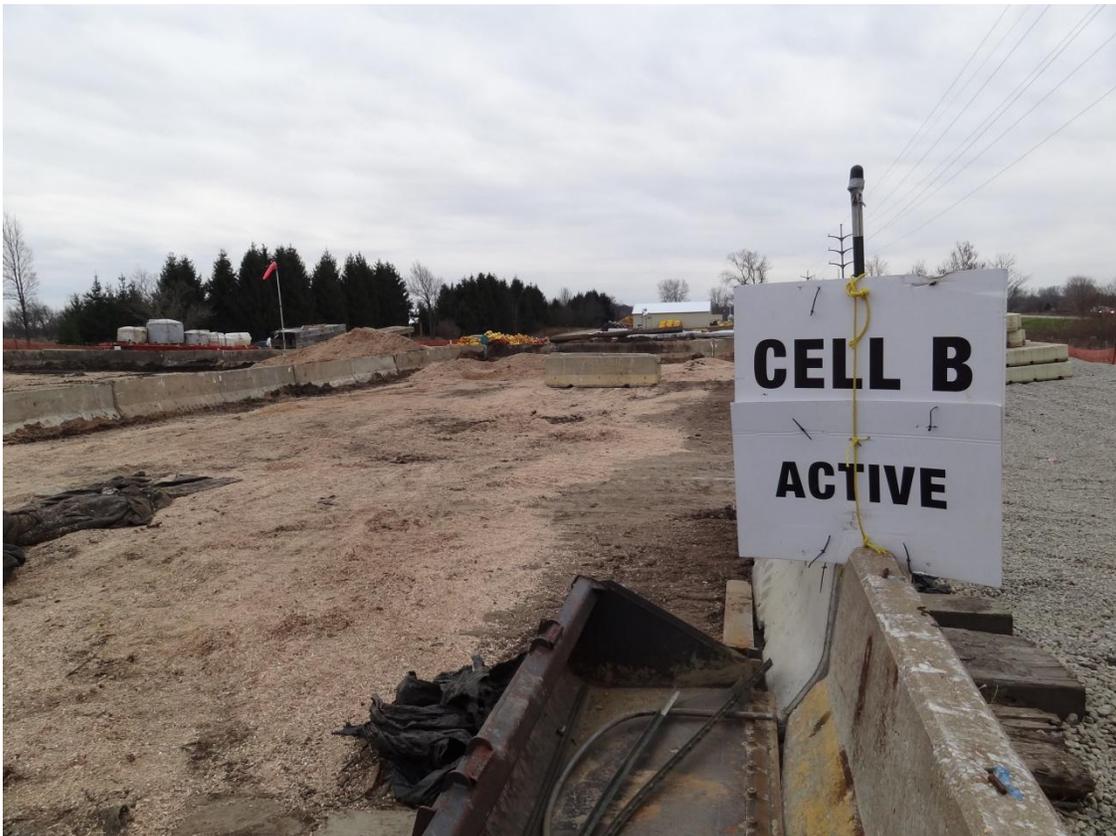
8. Frac-City Soil Cell B. Cell is empty except for some silt curtain.

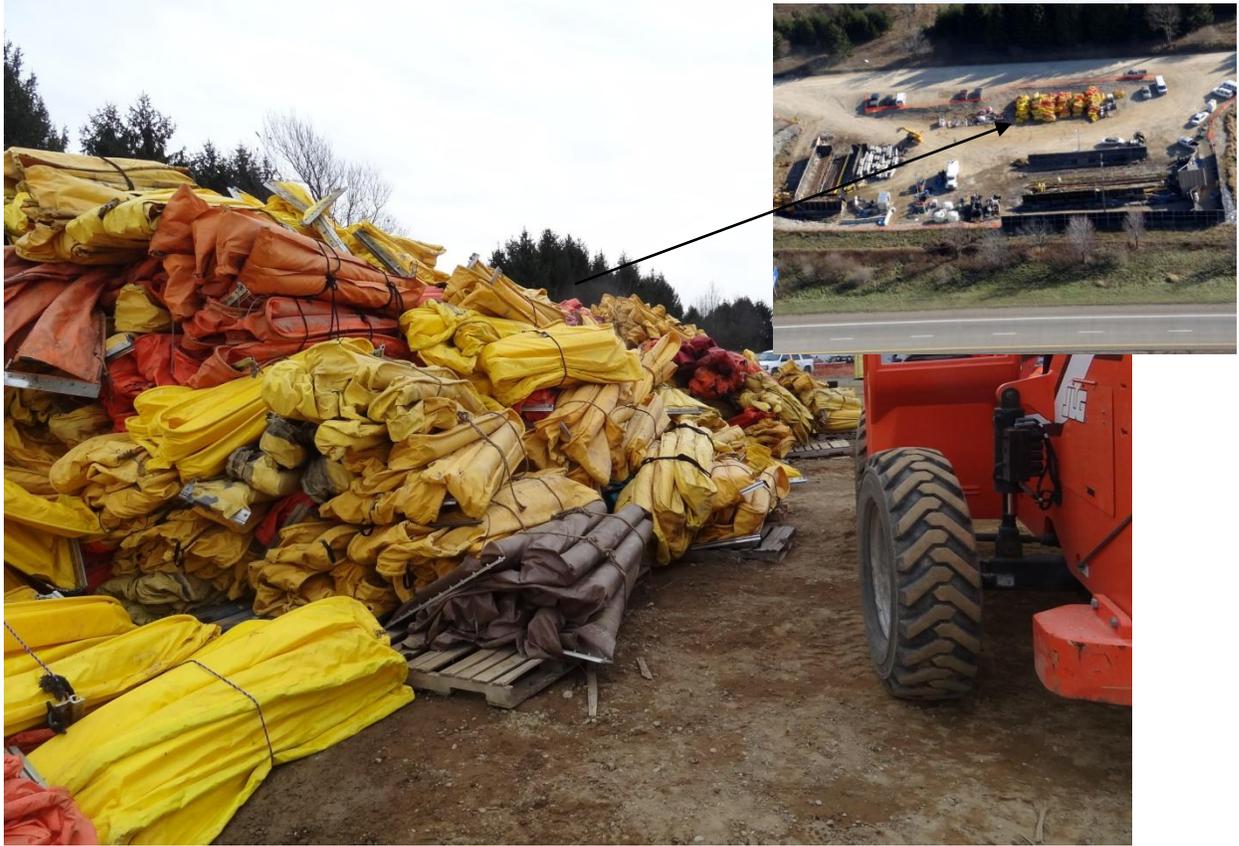
9. Frac Tank City Decon pad, cleaned containment boom awaiting inspection and repair.

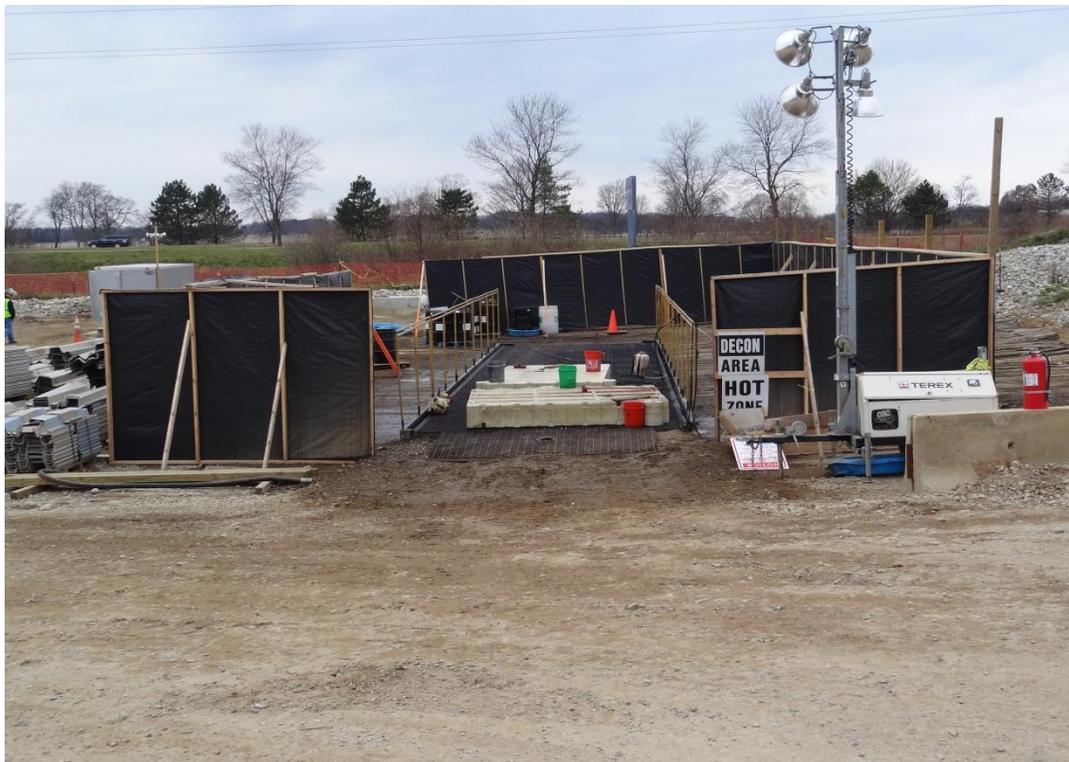
10. Northern decon pad at Frac City. Boat dock section awaiting decon.

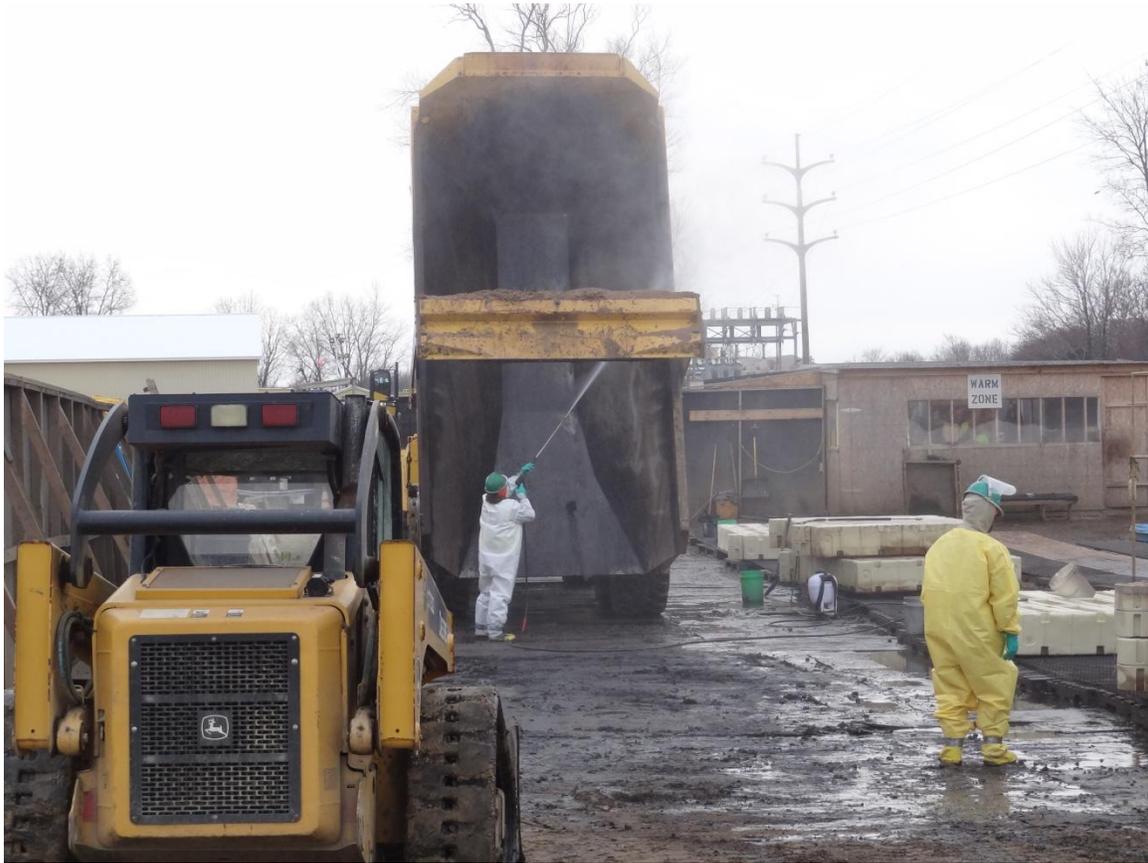
11. Southern decon pad at Frac City, workers cleaning dump truck.

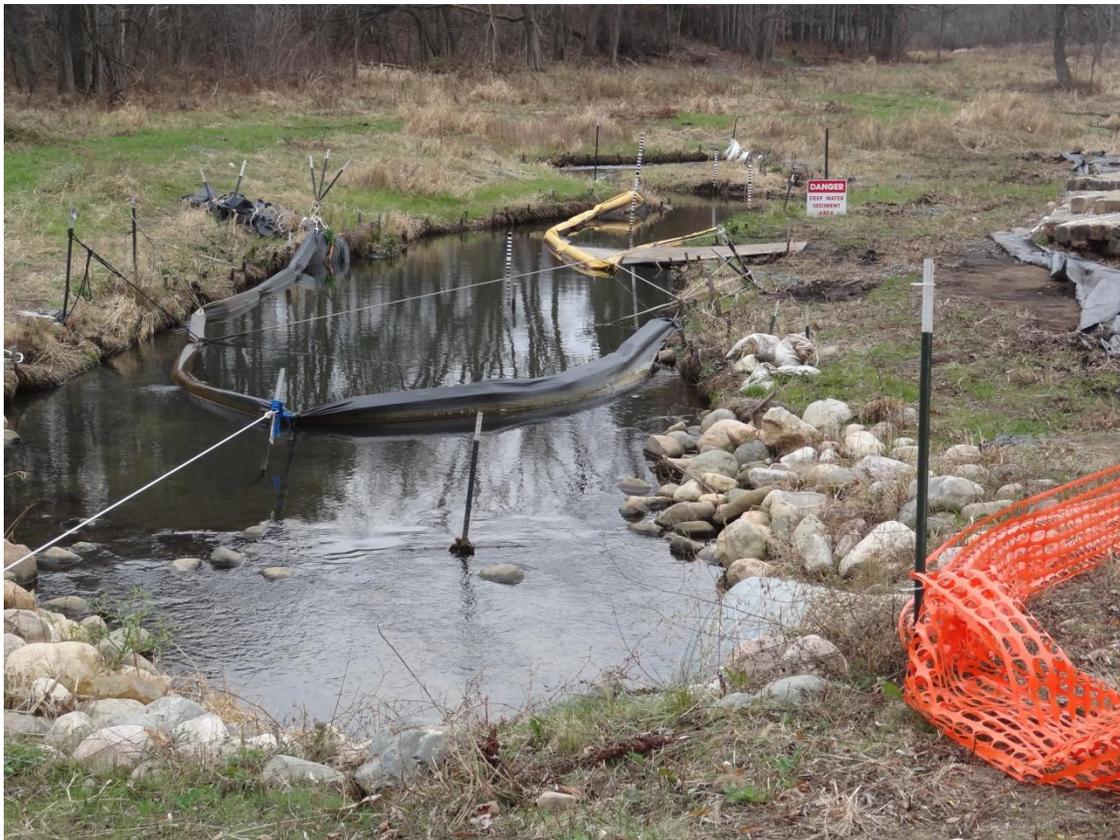
12. B5 sediment trap, no sheen or turbidity observed.

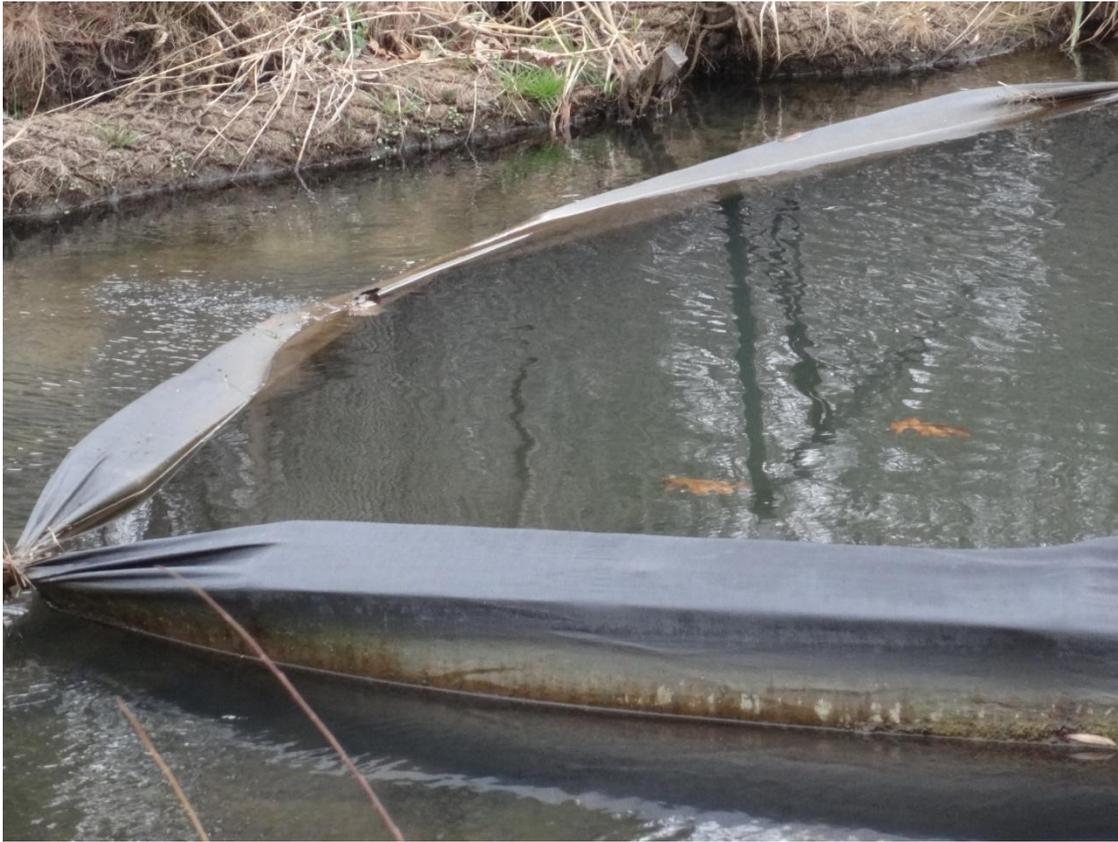
13. Close up of sediment trap.

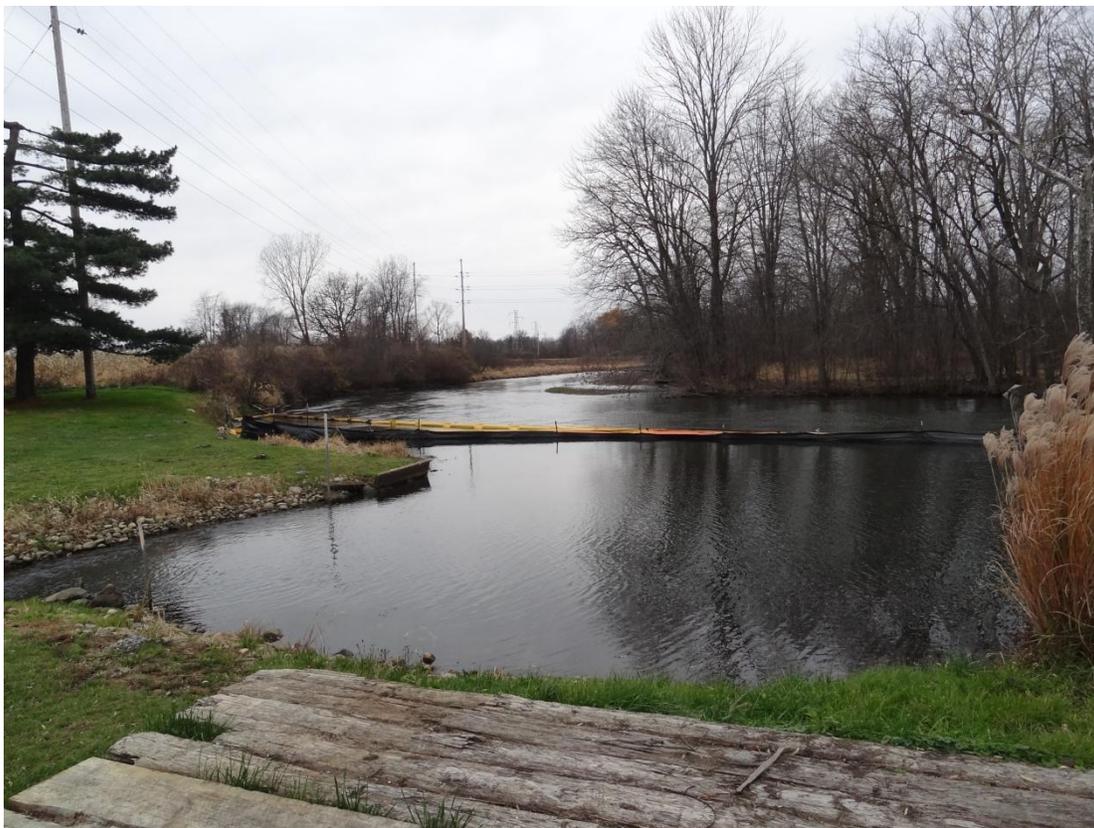
14. Confluence point, no sheen or turbidity observed.
