**APPENDIX K**

**Site Photographs**

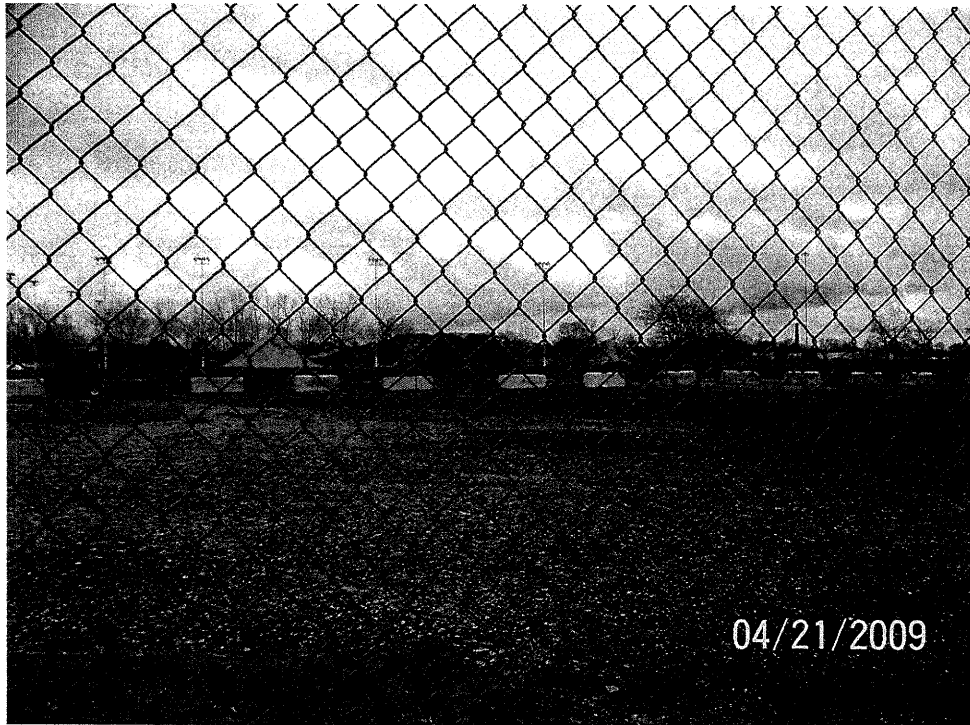
**Photograph No. 6:** View from the eastern boarder near the southeast corner looking at the dirt/soil mounds on the adjacent eastern property.

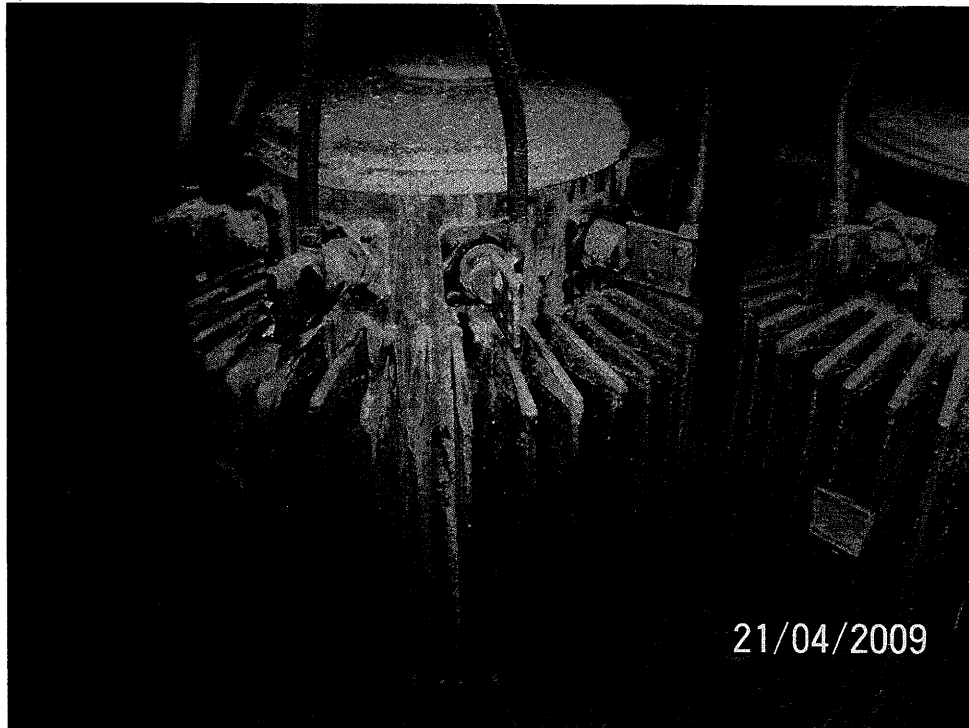
**Photograph No 17: View of two interior transformers in the Coliseum.**

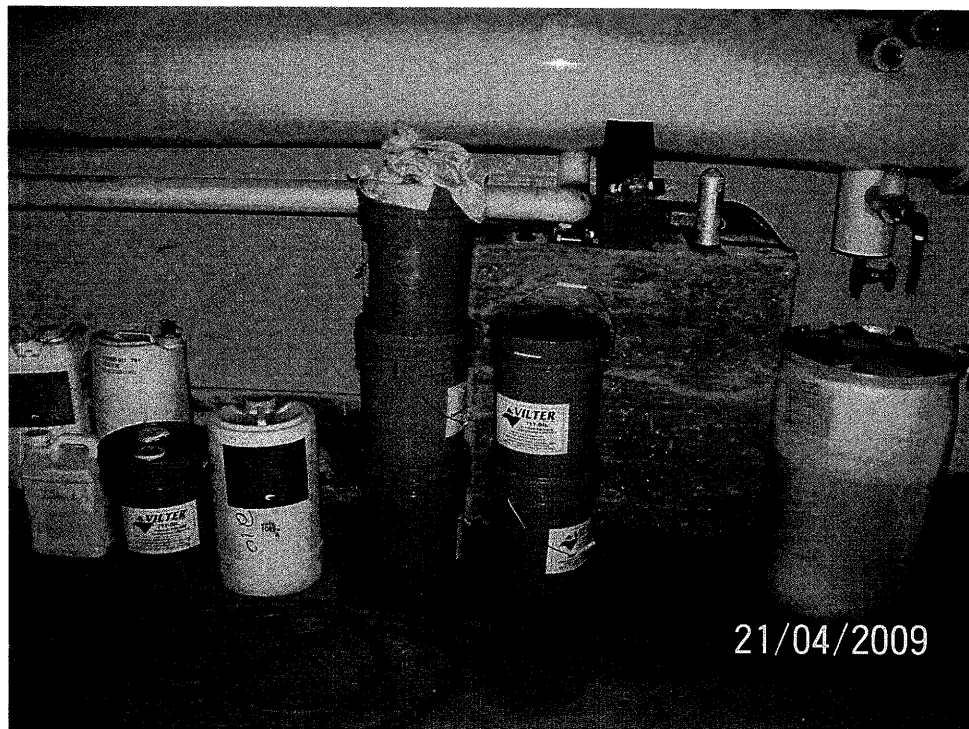
**Photograph No. 18: View of the chemicals in the chiller (refrigerant) room of the Coliseum.**

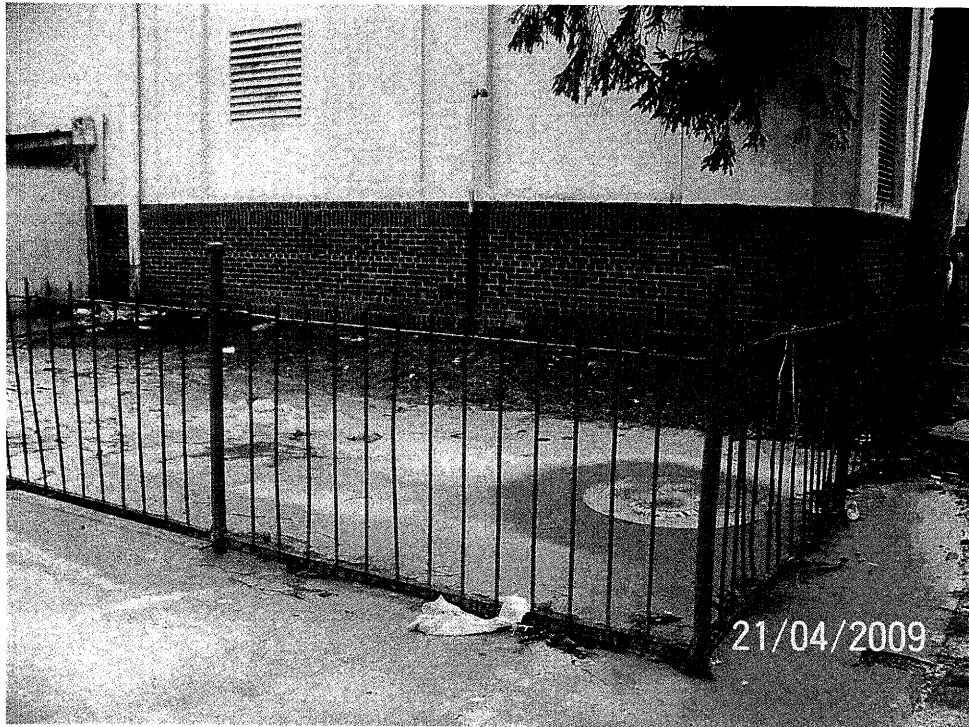
**Photograph No. 20:** View of the UST location showing the fill area and vent pipe. This UST is located at the northwest corner of the Coliseum.

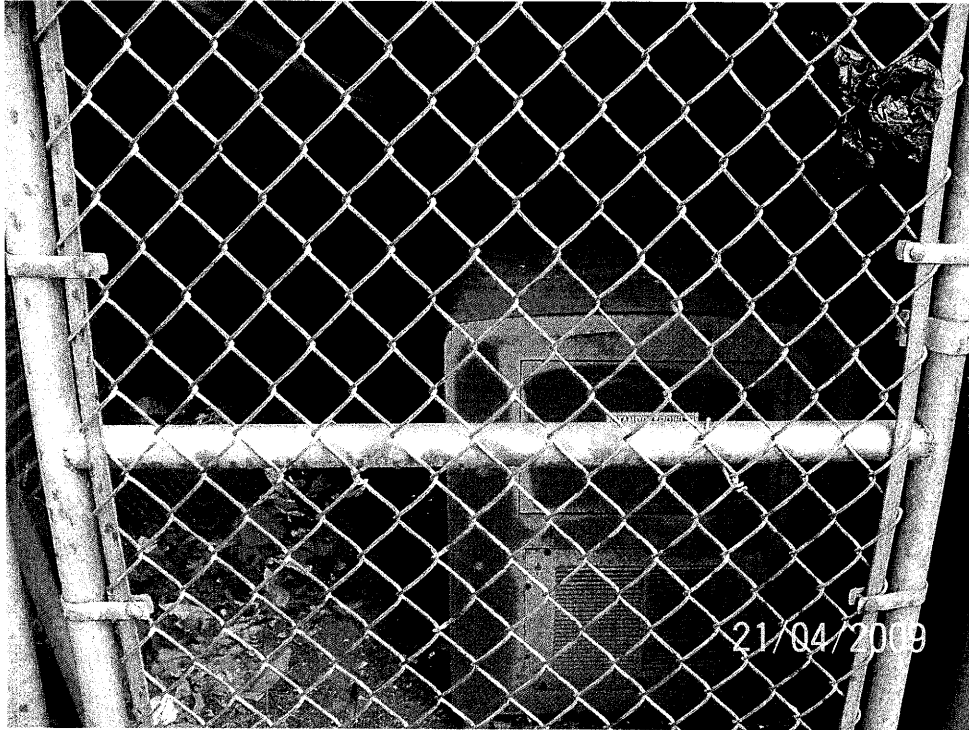
**Photograph No. 21:** View of the standby generator adjacent to the UST at the Coliseum.

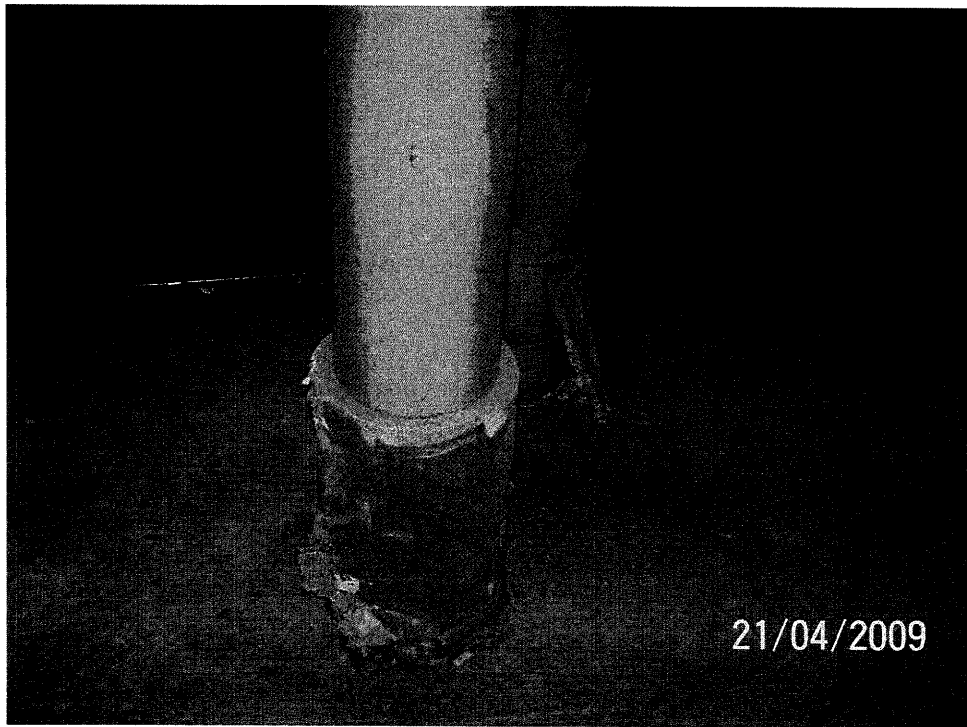
**Photograph No. 22:** View of damaged asbestos containing materials adjacent to the northeast arena mechanical room of the Coliseum.
