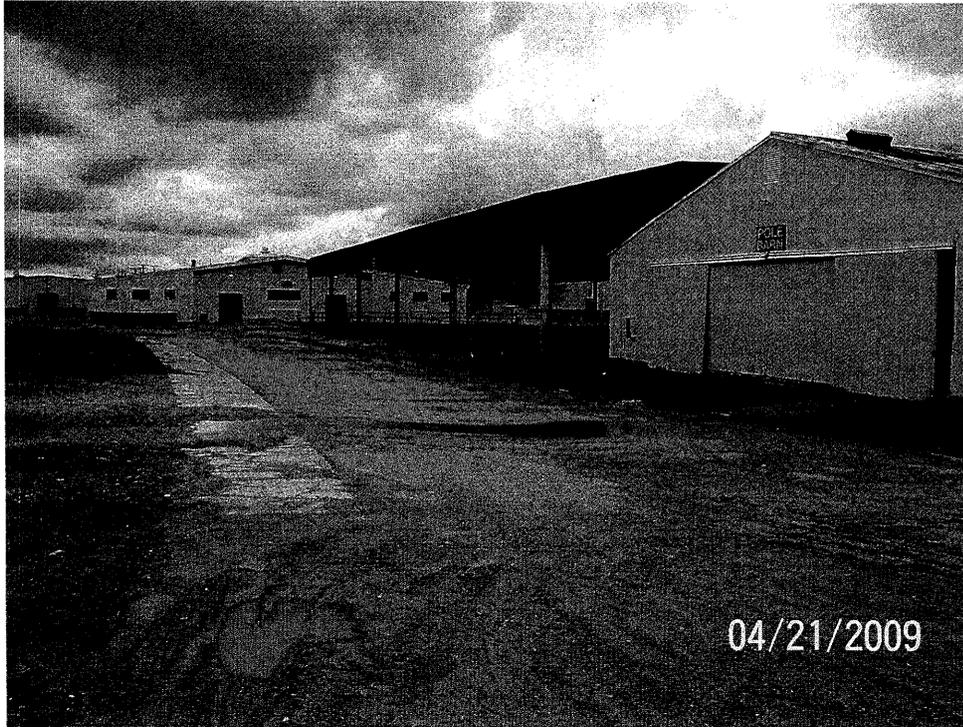
**Photograph No. 27: Exterior view of the Pole Barn, North Riding Arena and Main Horse Barn buildings.**

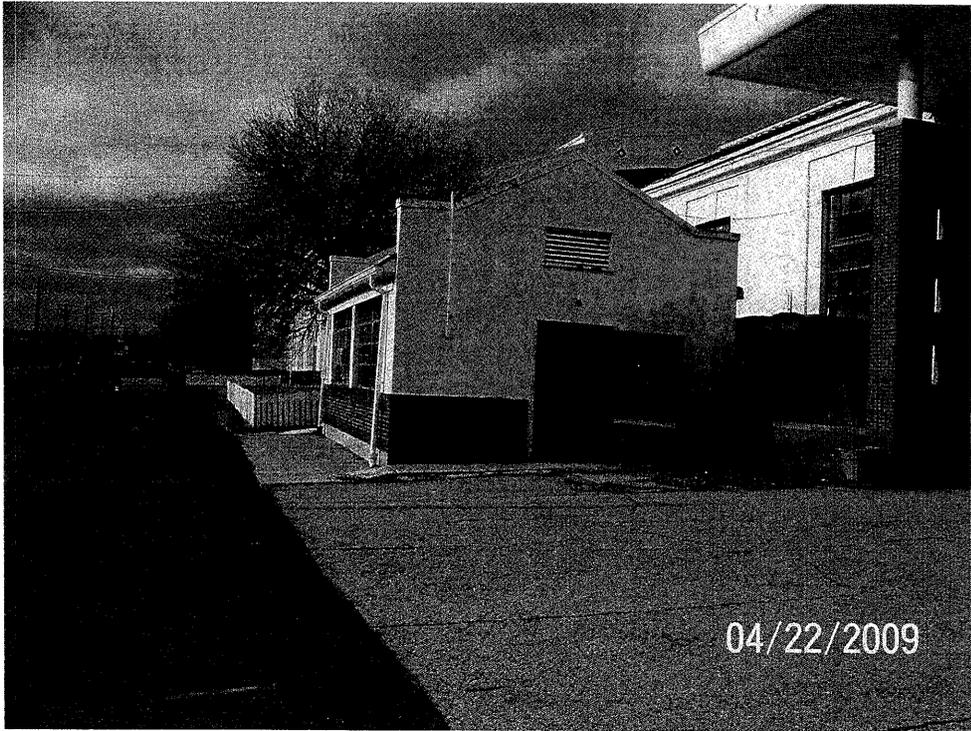
**Photograph No. 29:** Exterior view of the Milk House east from the Dairy Cattle building.

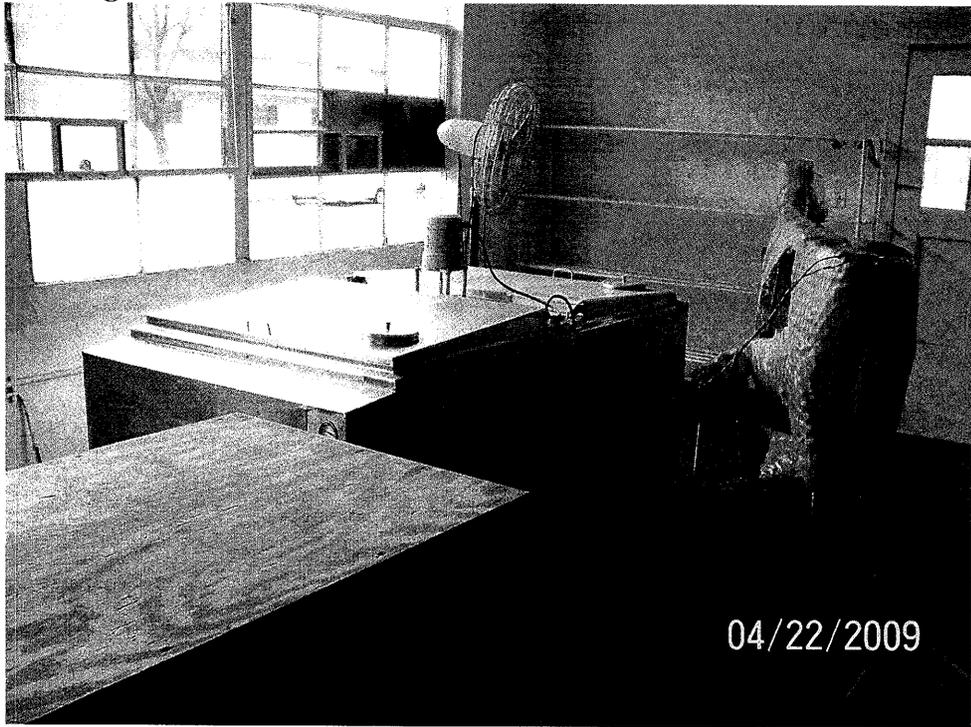
**Photograph No. 30:** Interior view of the Milk House building. Picture shows a refrigeration unit.

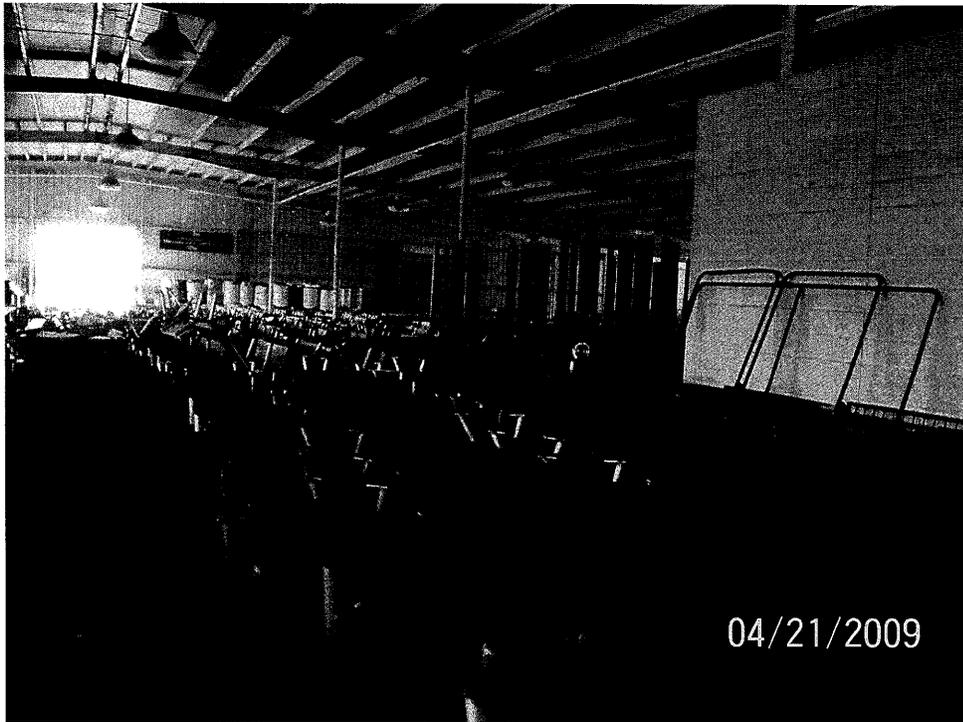
**Photograph No 32:** Interior view of the storage of benches and trash barrels in the southern half of the Multi-Livestock building.

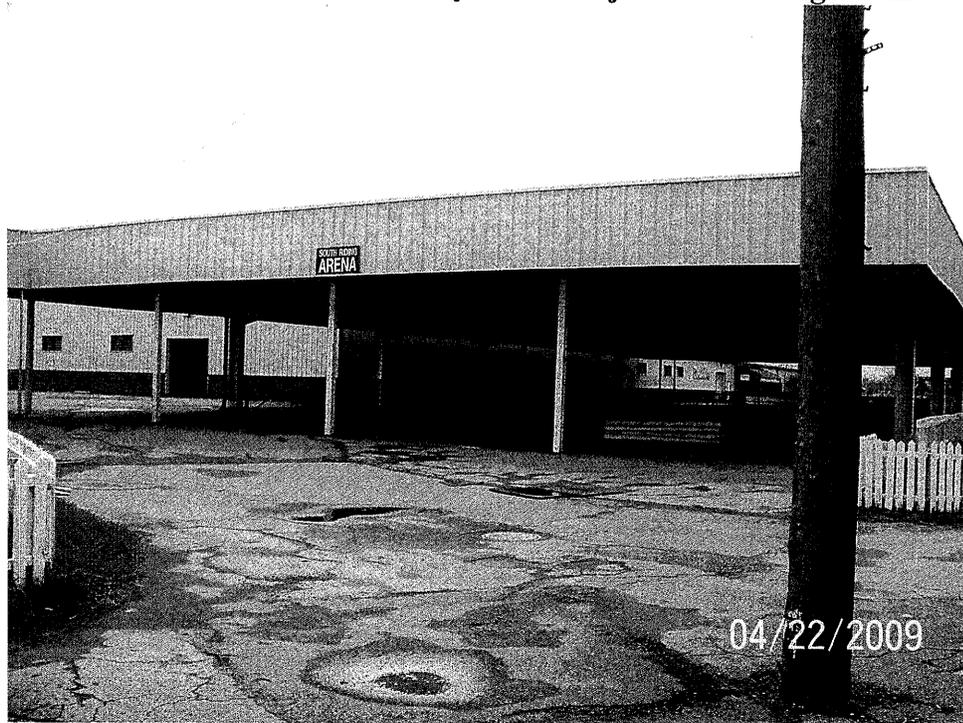
**Photograph No. 34:** View of the South Riding Arena.

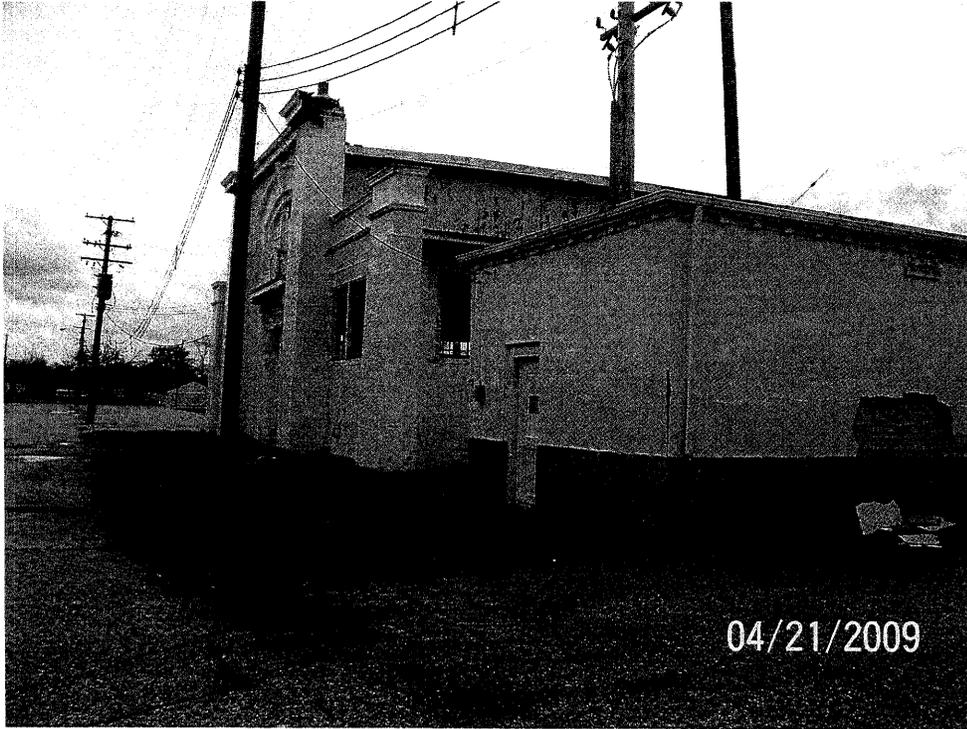
**Photograph No. 35:** Exterior view of the former Electrical building and Whitehall building.

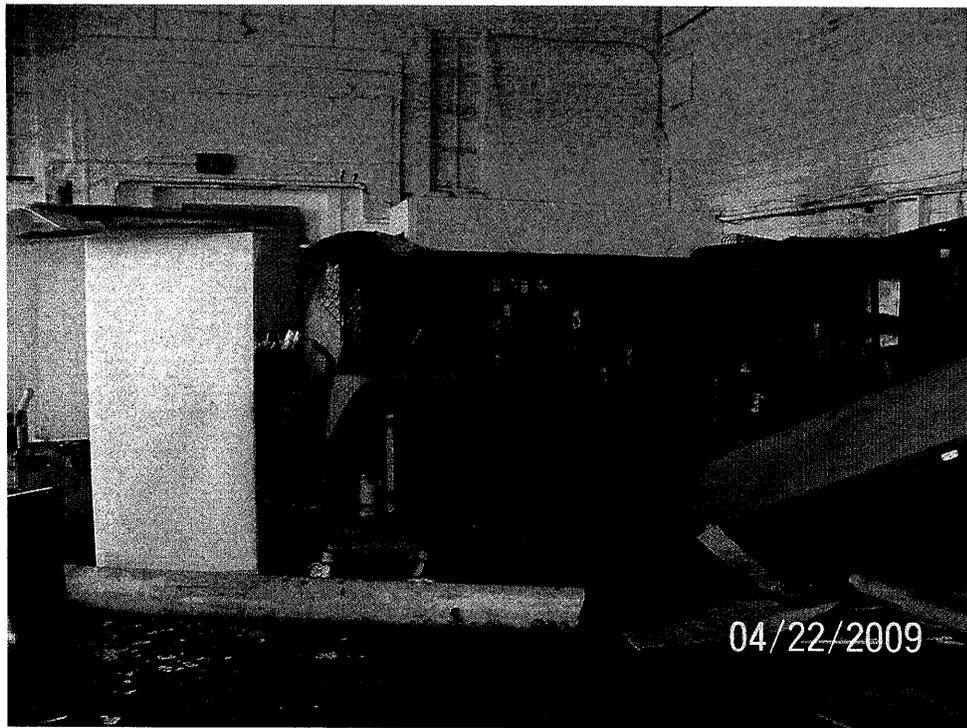
**Photograph No 36:** View of paint can storage in the Whitehall building.

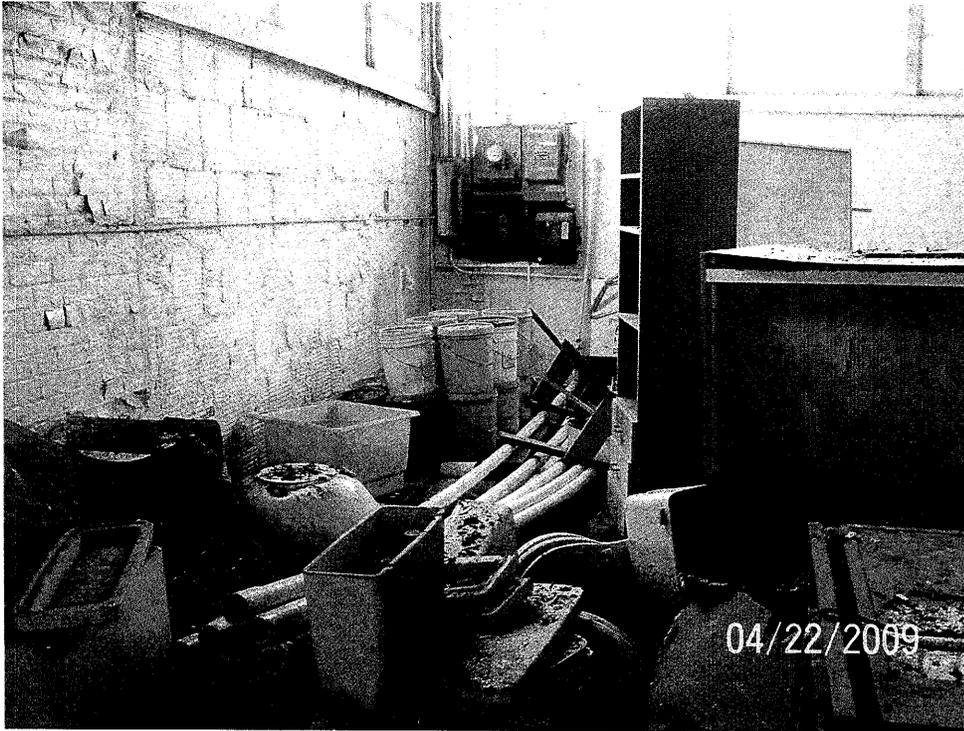
**Photograph No. 37: View of the chemical strippers within the Whitehall building.**

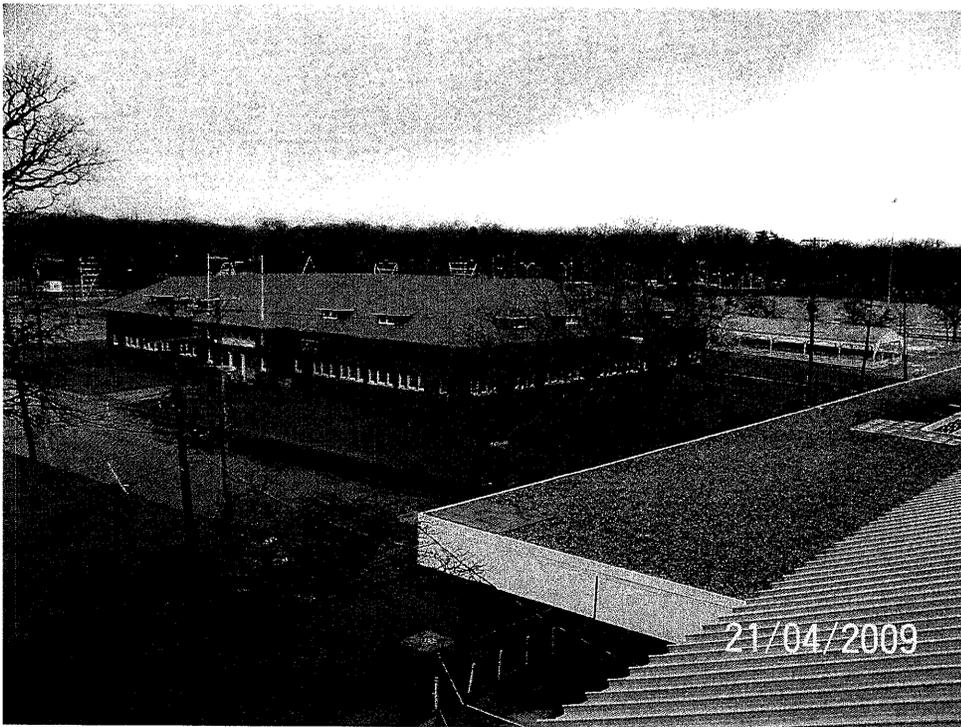
**Photograph No. 40: View of the Poultry building from the southwest mechanical room roof access of the Coliseum.**

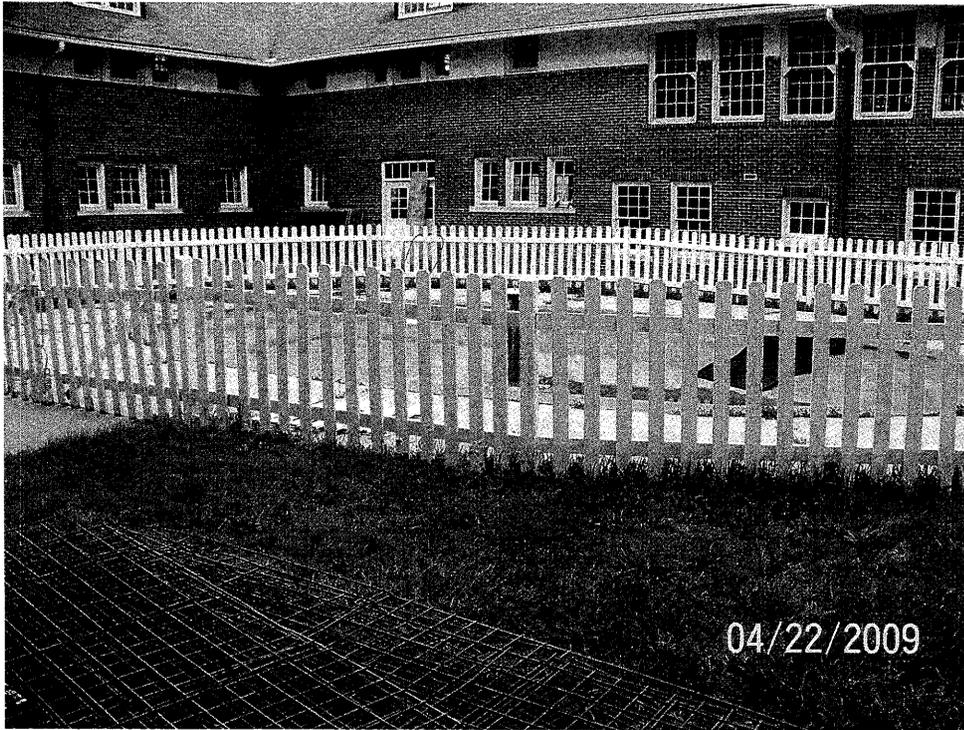
**Photograph No. 41: View of the pond within the Poultry building.**

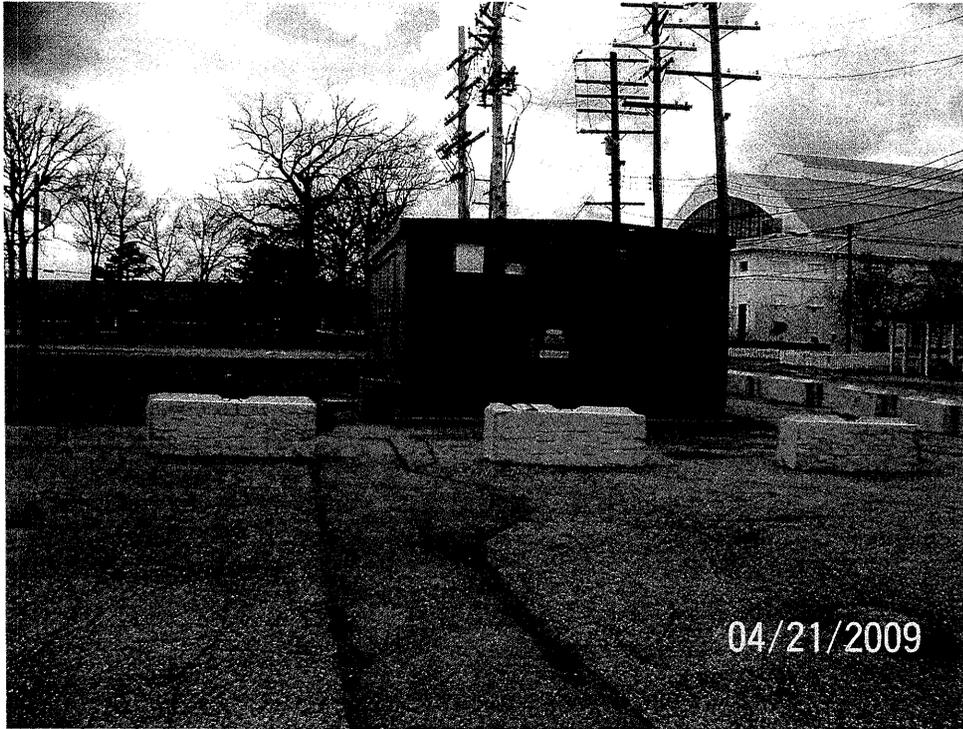
**Photograph No. 43:** Exterior view of the new electrical substation showing the Coliseum in the background.

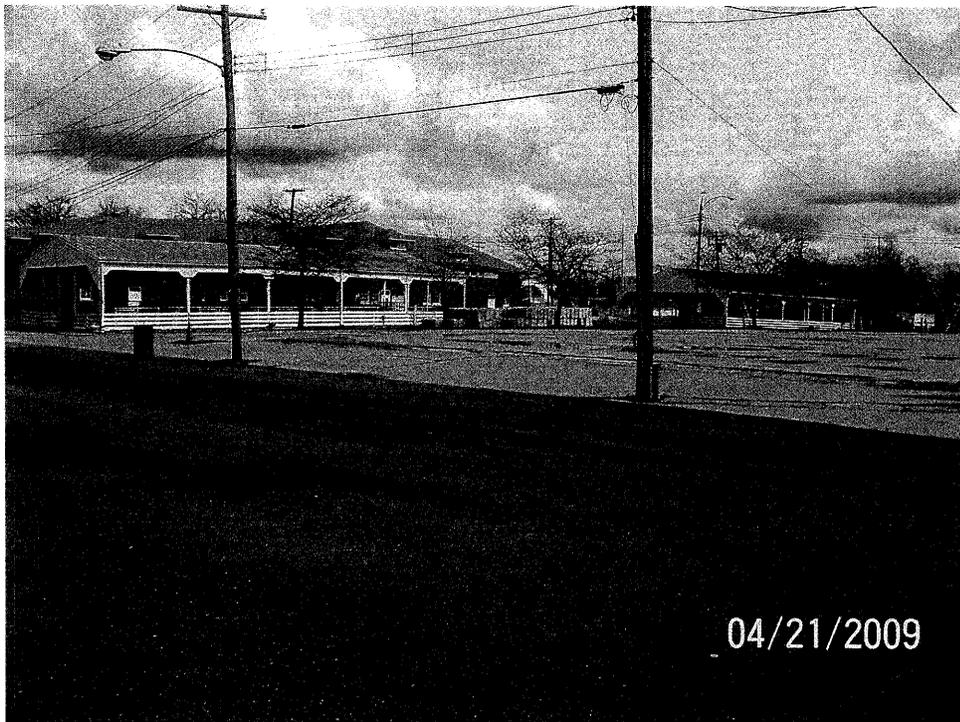
**Photograph No. 44:** View of the Goat Barns (north and south) with the Poultry building behind.

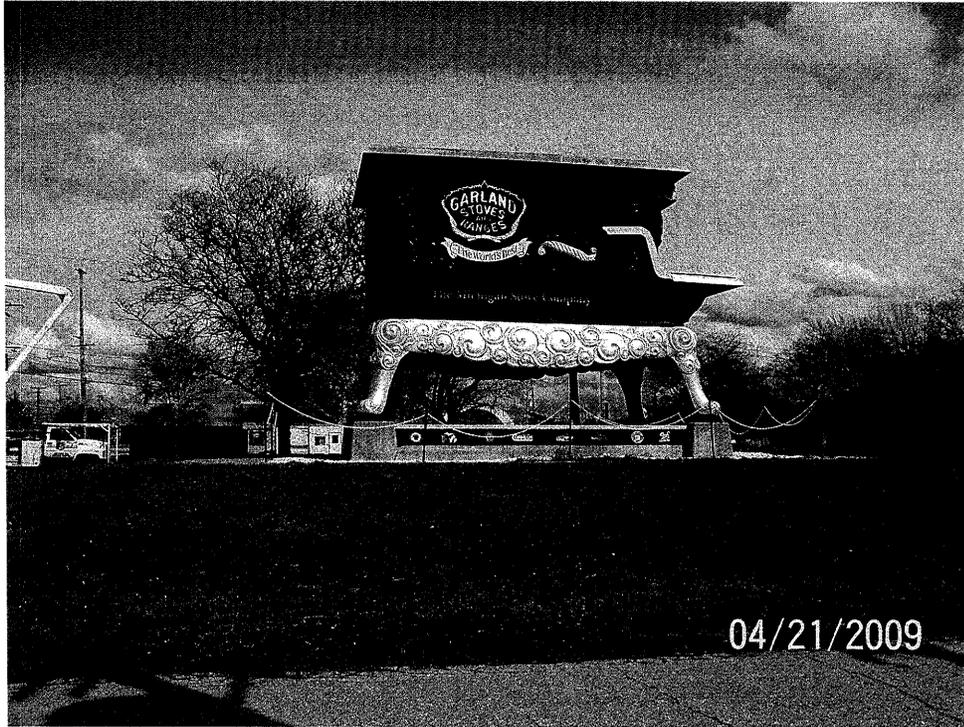
**Photograph No. 45: View of the World's Largest Stove.**

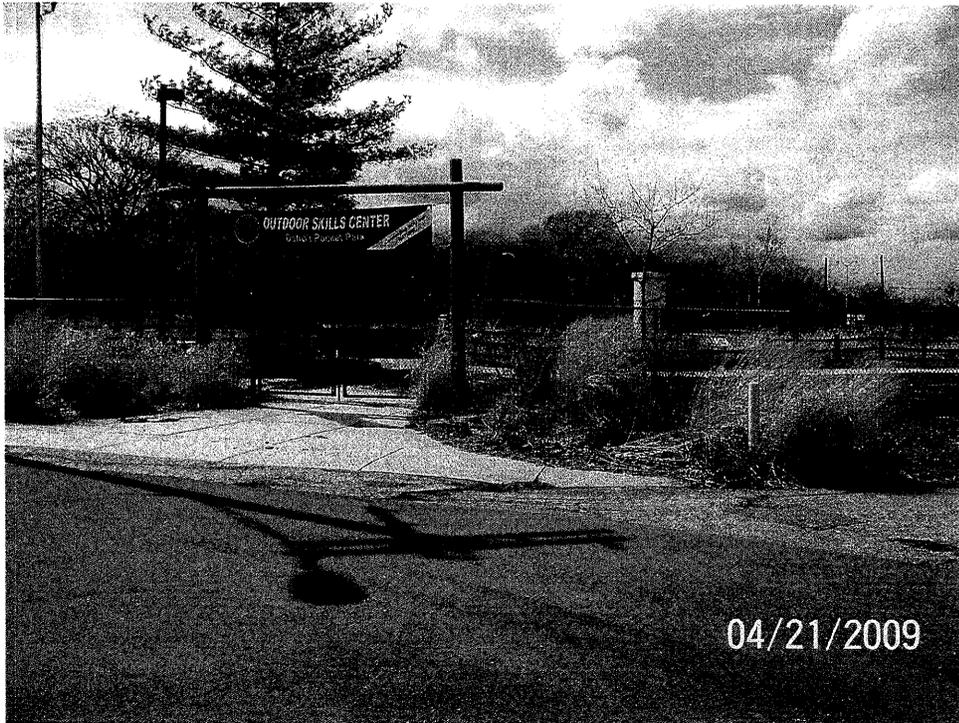
**Photograph No. 46: View of the Outdoor Skills Center. No access was available.**

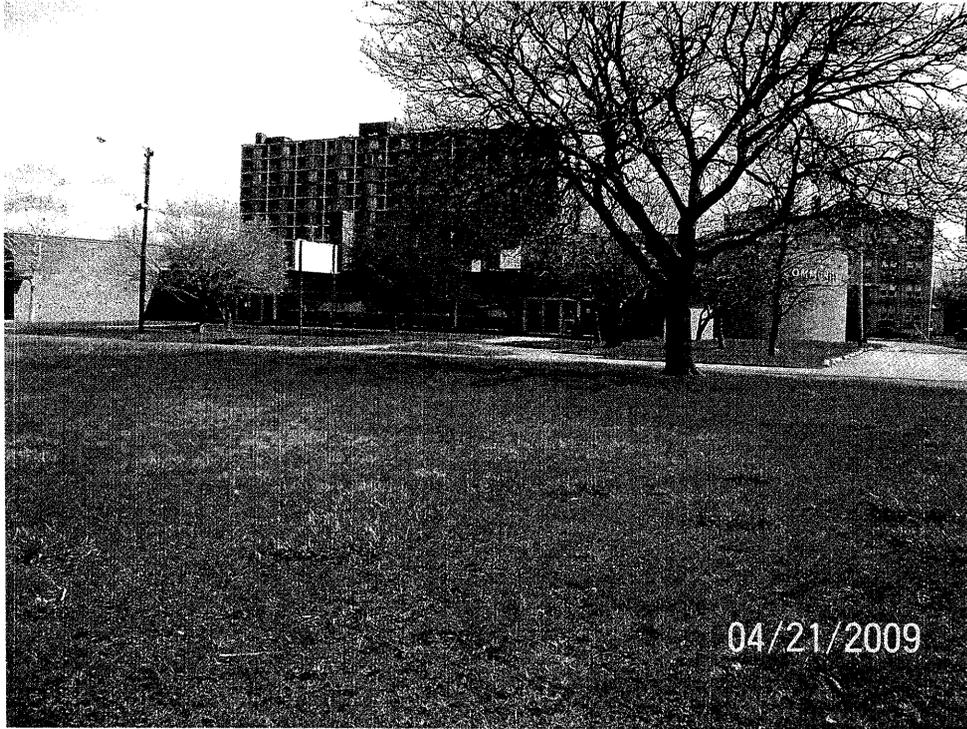
**Photograph No. 47: Exterior view of the Community Arts building from the north looking south with the State Fair and Palmer Lane Apartments behind.**

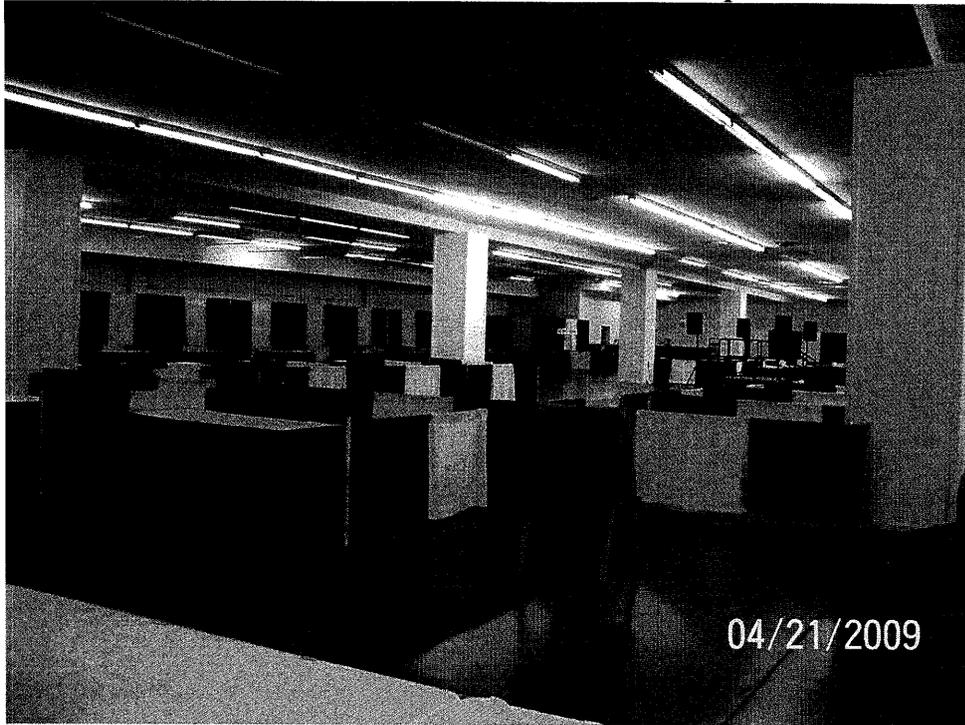
**Photograph No. 48: View of the exhibit hall within the Community Arts building. The exhibit hall was being setup for a science fair for the Head Start program.**

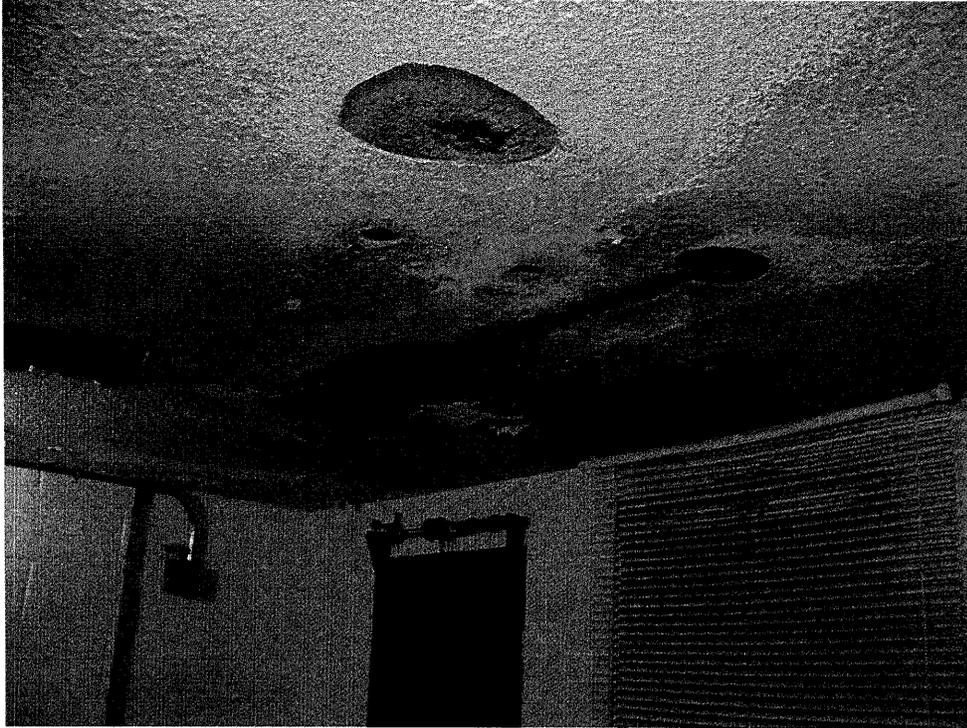
**Photograph No. 49:** View of the significant damage to the asbestos containing plaster ceiling within the projector room of the Community Arts building.

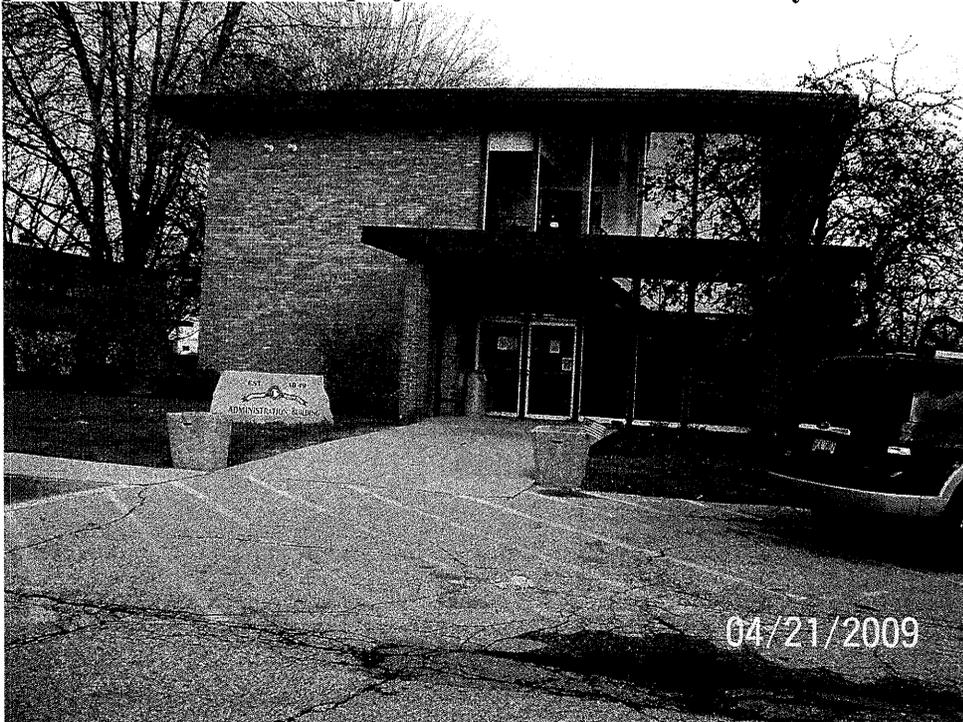
**Photograph No. 50:** Exterior view of the Administration Building.

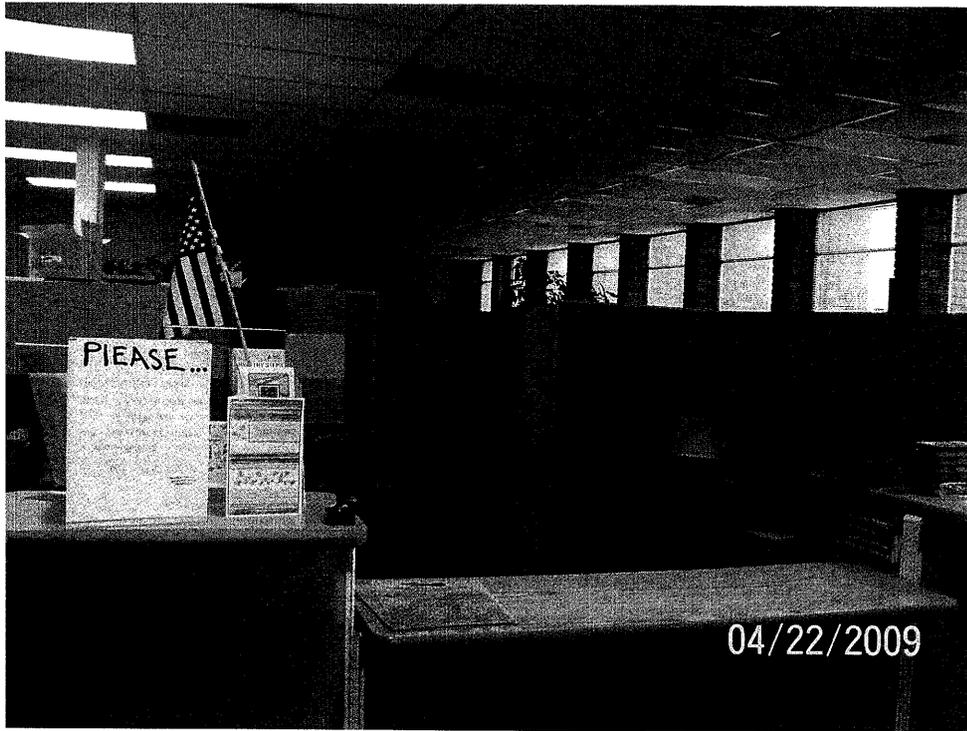
**Photograph No. 51:** View from the interior of the Administration Building looking at the 1<sup>st</sup> floor reception and office area.

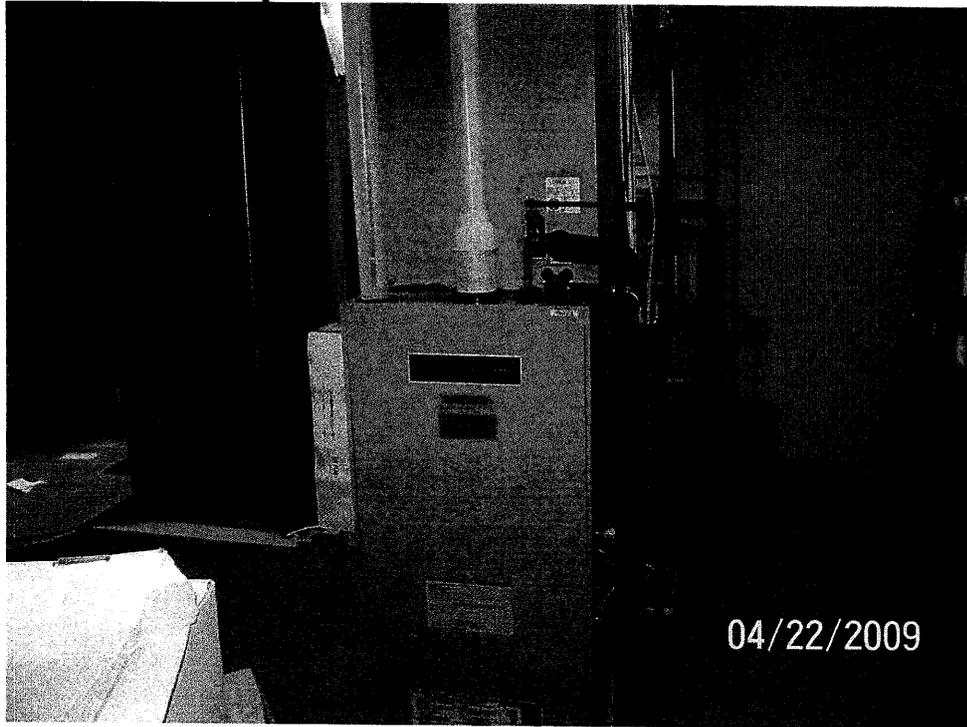
**Photograph No. 52:** View of the Administration Building 1<sup>st</sup> Floor mechanical room.
