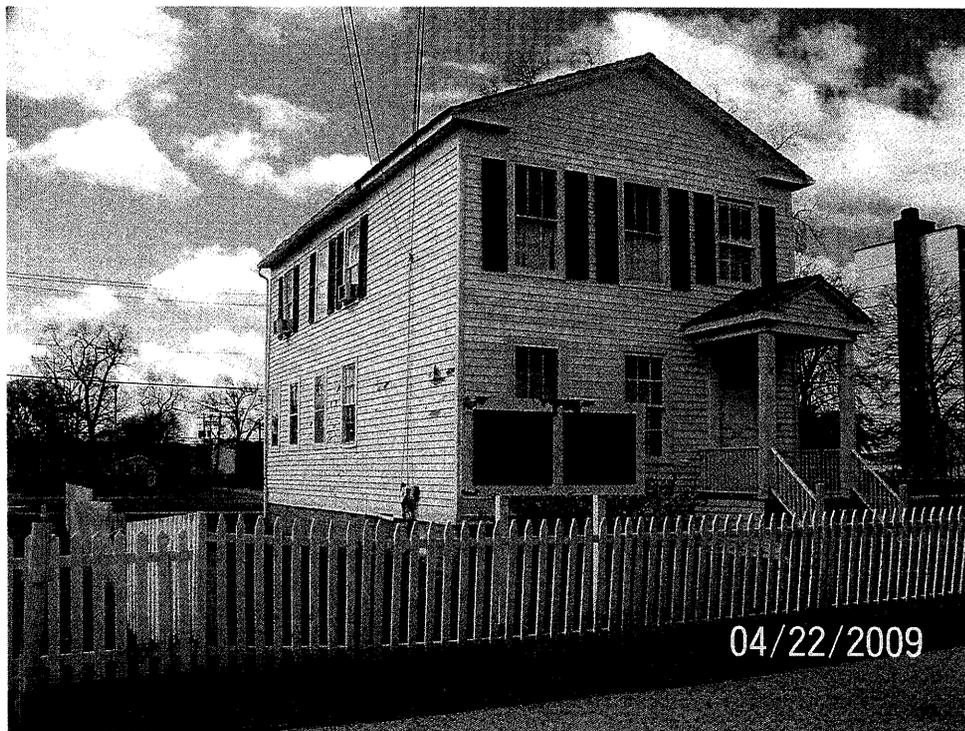
Photograph No. 53: Exterior view of Ulysses S. Grant's house.

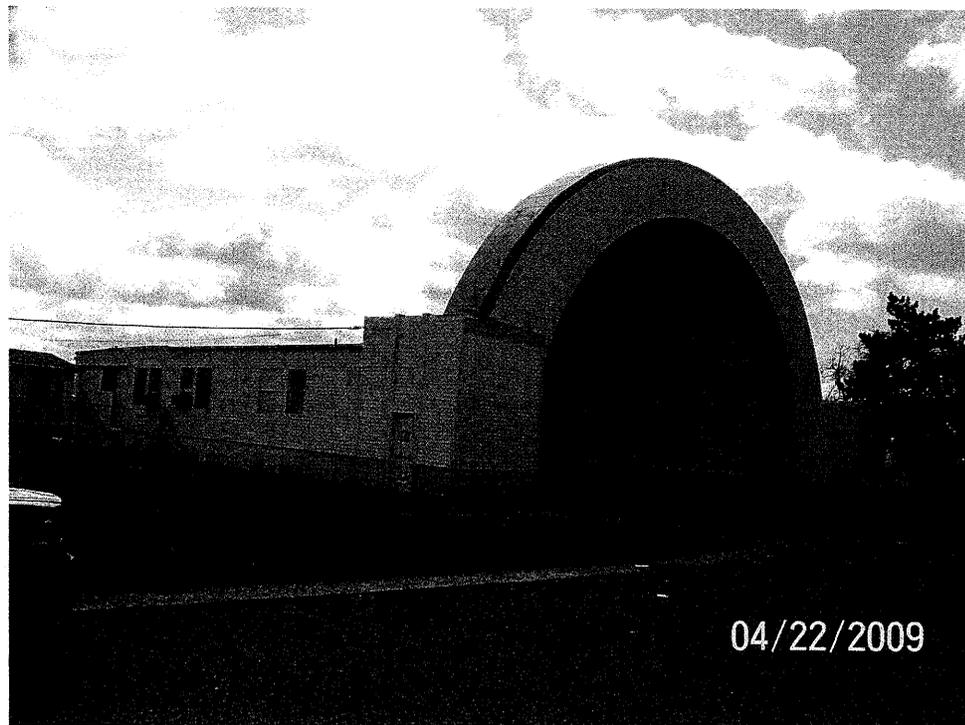
Photograph No. 54: Exterior view of the Bandshell.

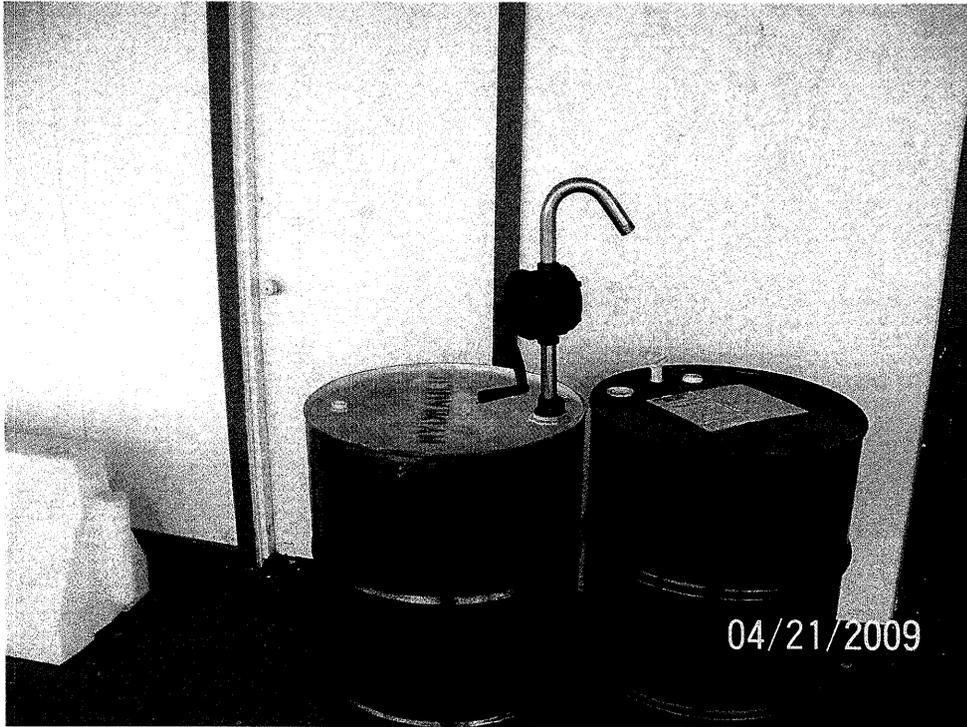
Photograph No. 55: View of drums containing hydraulic oil on the backside of the Bandshell.

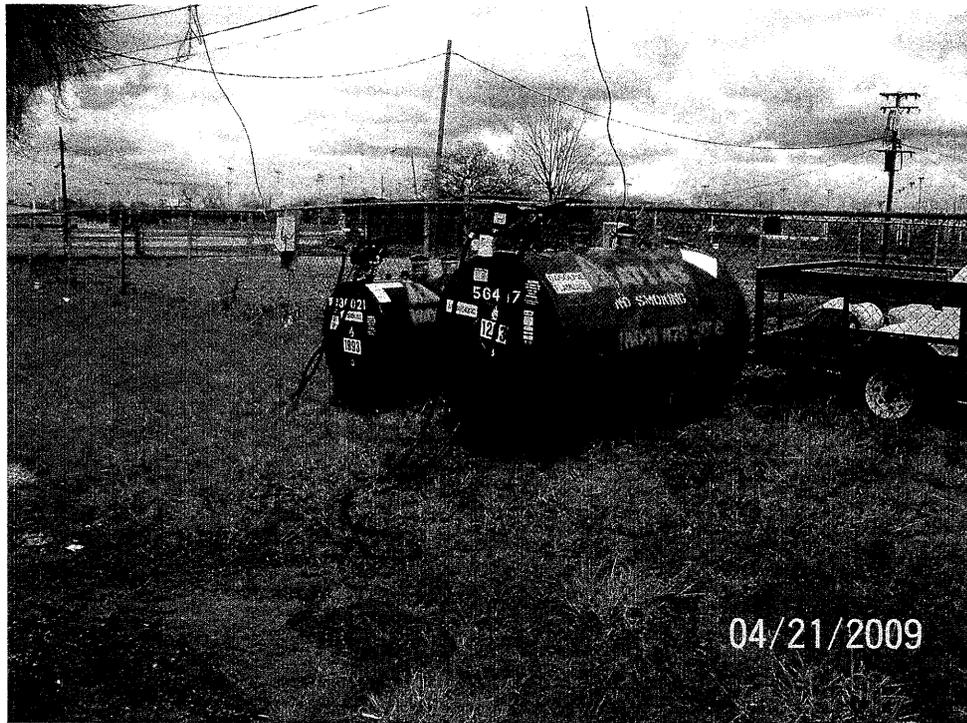
Photograph No. 56: View of two AST's (one gasoline and one diesel) to the east of the Bandshell.

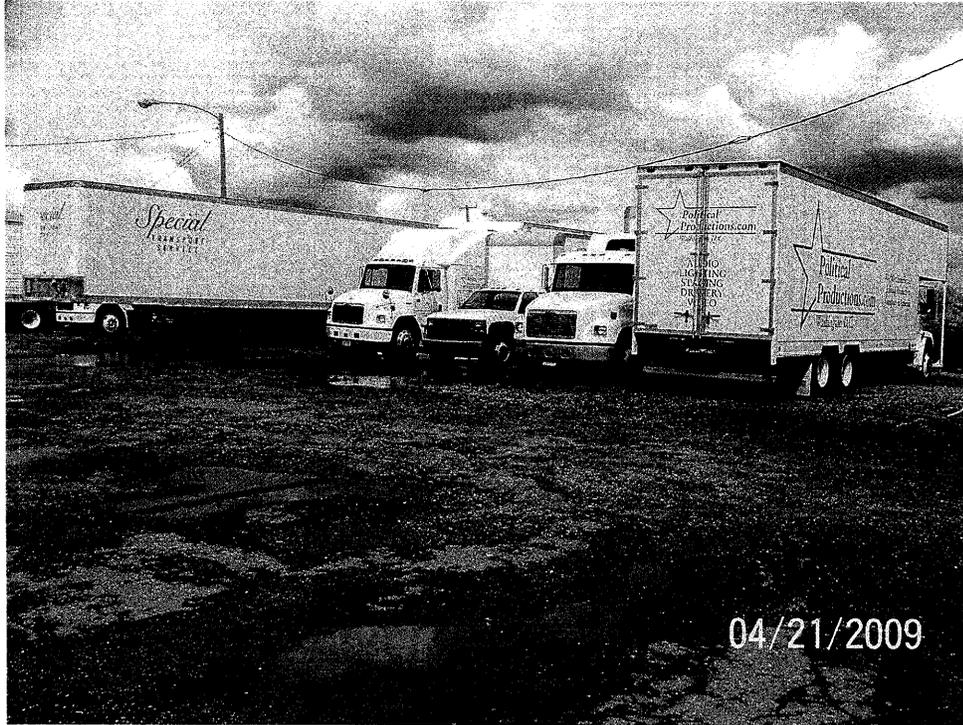
Photograph No. 57: View of semi trucks and tractor trailers to the east of the Bandshell (no access).

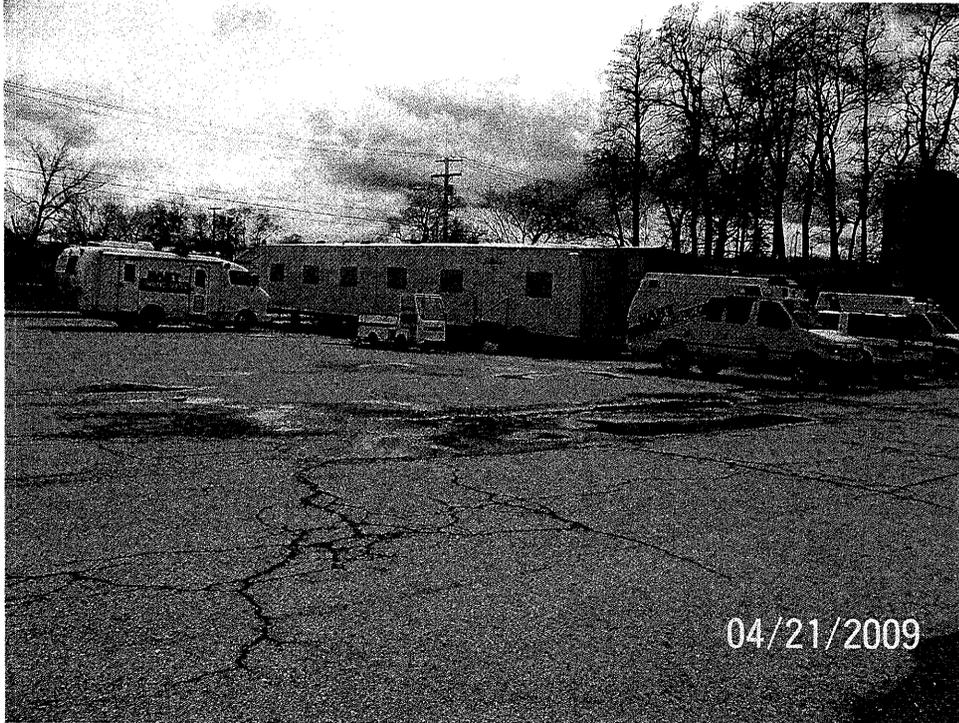
Photograph No. 58: View of various trailers and medical response vehicles (no access).

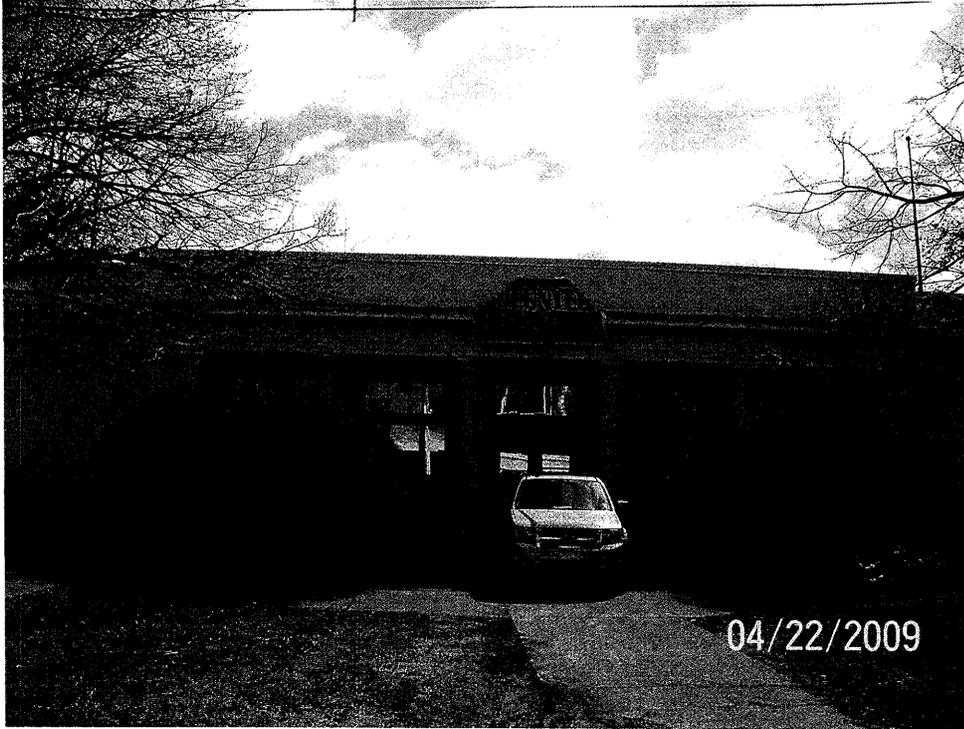
Photograph No. 59: Exterior view of the Volunteer Building housing the Youth Connection program.

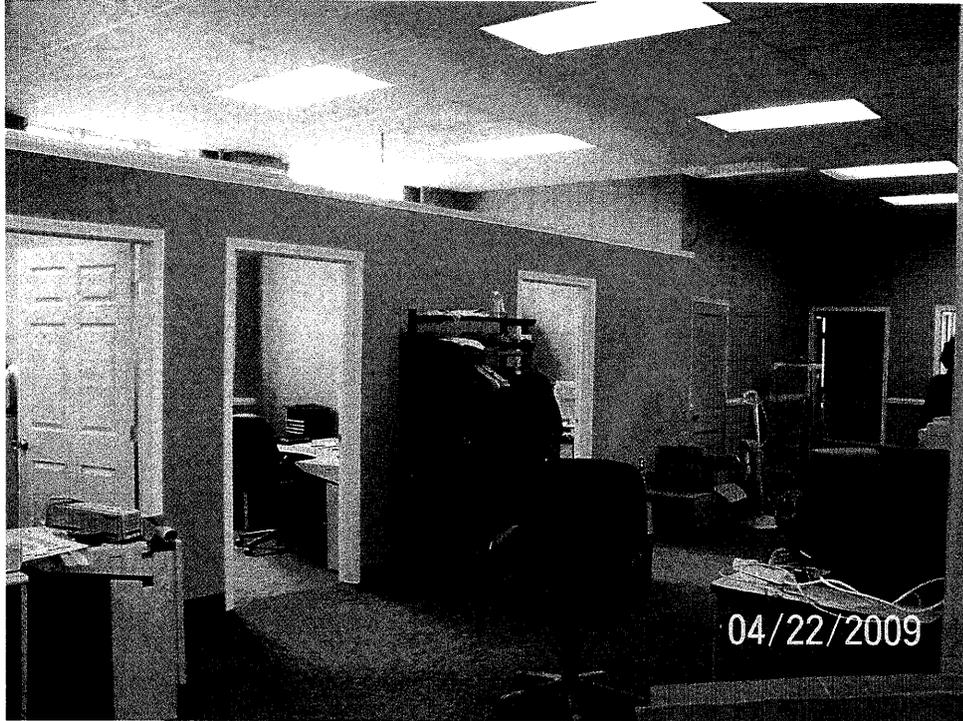
Photograph No 60: View of the interior of the Volunteer Building. Currently under renovation.

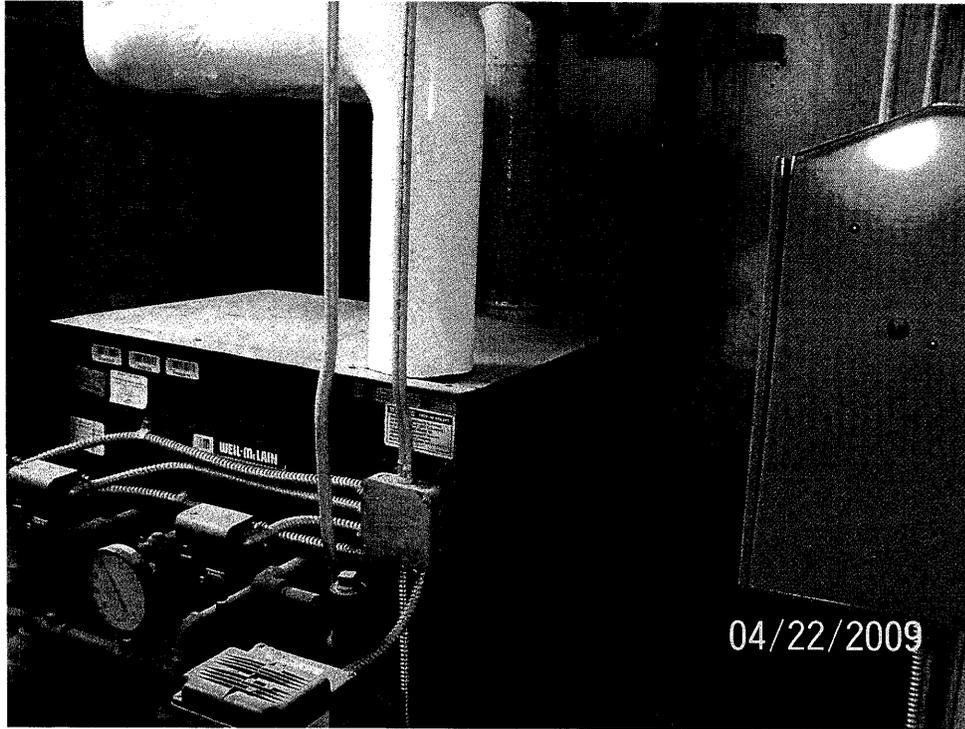
Photograph No 61: View of the boiler in the mechanical room of the Volunteer Building.

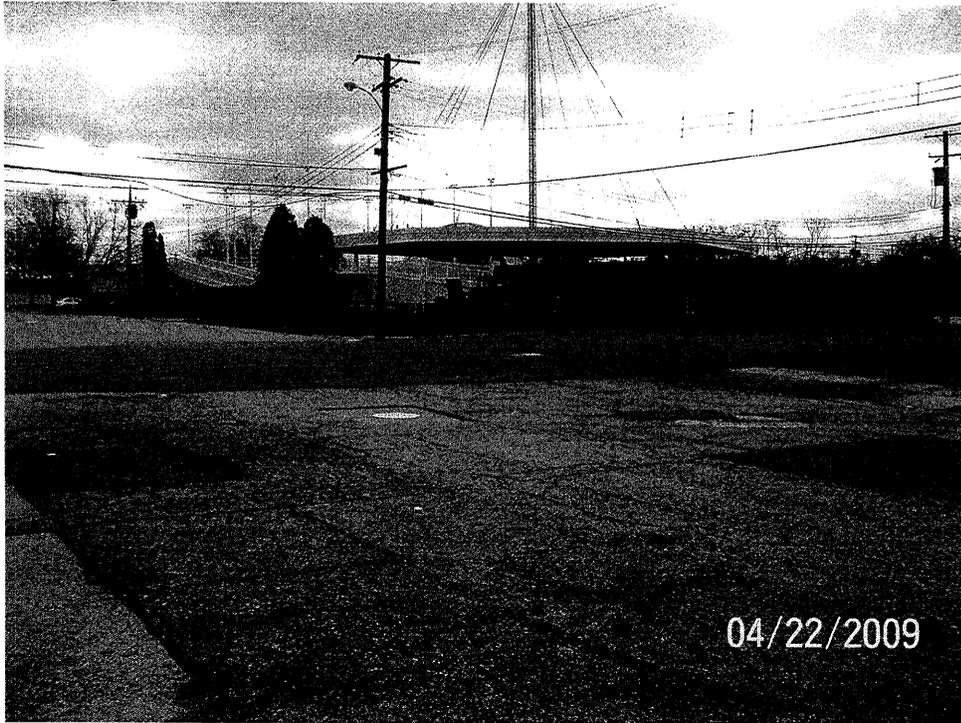
Photograph No. 62: Exterior view of the Dodge (Ford) Pavilion looking east.

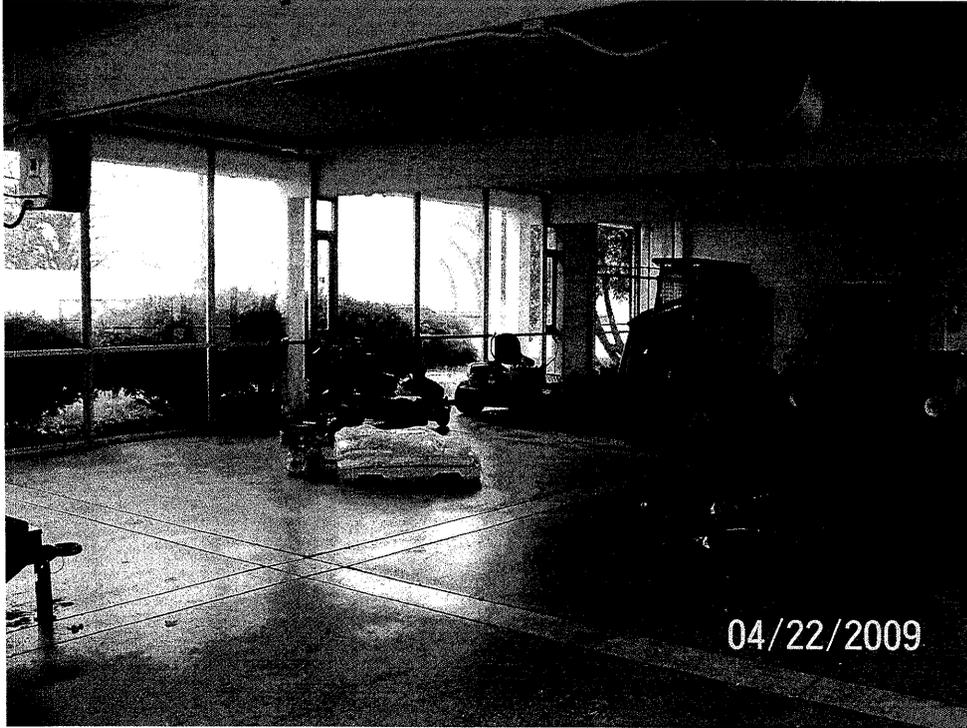
Photograph No. 63: View of the “showroom” in the Dodge Pavilion.

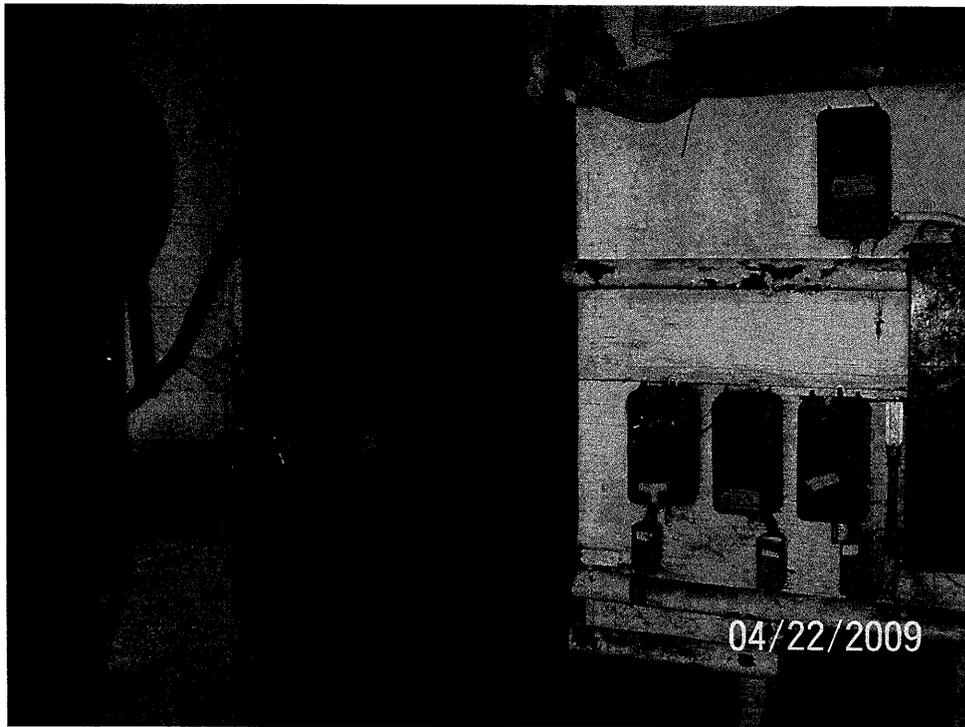
Photograph No. 64: View of the electrical room in the Dodge Pavilion.

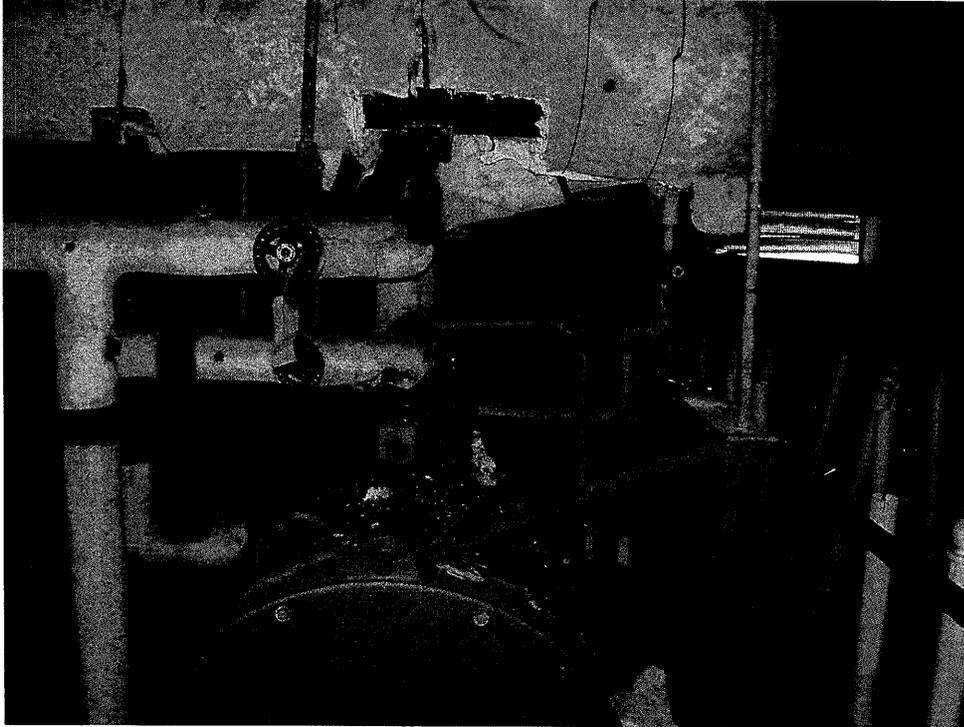
Photograph No. 65: View of the mechanical room of the Dodge Pavilion showing the significantly damaged asbestos containing material.

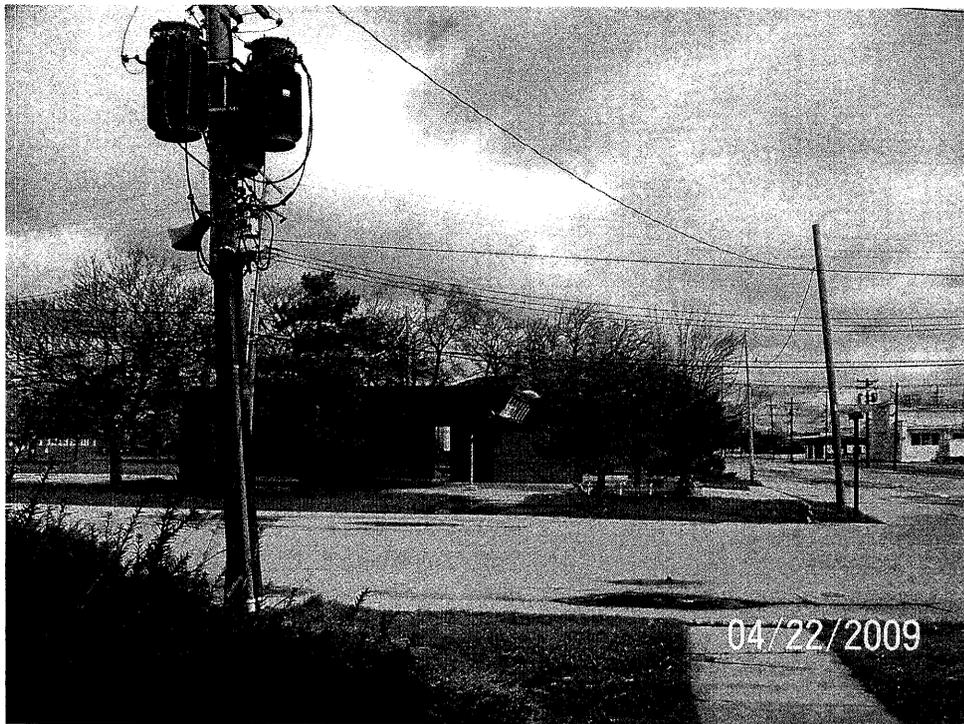
Photograph No. 66: View of the Plaza Toilet Building north of the Dodge Pavilion. Also show are pole mounted transformers.

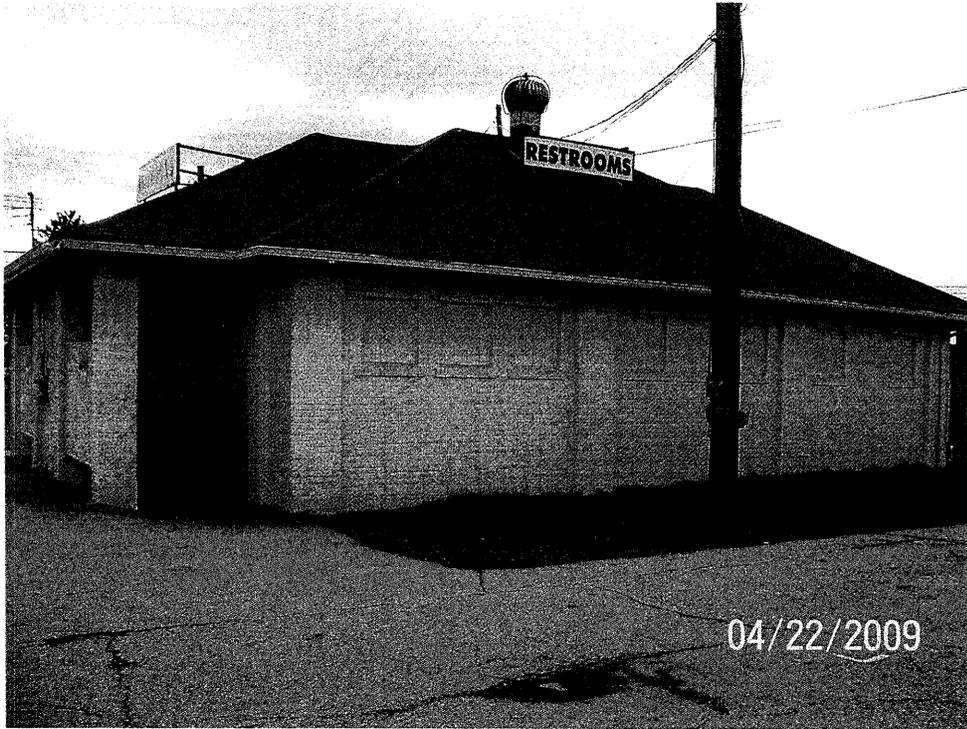
Photograph No. 67: Exterior view of the White Brick Comfort Station.

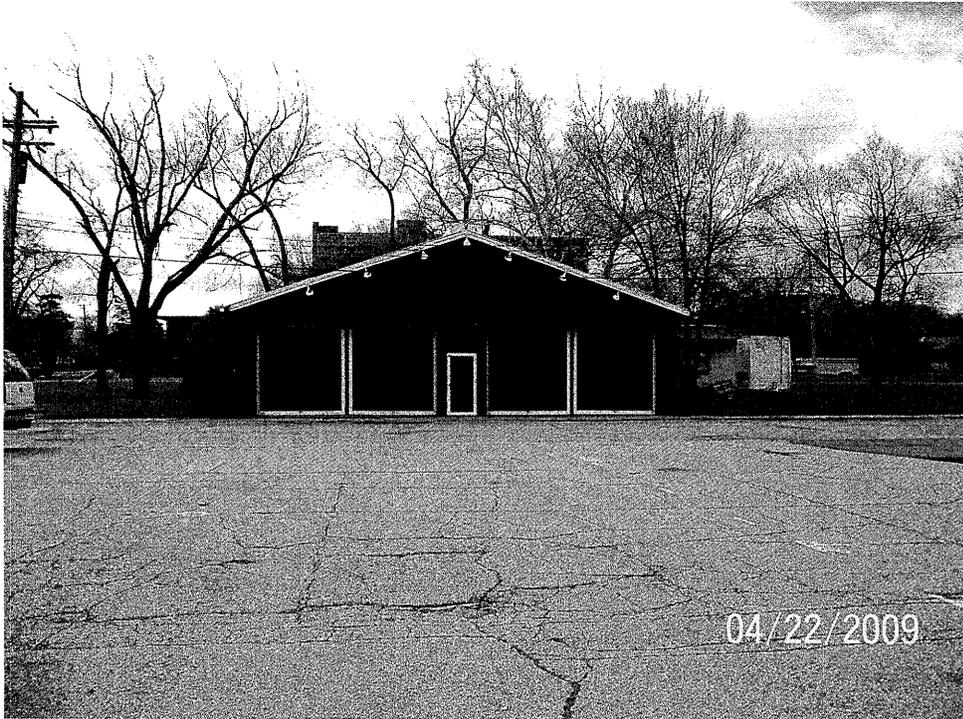
Photograph No. 68: Exterior view of the Exhibit Building looking south with the State Fair Apartments behind.

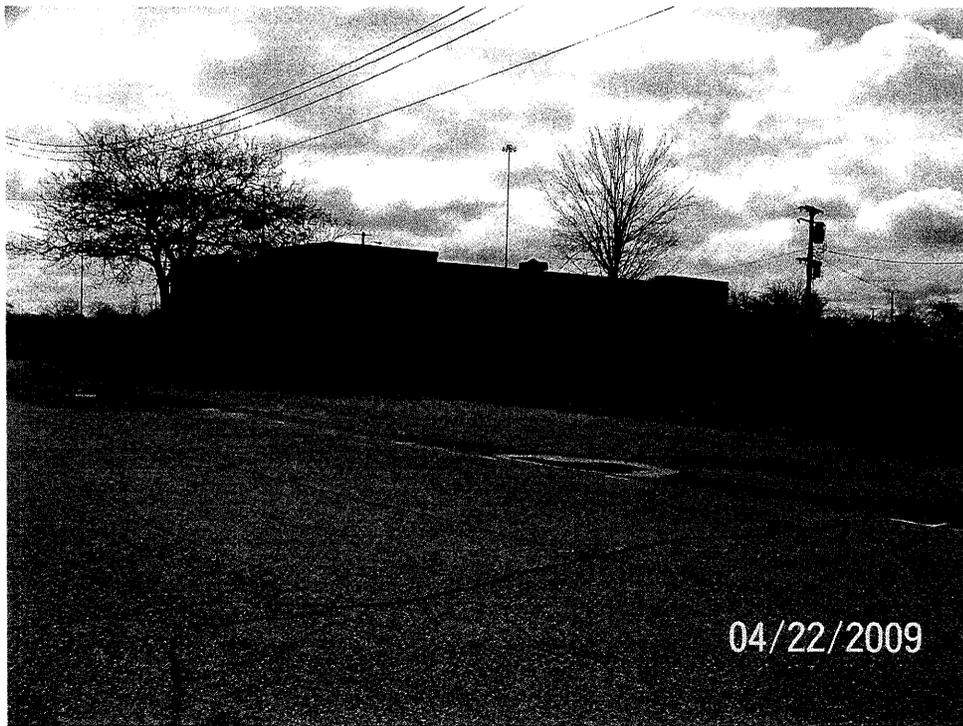
Photograph No. 70: View of the restrooms east of the Volunteer Building.

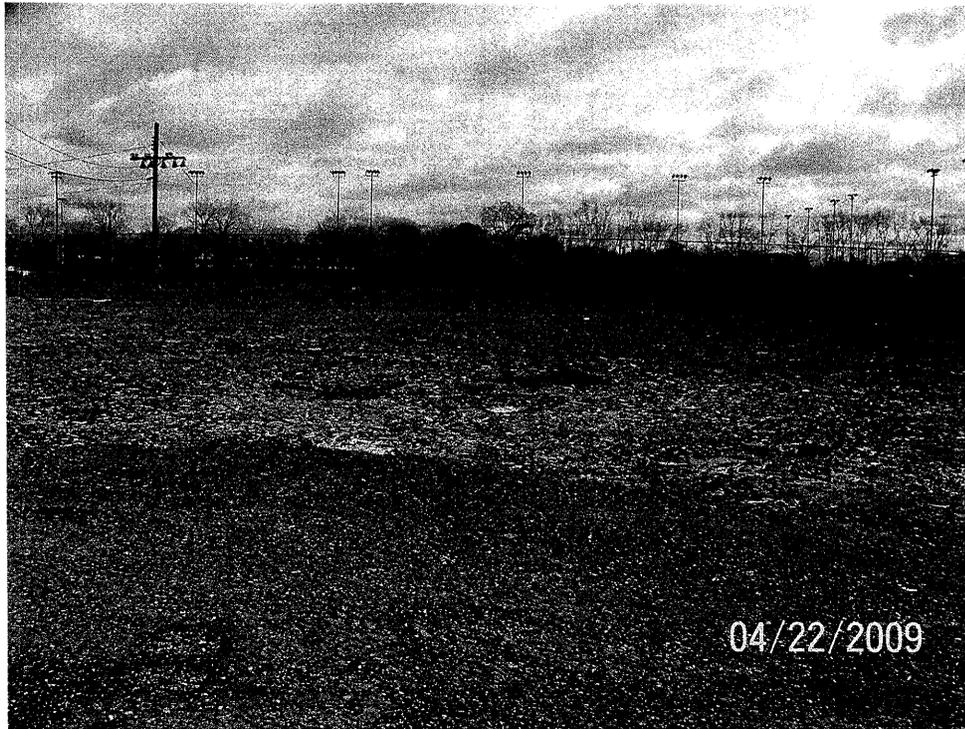
Photograph No. 71: View of the former UST location.

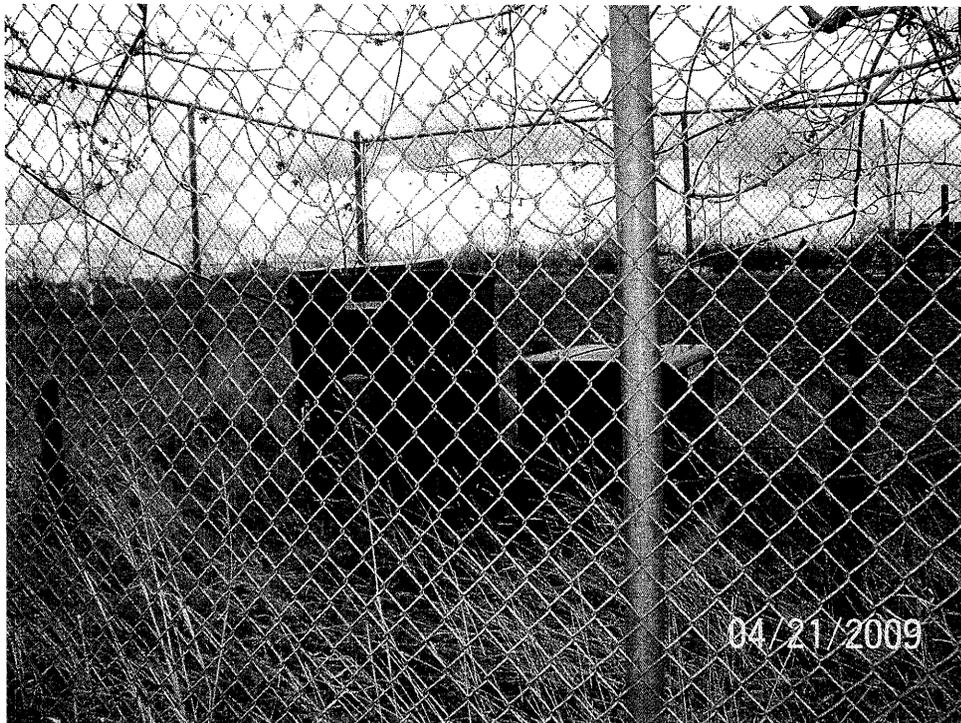
Photograph No. 72: View of fenced in transformers near the former UST location.

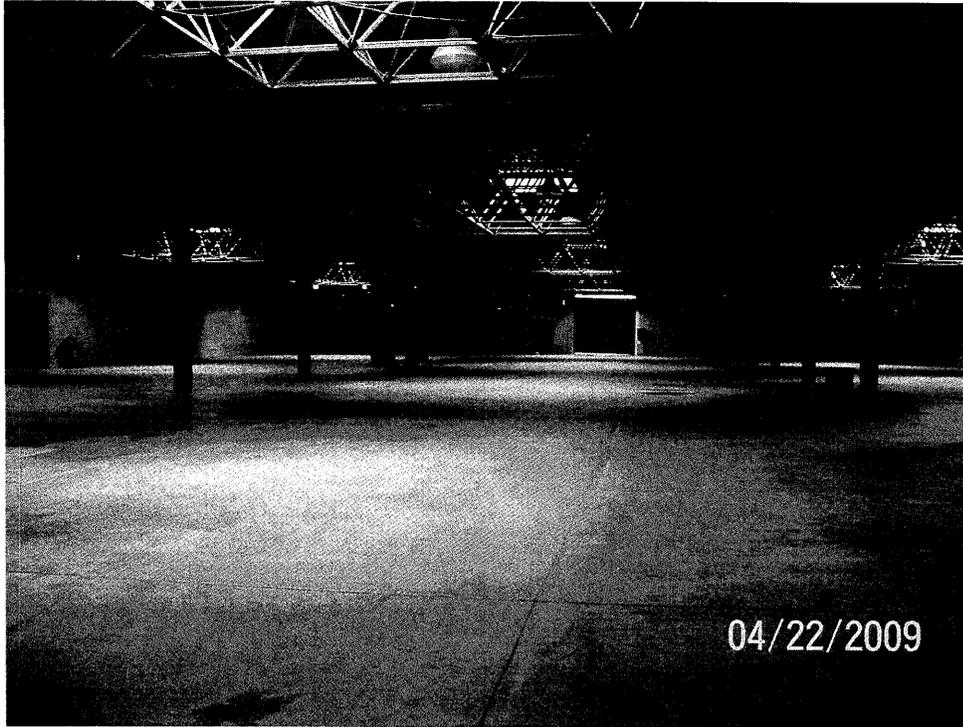
Photograph No. 73: View of the interior of the West Mall.

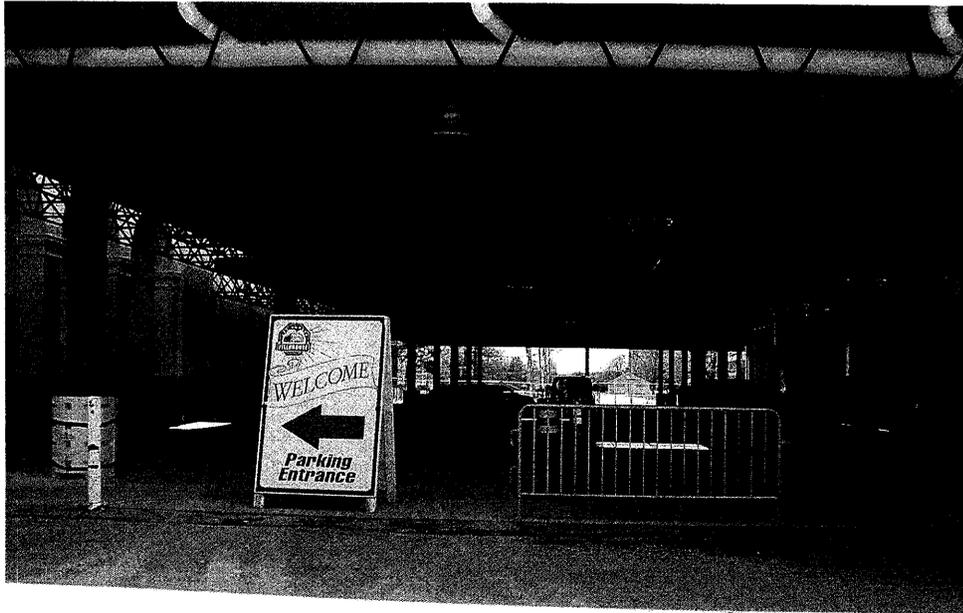
Photograph No. 74: View from the north looking south of the East Mall. This area is used for parking for the adjacent Agriculture Building.

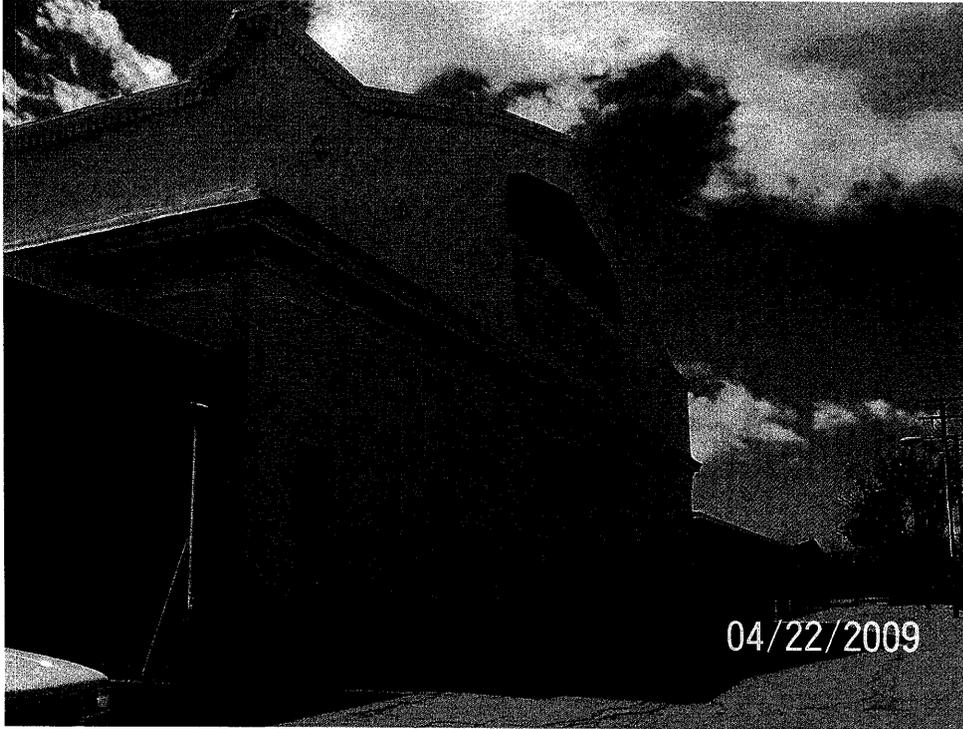
Photograph No. 75: Exterior view of the Agriculture Building (Joe Dumar's Fieldhouse) from the northeast looking west.

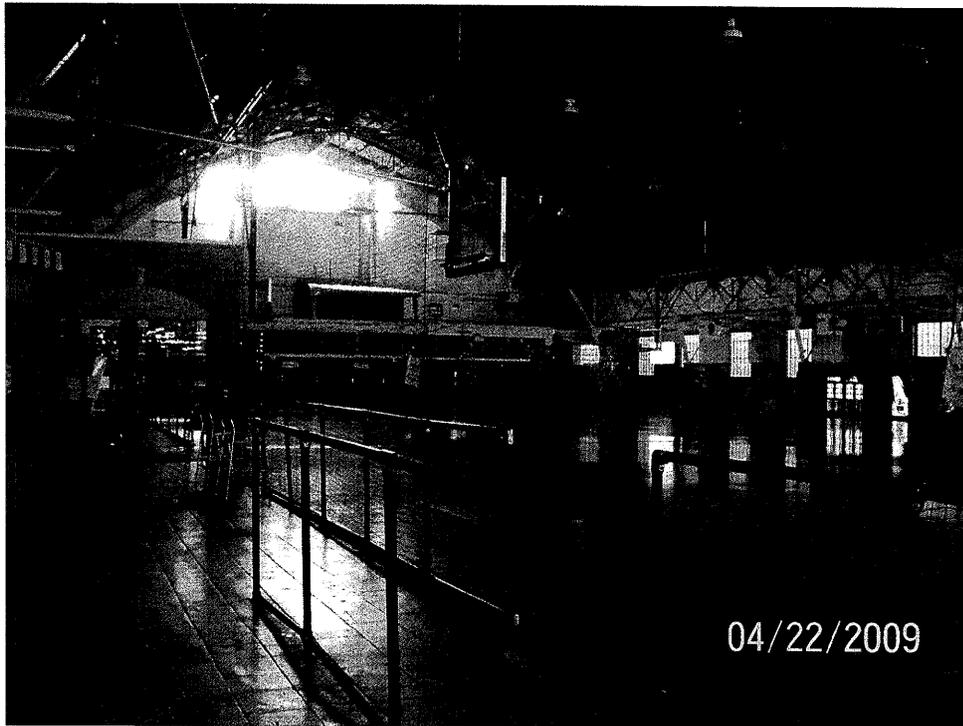
Photograph No 76: Interior view of the Agriculture Building (Joe Dumar's Fieldhouse) showing the basketball courts.

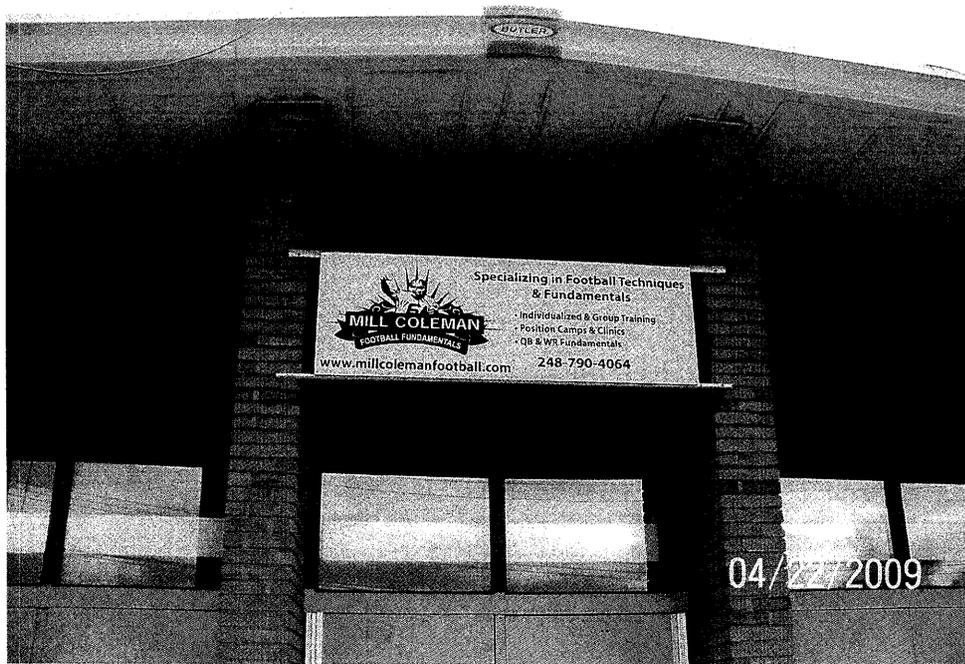
Photograph No. 77: Exterior view of the south entrance to the Michigan Mart.

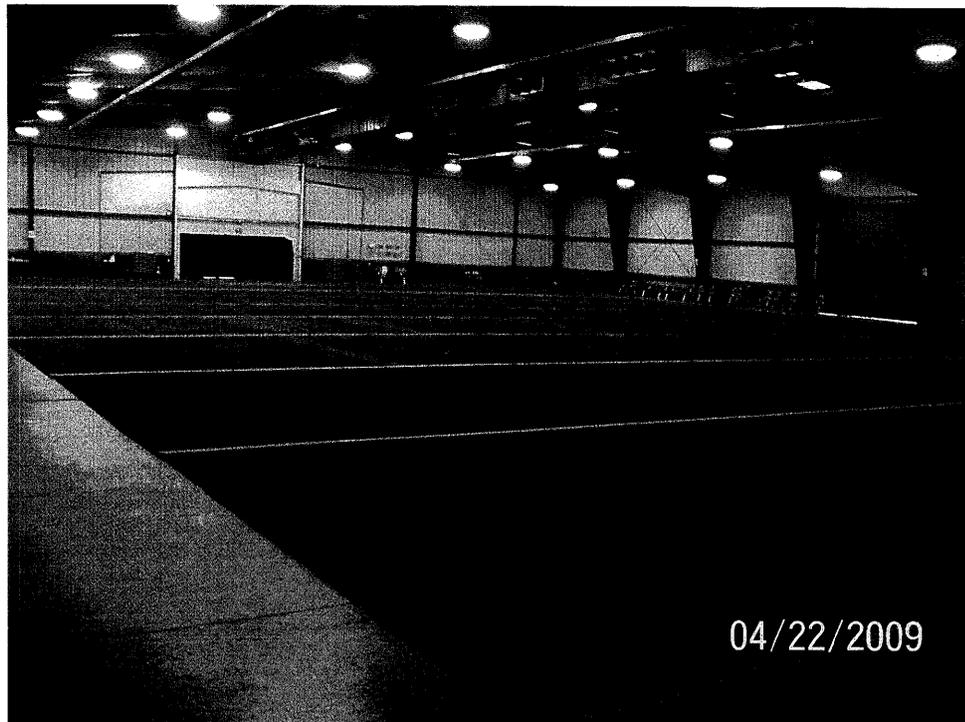
Photograph No. 78: View of the interior southern portion of the Michigan Mart showing the football turf.

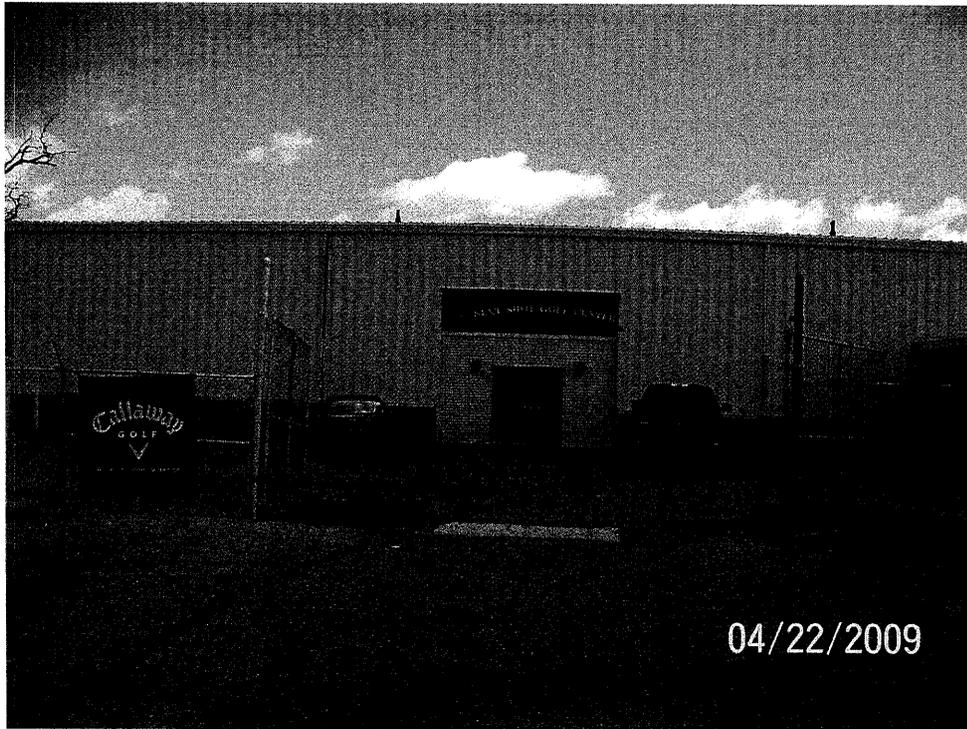
Photograph No. 79: View of the northwest entrance to the Michigan Mart.

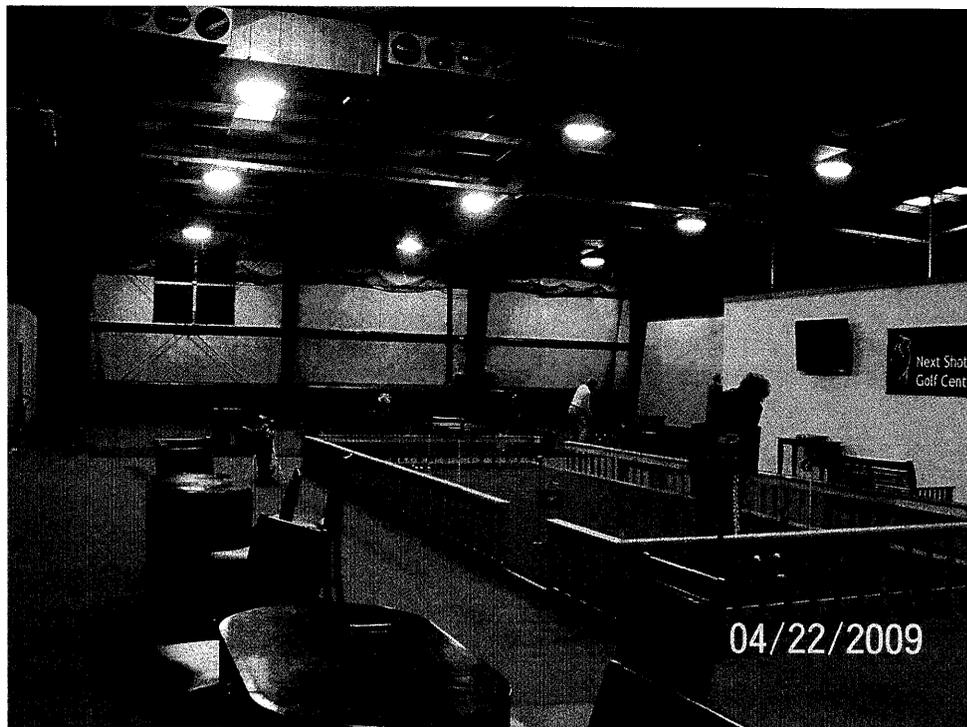
Photograph No 80: View of north interior section of the Michigan Mart showing the Next Shot Golf, LLC business.
