POTTER ELEMENTARY SCHOOL

Outlet Sampling and Plumbing Assessment Recommendations

2500 North Averill Avenue, Flint, Michigan 48506

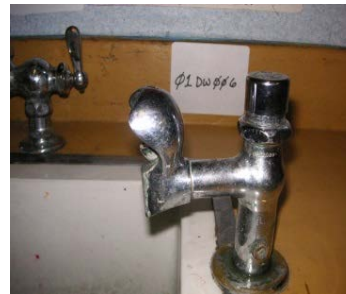
Outlet: Bubbler Fountain (01DW006)

Location: Classroom 15, south wall

Results: P1=30 parts per billion, P2=14 parts per billion
F01=2 parts per billion, F02=1 part per billion

These results suggest the highest contribution of lead may be from the bubbler itself. This bubbler fixture is made of chrome-plated brass. The connecting piping to the unit also contains some brass components, including brass fittings, a brass shut-off valve, and copper piping with lead solder.

Replacement of this bubbler and its connecting plumbing with lead-free materials will significantly reduce lead exposure at this location. If replacement is not currently feasible, sample results indicate that flushing this tap for three minutes following periods of stagnation is likely to reduce lead concentrations and lead exposure.

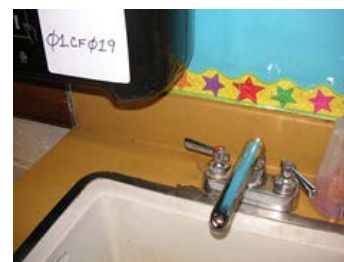
Outlet: Classroom Faucet (01CF019)

Location: Classroom 7, south wall

Results: P1=18 parts per billion, P2=12 parts per billion
F01=1 part per billion, F02=non-detect

These results suggest the highest contribution of lead may be from the faucet and its connecting plumbing. This faucet appears to be a Chicago Specialty model that may contain some brass components. The connecting plumbing contains some brass fittings.

Replacement of this faucet and its connecting plumbing with lead-free materials will significantly reduce lead exposure at this location. If replacement is not currently feasible, sample results indicate that flushing this tap for three minutes following periods of stagnation is likely to reduce lead concentrations and lead exposure.

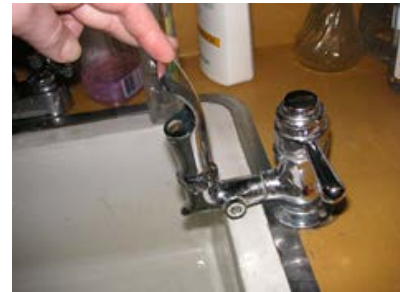
Outlet: Bubblers Fountain (01DW020)

Location: Classroom 7, south wall

Results: P1=17 parts per billion, P2=5 parts per billion
F01=4 parts per billion, F02=3 parts per billion

These results suggest the highest contribution of lead may be from the bubbler itself. This bubbler fixture is constructed of chrome-plated brass. The connecting plumbing contains some brass fittings.

Replacement of this bubbler and its connecting plumbing with lead-free materials will significantly reduce lead exposure at this location. If replacement is not currently feasible, sample results indicate that flushing this tap for three minutes following periods of stagnation is likely to reduce lead concentrations and lead exposure.

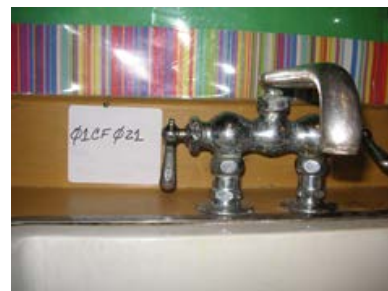
Outlet: Classroom Faucet (01CF021)

Location: Classroom 6, north wall

Results: P1=25 parts per billion, P2=8 parts per billion
F01=2 parts per billion, F02=1 part per billion

These results suggest the highest contribution of lead may be from the faucet and its connecting plumbing. The faucet appears to be a Chicago Specialty model with a solid brass body and spout. The connecting plumbing contains some brass fittings and copper piping with lead solder.

Replacement of this faucet and its connecting plumbing with lead-free materials will significantly reduce lead exposure at this location. If replacement is not currently feasible, sample results indicate that flushing this tap for three minutes following periods of stagnation is likely to reduce lead concentrations and lead exposure.

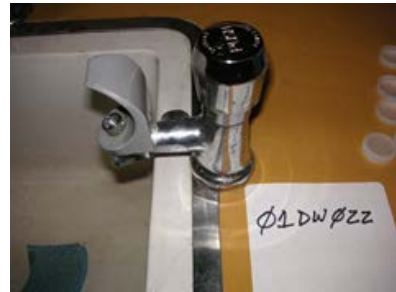
Outlet: Bubbler Fountain (01DW022)

Location: Classroom 6, north wall

Results: P1=65 parts per billion, P2=5 parts per billion
F01=3 parts per billion, F02=2 parts per billion

These results suggest the highest contribution of lead may be from the bubbler and connecting plumbing. This bubbler fixture is made of chrome-plated brass, with a brass connector on the underside of the sink. The connecting plumbing contains brass connections.

Replacement of this bubbler and its connecting plumbing with lead-free materials will significantly reduce lead exposure at this location. If replacement is not currently feasible, sample results indicate that flushing this tap for three minutes following periods of stagnation is likely to reduce lead concentrations and lead exposure.

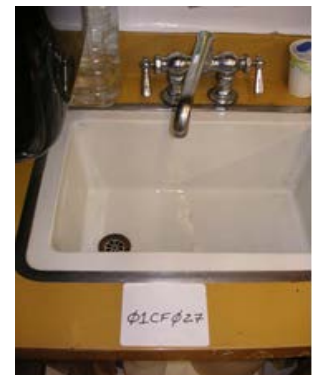
Outlet: Classroom Faucet (01CF027)

Location: Classroom 4, north wall

Results: P1=17 parts per billion, P2=10 parts per billion
F01=2 parts per billion, F02=non-detect

These results suggest the highest contribution of lead may be from the faucet and its connecting plumbing. The faucet appears to be a Chicago Specialty model with a solid brass body and spout. The connecting plumbing contains brass connections, brass fittings, brass shut-off valves, and copper piping with lead solder.

Replacement of this faucet and its connecting plumbing with lead-free materials will significantly reduce lead exposure at this location. If replacement is not currently feasible, sample results indicate that flushing this tap for three minutes following periods of stagnation is likely to reduce lead concentrations and lead exposure.

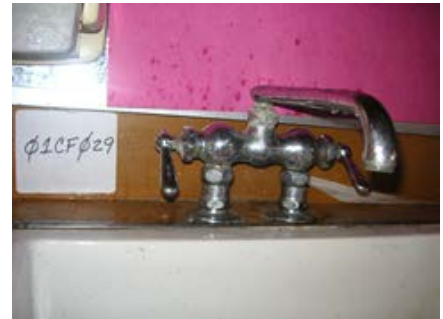
Outlet: Classroom Faucet (01CF029)

Location: Classroom 3, south wall

Results: P1=24 parts per billion, P2=24 parts per billion
F01=5 parts per billion, F02=9 parts per billion

These results suggest the highest contribution of lead may be from the faucet and its connecting plumbing. The faucet appears to be a Chicago Specialty model with a solid brass body and spout. The connecting plumbing contains brass connections, brass fittings, brass shut-off valves, and copper piping with lead solder.

Replacement of this faucet and its connecting plumbing with lead-free materials will significantly reduce lead exposure at this location. If replacement is not currently feasible, sample results indicate that flushing this tap for three minutes following periods of stagnation is likely to reduce lead concentrations and lead exposure.

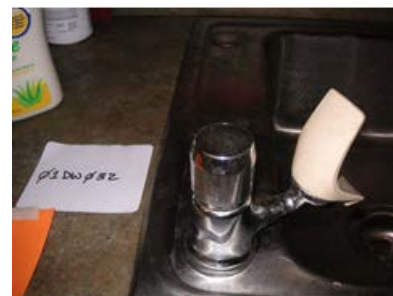
Outlet: Bubbler Fountain (01DW032)

Location: Room 1A, north wall

Results: P1=23 parts per billion, P2=11 parts per billion
F01=28 parts per billion, F02=5 parts per billion

These results suggest the highest contribution of lead may be from the bubbler fixture and its connecting plumbing. The bubbler unit is constructed of chrome-plated brass, with a brass connector on the underside of the sink. The connecting plumbing contains some brass fittings and brass connectors.

Replacement of the bubbler and connecting plumbing with lead-free materials will significantly reduce lead exposure at this location. If replacement is not currently feasible, sample results indicate that flushing this tap for three minutes following periods of stagnation is likely to reduce lead concentrations and lead exposure.

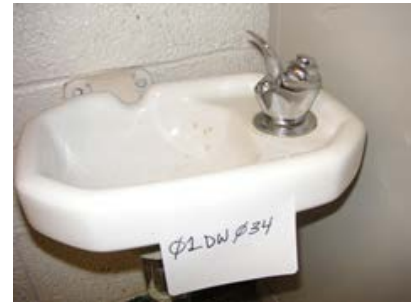
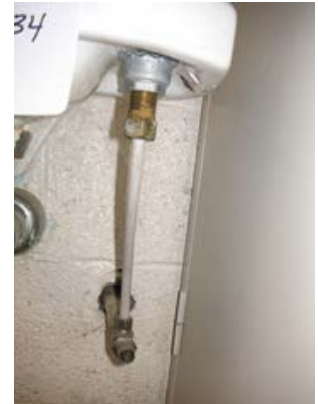
Outlet: Bubblers Fountain (01DW034)

Location: Room 1A, southeast corner

Results: P1=556 parts per billion, P2=69 parts per billion
F01=38 parts per billion, F02=4 parts per billion

These results suggest the highest contribution of lead may be from the bubbler fixture and its connecting plumbing. This bubbler unit is constructed of chrome-plated brass, with a brass connection on the underside of the fountain base. The connecting piping to the unit contains brass connections and a brass shut-off valve.

Copper results for P1 and F01 at this location were also at levels above which the DEQ recommends school facilities take action. Copper results suggest these same brass components and copper piping are contributing to this condition.

Replacement of the bubbler and connecting plumbing with lead-free materials will significantly reduce lead exposure at this location. If replacement is not currently feasible, sample results indicate that flushing this tap for three minutes following periods of stagnation is likely to reduce lead and copper concentrations and lead and copper exposure.

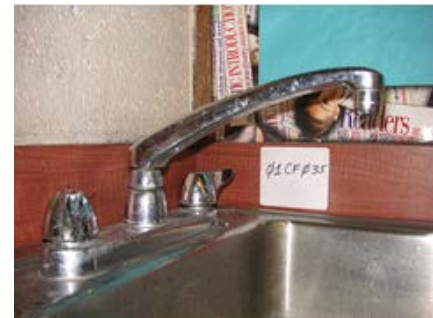
Outlet: Classroom Faucet (01CF035)

Location: Room 2A, north wall

Results: P1=9 parts per billion, P2=23 parts per billion
F01=12 parts per billion, F02=6 parts per billion

These results suggest the highest contribution of lead may be from the faucet and its connecting plumbing. This fixture appears to be a Chicago Specialty faucet. This model faucet typically has a brass tube in its deck body and contains some additional brass components. The connecting piping has some brass connections, brass fittings, and brass shut-off valves.

Replacement of this faucet and its connecting plumbing with lead-free materials will significantly reduce lead exposure at this location. If replacement is not currently feasible, sample results indicate that flushing this tap for three minutes following periods of stagnation is likely to reduce lead concentrations and lead exposure.

This faucet also has an aerator/screen at the outlet. If the faucet is not replaced, the aerator/screen should be removed, inspected for particulate accumulations, scrubbed clean, and reinstalled. If particulates are found, the aerator/screen should be periodically checked and cleaned.

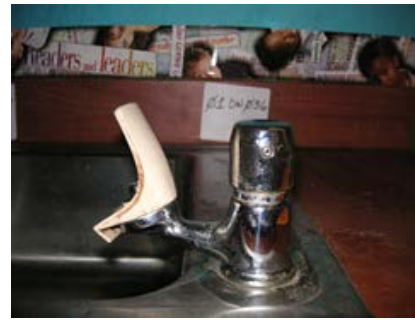
Outlet: Bubler Fountain (01DW036)

Location: Room 2A, north wall

Results: P1=25 parts per billion, P2=7 parts per billion
F01=4 parts per billion, F02=2 parts per billion

These results suggest the highest contribution of lead may be from the bubbler fixture itself. This bubbler unit is constructed of chrome-plated brass, and has a brass connection on the underside of the sink. The connecting piping to the unit contains brass connectors and a brass shut-off valve.

Replacement of this bubbler and its connecting plumbing with lead-free materials will significantly reduce lead exposure at this location. If replacement is not currently feasible, sample results indicate that flushing this tap for three minutes following periods of stagnation is likely to reduce lead concentrations and lead exposure.

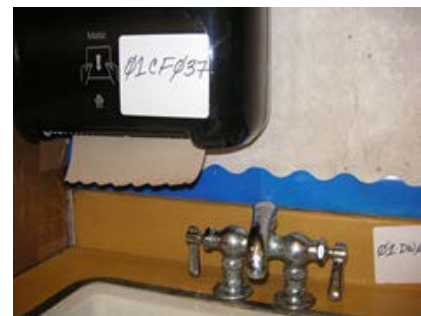
Outlet: Classroom Faucet (01CF037)

Location: Classroom 38, north wall

Results: P1= 30 parts per billion, P2=19 parts per billion
F01=2 parts per billion, F02=non-detect

These results suggest the highest contribution of lead may be from the faucet and its connecting plumbing. The faucet appears to be a Chicago Specialty model with a solid brass body and spout. The connecting plumbing contains brass connections, brass fittings, brass shut-off valves, and copper piping with lead solder.

Replacement of this faucet and its connecting plumbing with lead-free materials will significantly reduce lead exposure at this location. If replacement is not currently feasible, sample results indicate that flushing this tap for three minutes following periods of stagnation is likely to reduce lead concentrations and lead exposure.

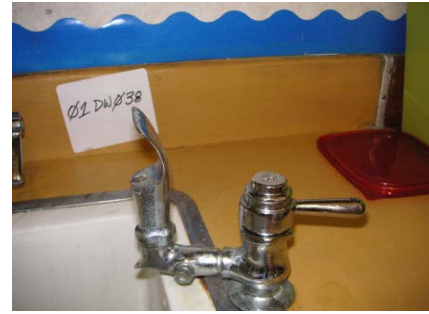
Outlet: Bubblers Fountain (01DW038)

Location: Classroom 38, north wall

Results: P1=23 parts per billion, P2=3 parts per billion
F01=non-detect, F02=non-detect

These results suggest the highest contribution of lead may be from the bubbler itself. This bubbler fixture is made of chrome-plated brass, with a brass operating valve, and a brass connector on the underside of the sink.

Replacement of this bubbler tap and its connecting plumbing with lead-free materials will significantly reduce lead exposure at this location. If replacement is not currently feasible, sample results indicate that flushing this tap for three minutes following periods of stagnation is likely to reduce lead concentrations and lead exposure.

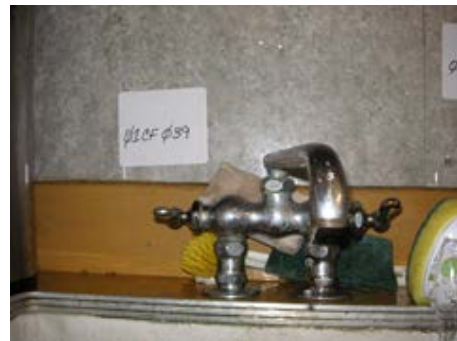
Outlet: Classroom Faucet (01CF039)

Location: Classroom 39, south wall

Results: P1=30 parts per billion, P2=22 parts per billion
F01=2 parts per billion, F02=2 parts per billion

These results suggest the highest contribution of lead may be from the faucet and its connecting plumbing. The faucet appears to be a Chicago Specialty model with a solid brass body and spout. The connecting plumbing contains brass connections, brass fittings, brass shut-off valves, and copper piping with lead solder.

Replacement of this faucet and its connecting plumbing with lead-free materials will significantly reduce lead exposure at this location. If replacement is not currently feasible, sample results indicate that flushing this tap for three minutes following periods of stagnation is likely to reduce lead concentrations and lead exposure.

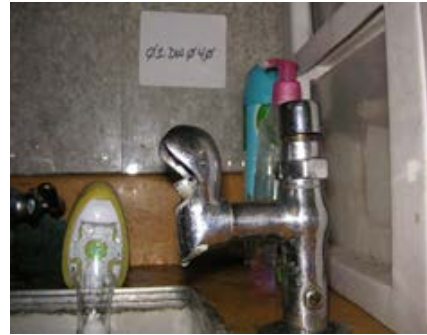
Outlet: Bubler Fountain (01DW040)

Location: Classroom 39, south wall

Results: P1=261 parts per billion, P2=26 parts per billion
F01=12 parts per billion, F02=8 parts per billion

These results suggest the highest contribution of lead may be from the bubbler fixture and its connecting plumbing. This bubbler fixture is made of chrome-plated brass. The connecting plumbing also contains some brass components, including brass fittings, a brass shut-off valve, and copper piping with lead solder.

Replacement of this bubbler and its connecting plumbing with lead-free materials will significantly reduce lead exposure at this location. If replacement is not currently feasible, sample results indicate that flushing this tap for three minutes following periods of stagnation is likely to reduce lead concentrations and lead exposure.

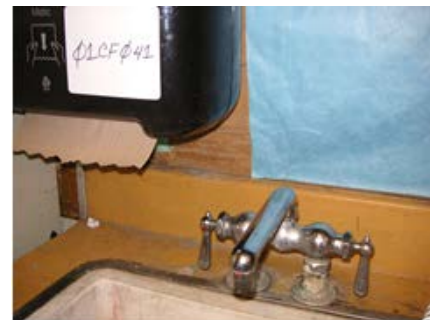
Outlet: Classroom Faucet (01CF041)

Location: Classroom 36, north wall

Results: P1= 20 parts per billion, P2=11 parts per billion
F01=1 part per billion, F02=non-detect

These results suggest the highest contribution of lead may be from the faucet and its connecting plumbing. The faucet appears to be a Chicago Specialty model with a solid brass body and spout. The connecting plumbing contains brass connections, brass fittings, brass shut-off valves, and copper piping with lead solder.

Replacement of this faucet and its connecting plumbing with lead-free materials will significantly reduce lead exposure at this location. If replacement is not currently feasible, sample results indicate that flushing this tap for three minutes following periods of stagnation is likely to reduce lead concentrations and lead exposure.

This faucet also has an aerator/screen at the outlet. If the faucet is not replaced, the aerator/screen should be removed, inspected for particulate accumulations, scrubbed clean, and reinstalled. If particulates are found, the aerator/screen should be periodically checked and cleaned.

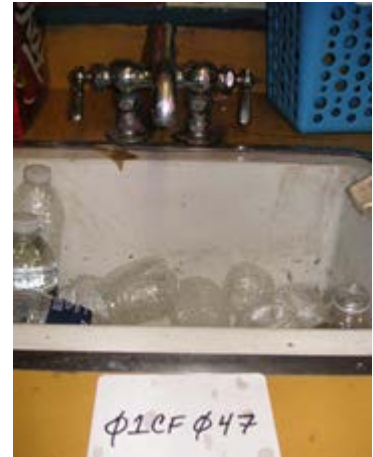
Outlet: Classroom Faucet (01CF047)

Location: Classroom 35, south wall

Results: P1= 22 parts per billion, P2=42 parts per billion
F01=15 parts per billion, F02=11 parts per billion

These results suggest the highest contribution of lead may be from the faucet and its connecting plumbing. The faucet appears to be a Chicago Specialty model with a solid brass body and spout. The connecting plumbing contains brass connections, brass fittings, brass shut-off valves, and copper piping with lead solder.

Replacement of this faucet and its connecting plumbing with lead-free materials will significantly reduce lead exposure at this location. If replacement is not currently feasible, sample results indicate that flushing this tap for three minutes following periods of stagnation is likely to reduce lead concentrations and lead exposure.

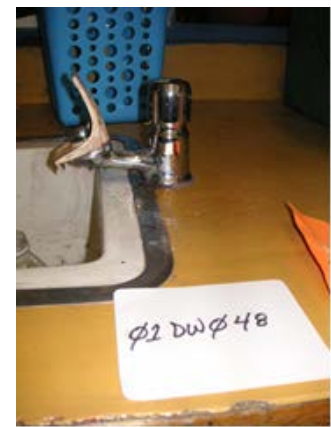
Outlet: Bubbler Fountain (01DW048)

Location: Classroom 35, south wall

Results: P1=17 parts per billion, P2=10 parts per billion
F01=9 parts per billion, F02=6 parts per billion

These results suggest the highest contribution of lead may be from the bubbler fixture itself. This bubbler unit is constructed of chrome-plated brass, with a brass connection on the underside of the sink. The connecting piping to the unit contains brass connectors and a brass shut-off valve.

Replacement of this bubbler and its connecting plumbing with lead-free materials will significantly reduce lead exposure at this location. If replacement is not currently feasible, sample results indicate that flushing this tap for three minutes following periods of stagnation is likely to reduce lead concentrations and lead exposure.

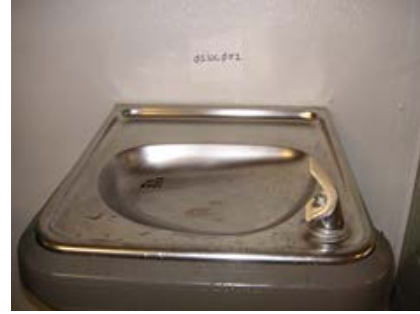
Outlet: Water Cooler (01WC051)

Location: Hallway Across from Classroom 31

Results: P1=2 parts per billion, P2=2 parts per billion
F01=21 parts per billion, F02=1 part per billion

These results suggest the highest contribution of lead may be from the water cooler unit and its connecting plumbing. The water cooler is an Elkay model MEBFS-8-1. This model contains some brass components. Connecting plumbing to the cooler unit may also contain some brass components.

Copper results for sample F01 at this location was also at levels above which the DEQ recommends school facilities take action. Copper results suggest these same brass components and copper piping are contributing to this condition.

Replacement of the water cooler unit and its connecting plumbing with lead-free materials will significantly reduce lead and copper exposure at this location. If replacement is not currently feasible, sample results indicate that flushing this tap for three minutes following periods of stagnation is likely to reduce lead and copper concentrations and lead and copper exposure.

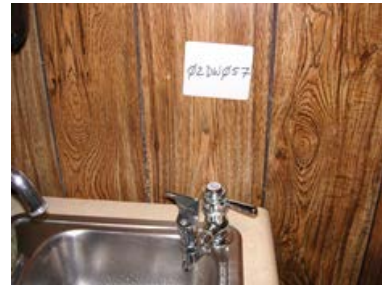
Outlet: Bubbler Fountain, (02DW057)

Location: Out-building Unit 2

Results: P1=27 parts per billion, P2=1 part per billion
F01=non-detect, F02=non-detect

These results suggest the highest contribution of lead may be from the bubbler itself. This bubbler fixture is made of chrome-plated brass, and has a brass operating valve. The connecting plumbing contains some brass fittings.

Replacement of this bubbler tap and its connecting plumbing with lead-free materials will significantly reduce lead exposure at this location. If replacement is not currently feasible, sample results indicate that flushing this tap for three minutes following periods of stagnation is likely to reduce lead concentrations and lead exposure.

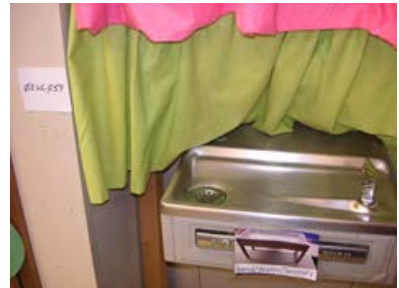
Outlet: Water Cooler (03WC059)

Location: Out-building Unit 3

Results: P1=0.85 parts per million, P2=1.11 parts per million
F01=2.54 parts per million, F02=1.31 parts per million

These results suggest the highest contribution of copper may be from the water cooler unit and its connecting plumbing. This model water cooler contains some brass and copper components. Connecting plumbing to the cooler unit may also contain brass components and copper piping.

Replacement of this unit and its connecting plumbing is recommended and will reduce copper exposure at this location. F01 and F02 sample results suggest stagnant water conditions in the copper supply piping may be contributing to these levels. Consecutive sampling results for out-building unit 3 suggest that development of a routine operational flushing procedure for this building and its outlets is likely to reduce copper concentrations and copper exposure.
