Appendix A – Rehabilitation Costs

Appendix B – Replacement Costs

Appendix E – Photographs

STRUCTURAL PHOTOGRAPHS

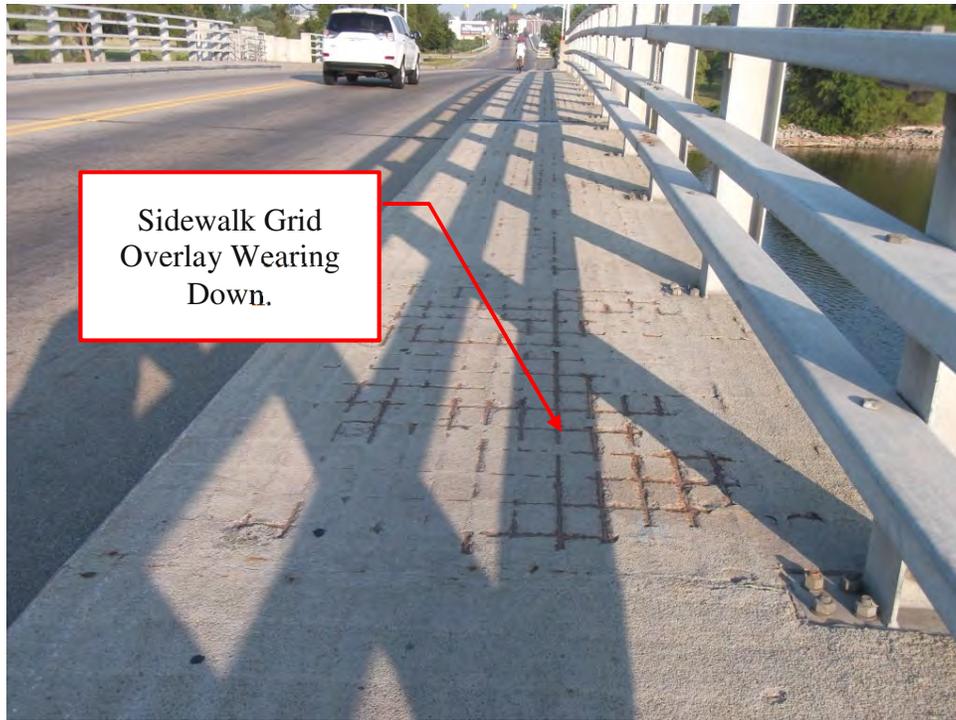
S-5. North Sidewalk of Bascule Span – Steel Grid Exposed (07-17-2013)

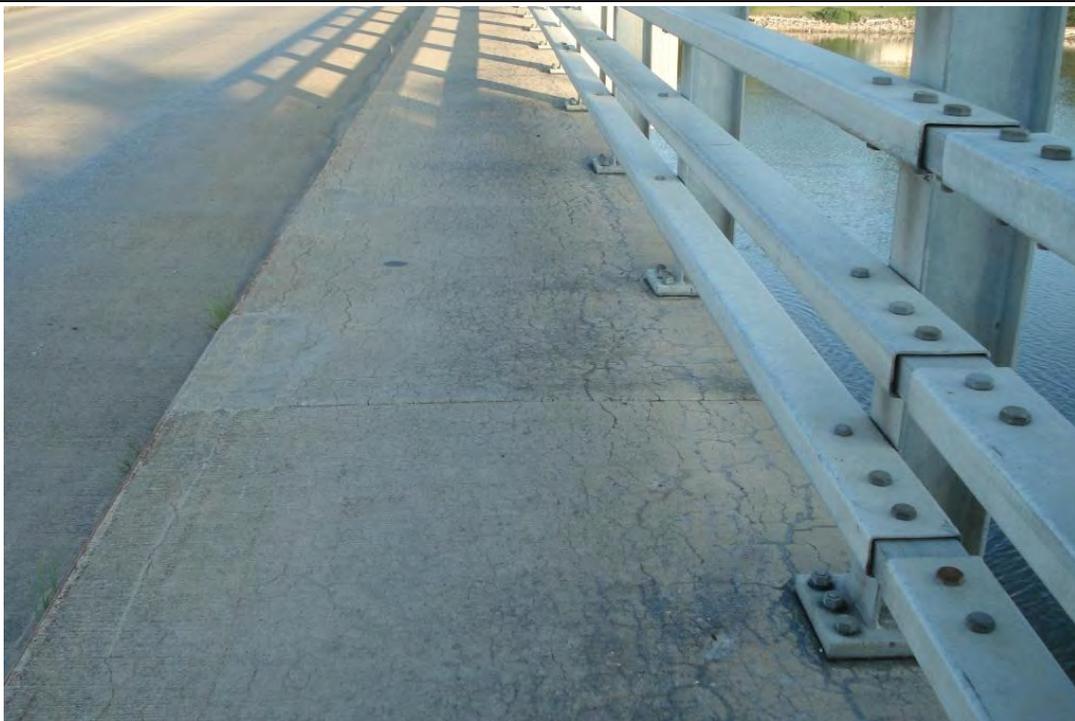
S-6. North Sidewalk on East Approach Span – Map Cracking (07-17-2013)

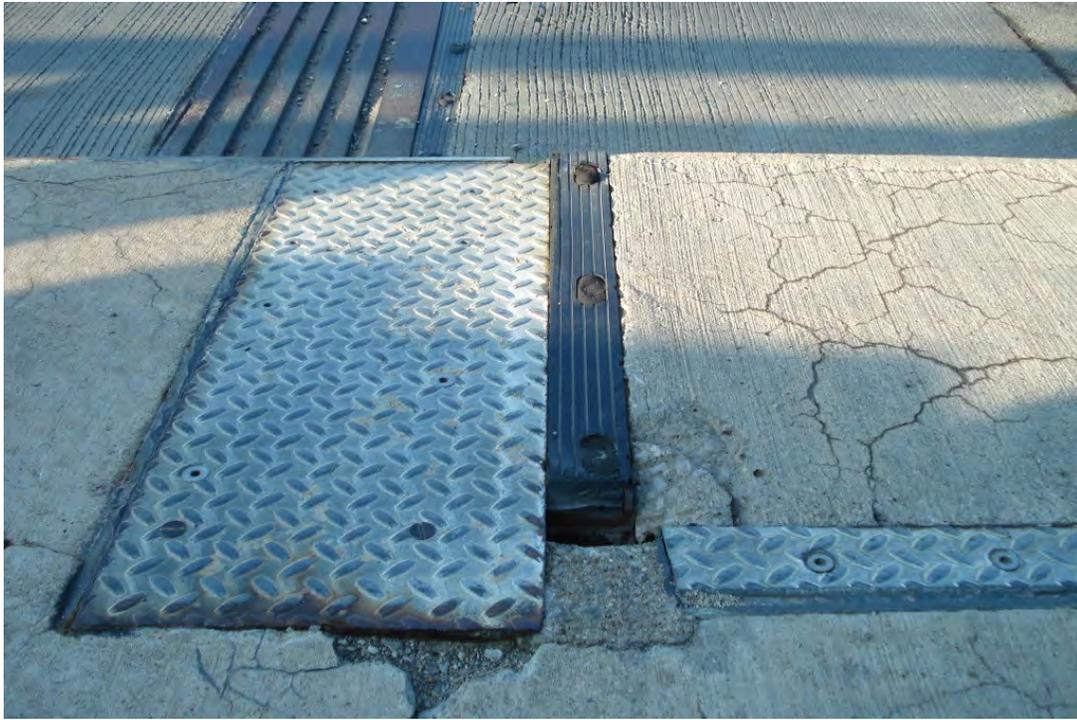
S-7. Rear Break at North Sidewalk on West Leaf – Cracking and Spalling of Concrete (07-17-2013)

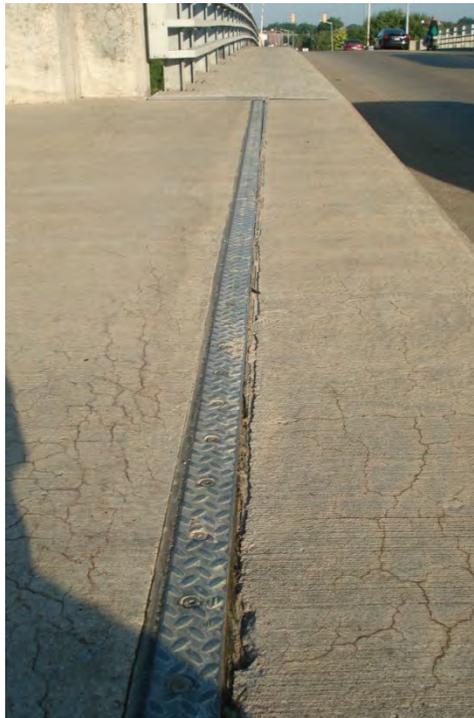
S-8. Joint at Longitudinal Break – Deterioration and Map Cracking at Joint (07-17-2013)

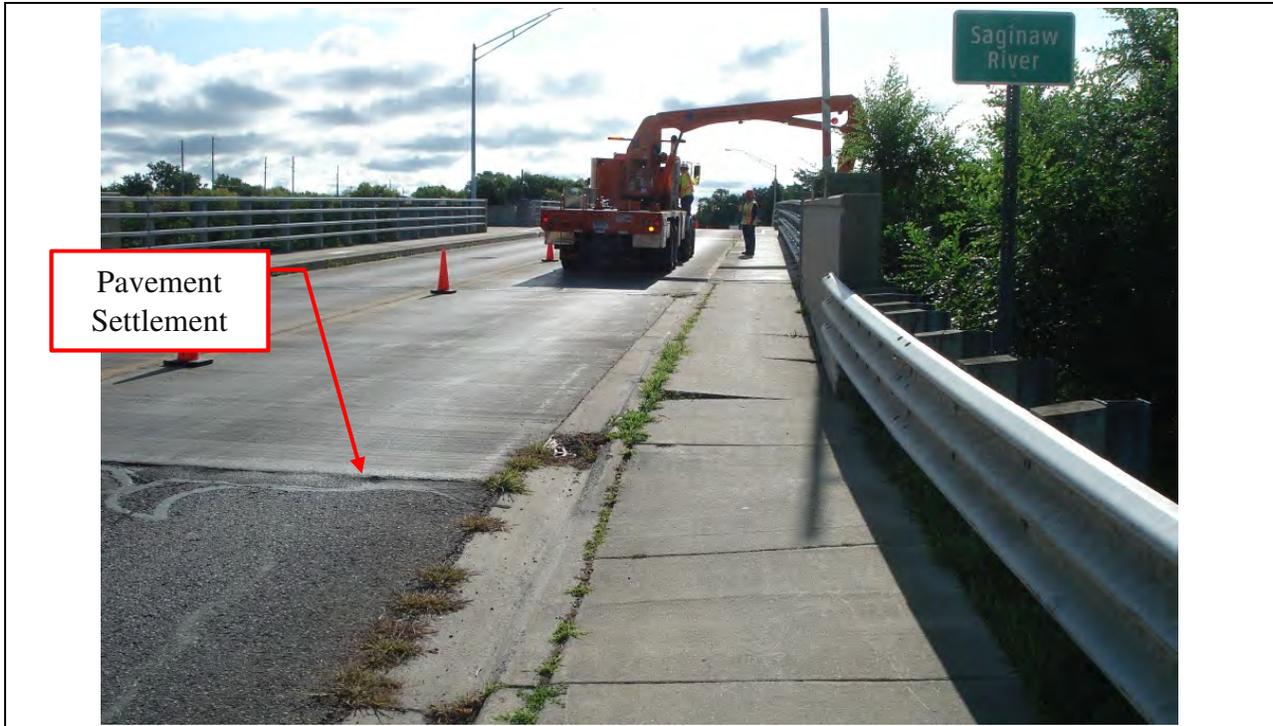
S-9. West Approach – South Sidewalk and Approach Pavement Settlement (08-13-2013)

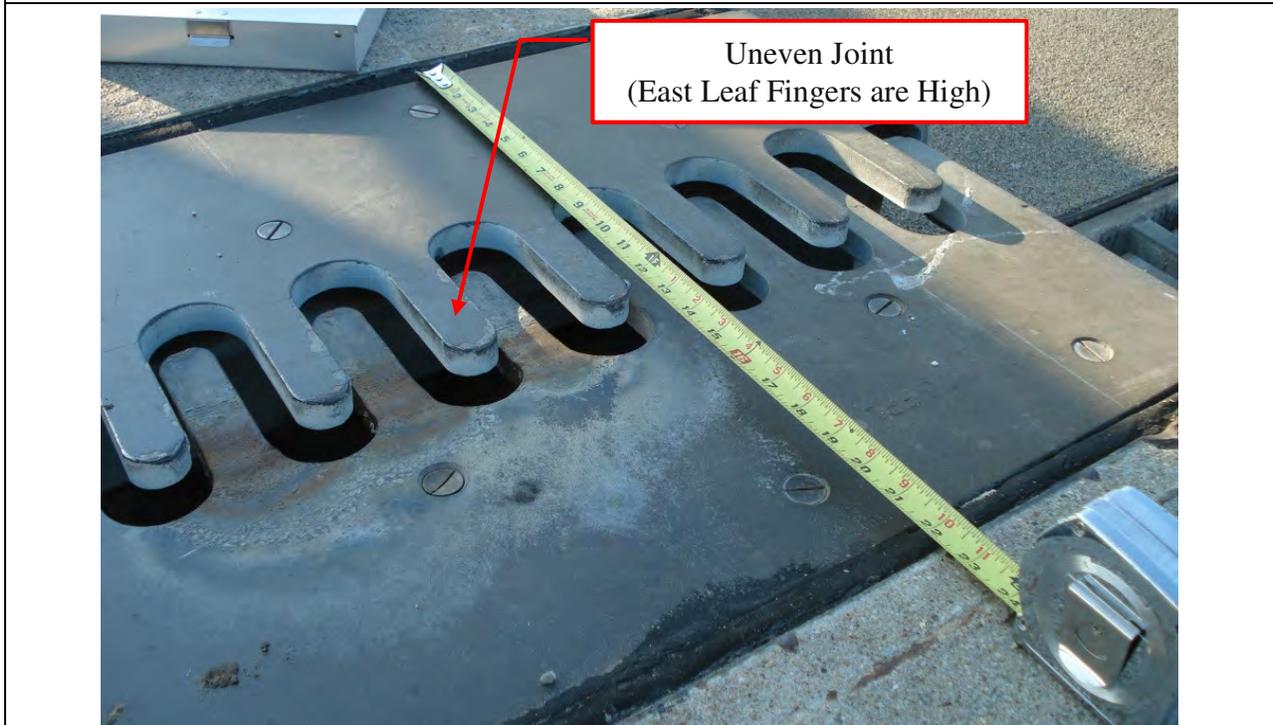
S-10. Center Break at North Sidewalk– Uneven Fingers at Joint (07-17-2013)

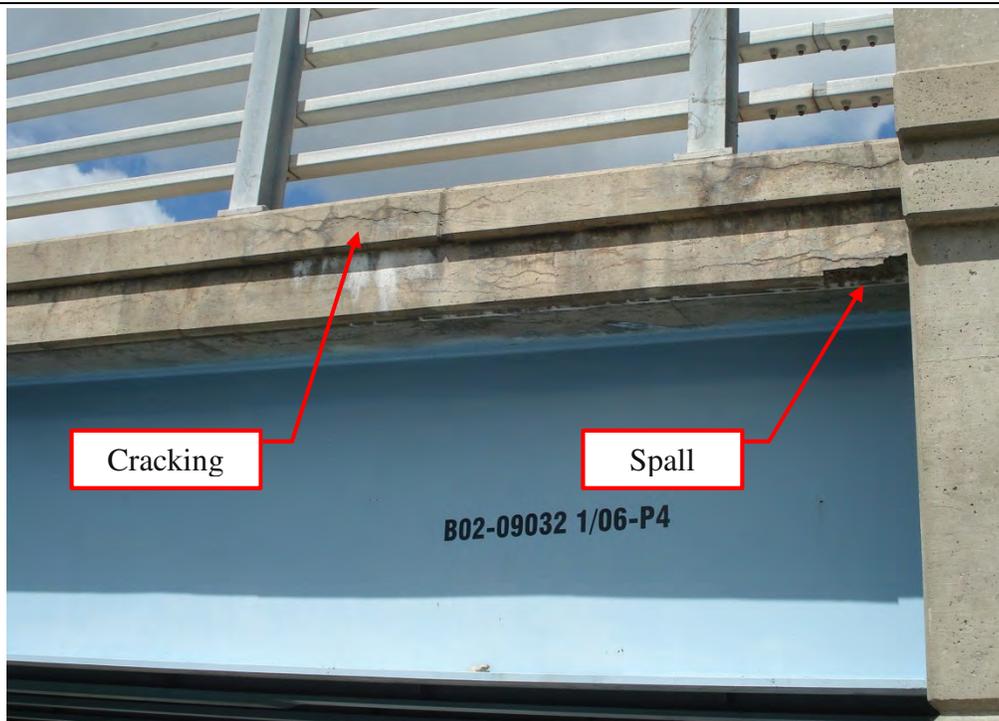
S-12. South Fascia at East Abutment – Cracks and Spalls on Coping (08-13-2013)

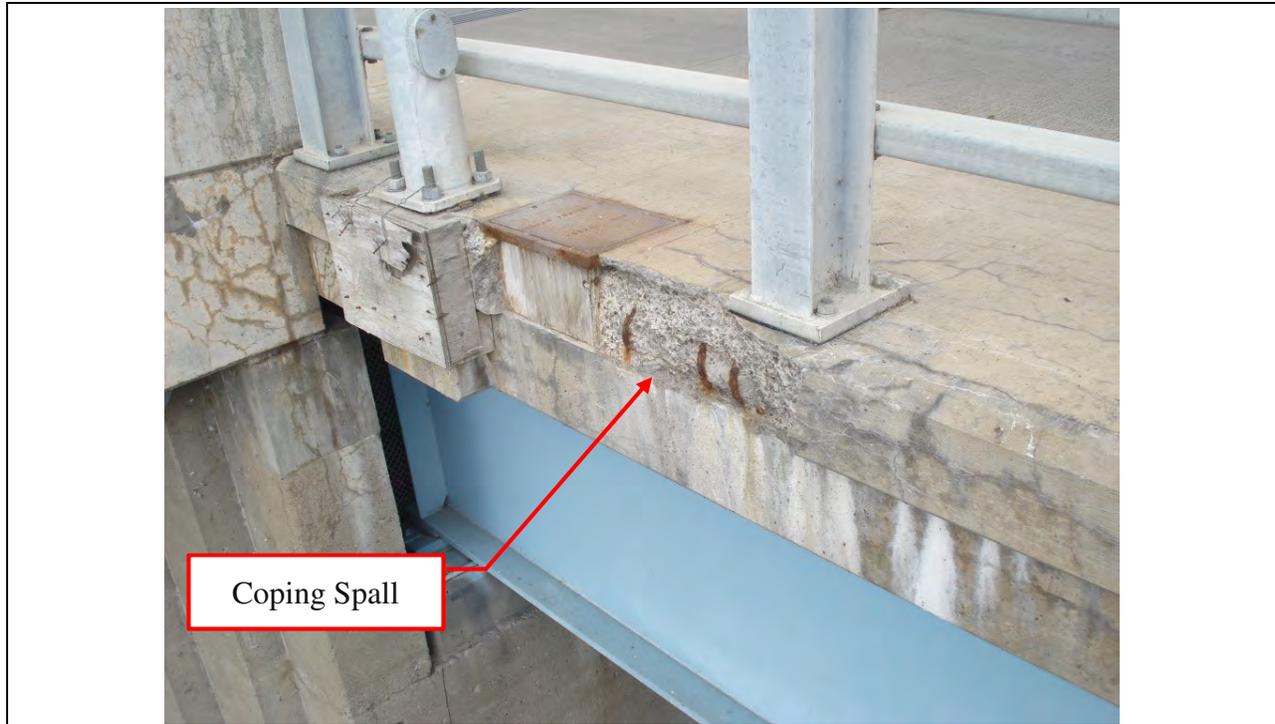
S-13. East Approach Span at South Coping – Spall with Exposed Rebar (08-13-2013)

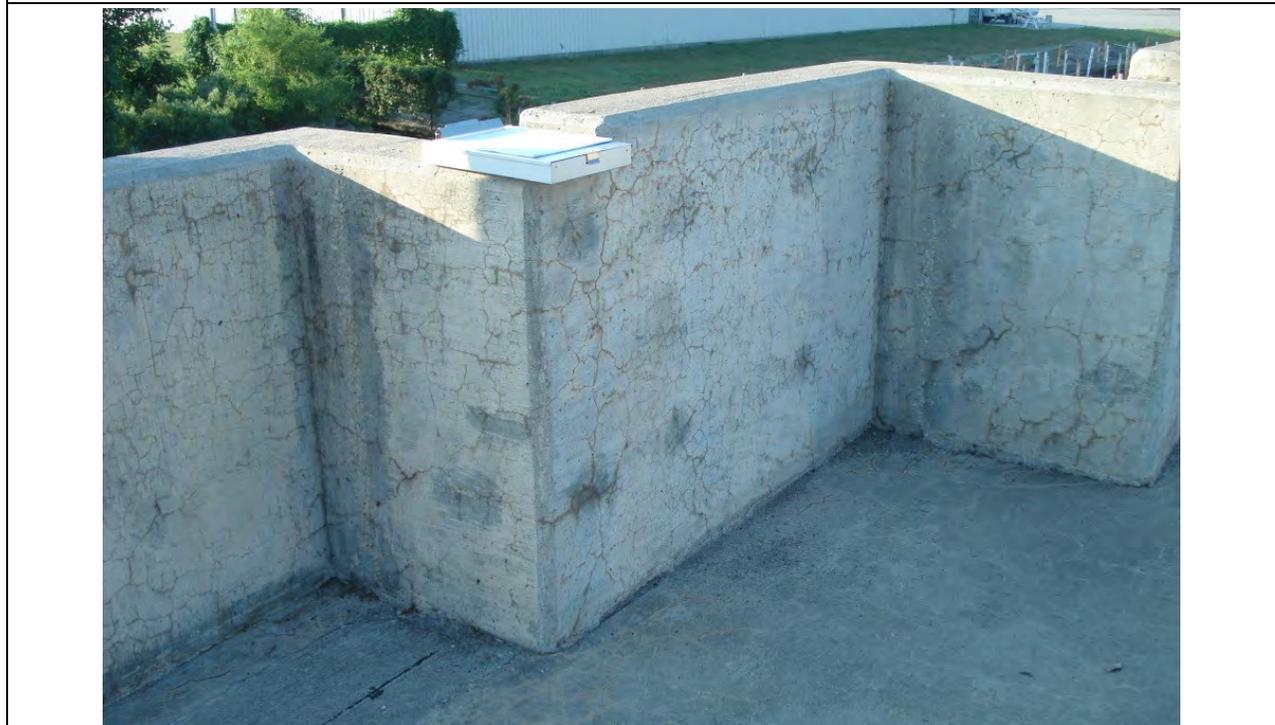
S-14. East Bascule Pier Looking South – Cracking in Parapet Walls of Lookout (07-17-2013)

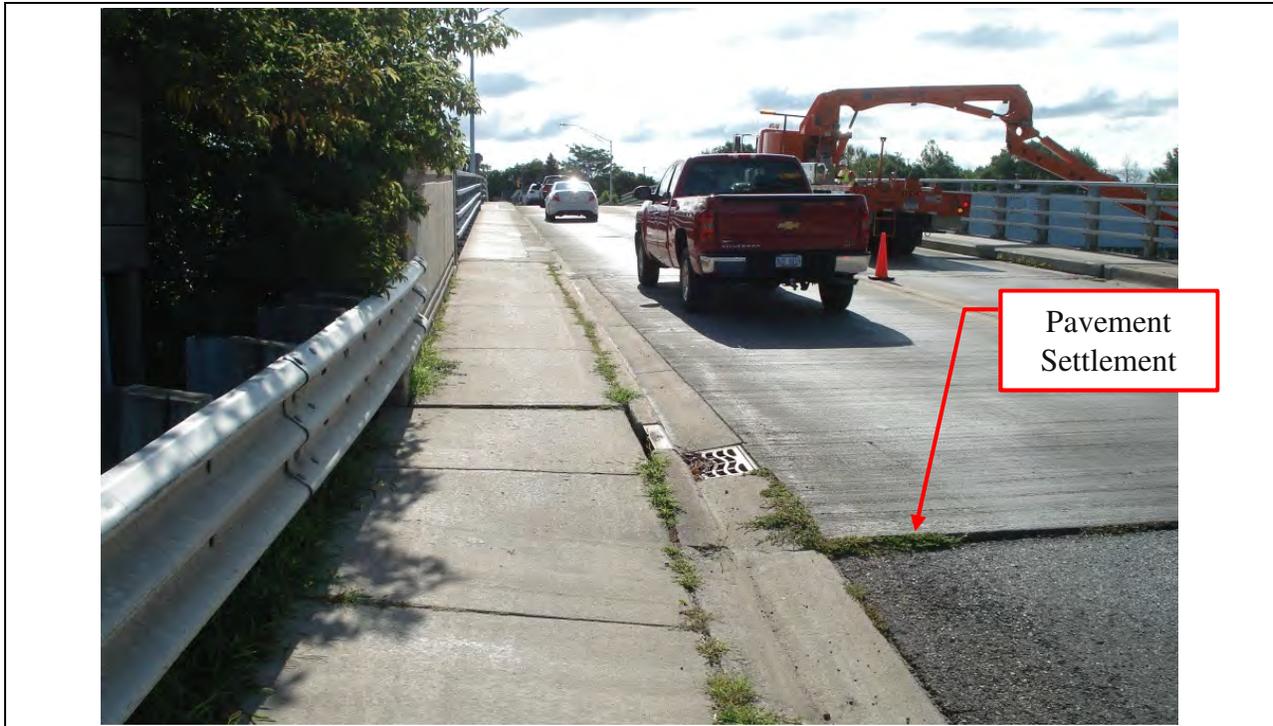
S-15. West Approach – North Sidewalk and Approach Pavement Settlement (08-13-2013)

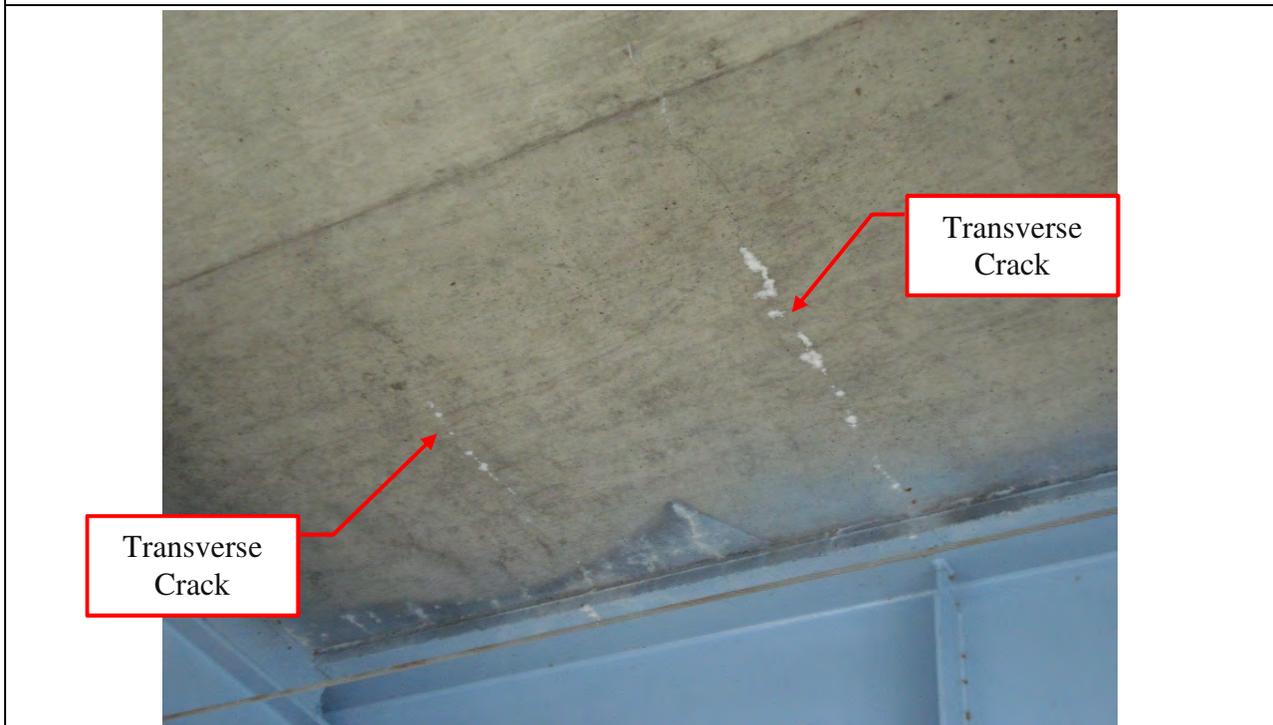
S-16. Underside of West Approach Span Deck – Transverse Cracks with Leaching, Typ. Condition (08-13-2013)

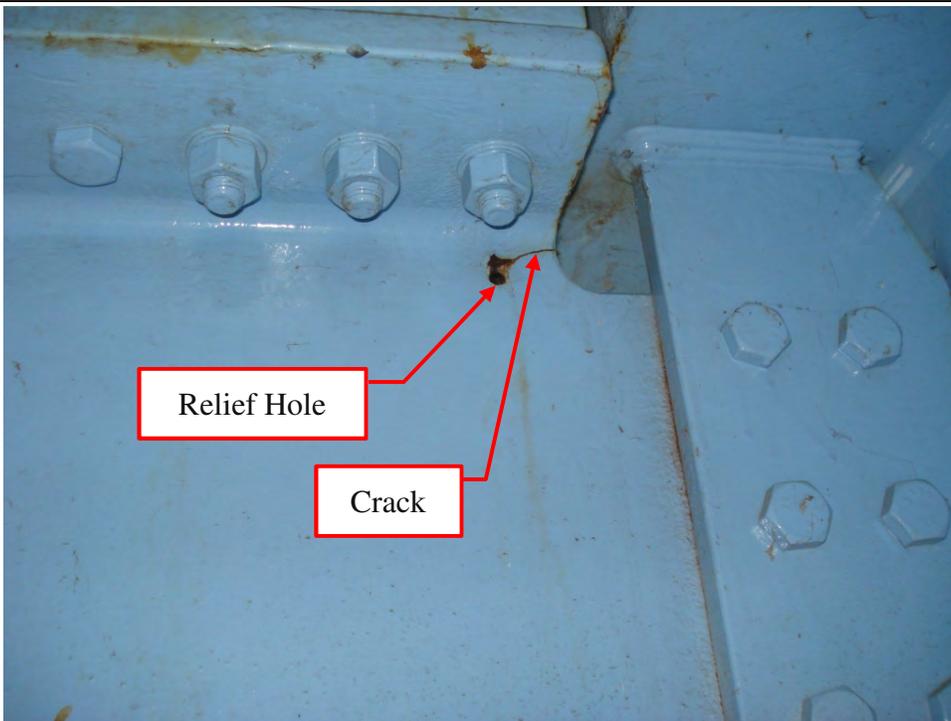
S-18. South End of FB5 on the West Leaf – Crack in Upper Portion of Web with 3/8" Drilled Relief Hole (08-13-2013)

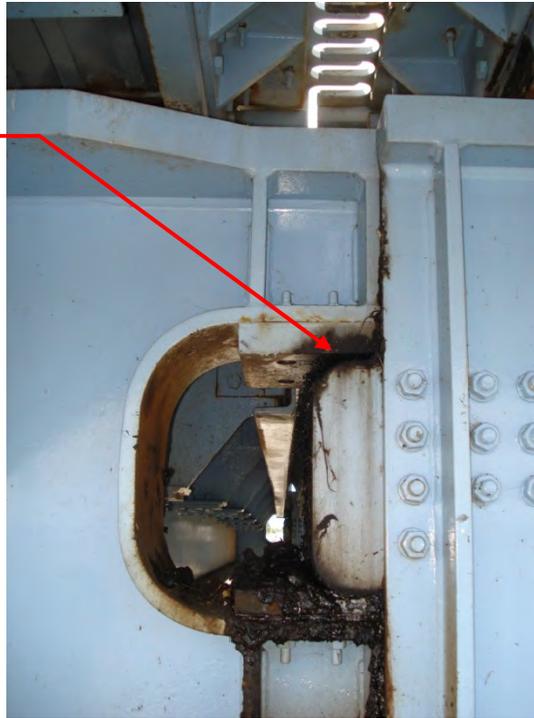
Excess Gap between
top of Jaw and
Diaphragm Casting

S-19. North Center Lock Looking South – Gap at Top Plate (08-13-2013)

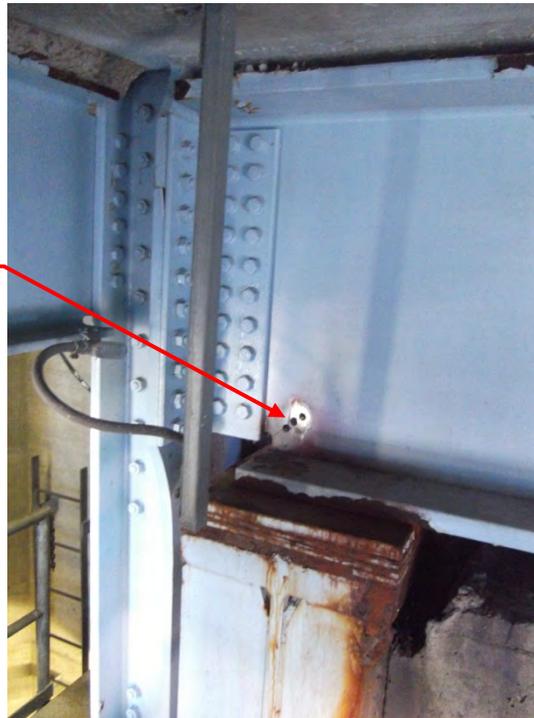
Web Cracks and
Drilled Relief
Holes

S-20. North Side of the West Uplift Girder – Cracks and Relief Holes in Web (07-17-2013)

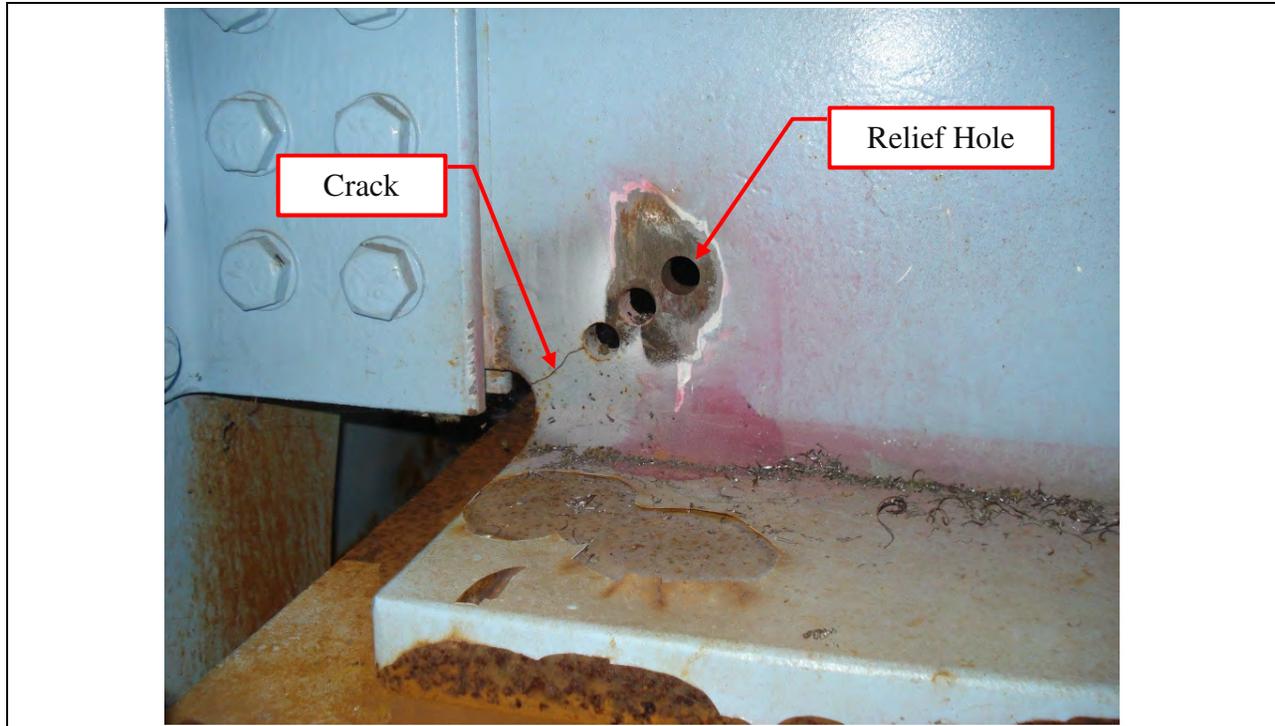
S-21. North Side of the West Uplift Girder – Cracks and Relief Holes in Web (08-13-2013)

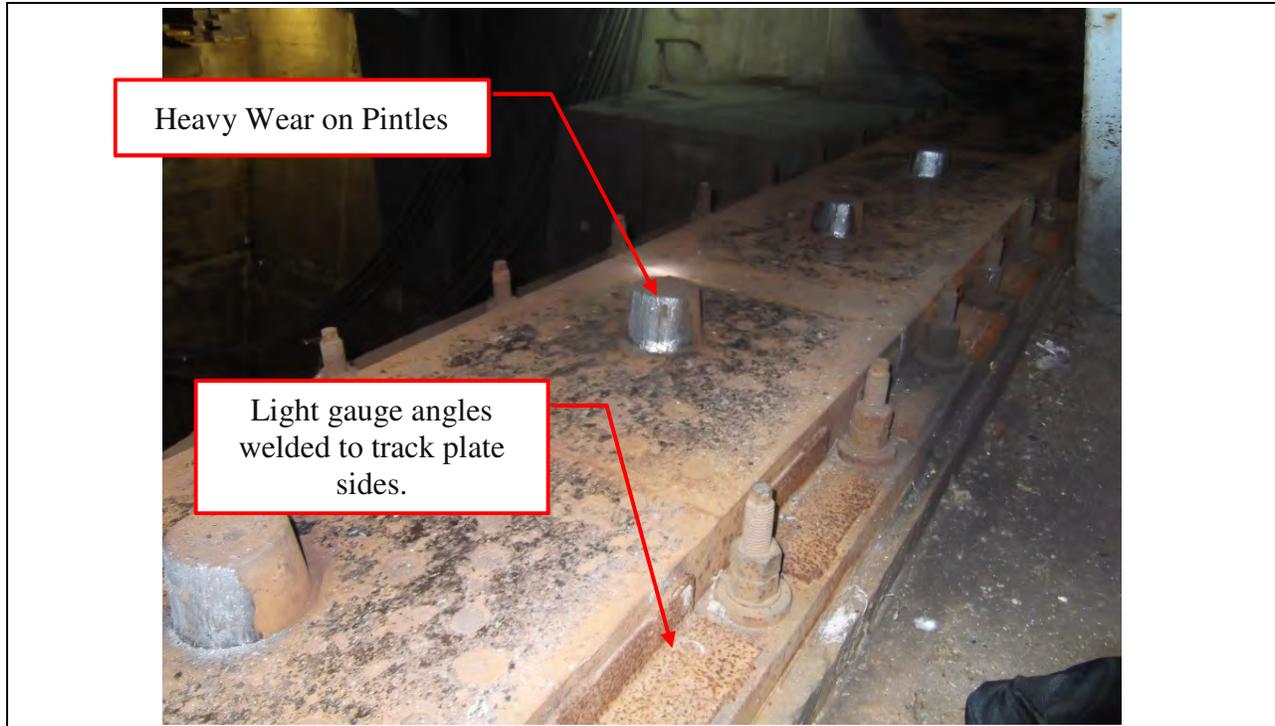
S-23. South Track of West Leaf – Overall Track Configuration with Wear on Back Side of Pintles (07-17-2013)

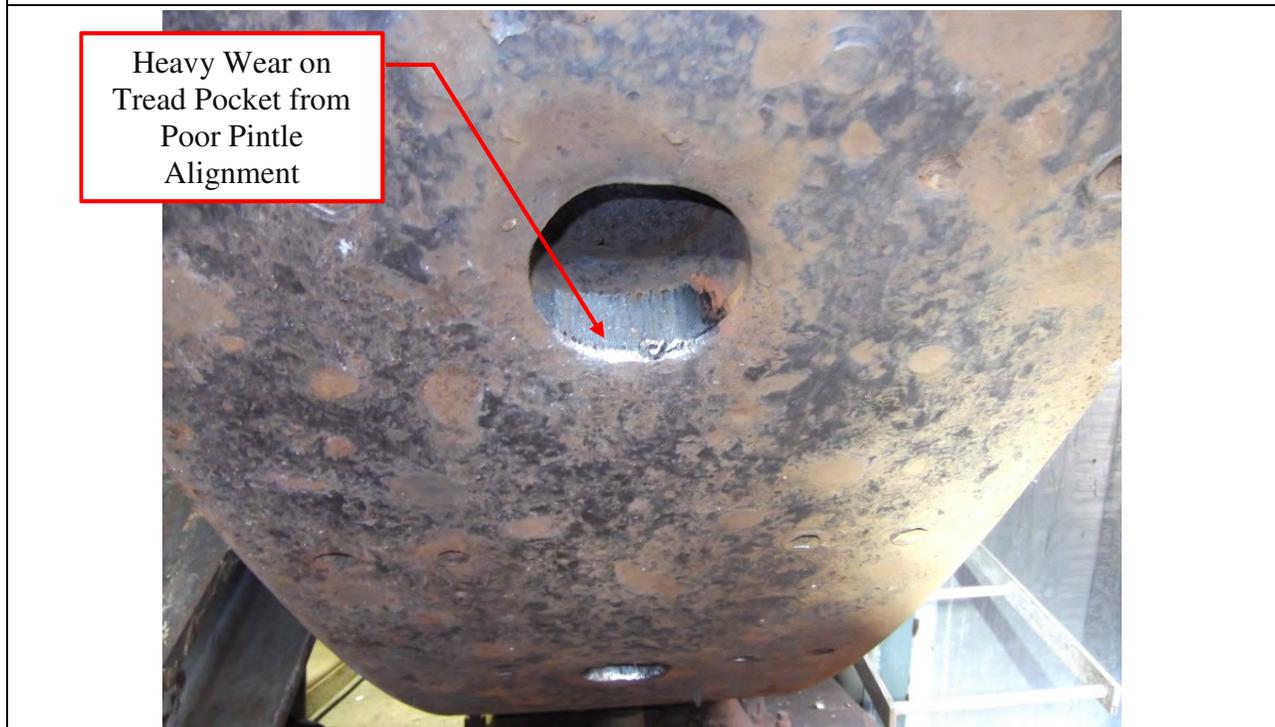
S-24. South Bascule Girder Tread on West Leaf – Evidence of Wear from Pintles (07-17-2013)

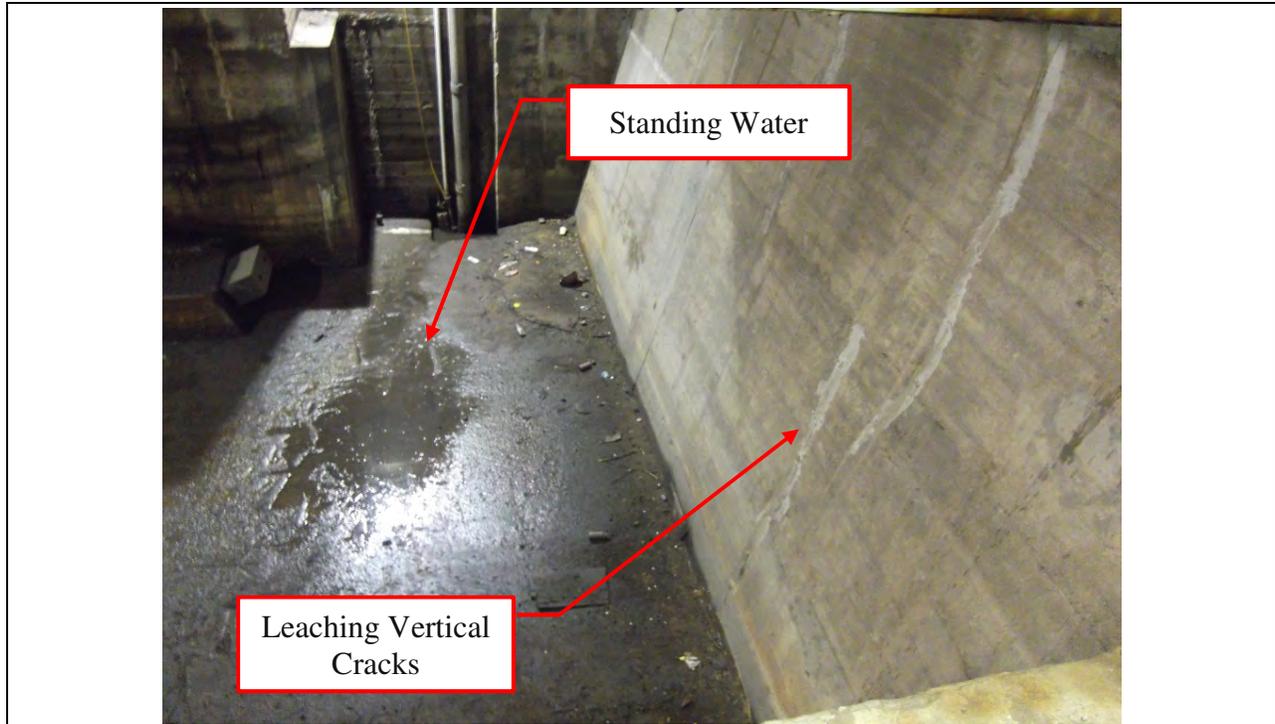
S-25. Counterweight Pit at West Bascule Pier – Standing Water/Mud on Floor and Cracks in Wall with Leaching (07-17-2013)

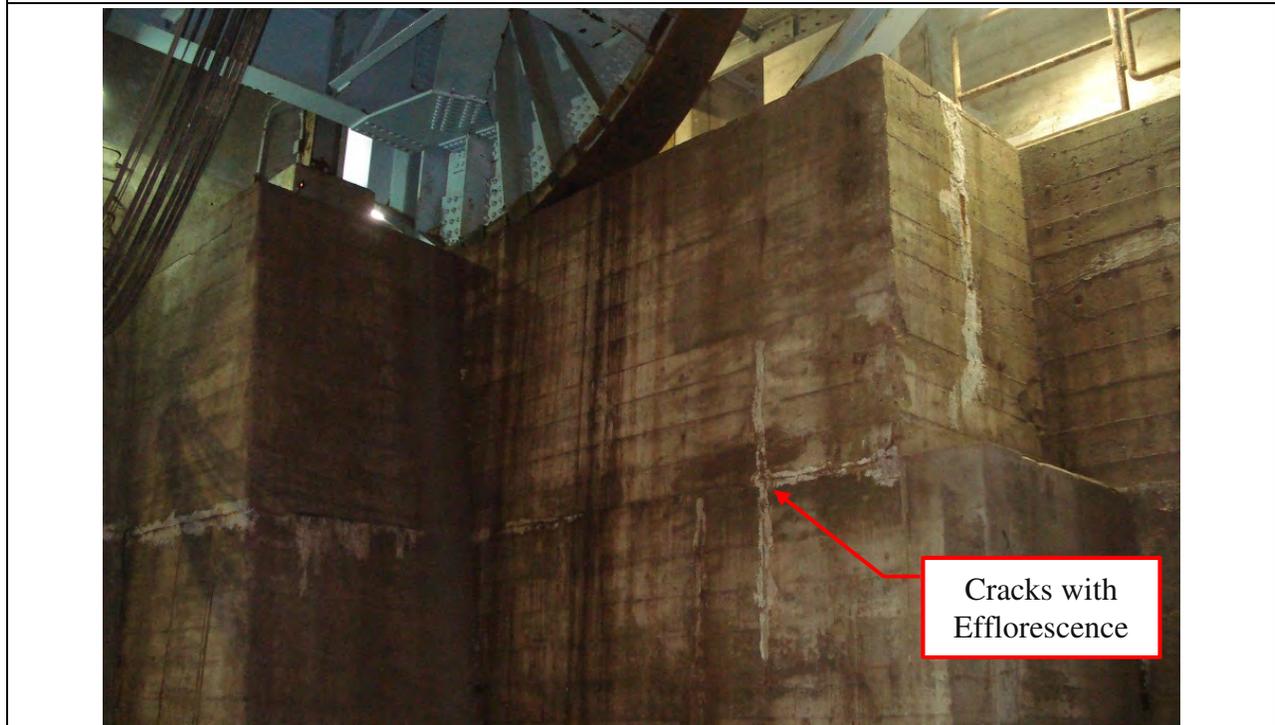
S-26. Counterweight Pit at West Bascule Pier – Walls Cracking with Leaching and Efflorescence (08-13-2013)
