MDOT RC-1617B

**Evaluation of Bridge Decks Using
Non-Destructive Evaluation (NDE)
at Near Highway Speeds
for Effective Asset Management
– Pilot Project**

FINAL REPORT

Michigan Department of Transportation

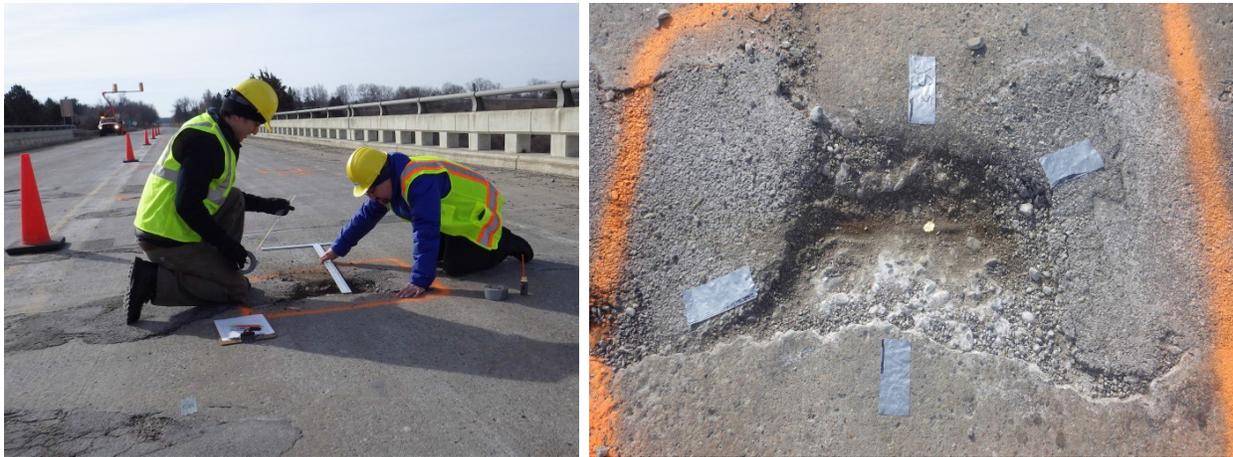
Figure 12: Manual measurements the length, width, and depth of spall and patch features on the bridge deck.

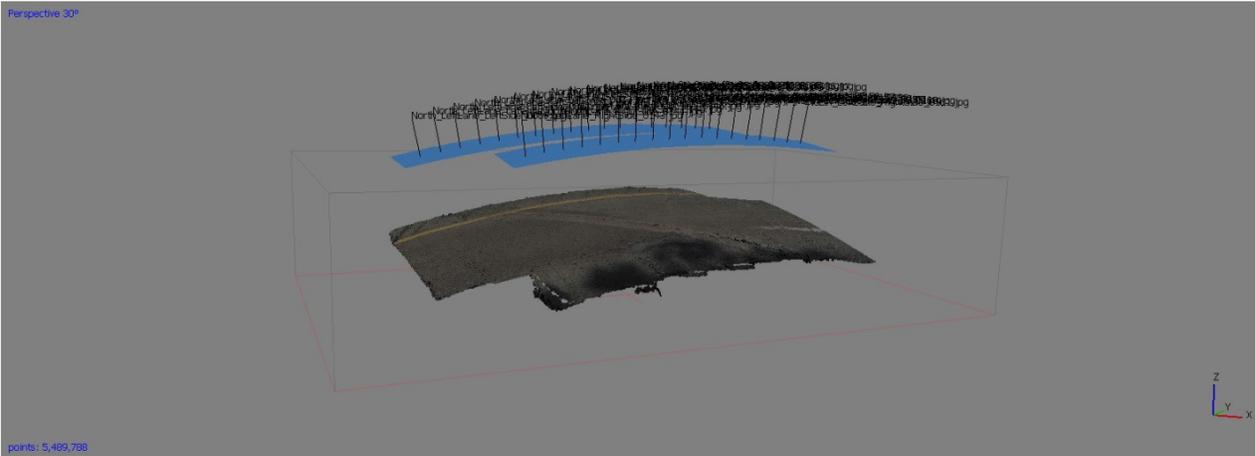
with few distresses. The resulting models would be severely distorted and not of sufficient quality to make reliable and accurate measurements (Figure 15). Because the RED Epic imagery was unable to be processed into an orthoimage and DEM, the imagery was mosaicked and georeferenced to the high-resolution base maps layer within ArcGIS. While this process is more time consuming, it provided a high-resolution base layer for manually georeferencing the thermal imagery and spalls.

Figure 15: Example of I-75 point cloud demonstrating the reconstruction challenges encountered.
