**CORROSION PERFORMANCE OF
ALUMINUM CULVERTS**

Final Report

**Research Laboratory Section
Testing and Research Division
Research Project 60 NM-26
Research Report No. R-976**

**Michigan State Highway Commission
Peter B. Fletcher, Chairman; Charles H. Hewitt,
Vice-Chairman, Carl V. Pellonpaa, Hannes Meyers, Jr.
John P. Woodford, Director
Lansing, November 1975**

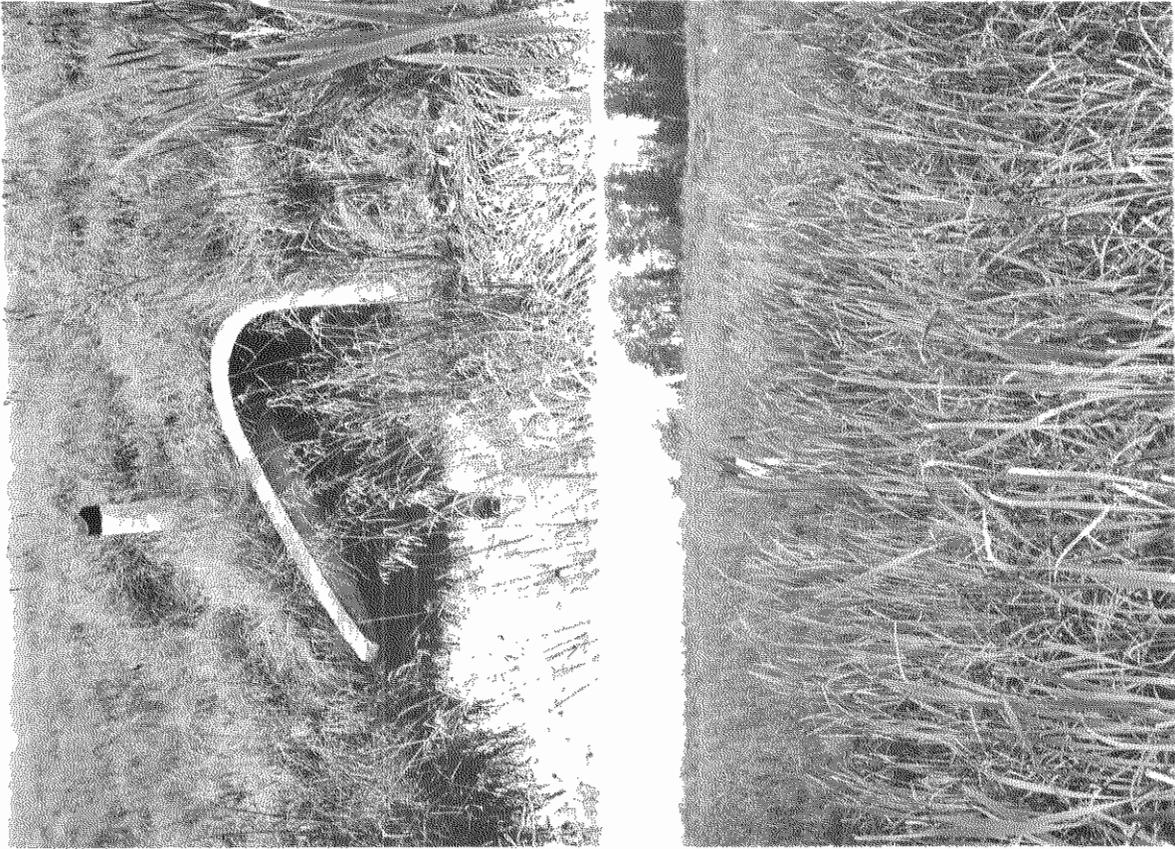
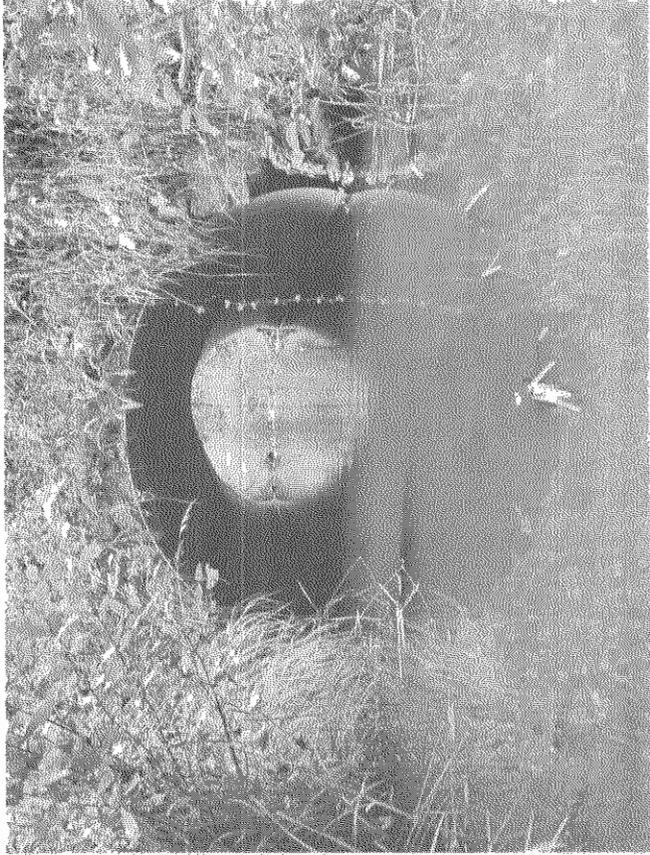
Figure 1. Typical culvert site conditions during Inspection No. 3.

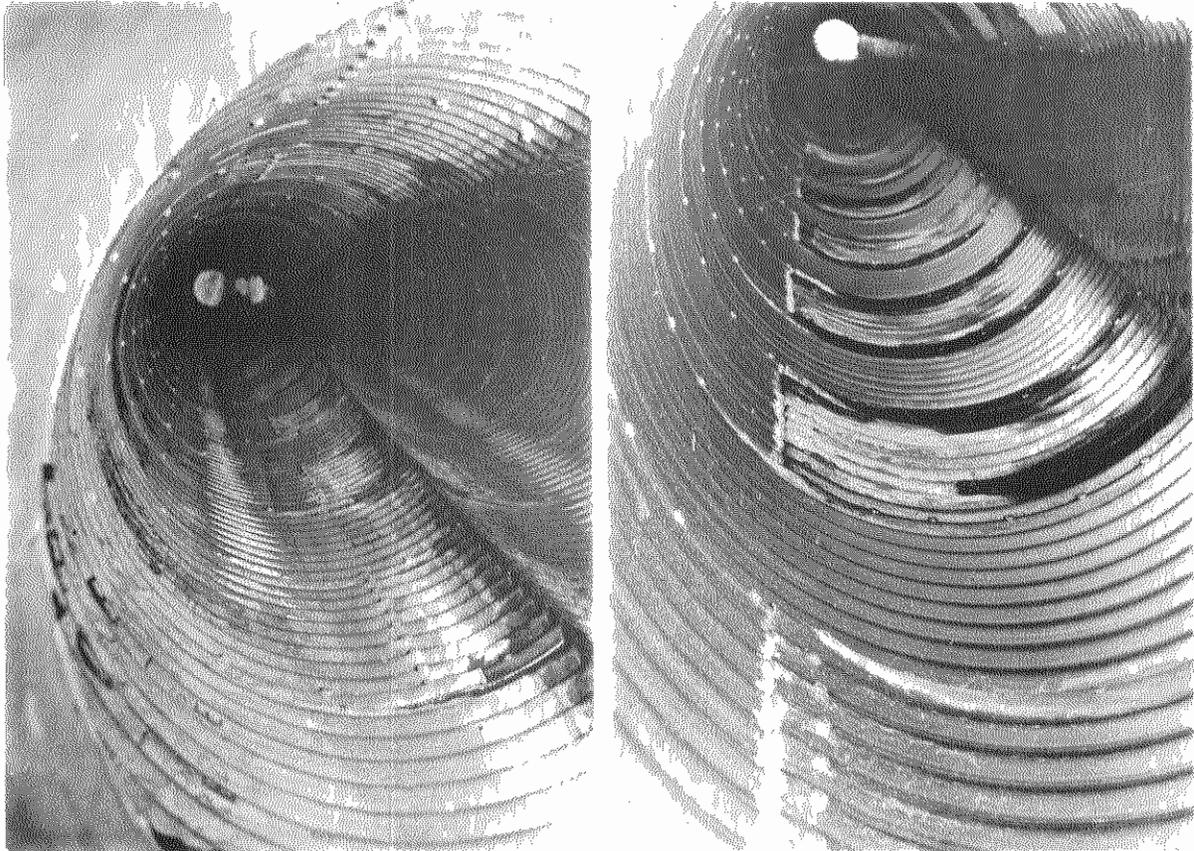
Invert: The 5-in. arc of white corrosion spots up to about 1/4 in. diameter noted before near the north end was still visible at about the same degree of severity (8 to 10 per sq in.). A similar type arc of smaller (up to about 1/8 in. in diameter) but more dense (12 to 15 per sq in.) white corrosion spots was observed near the south end (Fig. 2). Many other random white spots up to about 1/4 in. in diameter were noted throughout the entire invert. Soil staining of the bottom, and white and red corrosion on rivet heads and at horizontal plate joints were slightly more prevalent than before.

Figure 2. Galvanized steel culvert, Sta. 622+00. Middle left portion shows an arc of white corrosion.

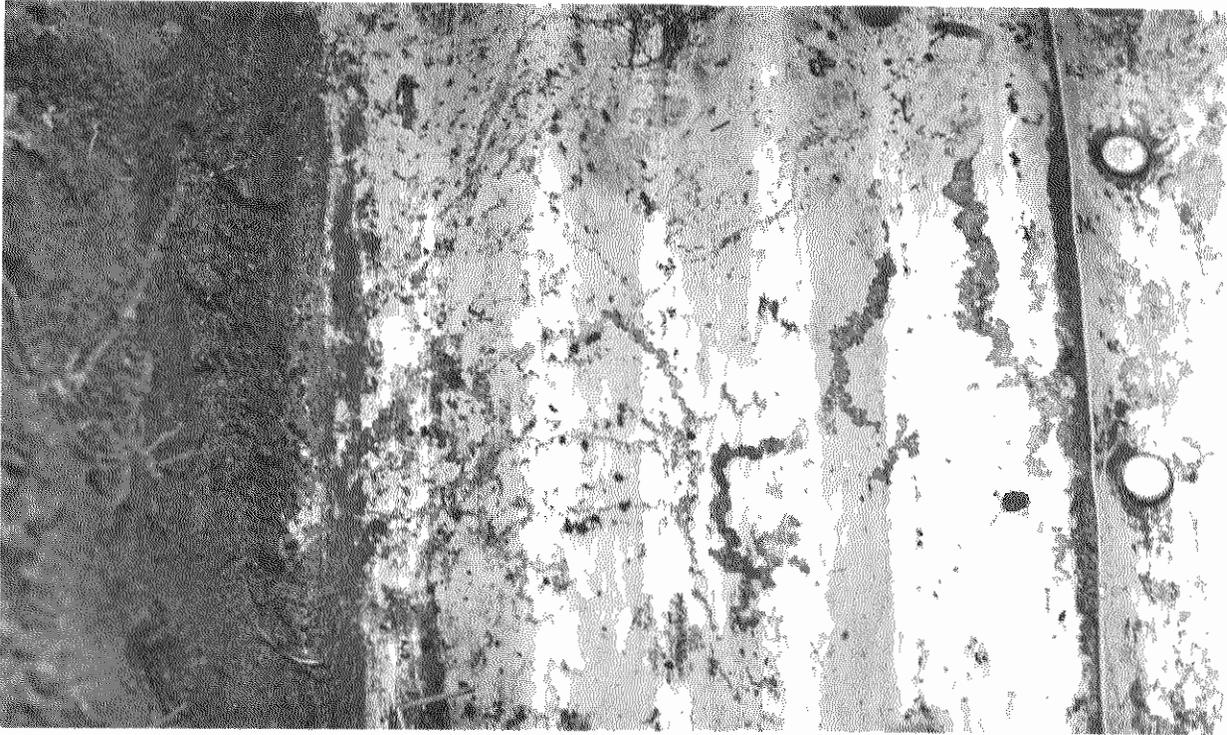
Figure 5. Aluminum culvert, Wood Spur (exvert). Elongated dark areas in the center and to the left of the joint are areas of corrosion attack where the cladding has been removed, exposing the core alloy.

Exvert: Several relatively large pitted areas up to 1 by 2 in. were present on the excavated exvert. Some of the pits were long and narrow (about 1/2 by 2 in.). The cladding was perforated and removed in most of the pitted areas (Fig. 5). No significant further penetration beyond the cladding into the core alloy was observed.

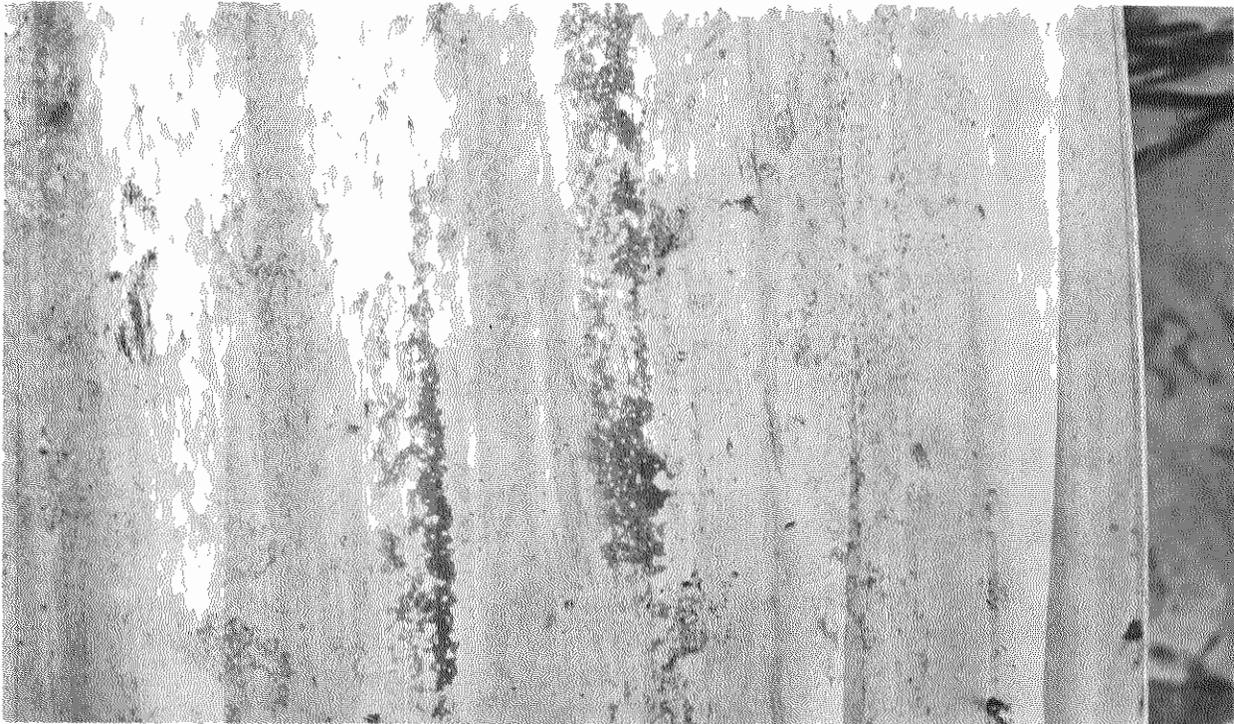
Figure 6. Aluminum culvert, Bruce Crossing (exvert). The dark areas in the center represent areas of corrosion attack where the cladding has been perforated, exposing the core alloy.

Exvert: Quite severe attack of the cladding was observed in several areas up to 1 by 2 in. in size. The cladding had been removed in these areas, but no deeper penetration beyond the cladding was noted (Fig. 6).

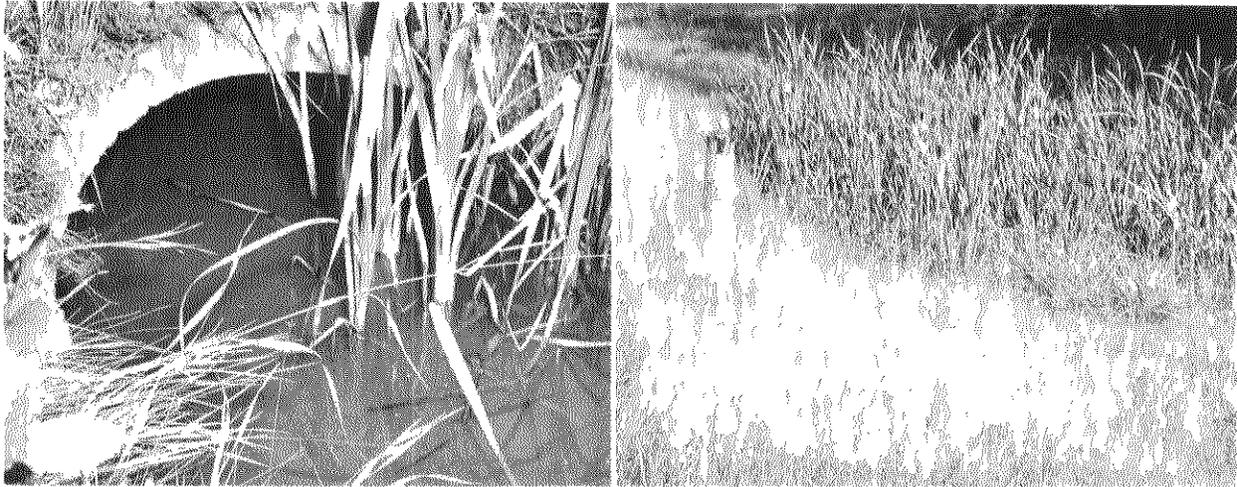
Figure 7. Typical site conditions during the final inspection.

The same environmental conditions prevailed at most culvert sites as during previous inspections (i.e., poor drainage, high water levels, and dense overgrowth of vegetation, as shown in Figure 7). Again, the visual examination of the invert was generally limited to the area above the existing water level and the exvert to about 1 sq ft of excavated area. The following notes describe the observed corrosion condition of the test culverts.

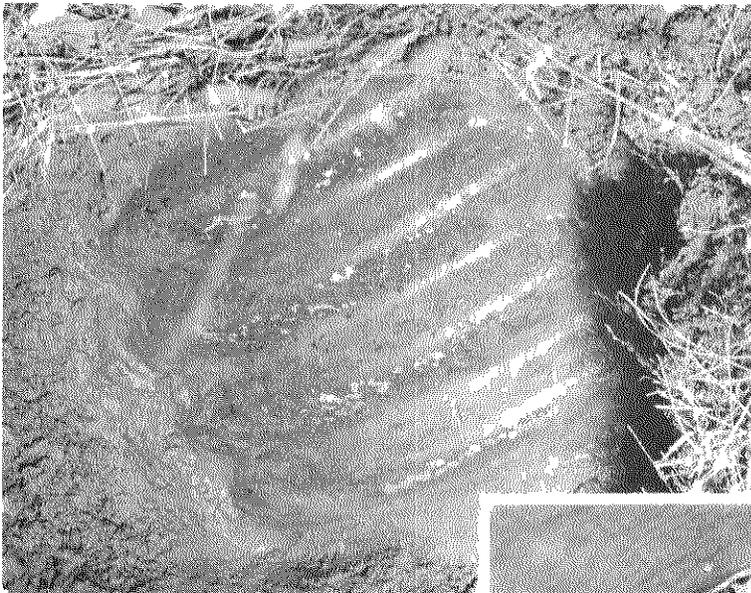
Figure 8. Galvanized steel culvert, Sta. 549+50 (exvert). Light spots are pitted areas where the galvanizing has been penetrated.

Exvert: The galvanizing is slightly more soil stained and darker than on the previous inspection. Several pits under soil nodules have penetrated the galvanizing (Fig. 8).

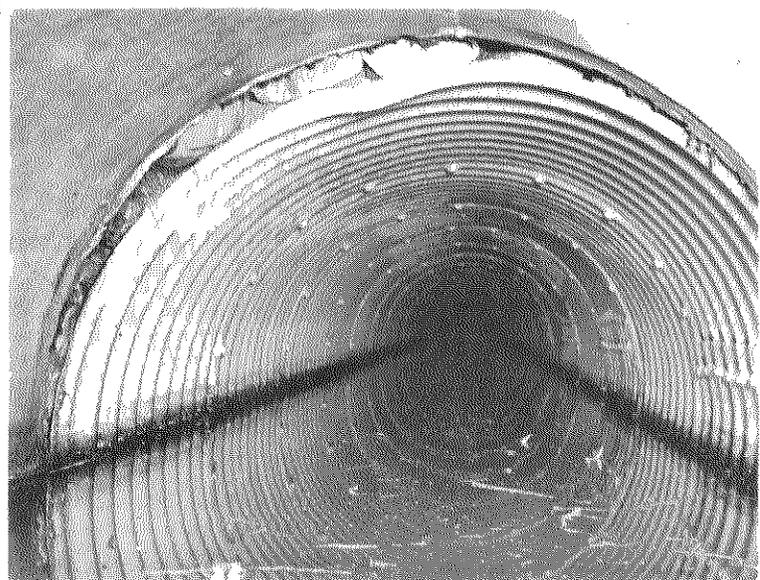
Figure 9. Aluminum culvert, Sta. 330+00. Upper portion shows separation of headwall from culvert and large stones in the backfill.

Invert: No significant change except that both the north and south headwalls have separated from the culvert about 2 in., exposing 2 to 4-in. diameter stones in the backfill (Fig. 9).

2) Since the most severe corrosion attack occurred on the exvert (soil side) of the test culverts, and non-uniform backfill was evident, it is recommended that the Design Standard for Bedding and Filling Around Pipe Culverts IV-82B, which states: "Minimum limits for granular materials Class III are shown in details 1, 2, and 3, except that for corrugated steel pipe, a minimum of six inches of granular material Class III, or better, shall be placed completely around the pipe for the full length of bedding and fill along the pipe." be revised so that it also applies to aluminum alloy pipe. This will prevent corrosion cells from forming due to different environments at various points on the soil side of the culvert pipe.

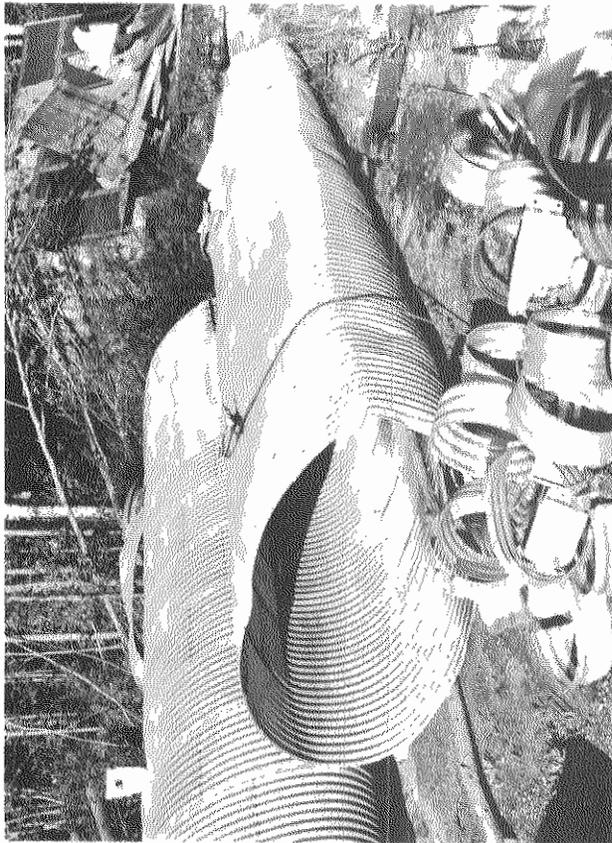
Aluminum - The culvert was in two sections; one section was partially collapsed and badly damaged during the washout (Fig. 10). The other section was intact and in generally good condition. The bottom of the invert

Figure 10. Aluminum culvert formerly at Ewen, now at Ontonagon County garage at Bruce Crossing.

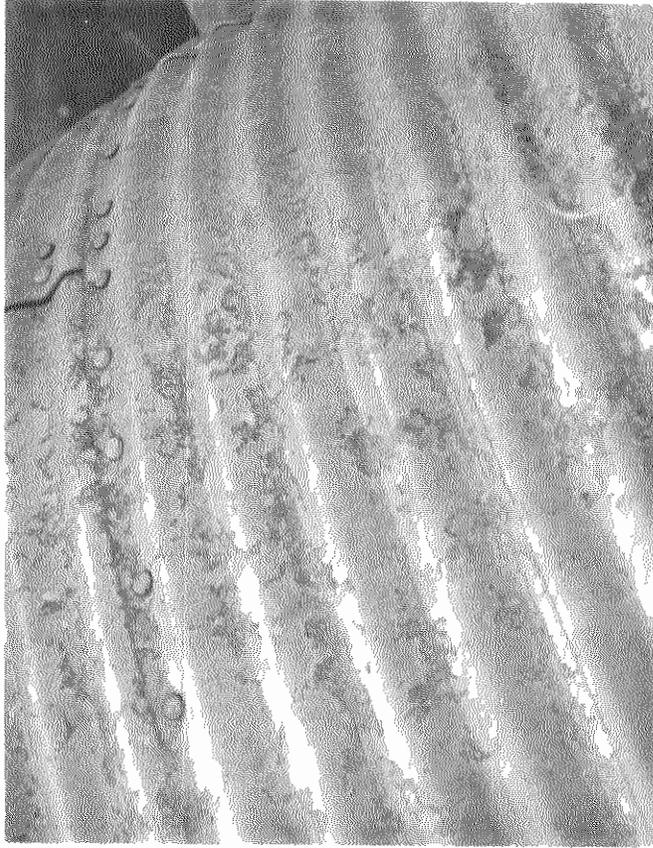
Figure 11. Close-up of aluminum culvert in Figure 10, showing the corrosion attack on the exvert (dark areas).

had many small pits up to about 1/2 in. in diameter which had perforated the cladding, but did not appear to have proceeded further. About 1/3 to 1/2 of the exvert was covered with pitted areas where the cladding had been removed (Fig. 11). In no instance did it appear that the corrosion had gone significantly beyond the cladding. The culvert, in general, was solid and in good condition with respect to corrosion attack.

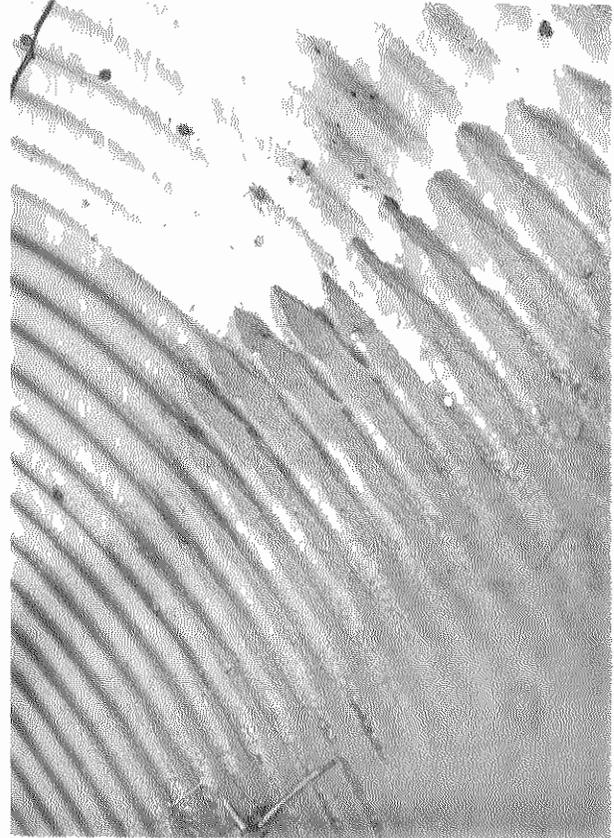
Figure 12. Close-up of galvanized steel replacement culvert at Ewen. Cleaned area at middle right shows part of the 5-ft arc of red rust on the invert bottom.

Galvanized Steel - An approximate 5-ft arc in the bottom of the invert was quite badly attacked and showed much red rust (Fig. 12). Abrasion had contributed to the attack as indicated by more severe rusting on the upstream side of the corrugations and the presence of many rocks inside. The culvert was solid with no observed deep penetration into the steel base metal. The culvert has been in service for about three years.
