Field Performance of Polymer Bridge Deck Overlays in Michigan

Final Report

January 2003

**Michigan Department of Transportation
Construction and Technology Division**

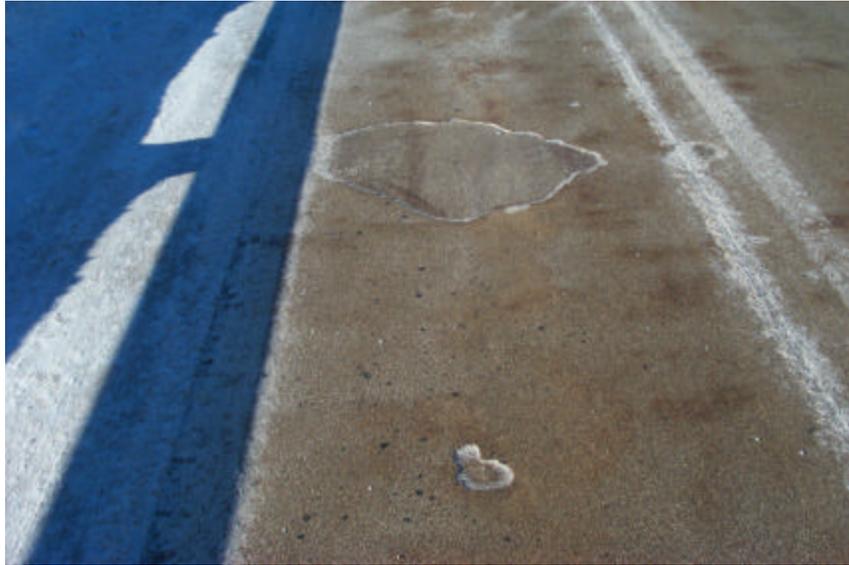
Figure 1. B01-66041 - Representative Delamination.

The B01-66041 Bridge is located on M-38 over the West Branch Firesteel River 2.7 miles east of M-26 in Ontonagon County (Bridge sign reads "Firesteel River"). This bridge was inspected on all three days. Damage was noticed in the coating in the east bound lane as shown in Figure 1. This deterioration caused by delamination at the interface.

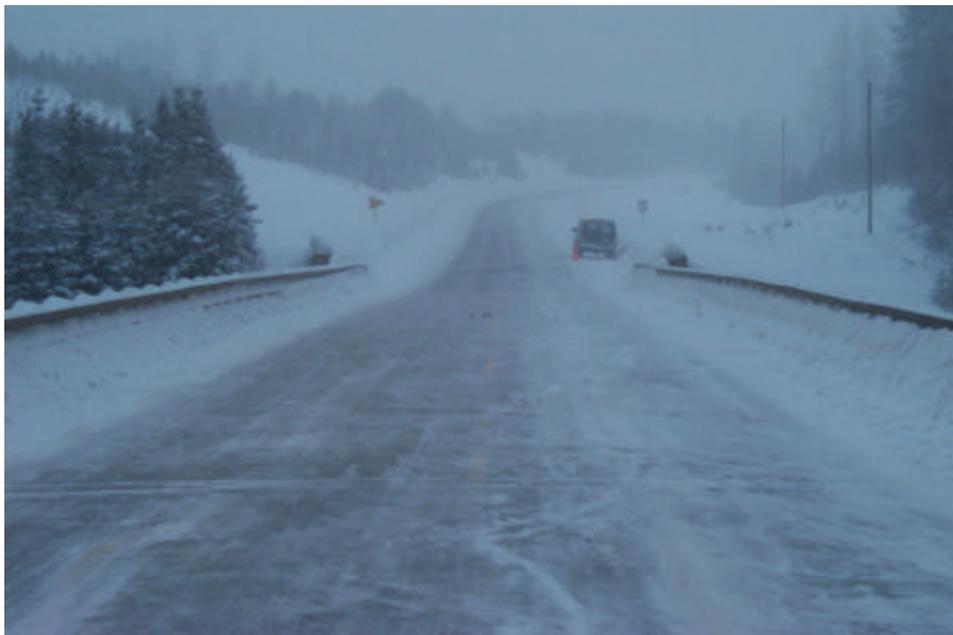
Figure 2. B01-66041 - Winter Condition.

The conditions were: -13°C (8.6°F), snow and light wind, 10:00 am. Most of the surface of the bridge and road was covered with light packed snow. See Figure 2. There was no noticeable difference between the adhesion of the snow between and road and the bridge.

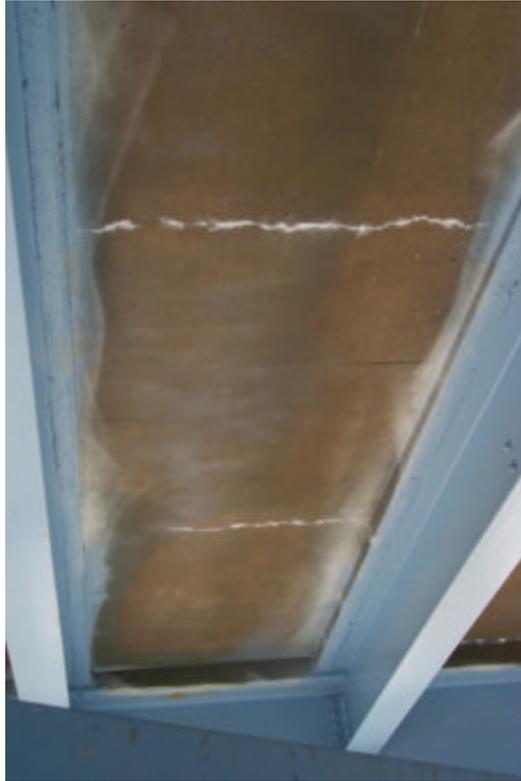
Figure 3. Underside of B01-66041.

Figure 3 shows a section of the underside of B01-66041.

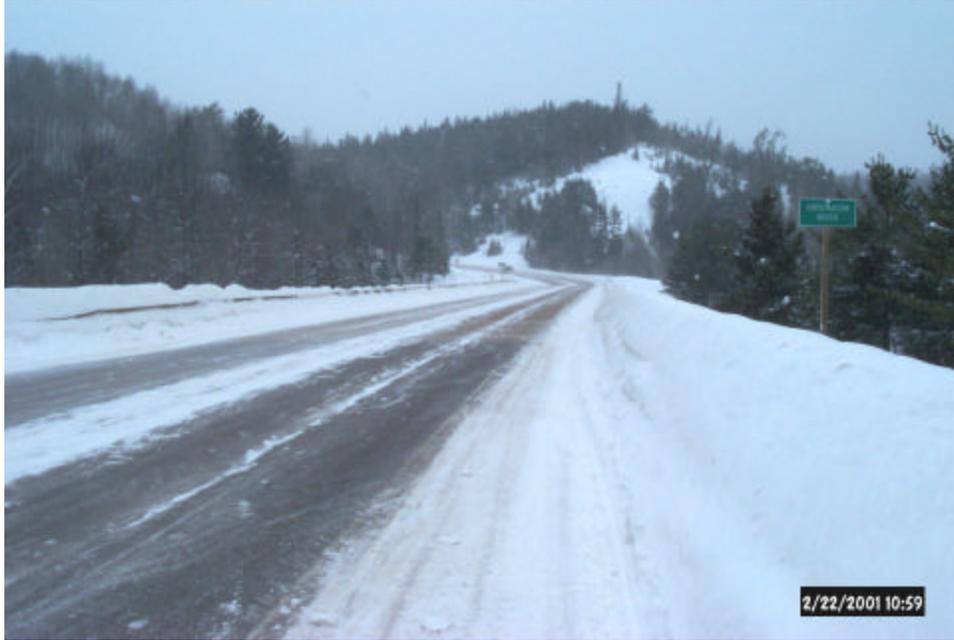
Figure 4. B02-66032 - Winter Conditions.

The conditions were: -11°C (12.2°F), light flurries and windy, 10:40 am. Most of the surface of the bridge and road was sparsely covered with light packed snow. See Figure 4. There was no noticeable difference in the surface condition between the adjacent road and the bridge.

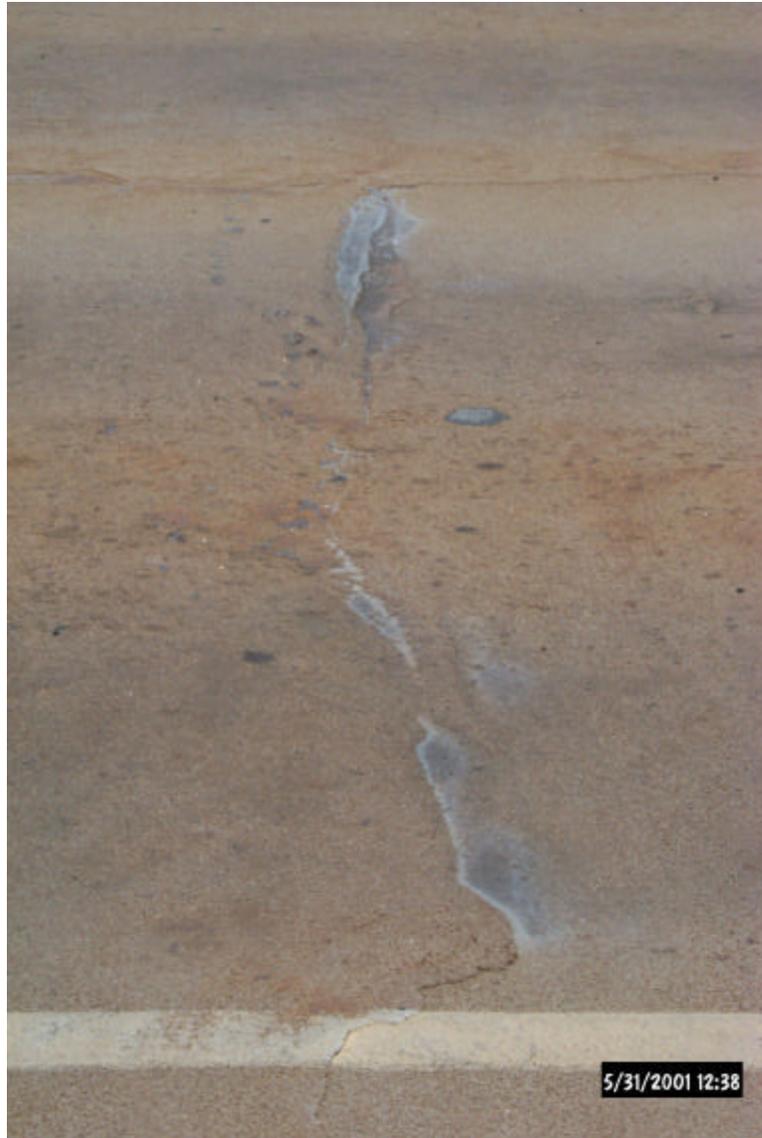
Figure 5. B03-66022.

The B03-66022 Bridge is located on M-28 in Ewen over the South Branch Ontonagon River 4.7 miles west of US-45 in Ontonagon County. Slight damage was noticed in the coating. Near the center of the west end, small chunks, approximately 5" wide and 48" long were missing from the overlay. The westbound lane exhibited some transverse cracks with some delamination. See Figure 5.

The conditions were: -12°C (10.4°F), sunny and windy, 11:32 am. Most of the surface of the bridge and road was covered with light packed snow. There was no noticeable difference in the surface condition between the adjacent road and the bridge, however, a little less snow appeared on the centerline of the bridge than the adjoining road surfaces.

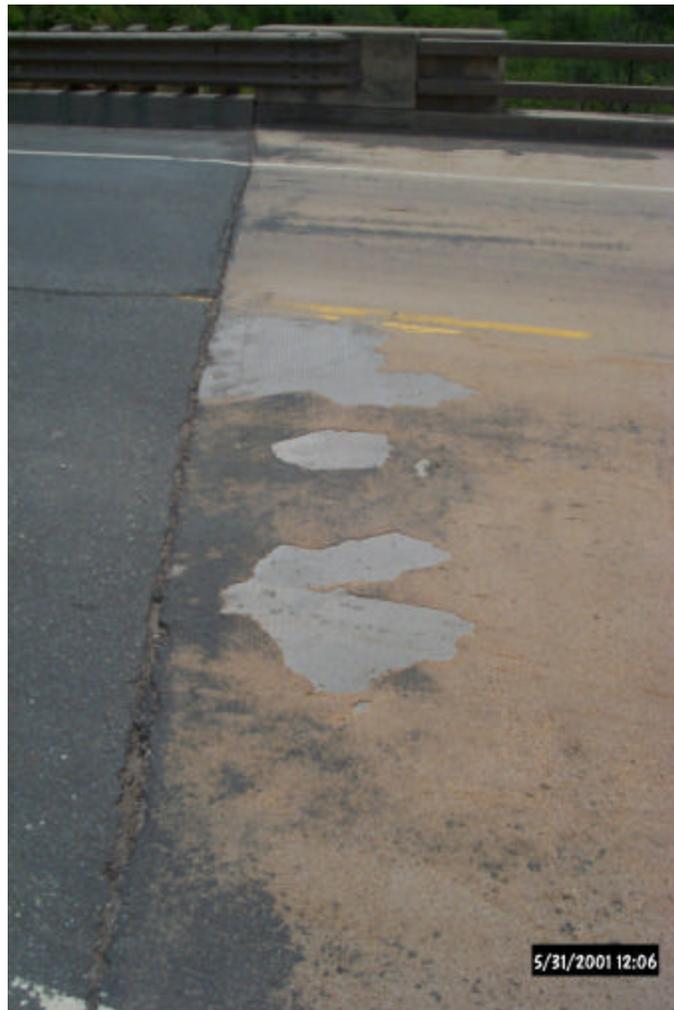
Figure 6. B02-31021

The B02-31021 Bridge is located on M-28 in Kenton over the East Branch Ontonagon River in Houghton County. This bridge was inspected on all three days. Some damage was noticed in the coating. Delamination on both inlet sides of the east and westbound lanes was recorded. See Figure 6.

The B02-31021 Bridge is located on M-28 in Kenton over the East Branch Ontonagon River in Houghton County. Damage was noticed in the coating. Delamination on both inlet sides of the east and westbound lanes was recorded. Looks like this bridge only had a single coating of the overlay. Generally this bridge was in poor shape. See Figure 6.

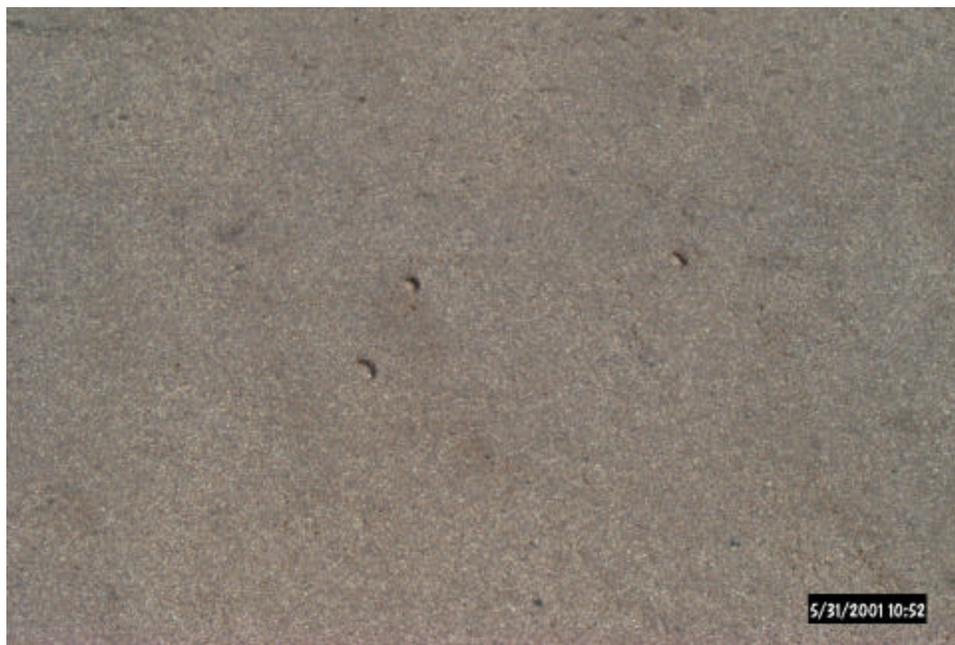
The B01-36022 Bridge is located on US 2 in Iron River over the Iron River in Iron County. This bridge was inspected on all three days. Damage was noticed in the coating in one area only. There were a few small spots on the surface that appeared to be poor mixing at the time of installation. See Figure 7.

Figure 7. Surface "Pock Marks" on B01-36022.

The B01-36022 Bridge is located on US 2 in Iron River over the Iron River in Iron County. Damage was noticed in the coating in one area only. Delamination on the eastbound lane was recorded. The delaminations on this bridge were generally about the size of a quarter. Some pitting was also noticed. See Figure 7.

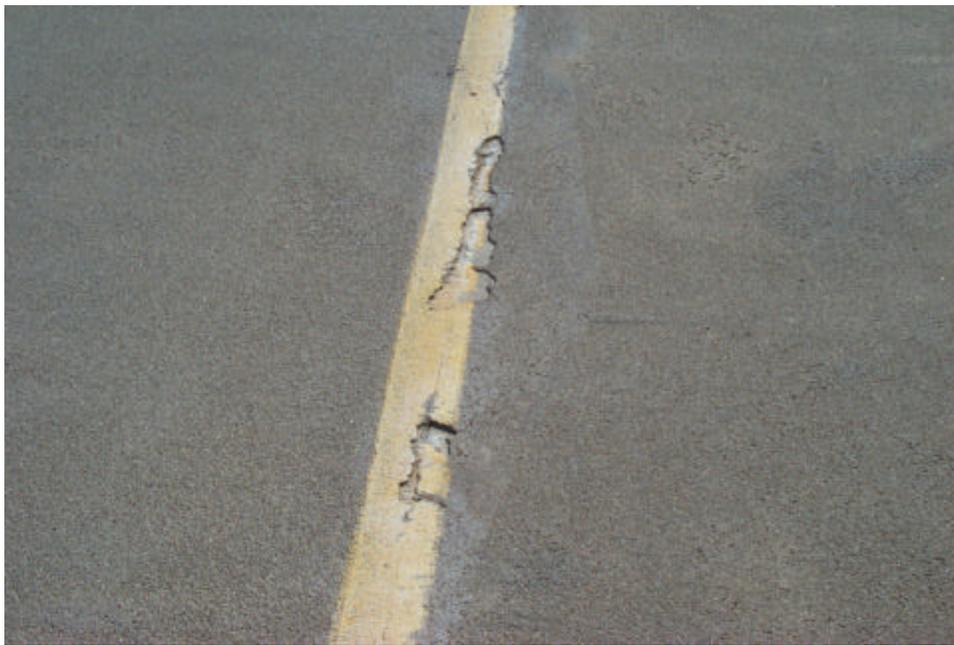
The B04-36052 Bridge is located on US 141 over the East Branch Net River 4.0 miles south of the Baraga County line in Iron County (Bridge sign reads “Net River”). This bridge was inspected on all three days. Delamination on the centerline of the bridge was recorded. See Figure 8. Damage to the expansion joints inlets was also observed.

Figure 8. Damage along Centerline on B04-36052.

The B04-36052 Bridge is located on US 141 over the East Branch Net River 4.0 miles south of the Baraga County line in Iron County (Bridge sign reads "Net River"). Damage was noticed in the coating. Delamination on the centerline of the bridge was recorded. See Figure 8. Damage to the expansion joints inlets was also observed. This bridge also appeared to have only a single coating overlay.

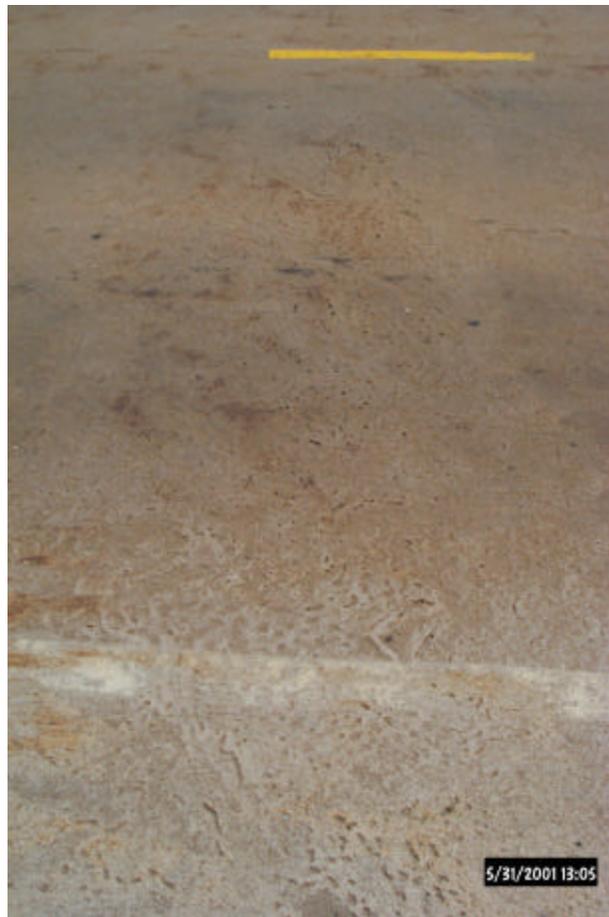
The B02-66032 Bridge is located on M-45 over the East Branch Ontonagon River 2.0 miles south of M-26 in Ontonagon County (Bridge sign reads “Ontonagon River”). Although there was no major delamination in this bridge deck coating, pitting was noticed. From looking at the pattern of the pitting it looks as though it may have been from bubbles in the epoxy. This is over an area of about 5% of the deck surface. This can be seen in Figure 10. Some plow damage in the form of chipping off the coating near the expansion joint was also noticed over a small area (3"wide over the width of the lane).

Figure 10. Bubble Pits in Coating Surface.

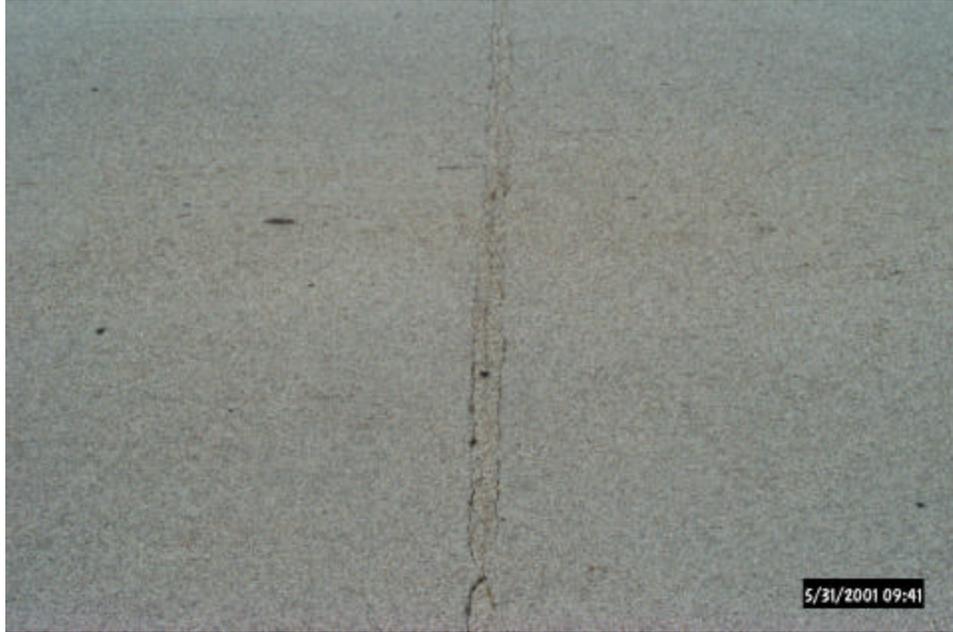
The B02-07012 Bridge is located on US 41 south of Baraga over the Sturgeon River 1.4 miles south of Alberta in Baraga County. Damage was noticed in the coating. Slight delamination on the seam between adjacent applications of coating in the middle of the bridge was recorded. . This was over an area of about 3" in width and over a length of 72". This is evident in Figure 11. Some pitting was also noticed, but this is over a small area only.

Figure 11. B02-07012 - Damage at Deck Joint.

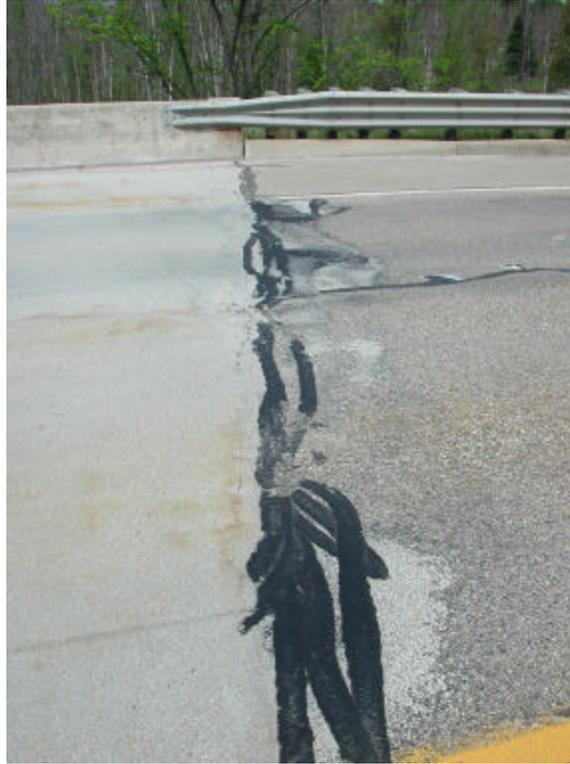
Figure 12. B01-16093 - South End.

The B01-16093 Bridge is located on I-75 southbound over the Sturgeon River 2.3 miles north of the Otsego County line in Cheboygan County. The only damage found was on the north side of the bridge at the expansion joint caused by plow blade chipping. Figure 12 shows this area as well as recent applications of crack sealer.

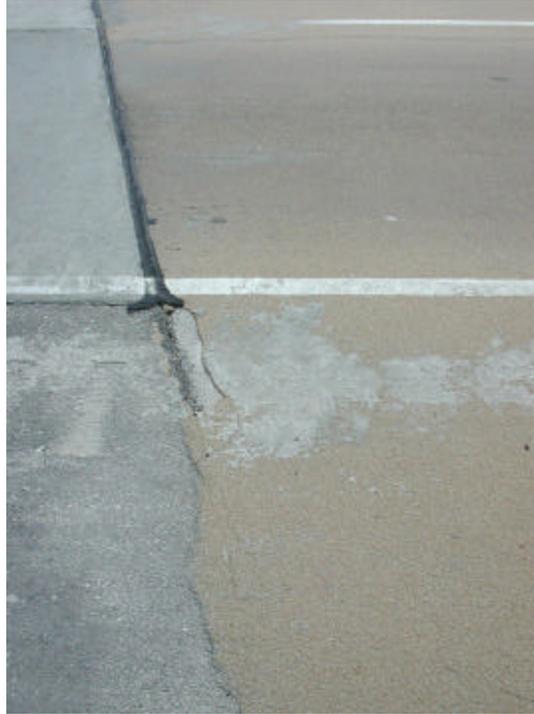
Figure 13. B10-09035 - South End.

The B10-09035 Bridge is located on I-75 northbound over the Saganing River 3.5 miles northwest of Pinconning in Bay County. The damage found was on the south side of the bridge at the expansion joint which looked like it was caused by a plow blade. Some delamination was evident around this area the cause of which is not evident. See Figure 13.

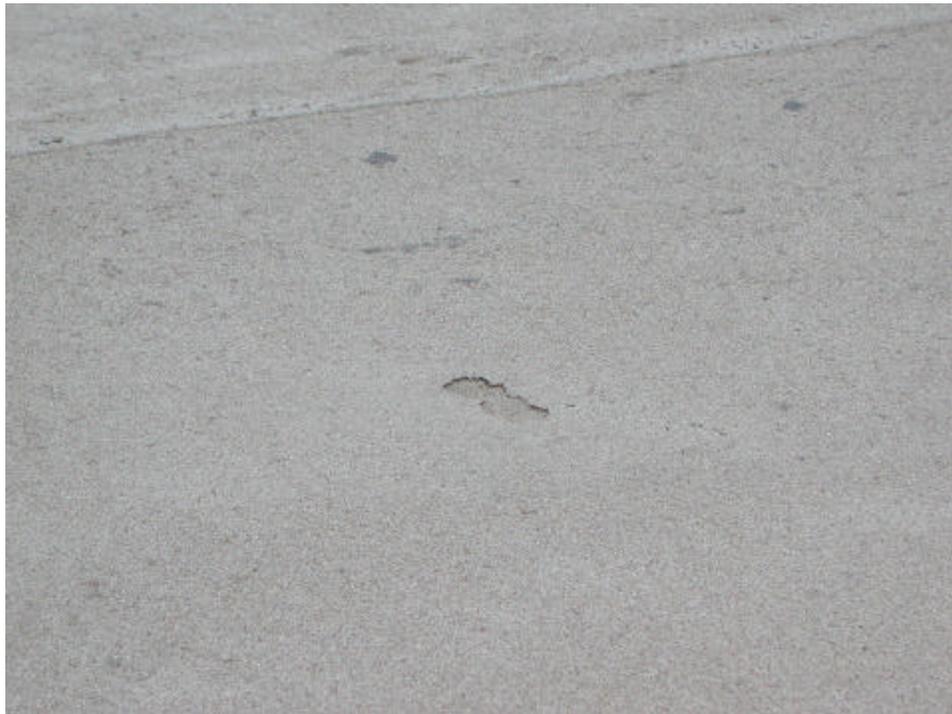
The S15-23063 Bridge is located on I-69 (southbound) over I-96 2.0 miles south of I-496 in Eaton County. This is a slower speed on-ramp area. One area looks like it may have been patched. Some small delamination was noted. This is shown in Figure 14.

Figure 14. S15-23063 Delamination.

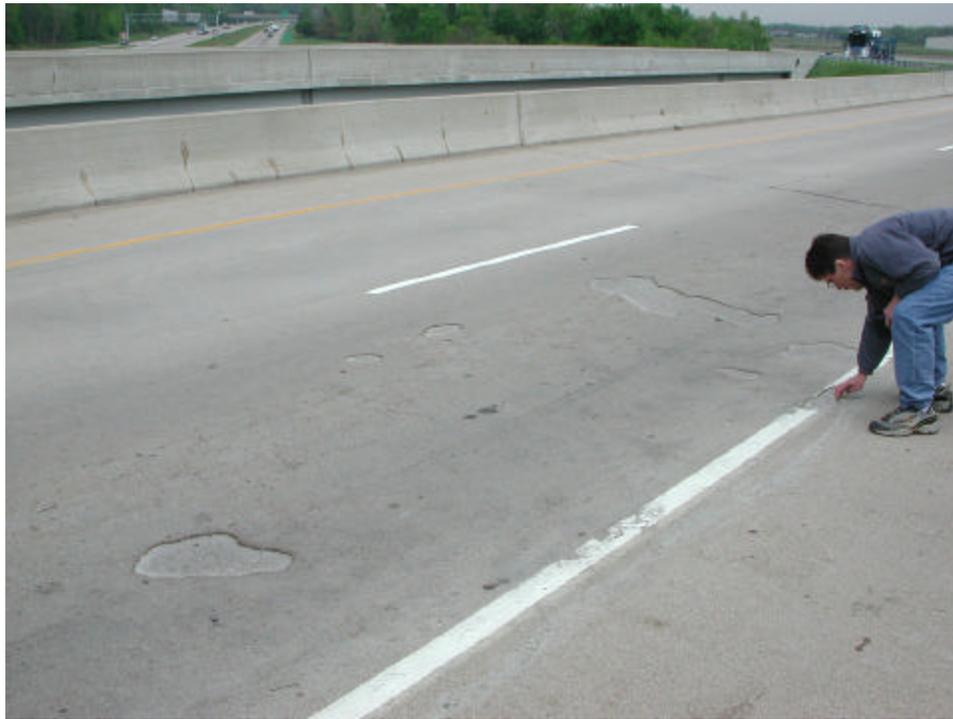
The S14-23063 Bridge is located on I69 (northbound) over I-96 2.0 miles south of I-496 in Eaton County. Delamination damage was found to occur mostly in the right lane and over about 5% of the area. Figure 15 shows some of these areas. Damage at the expansion joints from plowing was also found.

Figure 15. S14-23063 - Delaminated Areas.

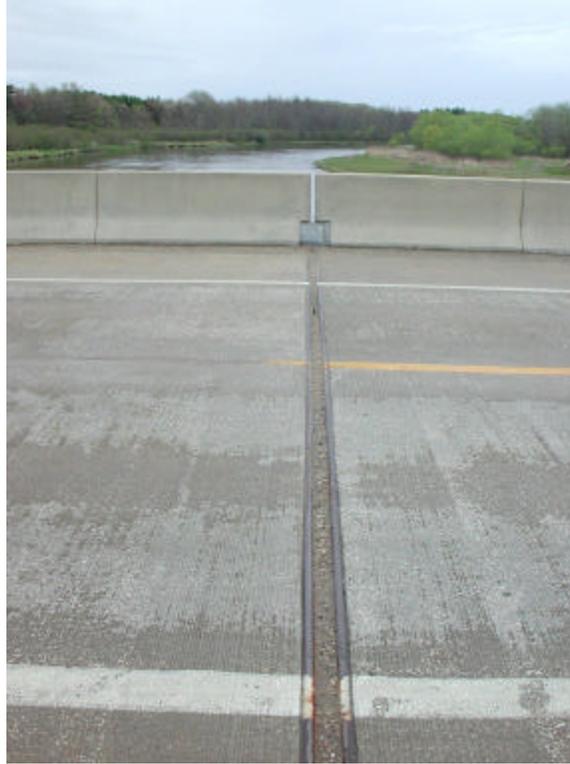
The B01-51021 Bridge is located on M-55 over the Manistee River 0.1 miles east of US-31 in Manistee County. This coating exhibited the greatest amount of wear seen on any bridge to date. The coating was worn down to the pavement in the tire travel ruts. See Figure 16. Most of the tining grooves on the pavement were visible over the entire deck indicating that the coating was thin when applied.

Figure 16. B01-51021 - Worn Lane Section.

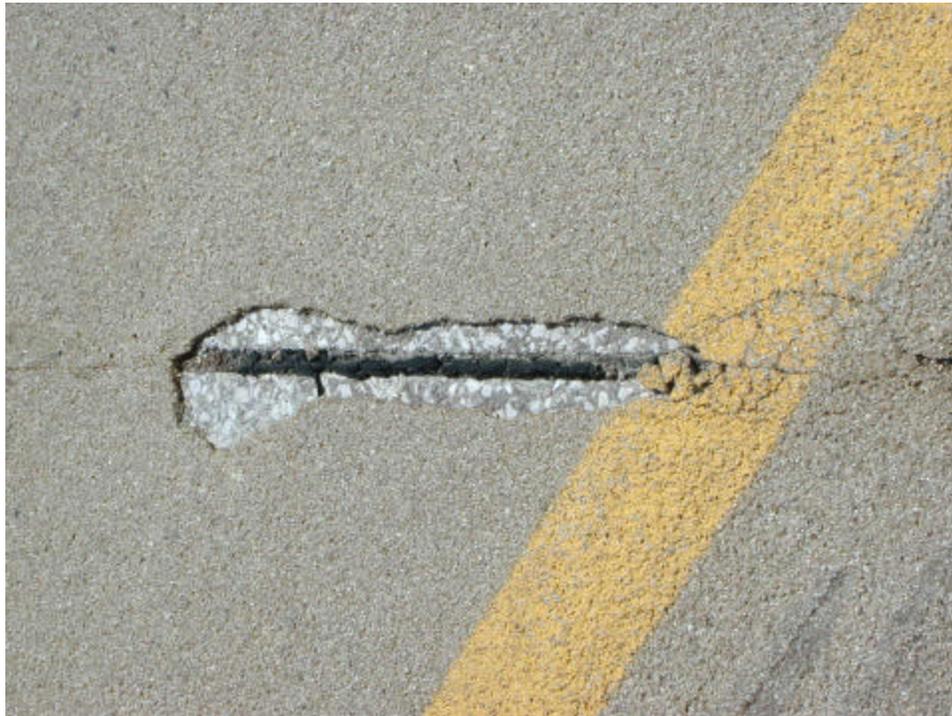
The R01-52041 Bridge is located on US-41 over the LS&I Railroad at the west limits of Ishpeming in Marquette County. Some damage was found. Most was seen near the expansion joints. However, some cracks did exist, and delamination near a hot-poured asphalt joint seal was also found. See Figure 17.

Figure 17. R01-52041 Damage.
