Appendix A
I-696 Core Site

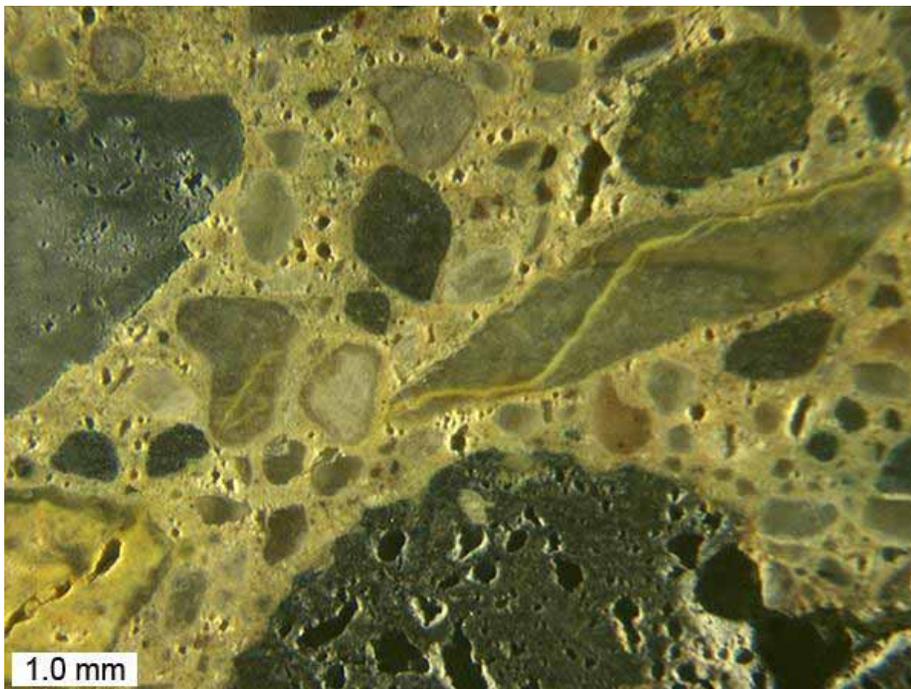
Alkali silica reaction in fine aggregate and associated cracking, before and after sodium cobaltinitrite stain, polished slab from I-696, constructed 1995, at transverse joint, top half of core A, MTU ID 696-06.

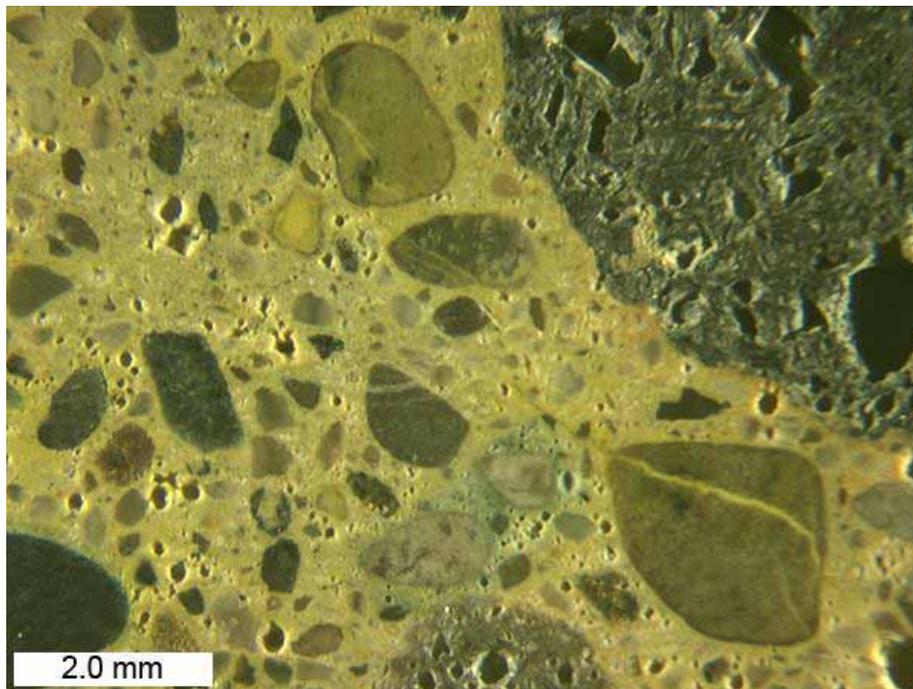
Alkali silica reaction in fine aggregate and associated cracking, before and after sodium cobaltinitrite stain, polished slab from I-696, constructed 1995, at transverse joint, top half of core A, MTU ID 696-06.

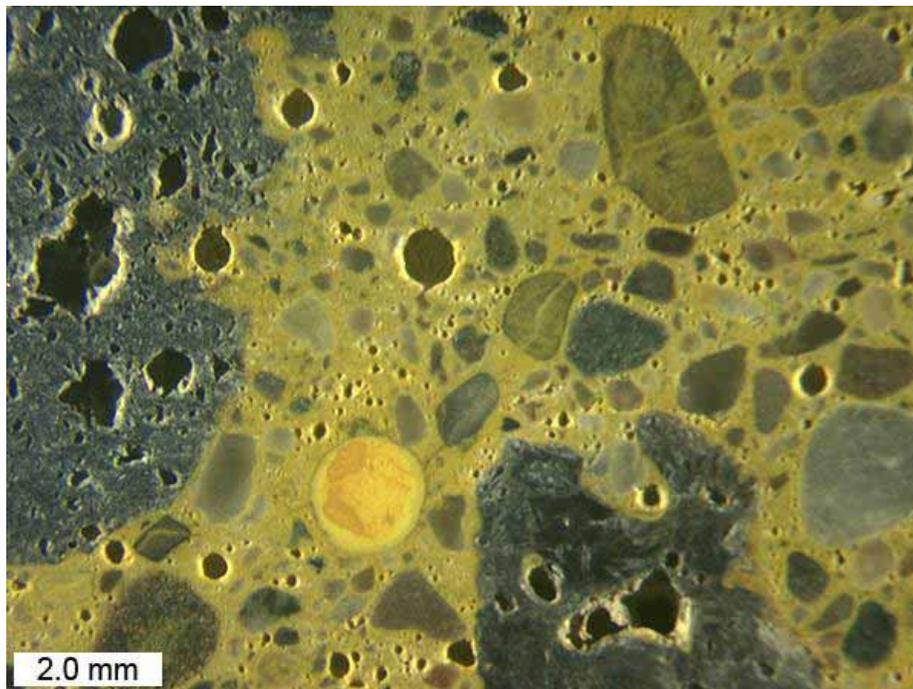
Alkali silica reaction in fine aggregate and associated cracking, before and after sodium cobaltinitrite stain, polished slab from I-696, constructed 1995, at transverse joint, top half of core A, MTU ID 696-06.

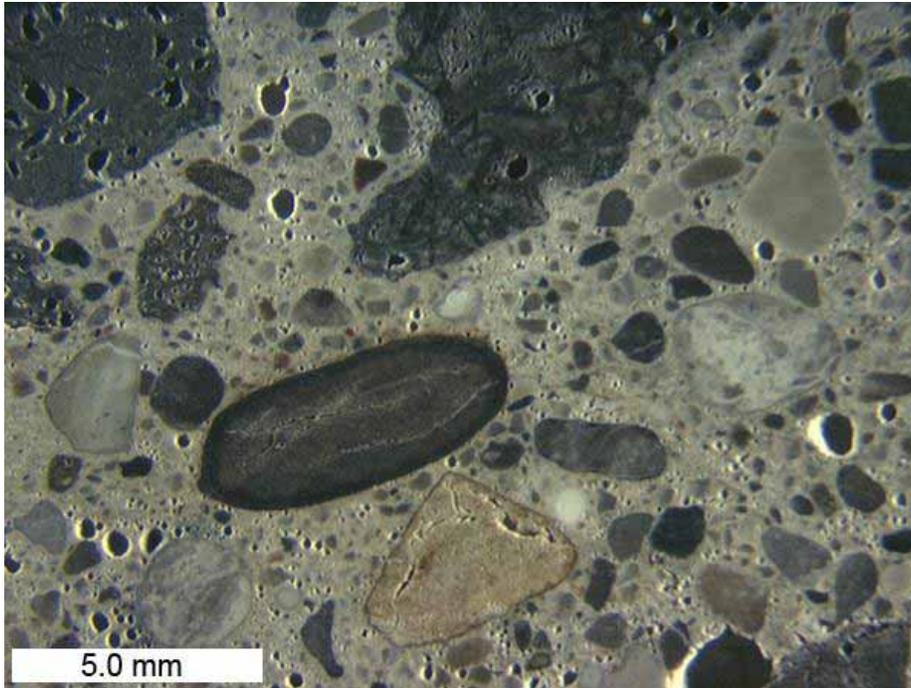
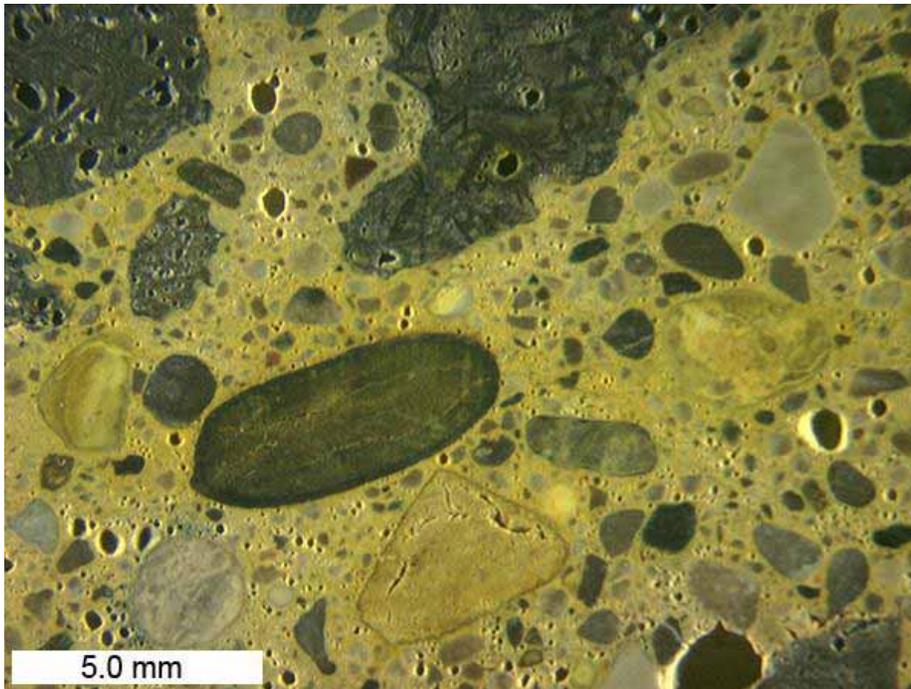
Alkali silica reaction in fine aggregate and associated cracking, before and after sodium cobaltinitrite stain, polished slab from I-696, constructed 1995, at transverse joint, top half of core A, MTU ID 696-06.

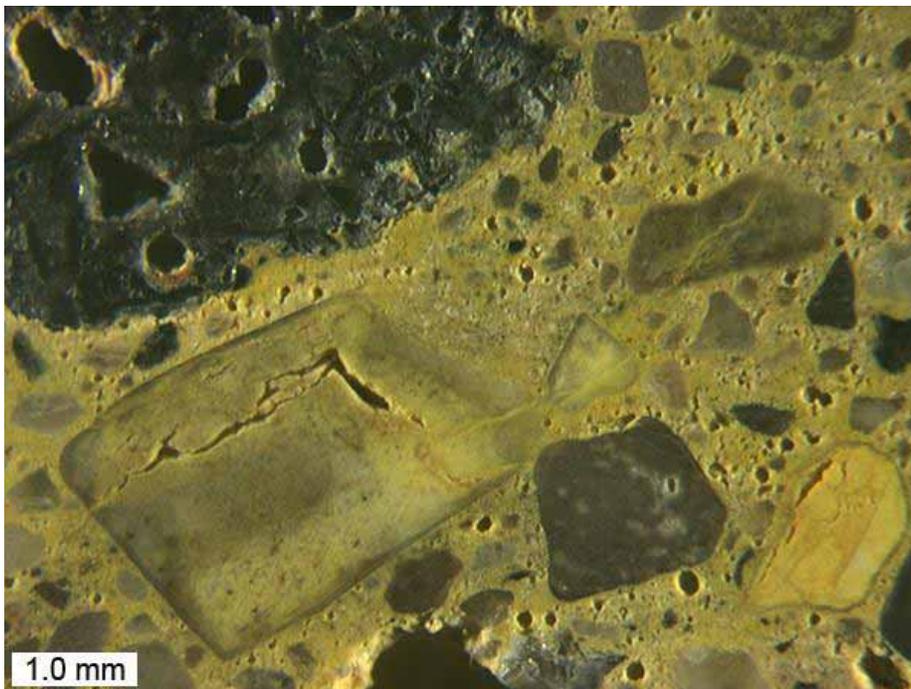
Alkali silica reaction in fine aggregate and associated cracking, before and after sodium cobaltinitrite stain, polished slab from I-696, constructed 1995, at transverse joint, bottom half of core A, MTU ID 696-06.

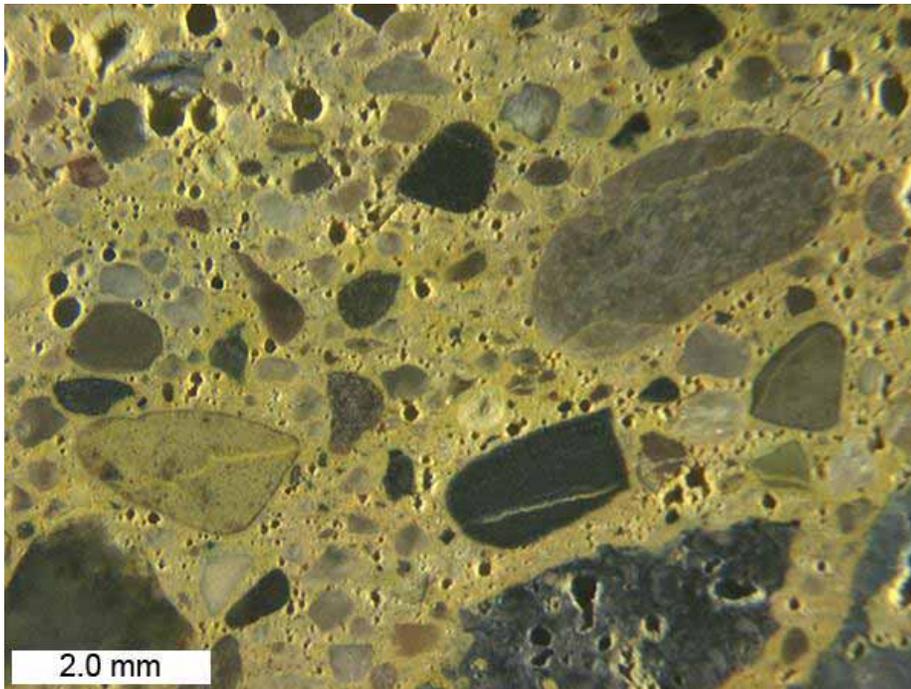
Alkali silica reaction in fine aggregate and associated cracking, before and after sodium cobaltinitrite stain, polished slab from I-696, constructed 1995, at transverse joint, bottom half of core A, MTU ID 696-06.

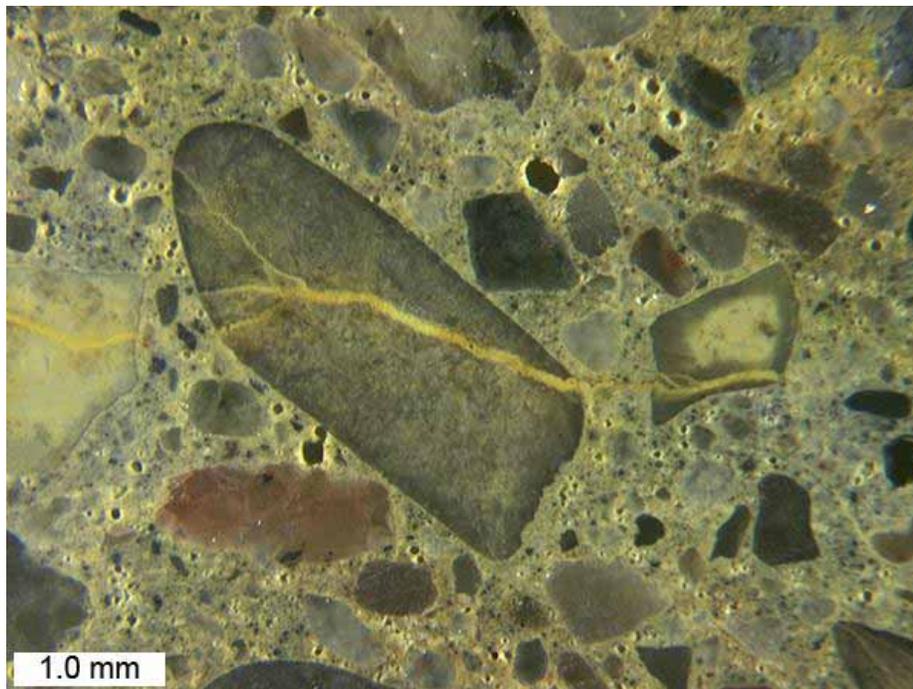
Alkali silica reaction in fine aggregate and associated cracking, before and after sodium cobaltinitrite stain, polished slab from I-696, constructed 1995, away from transverse joint, top half of core D, MTU ID 696-03.

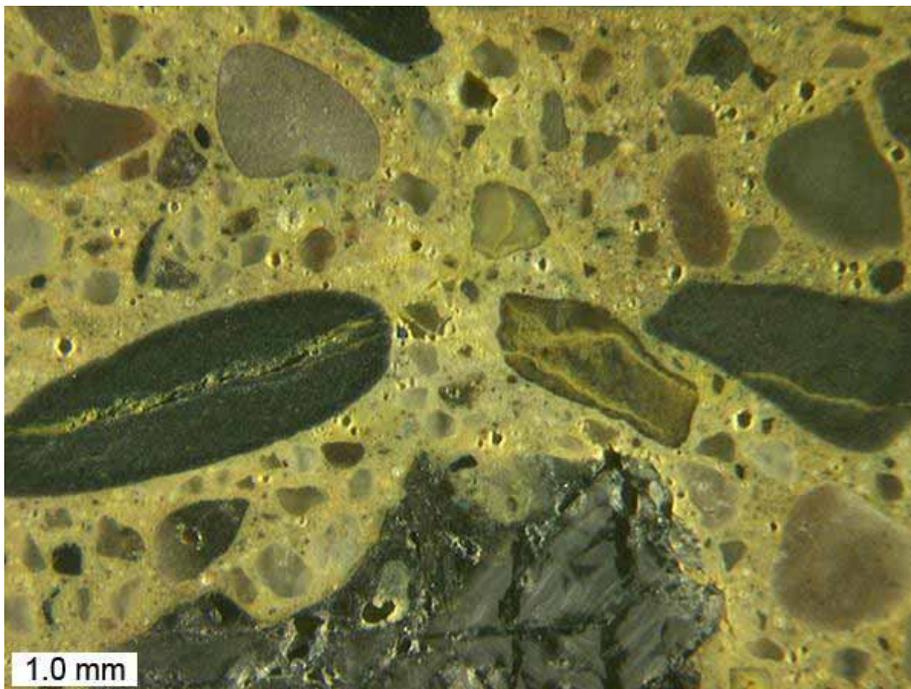
Alkali silica reaction in fine aggregate and associated cracking, before and after sodium cobaltinitrite stain, polished slab from I-696, constructed 1995, away from transverse joint, top half of core D, MTU ID 696-03.

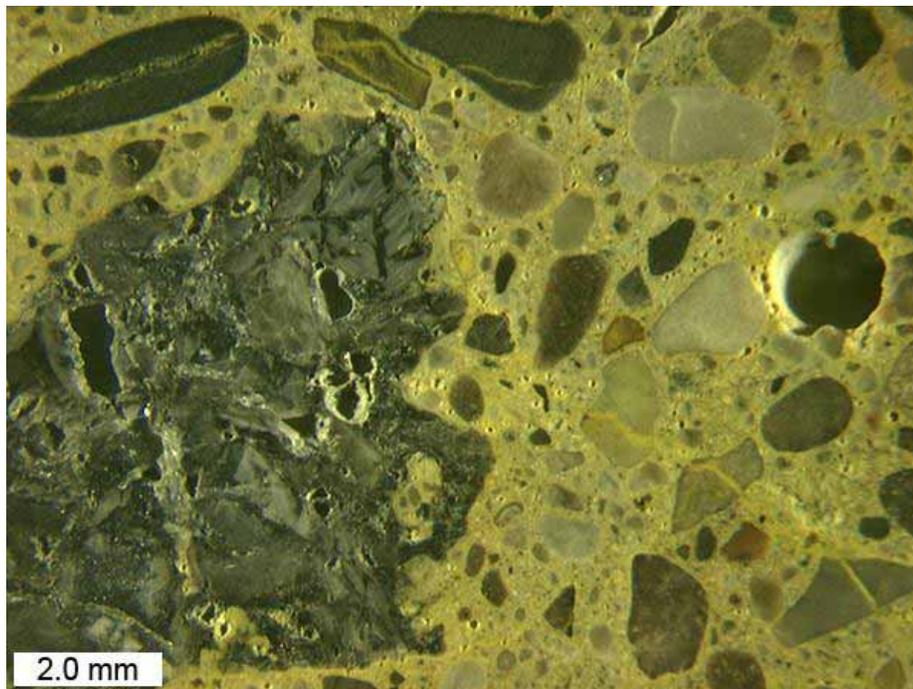
Alkali silica reaction in fine aggregate and associated cracking, before and after sodium cobaltinitrite stain, polished slab from I-696, constructed 1995, away from transverse joint, top half of core D, MTU ID 696-03.

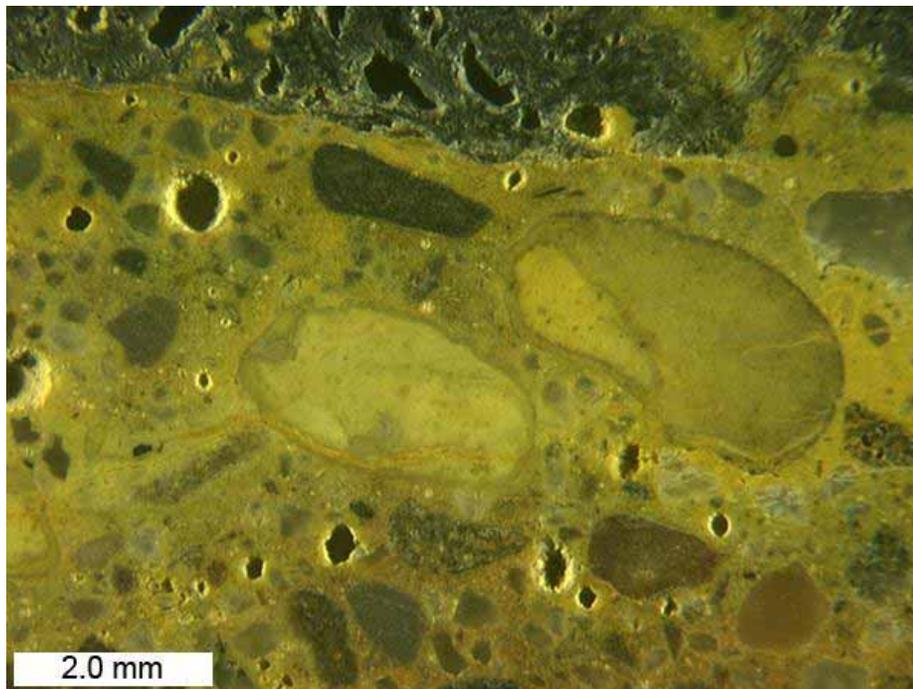
Alkali silica reaction in fine aggregate and associated cracking, before and after sodium cobaltinitrite stain, polished slab from I-696, constructed 1995, away from transverse joint, bottom half of core D, MTU ID 696-03.

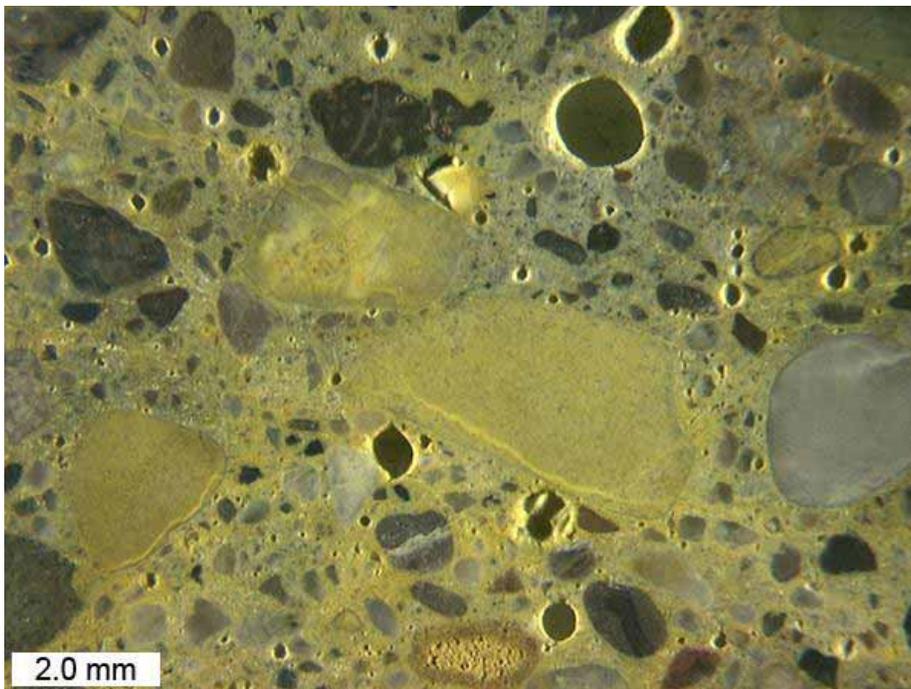
Alkali silica reaction in fine aggregate and associated cracking, before and after sodium cobaltinitrite stain, polished slab from I-696, constructed 1995, away from transverse joint, bottom half of core D, MTU ID 696-03.

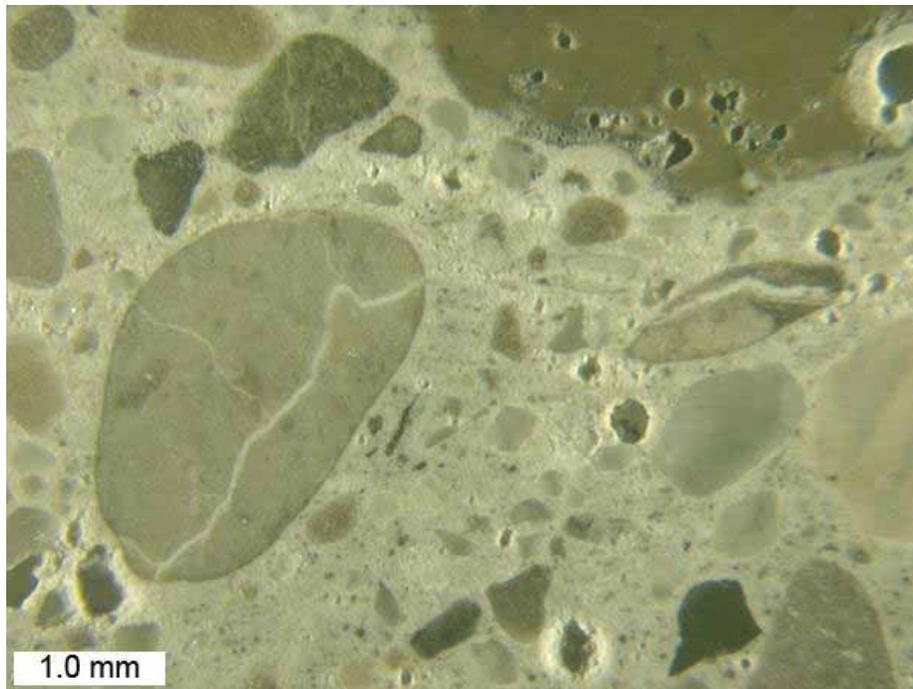
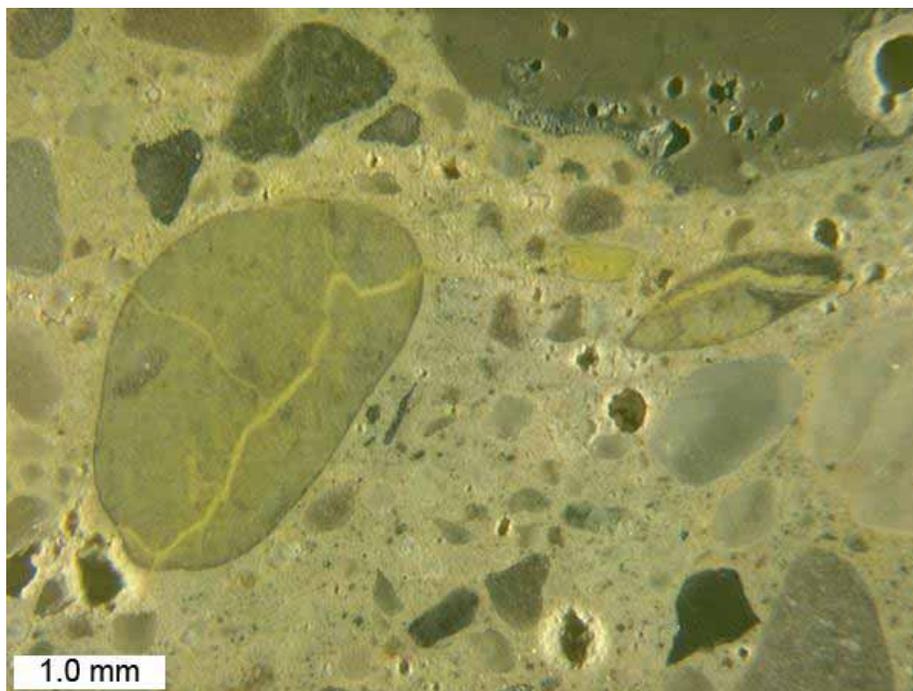
Alkali silica reaction in fine aggregate and associated cracking, before and after sodium cobaltinitrite stain, polished slab from I-696, constructed 1995, at transverse joint, top half of core A, MTU ID 696-09.

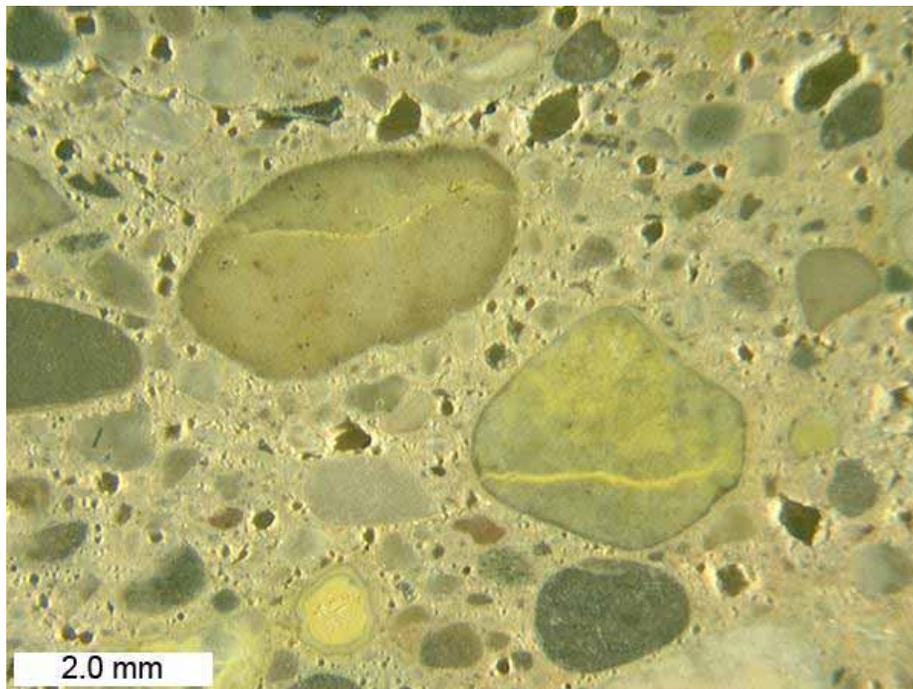
Alkali silica reaction in fine aggregate and associated cracking, before and after sodium cobaltinitrite stain, polished slab from I-696, constructed 1995, at transverse joint, top half of core A, MTU ID 696-09.

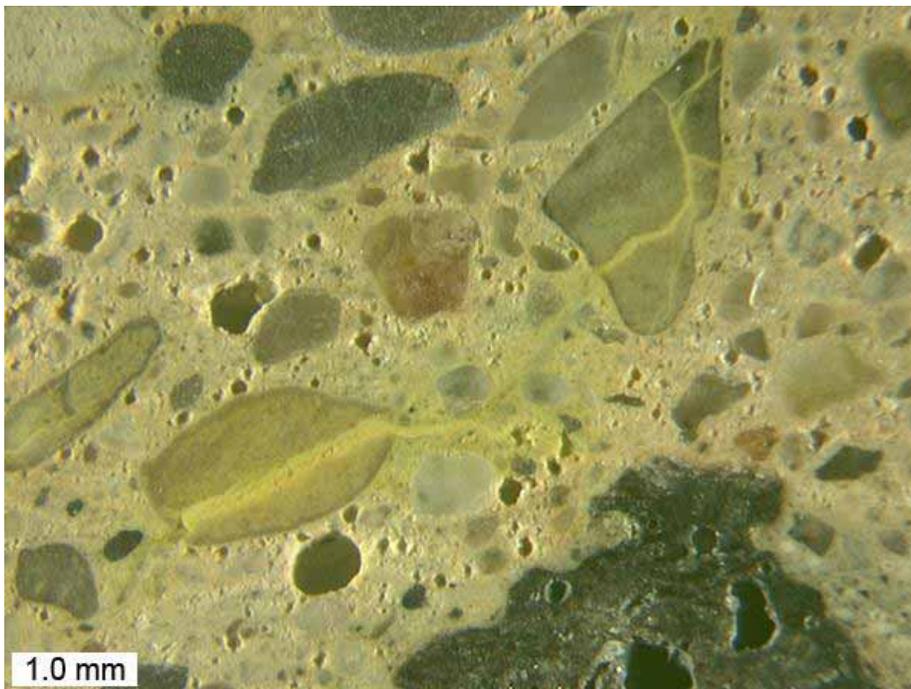
Alkali silica reaction in fine aggregate and associated cracking, before and after sodium cobaltinitrite stain, polished slab from I-696, constructed 1995, at transverse joint, top half of core A, MTU ID 696-09.

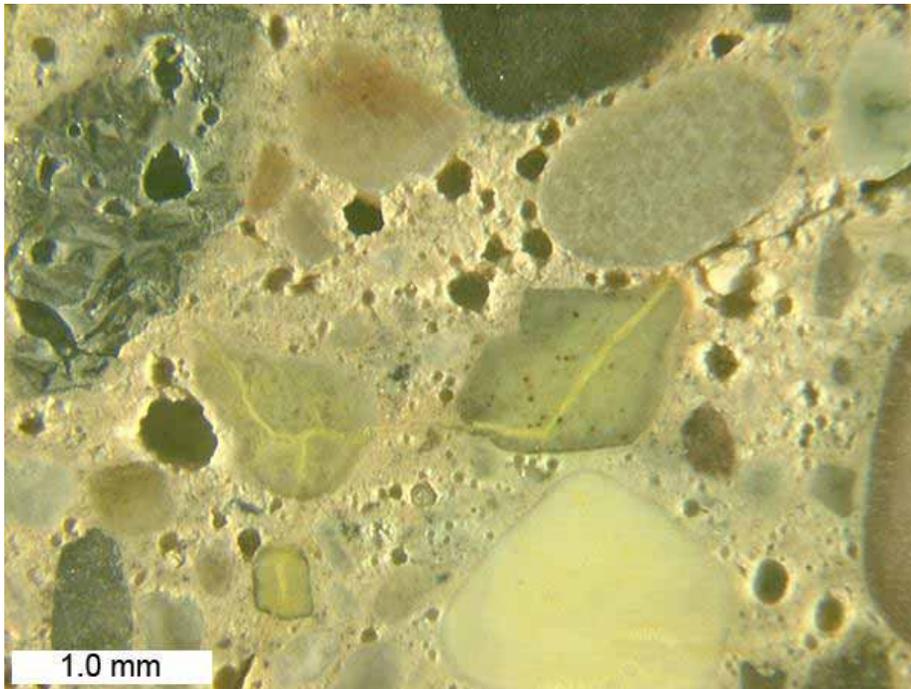
Alkali silica reaction in fine aggregate and associated cracking, before and after sodium cobaltinitrite stain, polished slab from I-696, constructed 1995, at transverse joint, top half of core A, MTU ID 696-09.

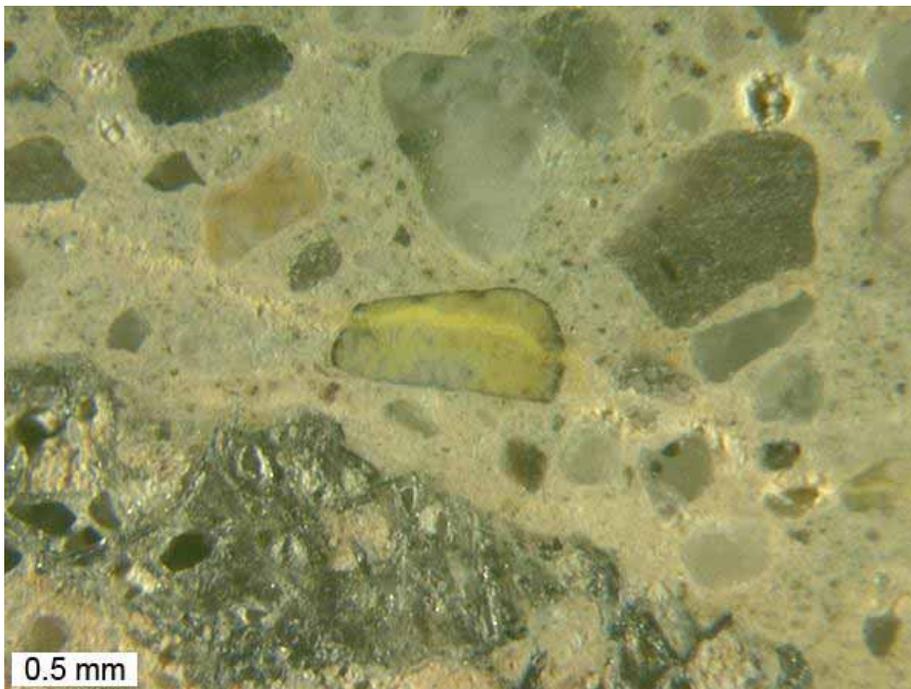
Alkali silica reaction in fine aggregate and associated cracking, before and after sodium cobaltinitrite stain, polished slab from I-696, constructed 1995, at transverse joint, top half of core A, MTU ID 696-09.

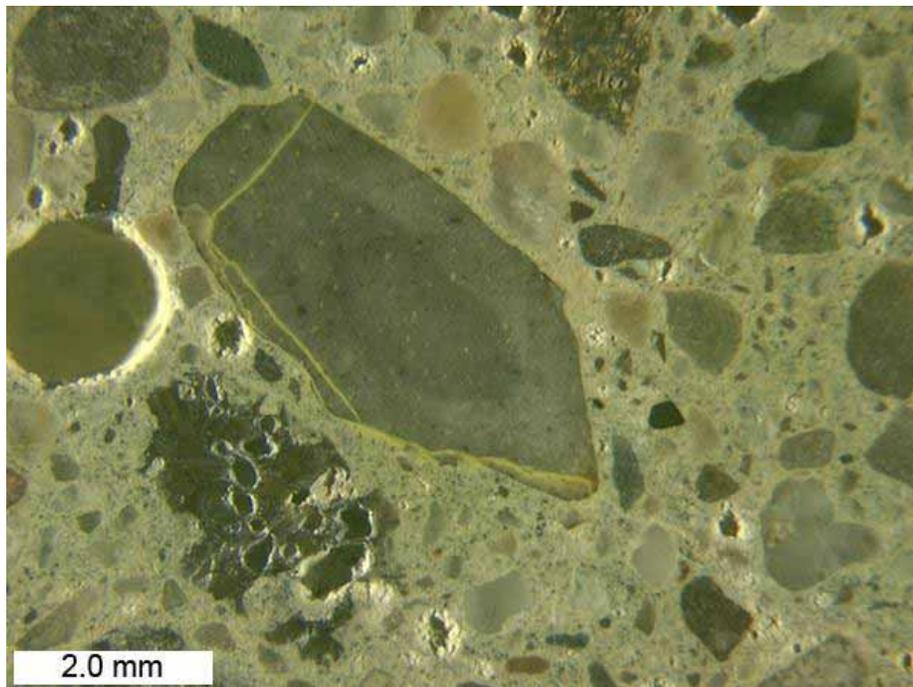
Alkali silica reaction in fine aggregate and associated cracking, before and after sodium cobaltinitrite stain, polished slab from I-696, constructed 1995, at transverse joint, bottom half of core A, MTU ID 696-09.

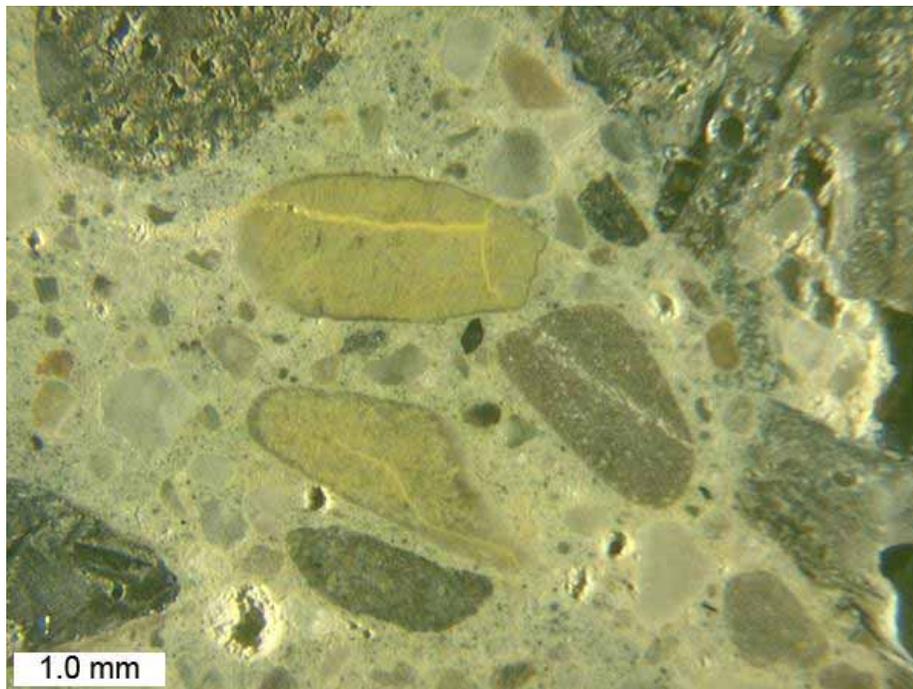
Alkali silica reaction in fine aggregate and associated cracking, before and after sodium cobaltinitrite stain, polished slab from I-696, constructed 1995, at transverse joint, bottom half of core A, MTU ID 696-09.

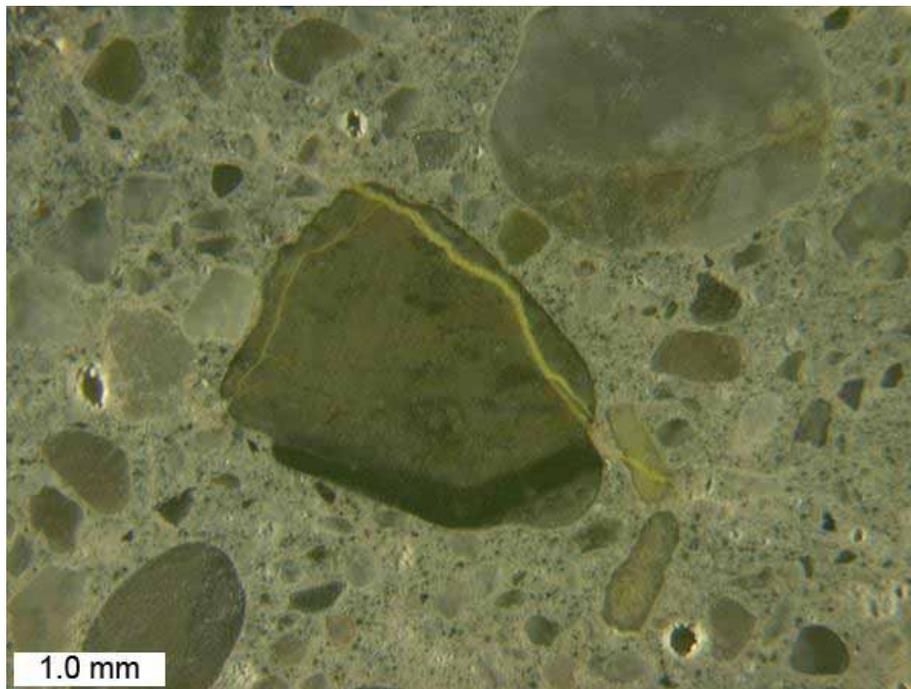
Alkali silica reaction in fine aggregate and associated cracking, before and after sodium cobaltinitrite stain, polished slab from I-696, constructed 1995, at transverse joint, bottom half of core A, MTU ID 696-09.

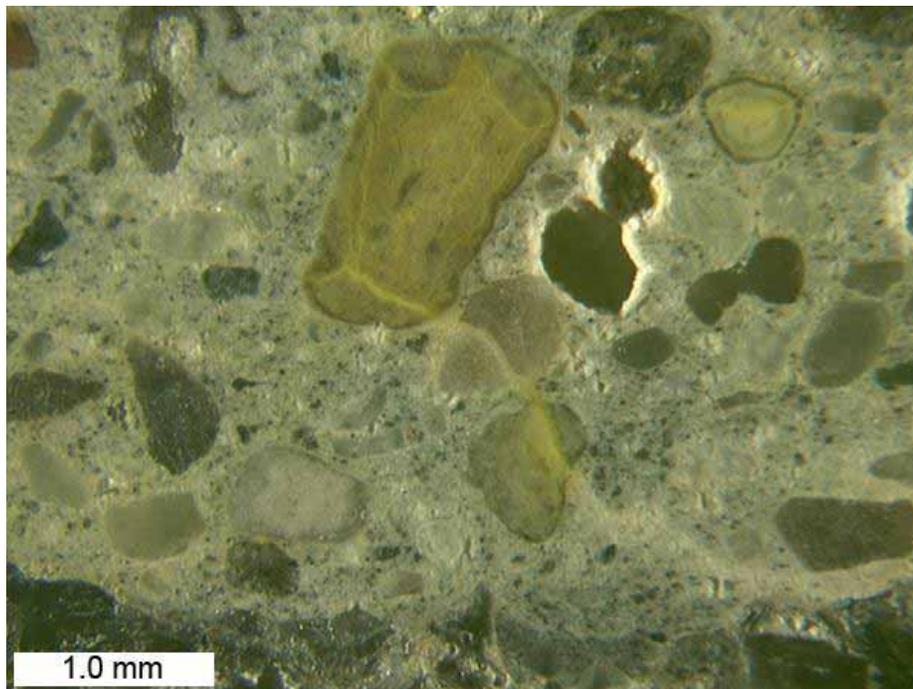
Alkali silica reaction in fine aggregate and associated cracking, before and after sodium cobaltinitrite stain, polished slab from I-696, constructed 1995, at transverse joint, bottom half of core A, MTU ID 696-09.

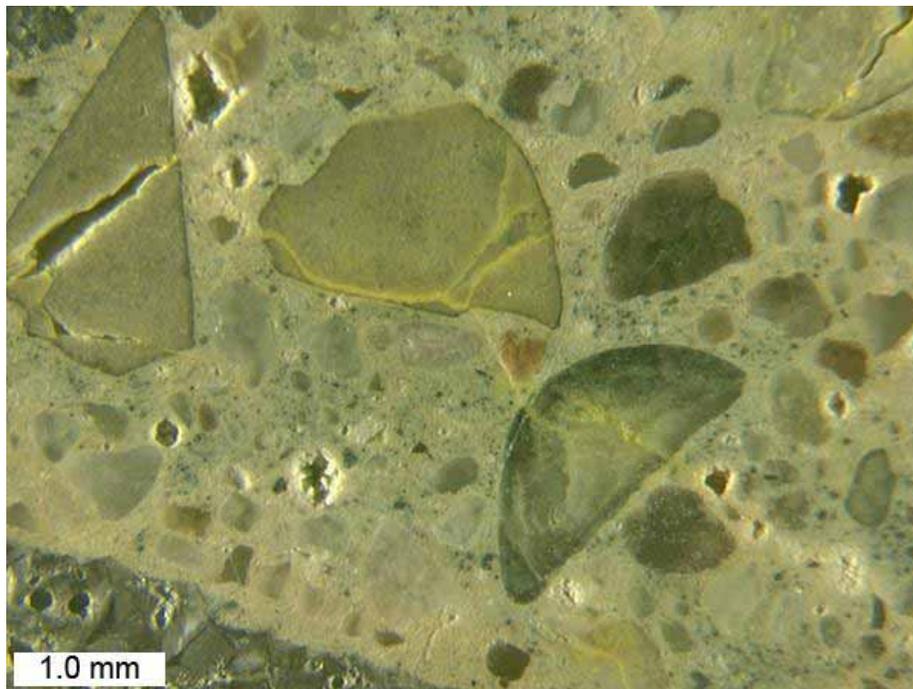
Alkali silica reaction in fine aggregate and associated cracking, before and after sodium cobaltinitrite stain, polished slab from I-696, constructed 1995, at transverse joint, bottom half of core A, MTU ID 696-09.

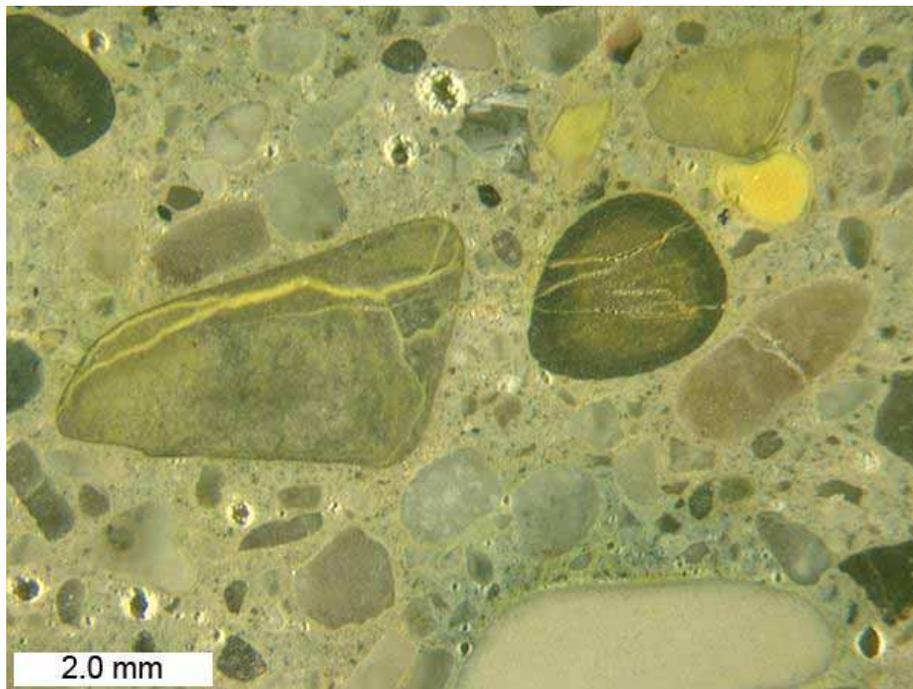
Alkali silica reaction in fine aggregate and associated cracking, before and after sodium cobaltinitrite stain, polished slab from I-696, constructed 1995, at transverse joint, bottom half of core A, MTU ID 696-09.

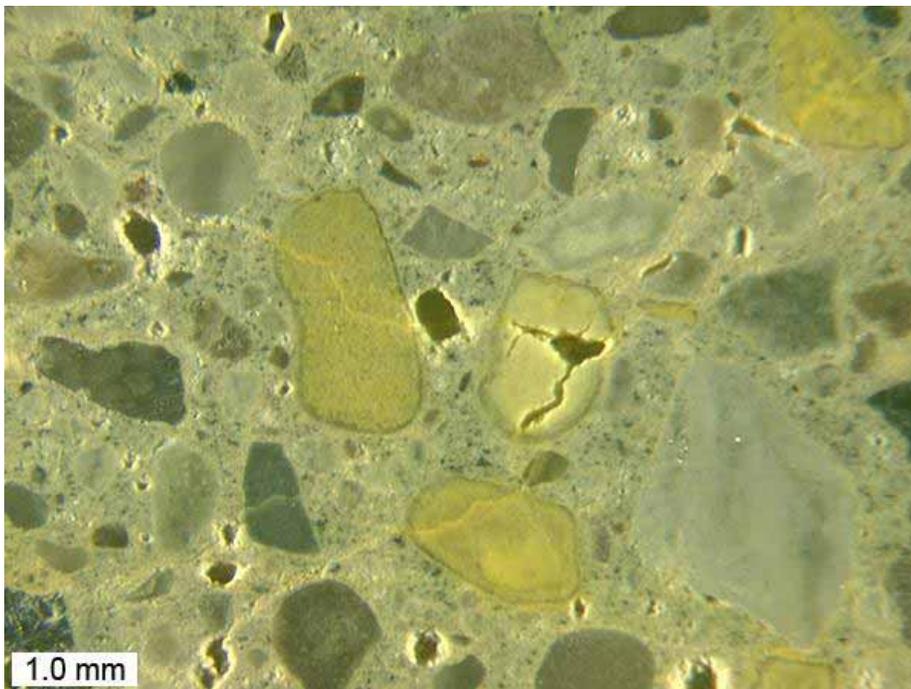
Alkali silica reaction in fine aggregate and associated cracking, before and after sodium cobaltinitrite stain, polished slab from I-696, constructed 1995, at transverse joint, bottom half of core A, MTU ID 696-09.

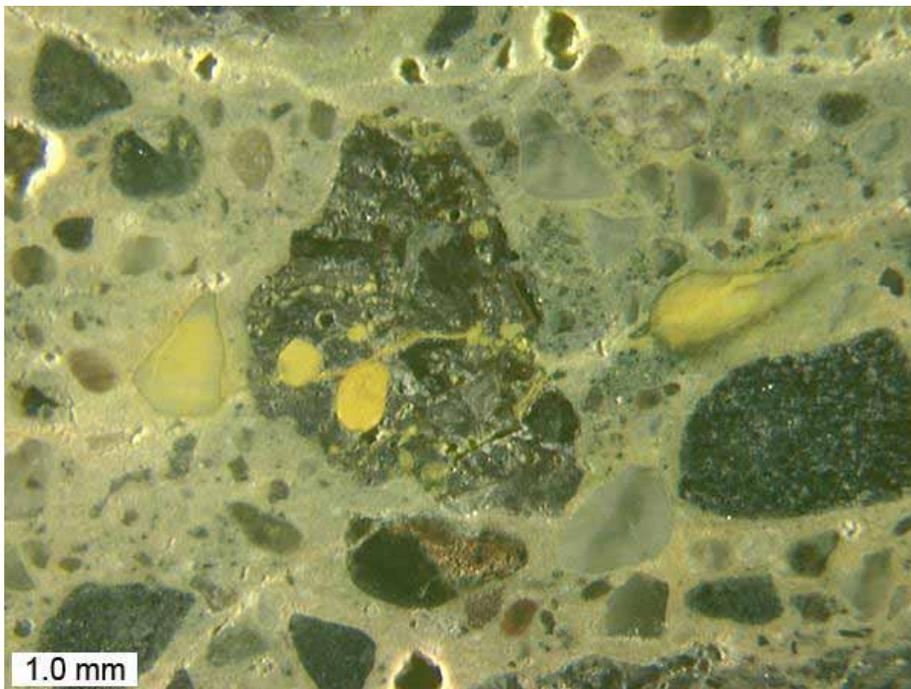
Alkali silica reaction in fine aggregate and associated cracking, before and after sodium cobaltinitrite stain, polished slab from I-696, constructed 1995, at transverse joint, bottom half of core A, MTU ID 696-09. Note voids in slag aggregate particle filled with alkali-silica reaction product.

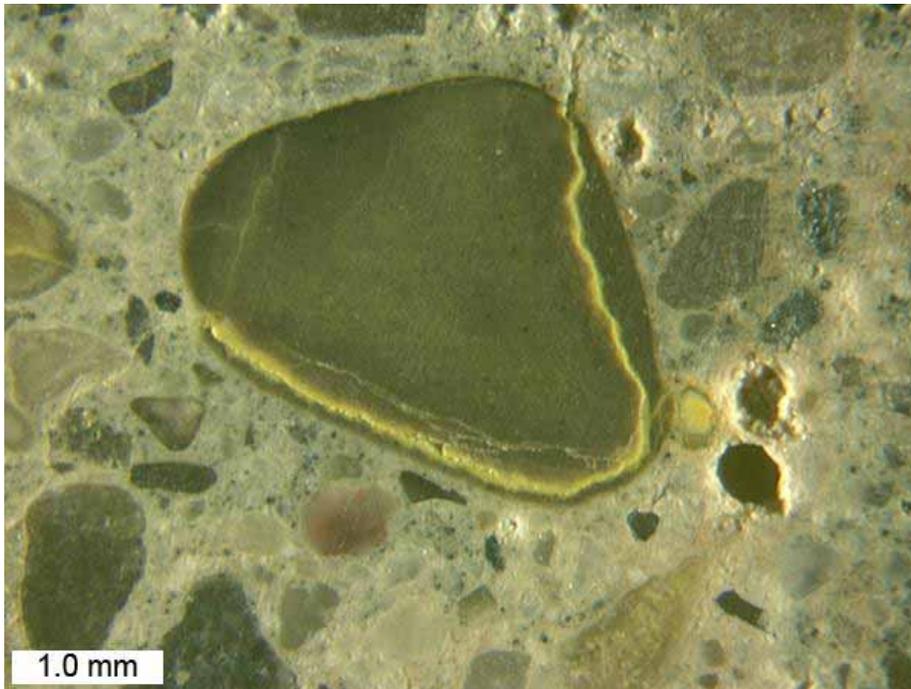
Alkali silica reaction in fine aggregate and associated cracking, before and after sodium cobaltinitrite stain, polished slab from I-696, constructed 1995, at transverse joint, bottom half of core A, MTU ID 696-09.

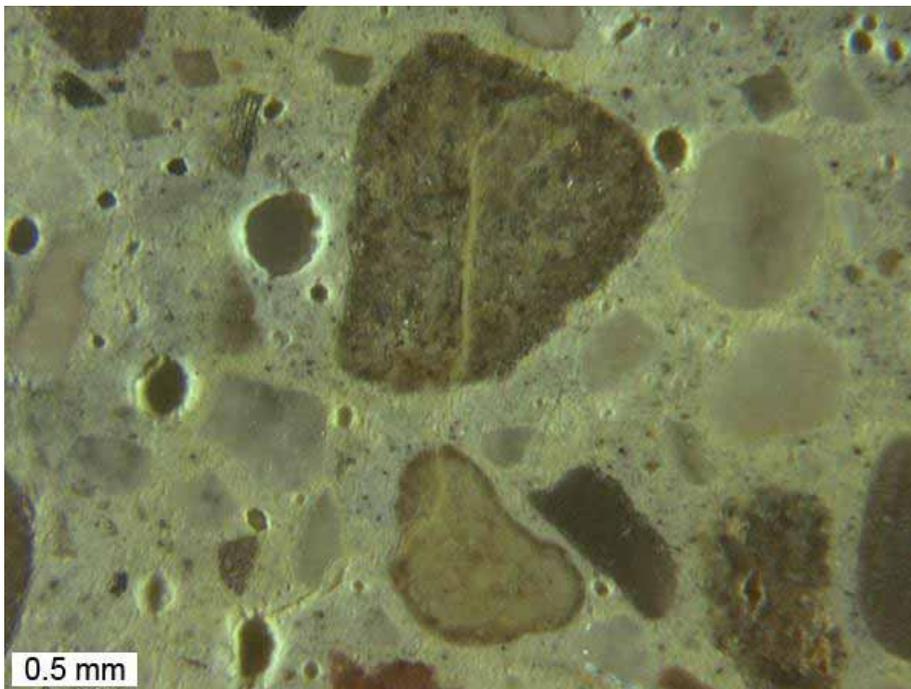
Alkali silica reaction in fine aggregate and associated cracking, before and after sodium cobaltinitrite stain, polished slab from I-696, constructed 1995, away from transverse joint, top half of core C, MTU ID 696-11.

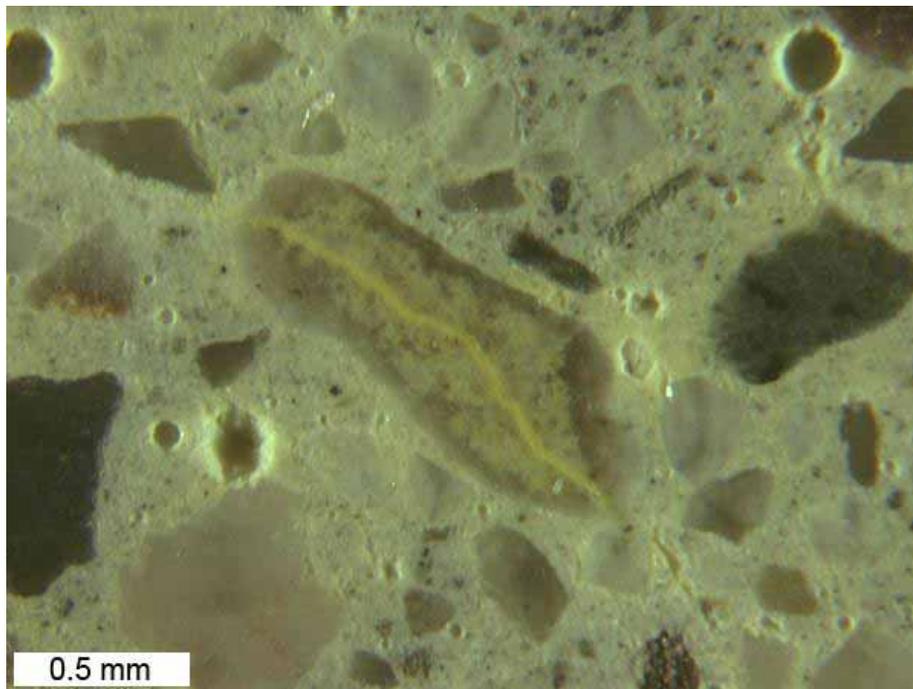
Alkali silica reaction in fine aggregate and associated cracking, before and after sodium cobaltinitrite stain, polished slab from I-696, constructed 1995, away from transverse joint, top half of core C, MTU ID 696-11.

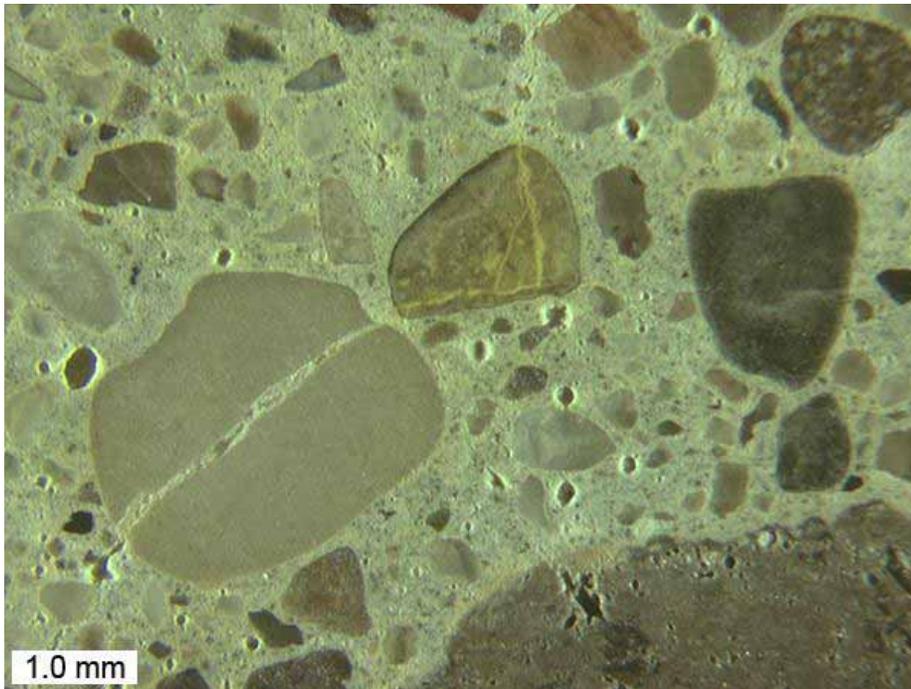
Alkali silica reaction in fine aggregate and associated cracking, before and after sodium cobaltinitrite stain, polished slab from I-696, constructed 1995, away from transverse joint, top half of core C, MTU ID 696-11.

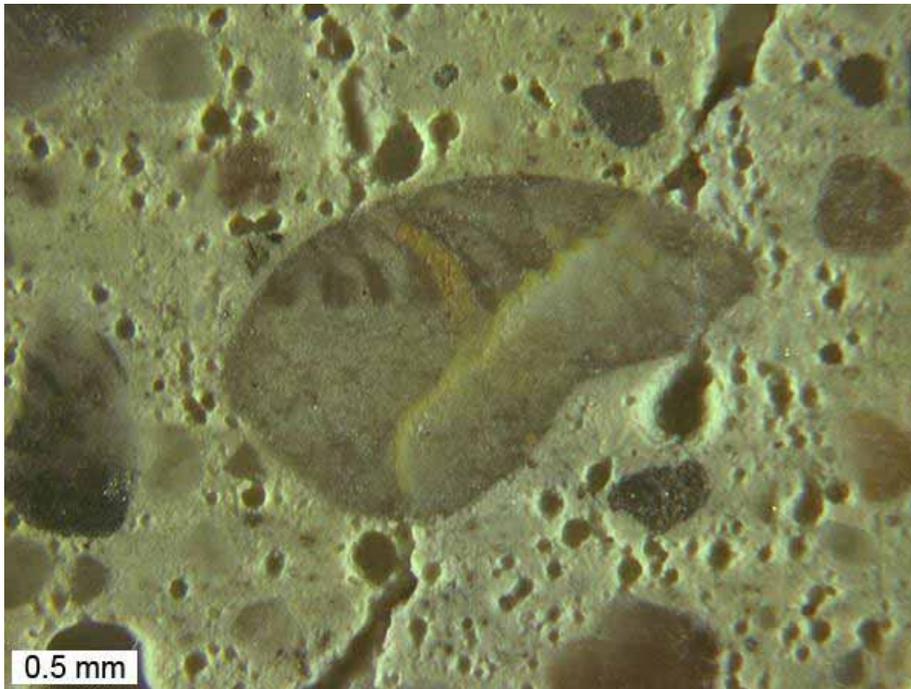
Alkali silica reaction in fine aggregate and associated cracking, before and after sodium cobaltinitrite stain, polished slab from I-696, constructed 1995, away from transverse joint, top half of core C, MTU ID 696-11.

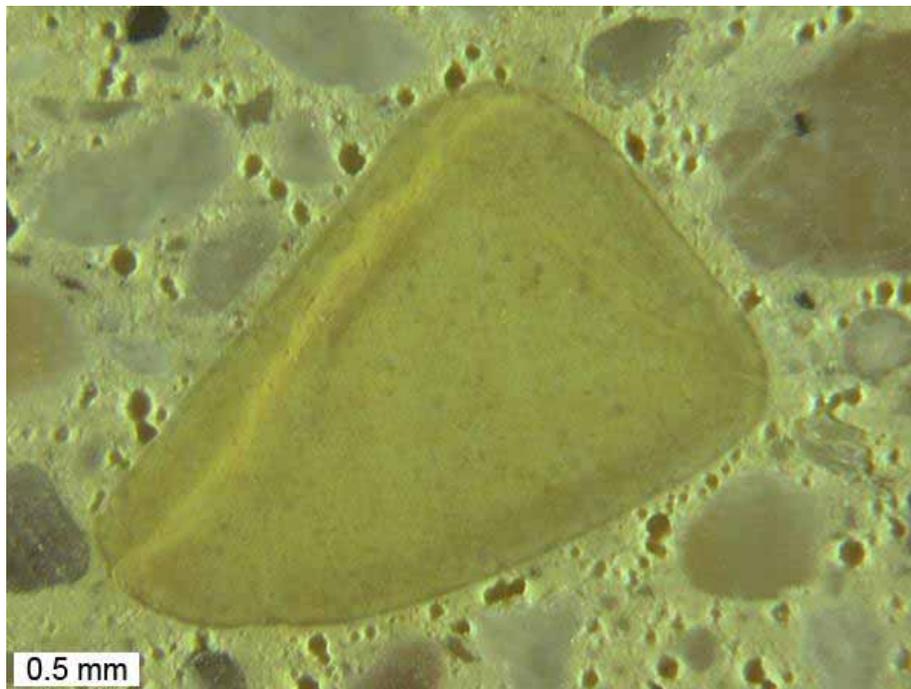
Alkali silica reaction in fine aggregate and associated cracking, before and after sodium cobaltinitrite stain, polished slab from I-696, constructed 1995, away from transverse joint, top half of core C, MTU ID 696-11.

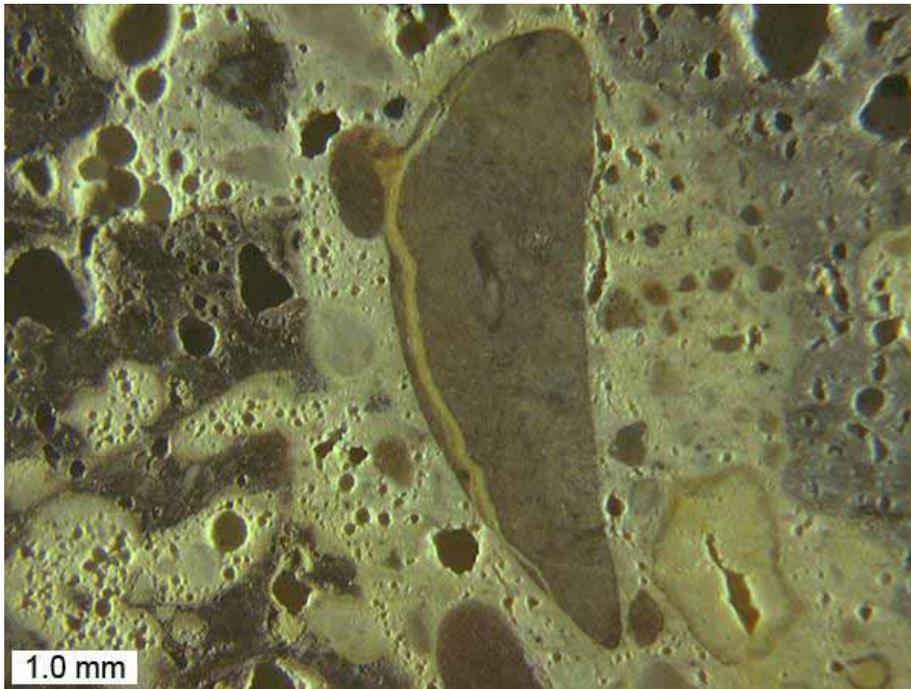
Alkali silica reaction in fine aggregate and associated cracking, before and after sodium cobaltinitrite stain, polished slab from I-696, constructed 1995, away from transverse joint, top half of core C, MTU ID 696-11.
