Appendix A
I-696 Core Site

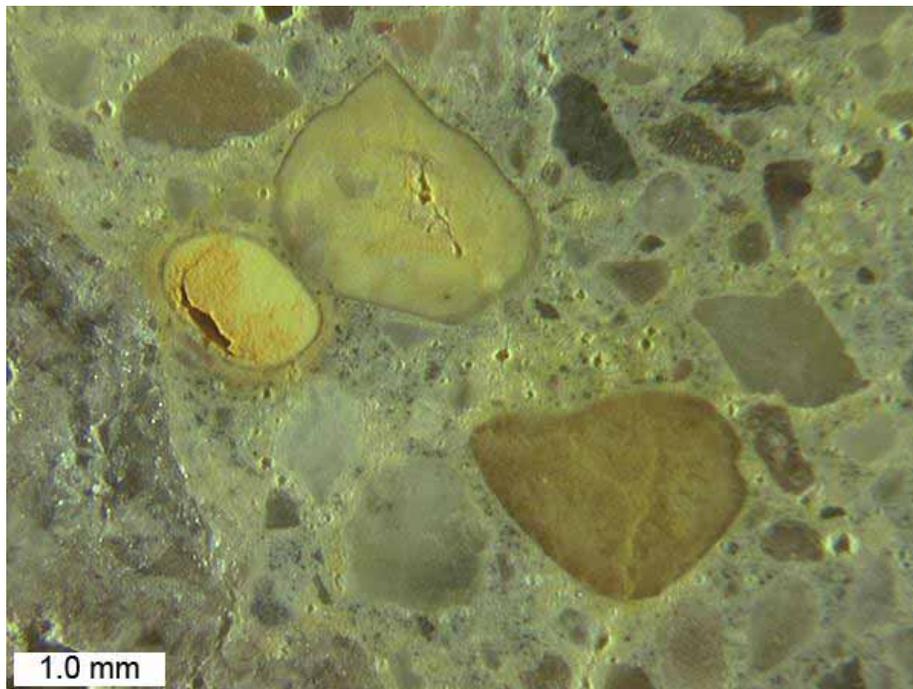
Alkali silica reaction in fine aggregate and associated cracking, before and after sodium cobaltinitrite stain, polished slab from I-696, constructed 1995, away from transverse joint, bottom half of core C, MTU ID 696-11.

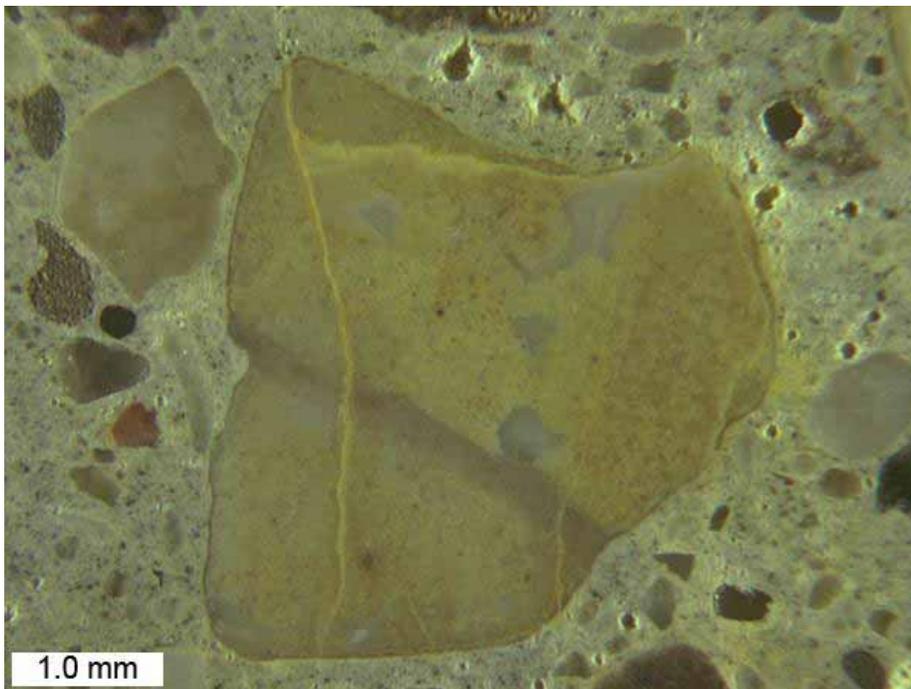
Alkali silica reaction in fine aggregate and associated cracking, before and after sodium cobaltinitrite stain, polished slab from I-696, constructed 1995, away from transverse joint, bottom half of core C, MTU ID 696-11.

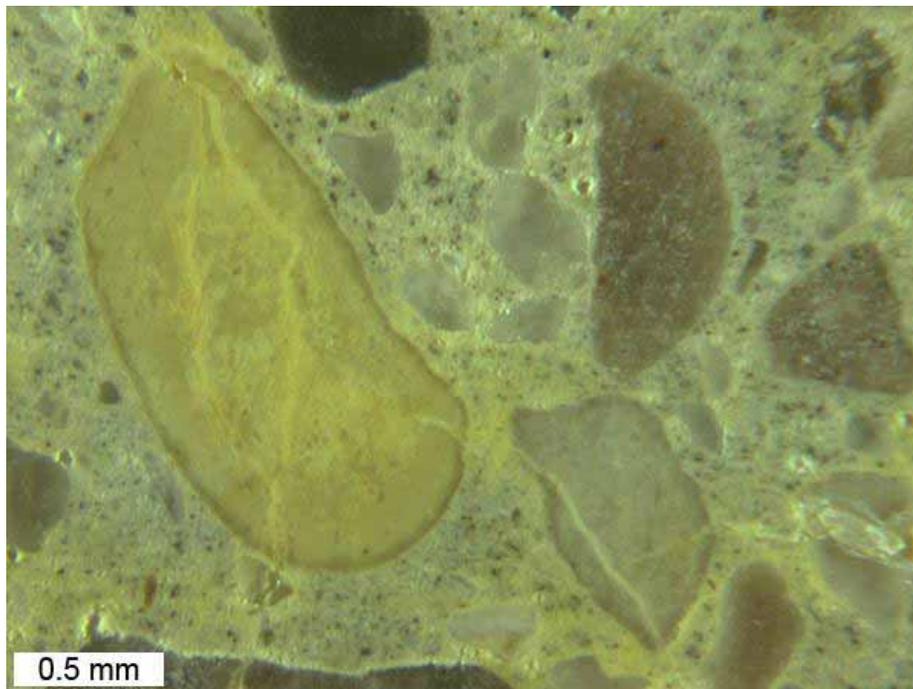
Alkali silica reaction in fine aggregate and associated cracking, before and after sodium cobaltinitrite stain, polished slab from I-696, constructed 1995, away from transverse joint, bottom half of core C, MTU ID 696-11.

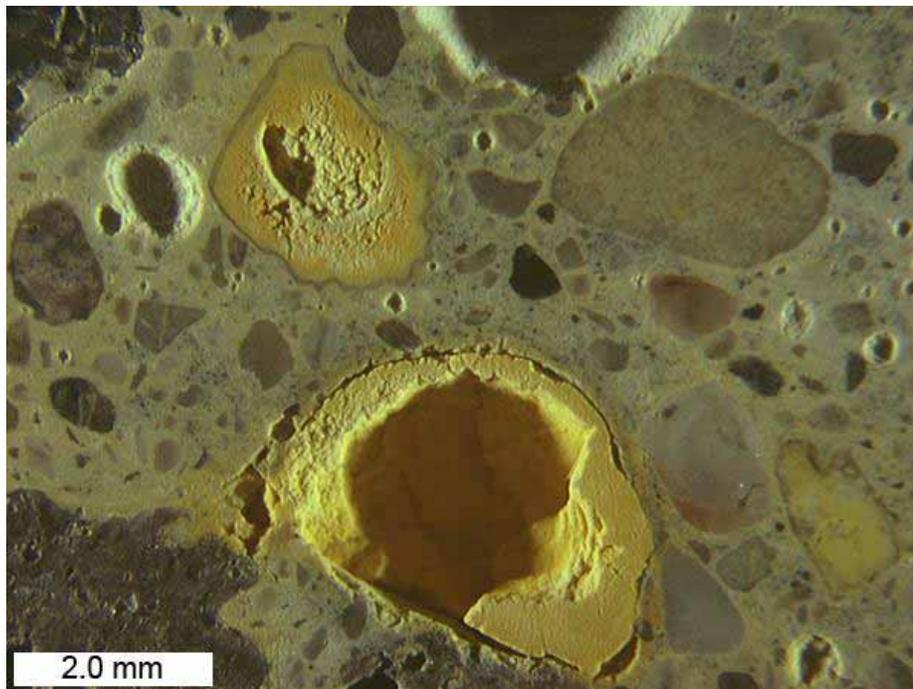
Alkali silica reaction in fine aggregate and nearby air void filled with reaction product, before and after sodium cobaltinitrite stain, polished slab from I-696, constructed 1995, away from transverse joint, bottom half of core C, MTU ID 696-11.

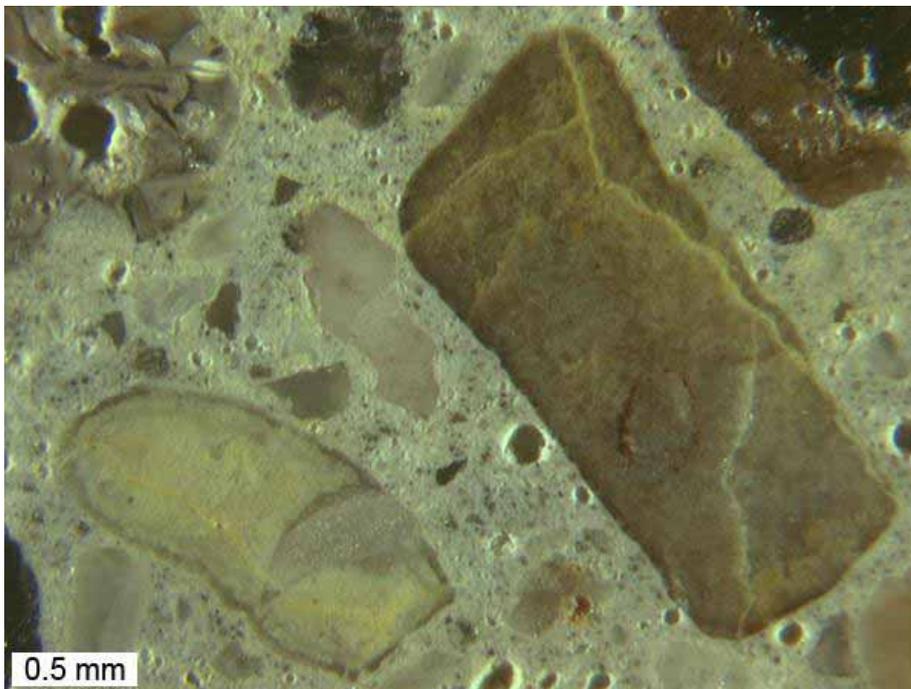
Alkali silica reaction in fine aggregate and associated cracking, before and after sodium cobaltinitrite stain, polished slab from I-696, constructed 1995, away from transverse joint, bottom half of core C, MTU ID 696-11.

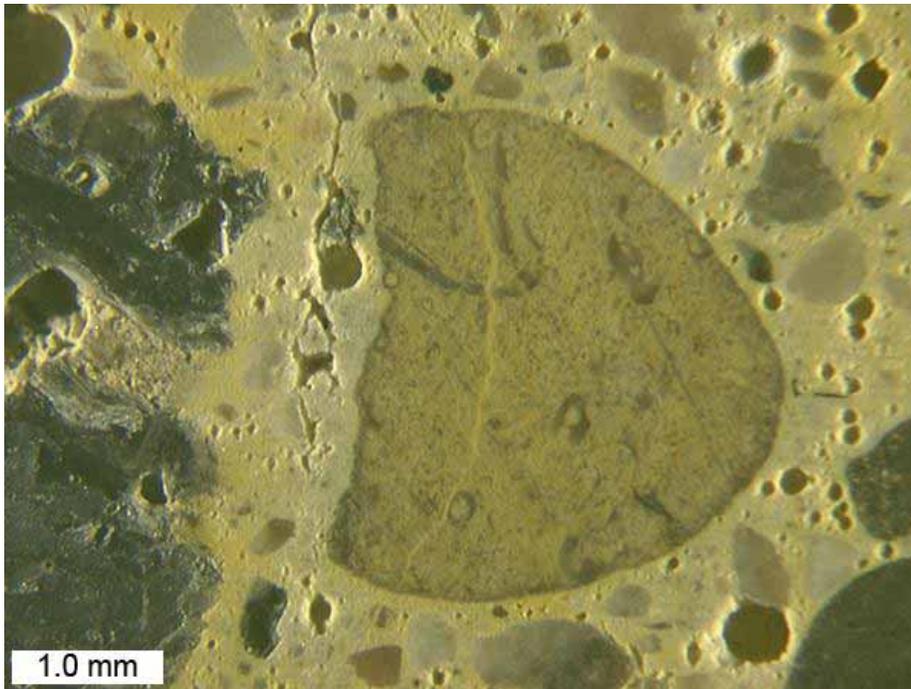
Alkali silica reaction in fine aggregate and associated cracking, before and after sodium cobaltinitrite stain, polished slab from I-696, constructed 1995, away from transverse joint, top half of core D, MTU ID 696-12.

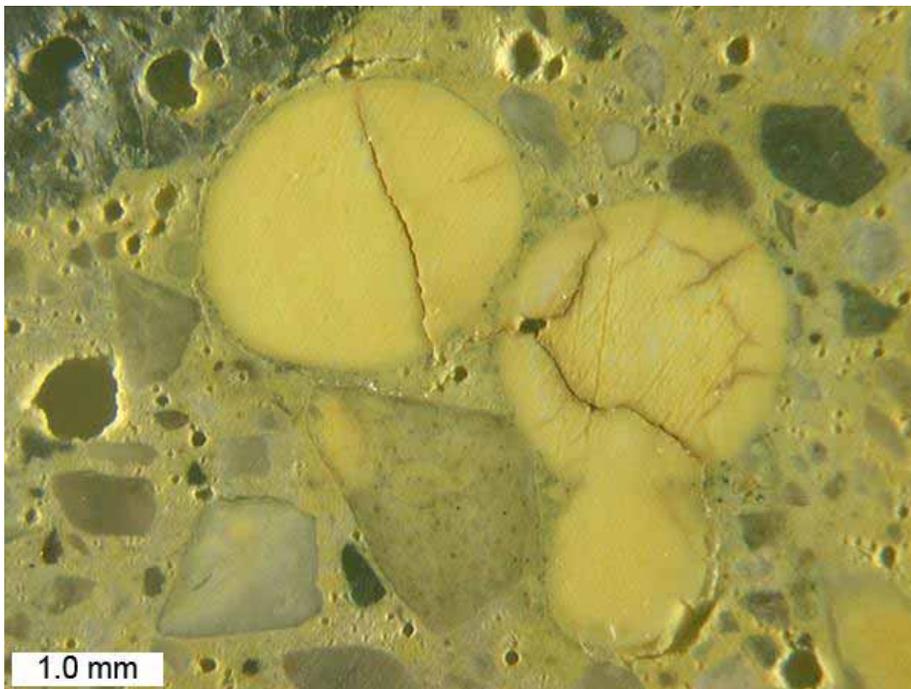
Alkali silica reaction in fine aggregate and adjacent voids filled with reaction product, before and after sodium cobaltinitrite stain, polished slab from I-696, constructed 1995, away from transverse joint, top half of core D, MTU ID 696-12.

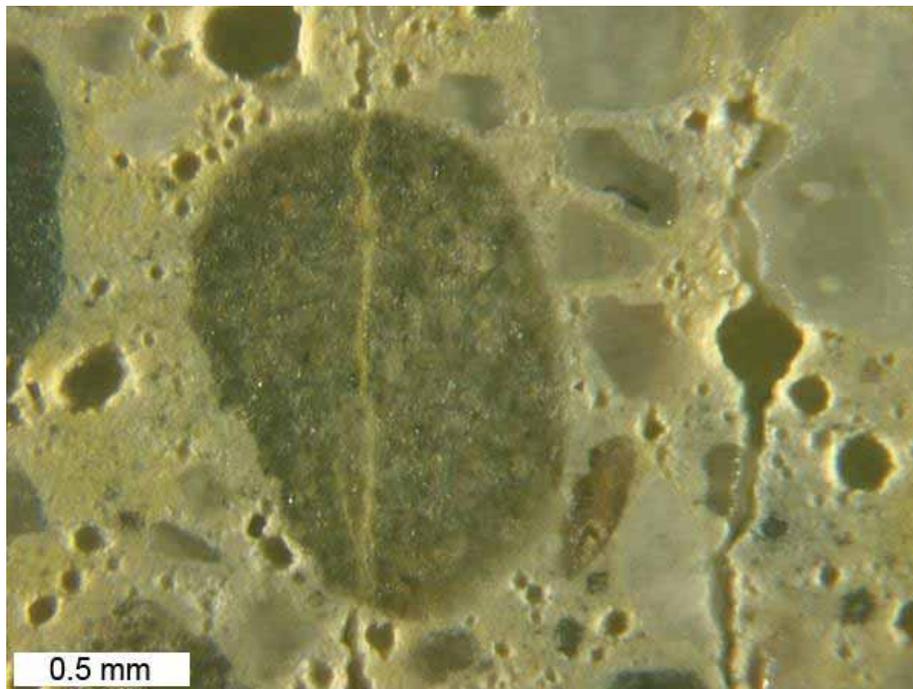
Alkali silica reaction in fine aggregate and associated cracking, before and after sodium cobaltinitrite stain, polished slab from I-696, constructed 1995, away from transverse joint, top half of core D, MTU ID 696-12.

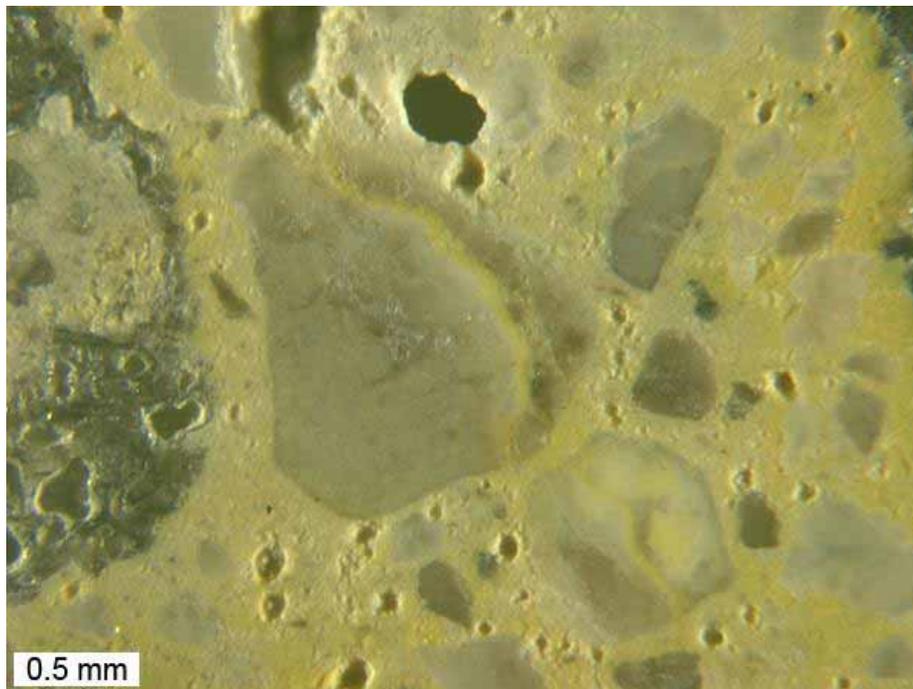
Alkali silica reaction in fine aggregate and associated cracking, before and after sodium cobaltinitrite stain, polished slab from I-696, constructed 1995, away from transverse joint, top half of core D, MTU ID 696-12.

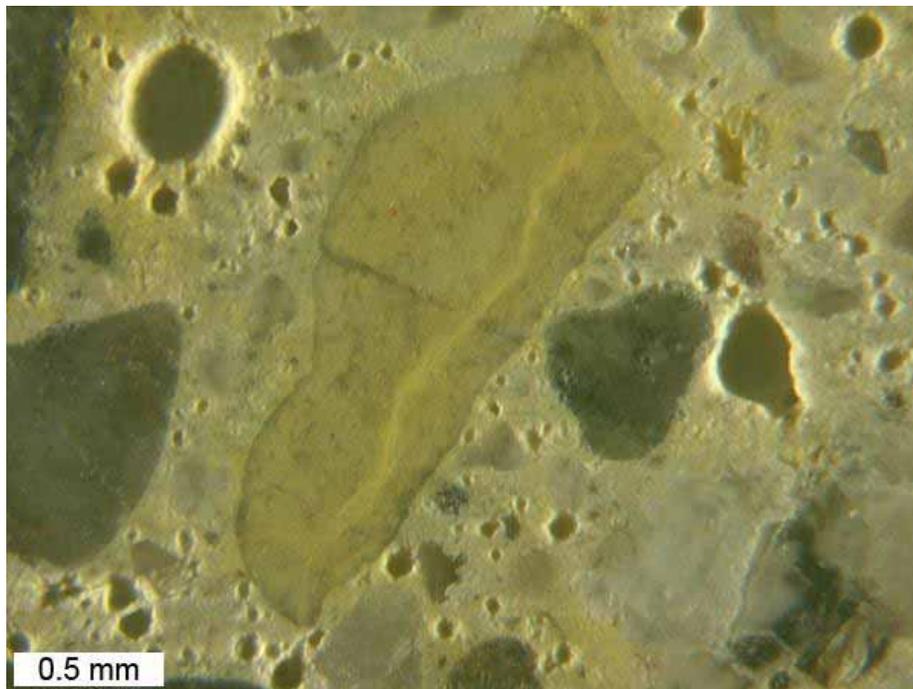
Alkali silica reaction in fine aggregate and associated cracking, before and after sodium cobaltinitrite stain, polished slab from I-696, constructed 1995, away from transverse joint, top half of core D, MTU ID 696-12.

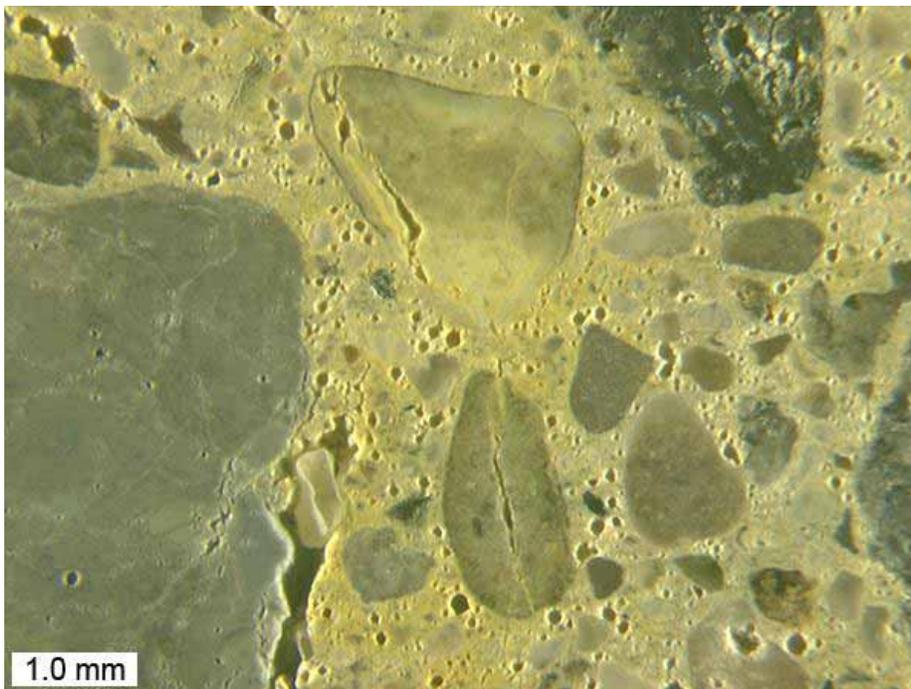
Alkali silica reaction in fine aggregate and associated cracking, before and after sodium cobaltinitrite stain, polished slab from I-696, constructed 1995, away from transverse joint, top half of core D, MTU ID 696-12.

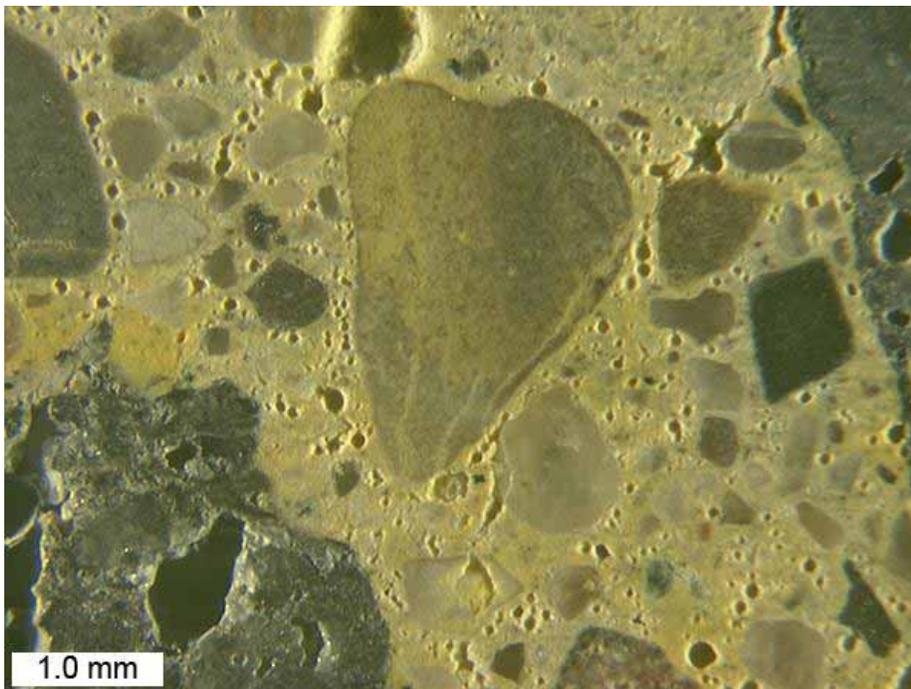
Alkali silica reaction in fine aggregate and associated cracking, before and after sodium cobaltinitrite stain, polished slab from I-696, constructed 1995, away from transverse joint, top half of core D, MTU ID 696-12.

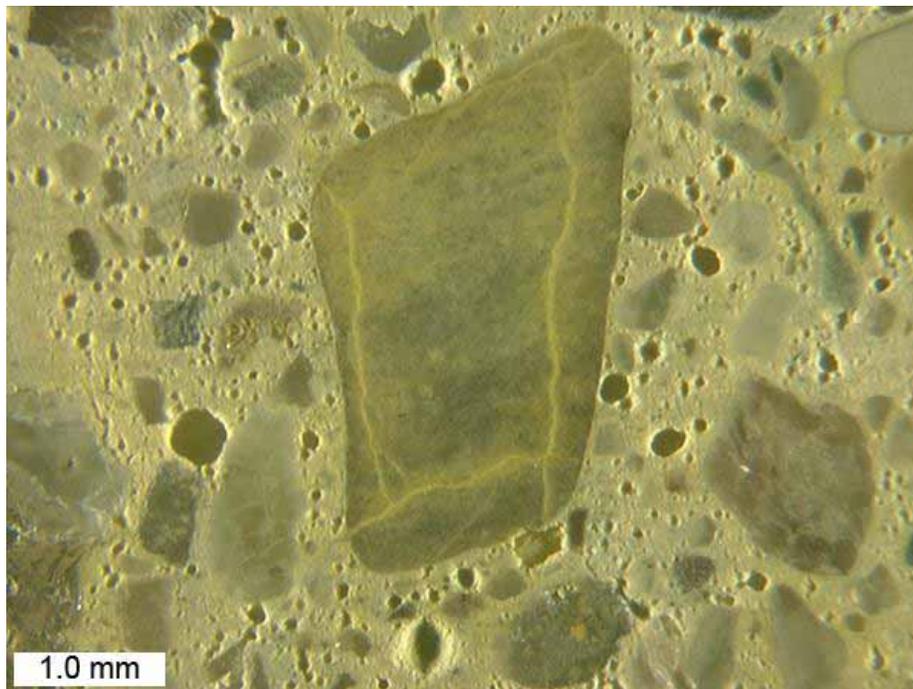
Alkali silica reaction in fine aggregate and associated cracking, before and after sodium cobaltinitrite stain, polished slab from I-696, constructed 1995, away from transverse joint, bottom half of core D, MTU ID 696-12.

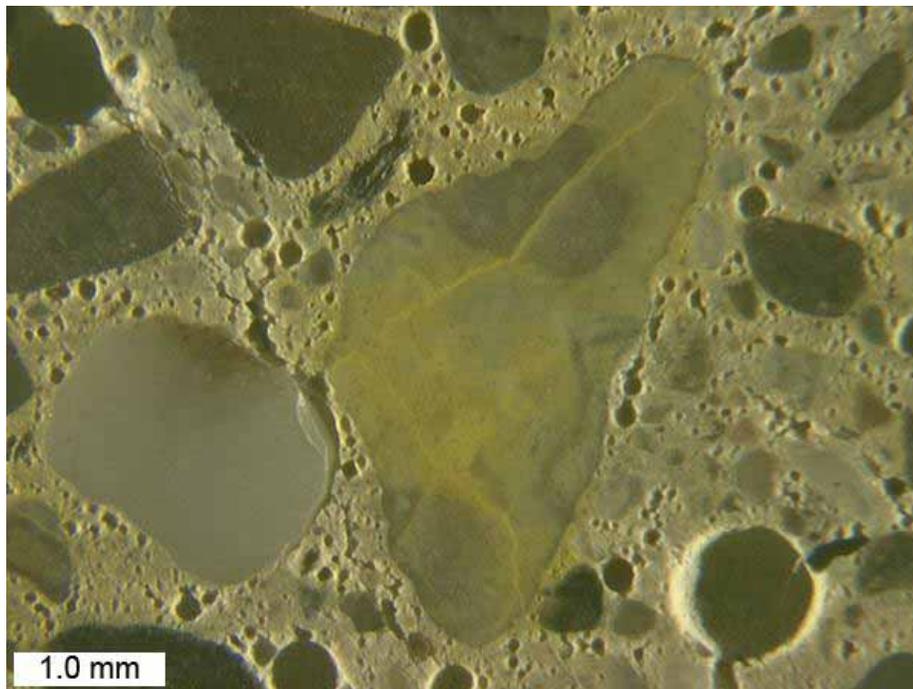
Alkali silica reaction in fine aggregate and associated cracking, before and after sodium cobaltinitrite stain, polished slab from I-696, constructed 1995, away from transverse joint, bottom half of core D, MTU ID 696-12.

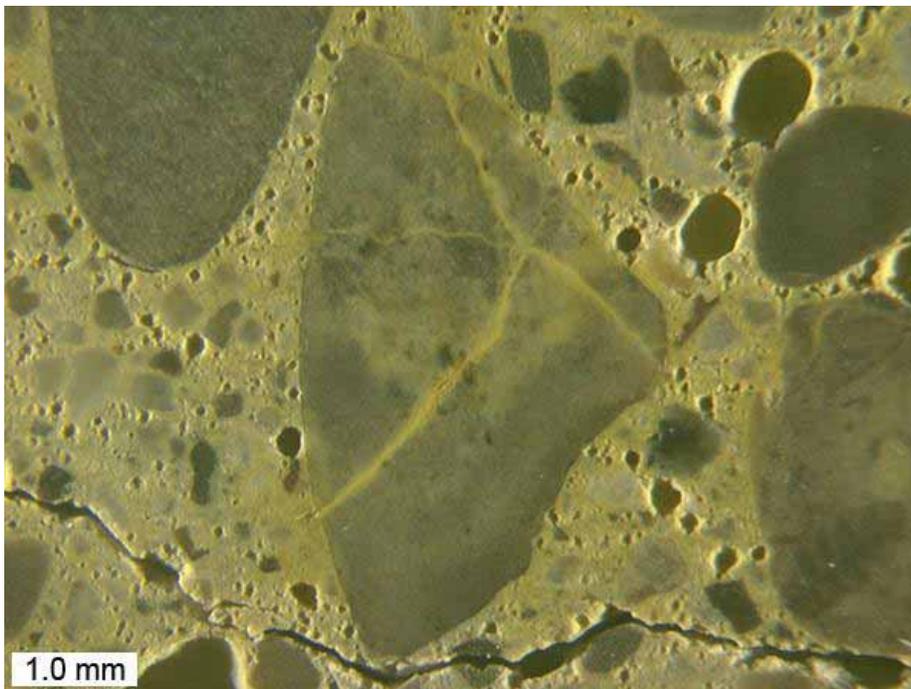
Alkali silica reaction in fine aggregate and associated cracking, before and after sodium cobaltinitrite stain, polished slab from I-696, constructed 1995, away from transverse joint, bottom half of core D, MTU ID 696-12.

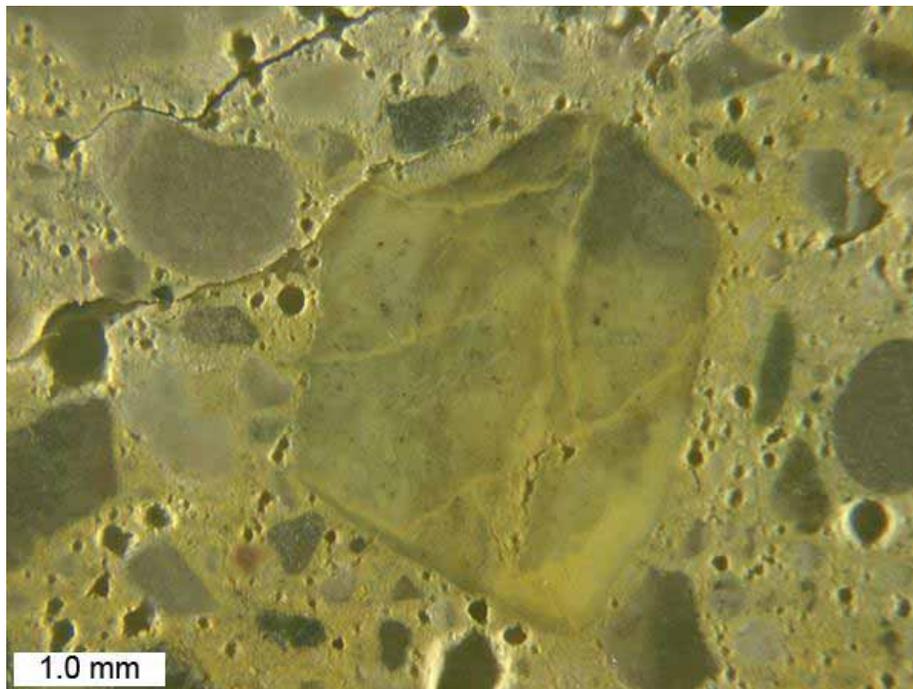
Alkali silica reaction in fine aggregate and associated cracking, before and after sodium cobaltinitrite stain, polished slab from I-696, constructed 1995, away from transverse joint, bottom half of core D, MTU ID 696-12.

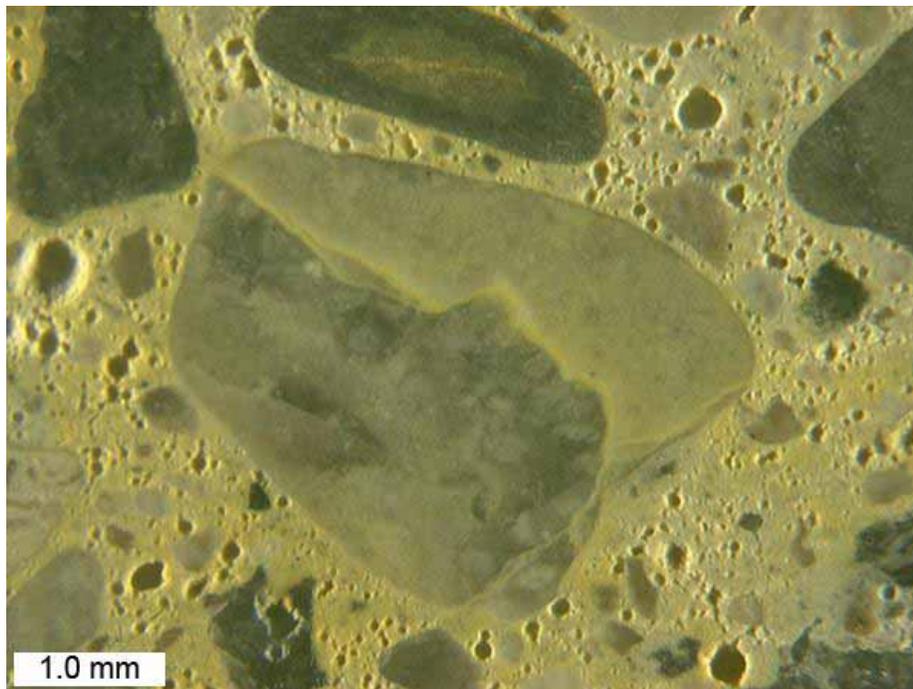
Alkali silica reaction in fine aggregate and associated cracking, before and after sodium cobaltinitrite stain, polished slab from I-696, constructed 1995, away from transverse joint, bottom half of core D, MTU ID 696-12.

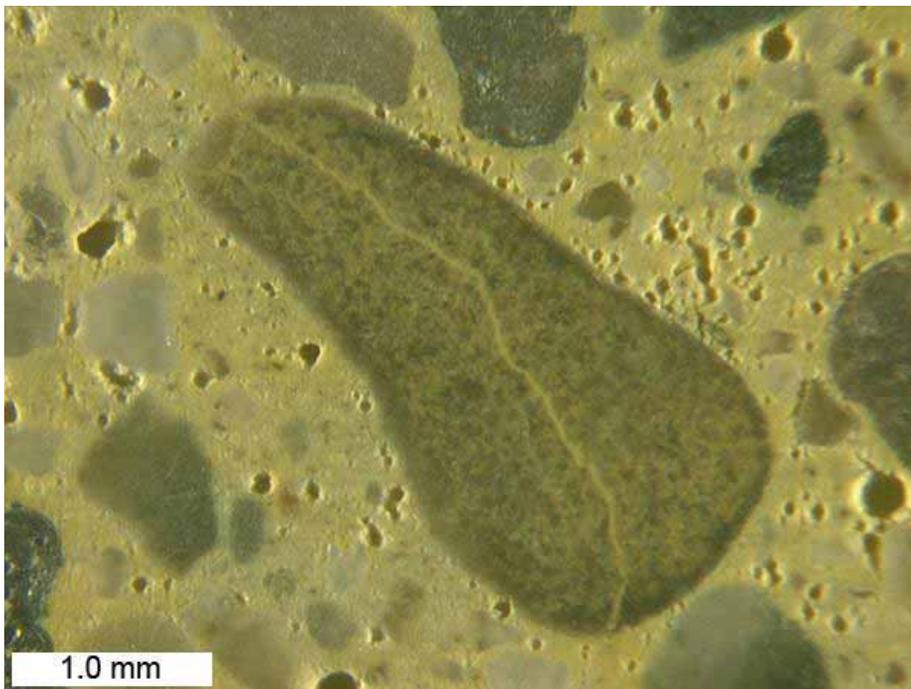
Alkali silica reaction in fine aggregate and associated cracking, before and after sodium cobaltinitrite stain, polished slab from I-696, constructed 1995, away from transverse joint, bottom half of core D, MTU ID 696-12.

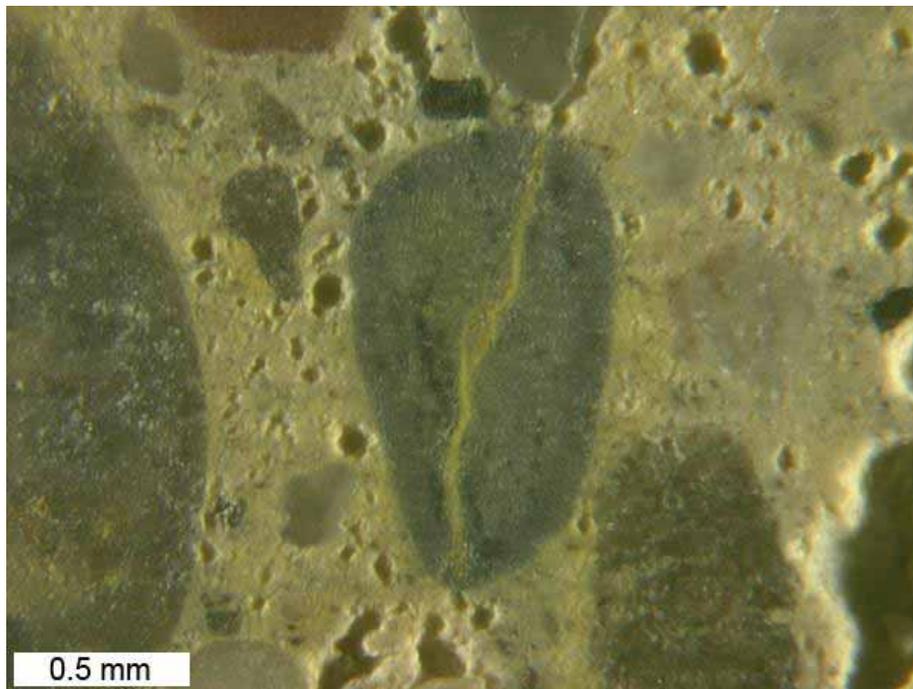
Alkali silica reaction in fine aggregate and associated cracking, before and after sodium cobaltinitrite stain, polished slab from I-696, constructed 1995, away from transverse joint, bottom half of core D, MTU ID 696-12.

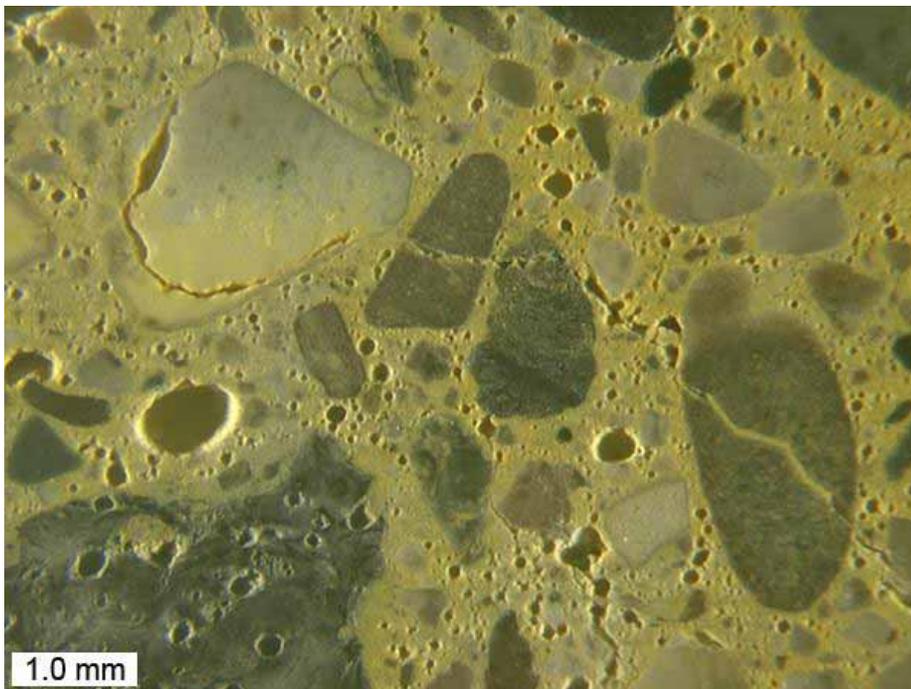
Alkali silica reaction in fine aggregate and associated cracking, before and after sodium cobaltinitrite stain, polished slab from I-696, constructed 1995, away from transverse joint, bottom half of core D, MTU ID 696-12.

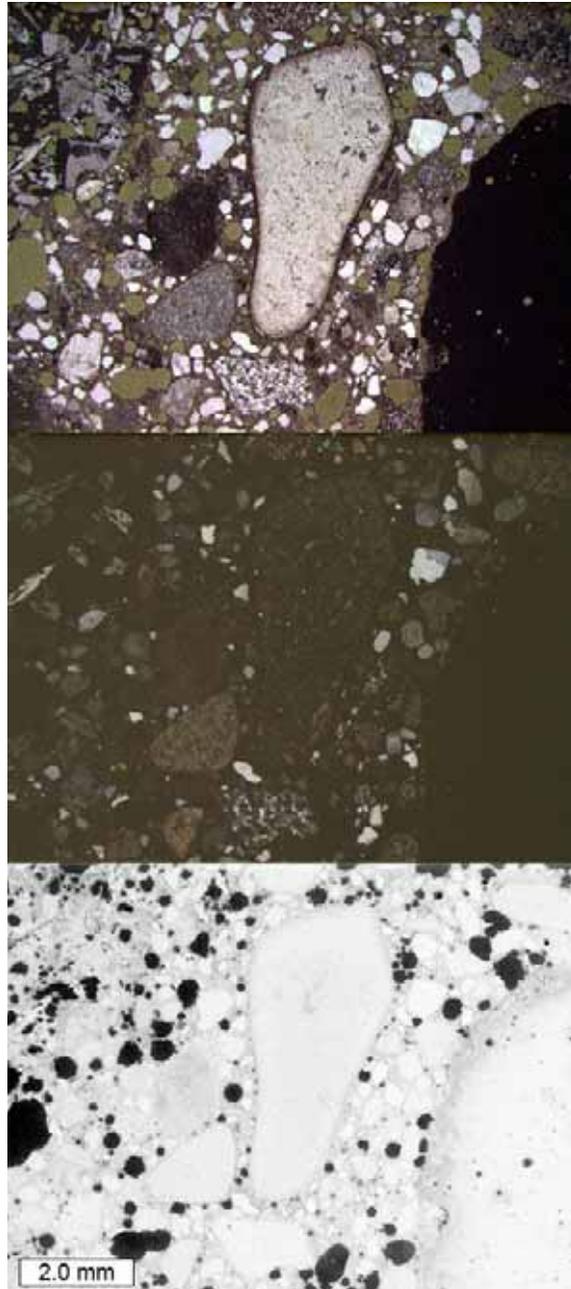
Example of chert particle exhibiting alkali-silica reaction without any associated cracking, from thin section prepared from core from I-696, constructed 1978, at transverse joint, MTU ID 696-07. From top to bottom: transmitted light, crossed-polars, and epifluorescent mode images.

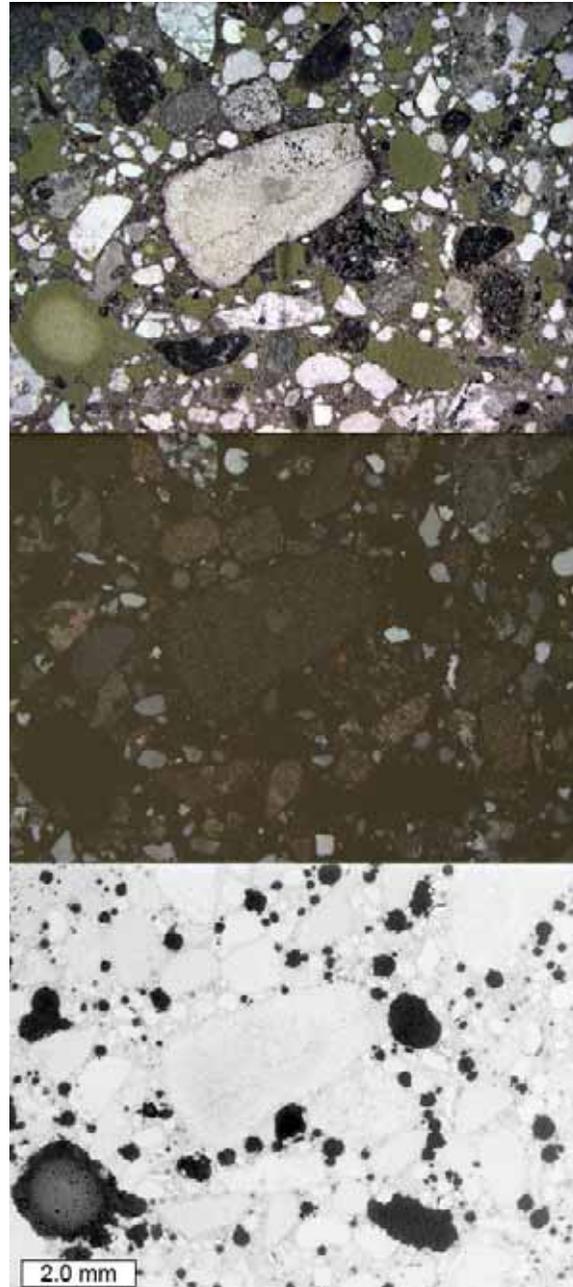
Example of chert particle exhibiting alkali-silica reaction with minor cracking within particle, from thin section prepared from core from I-696, constructed 1978, at transverse joint, MTU ID 696-07. From top to bottom: transmitted light, crossed-polars, and epifluorescent mode images.
