MICHIGAN  
STATE HIGHWAY DEPARTMENT  
Charles M. Ziegler  
State Highway Commissioner

METCOSEAL  
A PROTECTIVE COATING FOR STRUCTURAL STEEL

Research Project 49 G-50 (1)

Research Laboratory  
Testing and Research Division  
Report No. 263  
August 23, 1956

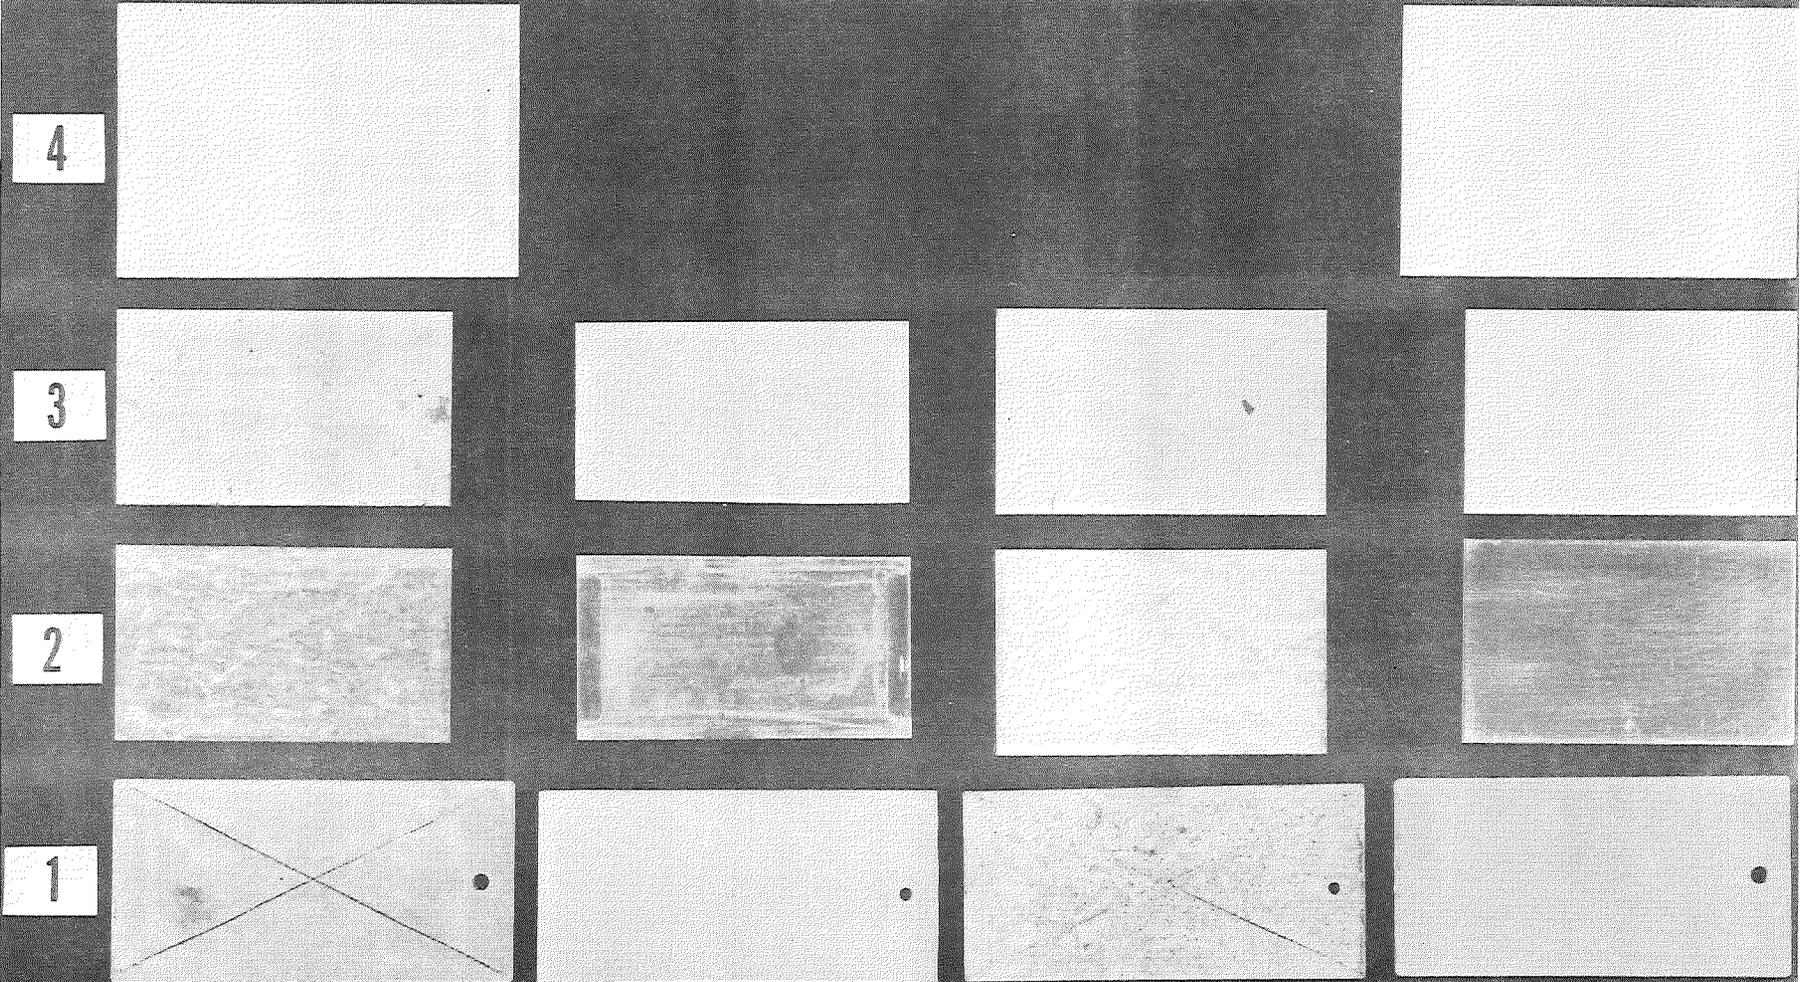
FIGURE 1 TEST PANELS

The ratings of the systems in the salt-spray test, together with comments are given in Table 2. Photographs of the tested panels are shown in Figure 1.

The ratings of the test systems in the accelerated weathering tests are also given in Table 2. Photographs of the tested panels are shown in Figure 1.

Test System No.	Salt Spray 300 - hours		Weather-Ometer 400 - hours		Alternating Salt Spray and Weather-Ometer 700 - hours	
	Rating*	Comments	Rating*	Comments	Rating*	Comments
1**	4	Panel covered with some white corrosion products, plus a little yellow stain.	9	Slight bleaching	6	Yellow staining along cross-scratches due to sealer degradation.
2	3	Panel covered with white corrosion products	7	Slight uneven corrosion and loss of brightness - not un-sightly.	5	Panel covered with some white corrosion products and yellow staining.
3	7	Some blistering along cross-scratches.	8	Dulling of applied surface coating.	6	Slight corrosion of metal base where applied finish blistered.
4	-		-		8	Appearance of some small localized points of corrosion.
Test System No.	Automobile Fender-Well Exposure				Field Exposure

The entire test included a total of 500 hours of Weather-Ometer exposure and 200 hours of salt spray exposure. The ratings of the systems in the alternating accelerated weathering and salt spray tests are also given in Table 2. Photographs of the tested panels are shown in Figure 1.

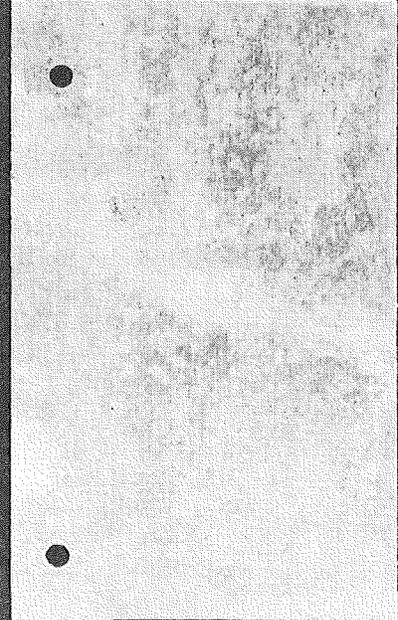
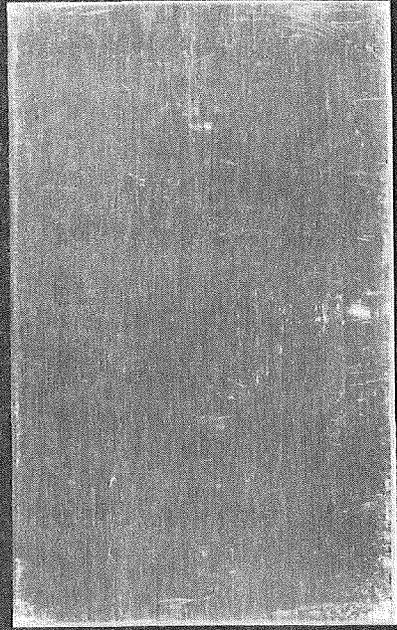
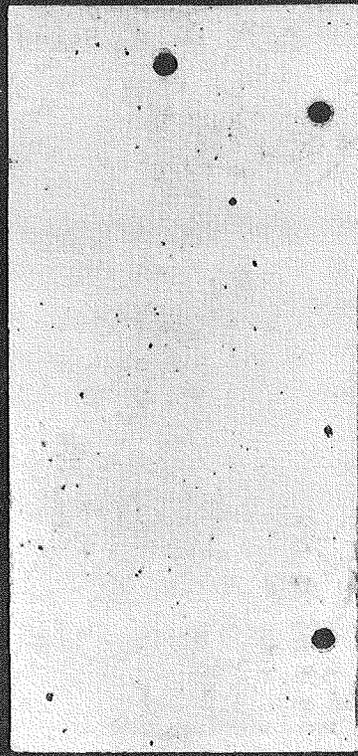
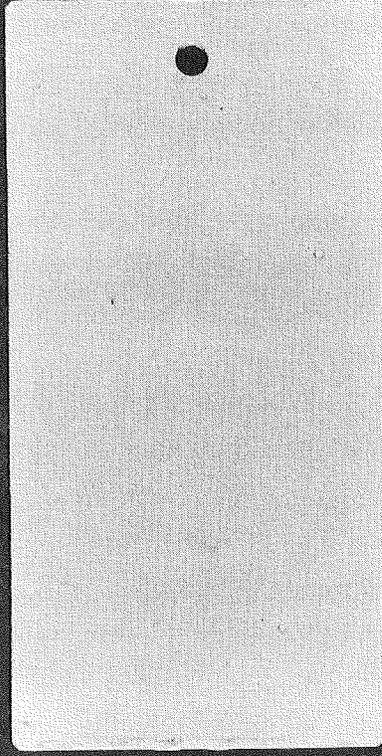
FIGURE 2 TEST PANELS

Examination of the two panels after removal showed that under these conditions, the aluminum alloy System No. 2, exhibited an uneven, light formation of white corrosion products. The Metcoseal-treated panel, although not corroded, exhibited a spotty, light-brown surface deposit which, because it was soluble in and removable with organic solvents, was considered to be a degradation product of the silicone sealer used in the treatment.

Upon removal, the panels were found to be coated with a heavy layer of wet sand. It is not known whether the adhering sand functioned as a protective layer for the panels, but the Metcoseal panel was essentially unchanged while the aluminum System No. 2 showed a slight increase of surface corrosion during the additional 3-3/4 months of exposure. Figure 2 shows the condition of these panels.

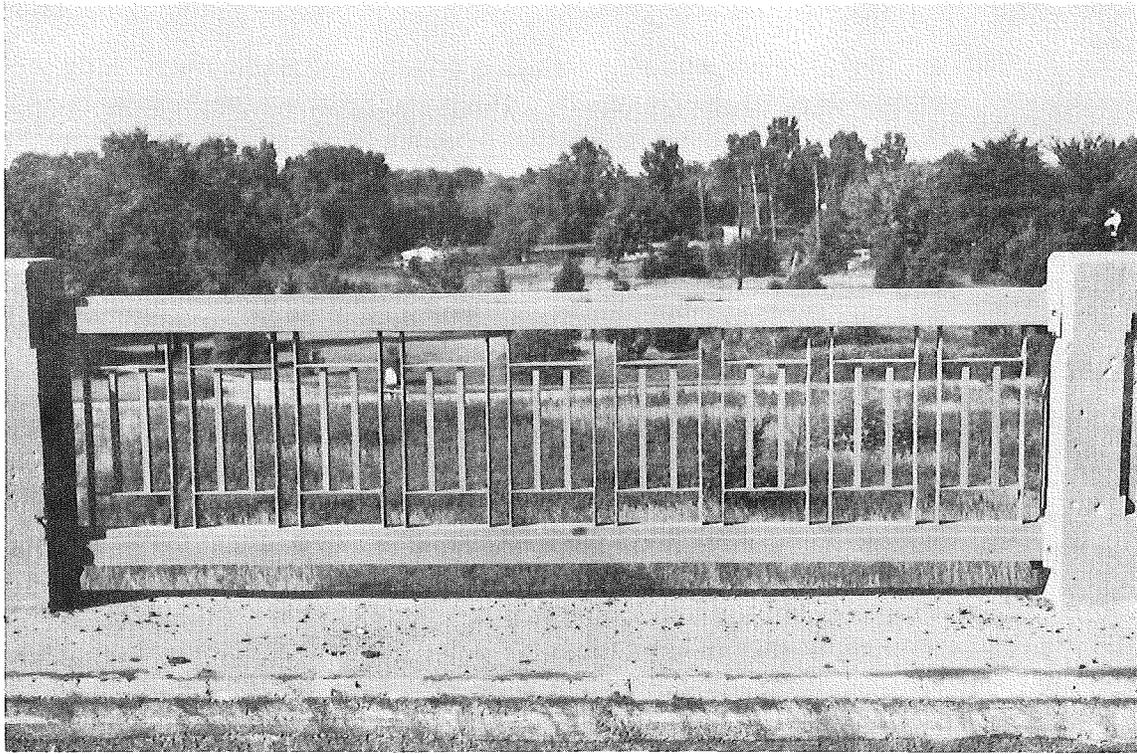
▲ FIGURE 3. PRELIMINARY FIELD EXPOSURE OF METCOSEAL PROCESSED BRIDGE RAILING.

Mr. S. Cardone arranged to have one section of bridge railing which was Metcoseal-treated installed in October, 1955 on the southwest portion of the grade separation over PMRR on Highway US-16 just west of Lansing. Examinations of this test railing, shown in Figure 3, in the first half of 1956 have revealed the following:

- a) The Metcoseal metallizing treatment, because it produces a rough, matte finish, is more dirt retentive than paint-type coatings.

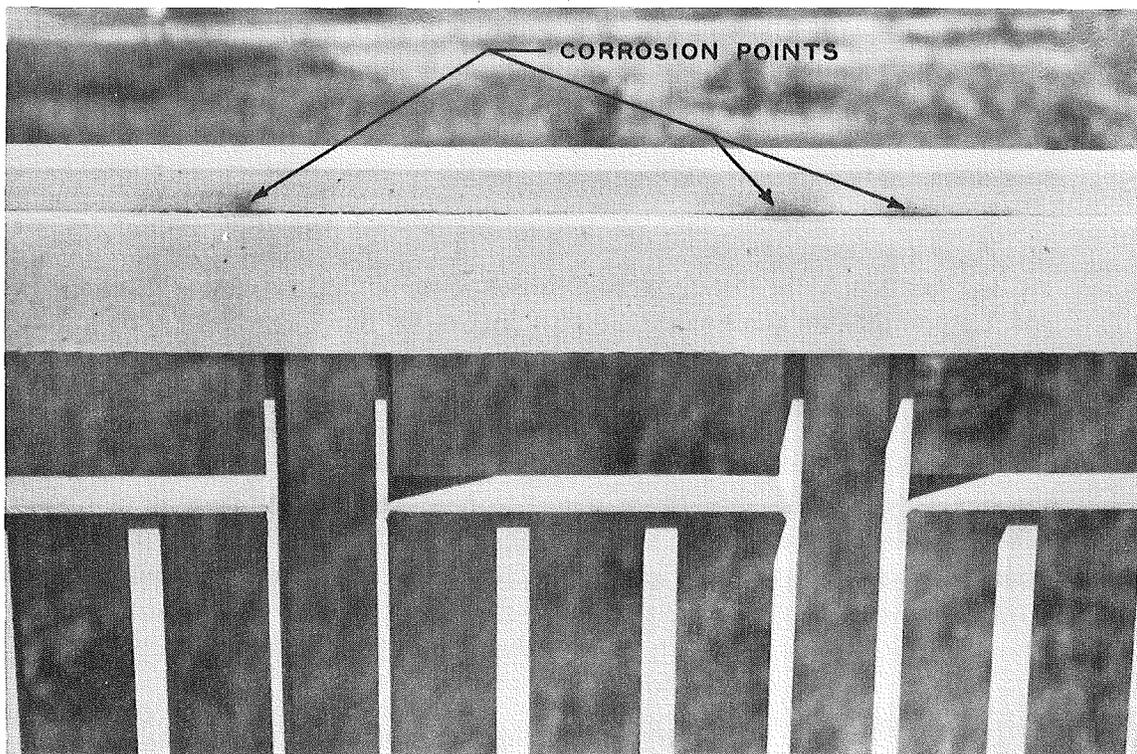
▲ FIGURE 4. INCIPIENT CORROSION AT JUNCTURES OF TOP RAIL SUB-MEMBERS OF METCOSEAL PROCESSED BRIDGE RAILING. EMPLACED OCTOBER, 1955. PHOTOGRAPH TAKEN JULY 6, 1956.

b) Light-brown staining was in evidence and was progressing slowly with time (Figure 4). The staining was analyzed as being due both to a degradation product of the organic sealer used in the treatment and to corrosion of the steel base metal at juncture points on the sub-members of the top rail, which could not be sealed properly by this treatment when applied on assembled railing units.

A preliminary surface exposure of one Metcoseal-treated bridge railing section shows early initial breakdown of that coating system only at juncture points on the top rail. The failure as measured by corroded area has increased during the six-to-nine month period of exposure. The relatively short period of the service exposure test for the Metcoseal coating system yields too little information to allow a prediction of the service life for such coatings. Except at the juncture cracks present in the top rail, the service life of a Metcoseal metallic coating (similar in type to a galvanized coating), is expected to be greater than that of the paint-type coatings currently being used on railings; the Metcoseal coating is thicker, more durable, more chip and scratch resistant, and also is capable of protecting small breaks by an anodic type of electrochemical reaction.

It should be noted here that the problem of maintaining a coating or a metallic finish on bridge railings would be alleviated, if the present design were altered to eliminate the many sharp edges and 90-deg. angles which in service so often become focal points for corrosion.
