**DETERIORATION OF CONCRETE HIGHWAYS AND BRIDGES
CONTAINING BIG CUT PIT AGGREGATES**

Research Laboratory Division
Office of Testing and Research
Report No. 332
Research Project 59 A-19

Michigan State Highway Department
John C. Mackie, Commissioner
Lansing, June 1960

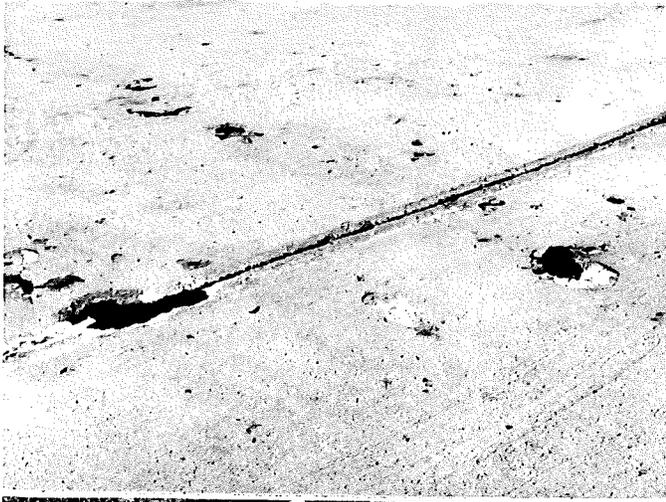
Figure 2

Located on M 76 in Roscommon County approximately 1.0 mi northwest of St. Helens, this structure was built in 1949. The superstructure has medium to heavy popouts, with some disintegration of railing posts. Typical popouts are shown on the deck surface (Fig. 2), curb (Fig. 3), and substructure wingwall (Fig. 4). FB 2 of 72-8-12, C1 (72092).

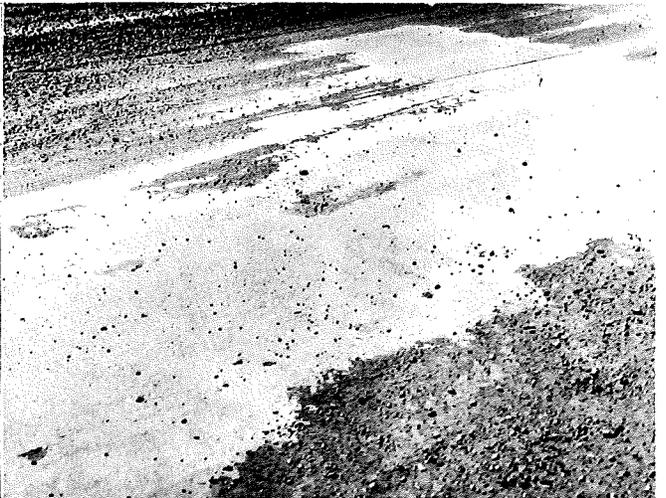
Figure 6

This 1949 structure lies on a Cheboygan county road in the southeast corner of the Village of Wolverine. Although the substructure is in good condition and free of popouts, the deck displays this light pop-out condition. CSB1 of 16-16-14, C1

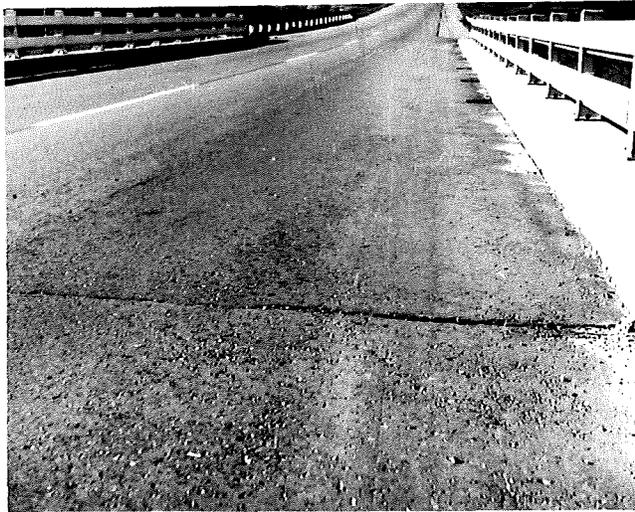
▲ Figure 7. Located on M 65 in Iosco County, 1.5 mi north of the Whittemore Village limit, the deck of this 1950 structure has been covered with bituminous concrete. Curbs, posts, and substructure are in excellent condition with no popouts. SSB1 of 35-8-1, C2 (35011)

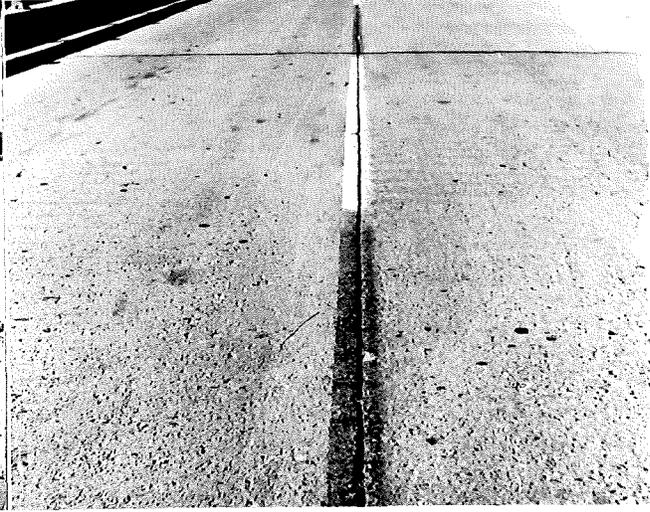
▲ Figure 8. Also on M 65 in Iosco County, 2.7 mi north of the Arenac County line, this 1950 structure has numerous small popouts on the deck, although the other surfaces are good. SSB1 of 35-4-1, C2 (35011)

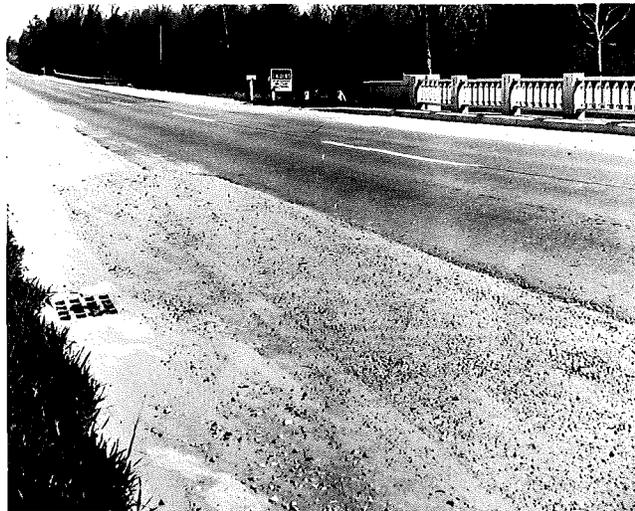
◀ Figure 9

This bridge, built in 1951, is on M 33 in Montmorency County, 3.8 mi south of the junction with M 32. The general view (Fig. 9) shows that the center deck lanes have been covered with bituminous concrete; however, a fairly heavy frequency of popouts and light scale are found on the exposed deck surface (Fig. 10). The substructure has light traces of popout action, as may be seen on the wingwall (Fig. 11). SSB1 of 60-5-1, C1 (60011)

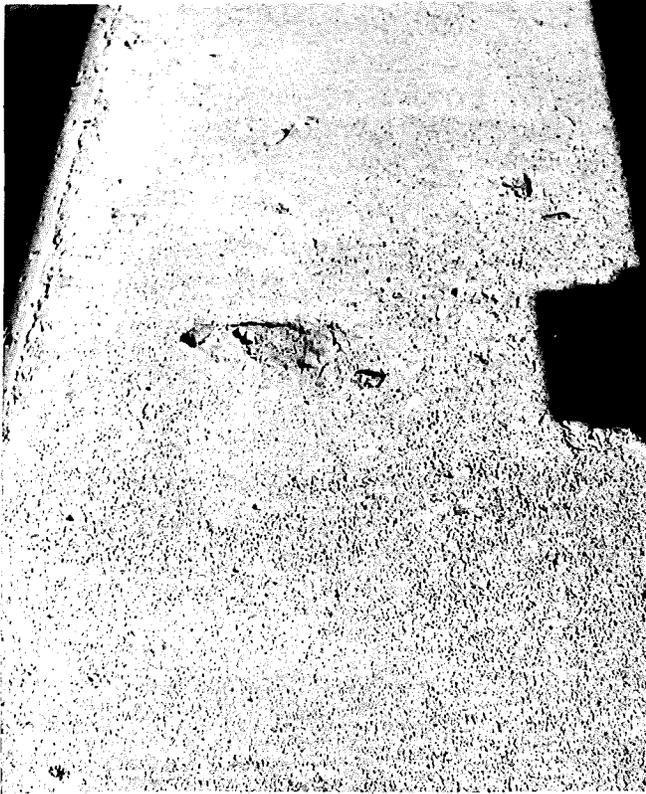
▲ Figure 12.

Located on south Cedar St. (US 27) in Lansing, this bridge was constructed in 1951. The deck surface has light to medium incidence of popouts. Walks at railing post locations show evidence of popouts and scale (Figs. 12 and 13). UUGX3 of 33-6-1 (33032).

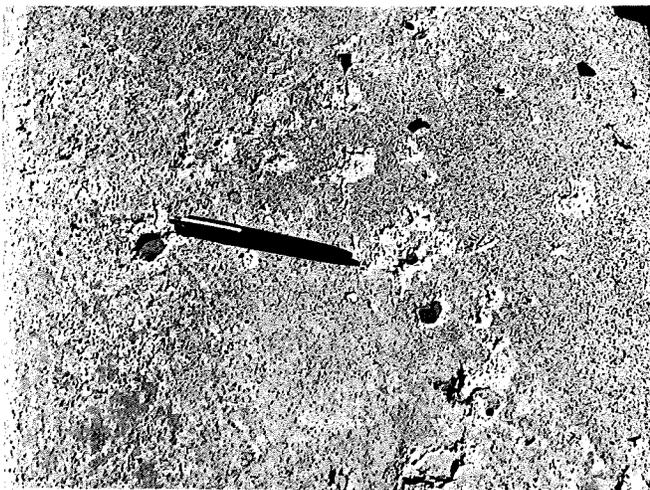
▲ Figure 14.

Constructed in 1951, this structure is on South St. in Lansing. The top surfaces of the wingwalls have medium to heavy popouts (Fig. 14), but the sub-structure is generally free of this type of deterioration. The tar found on the deck surface (Fig. 15) was tracked over from the approach road surfaces. UB1 of 33-6-36, C1.

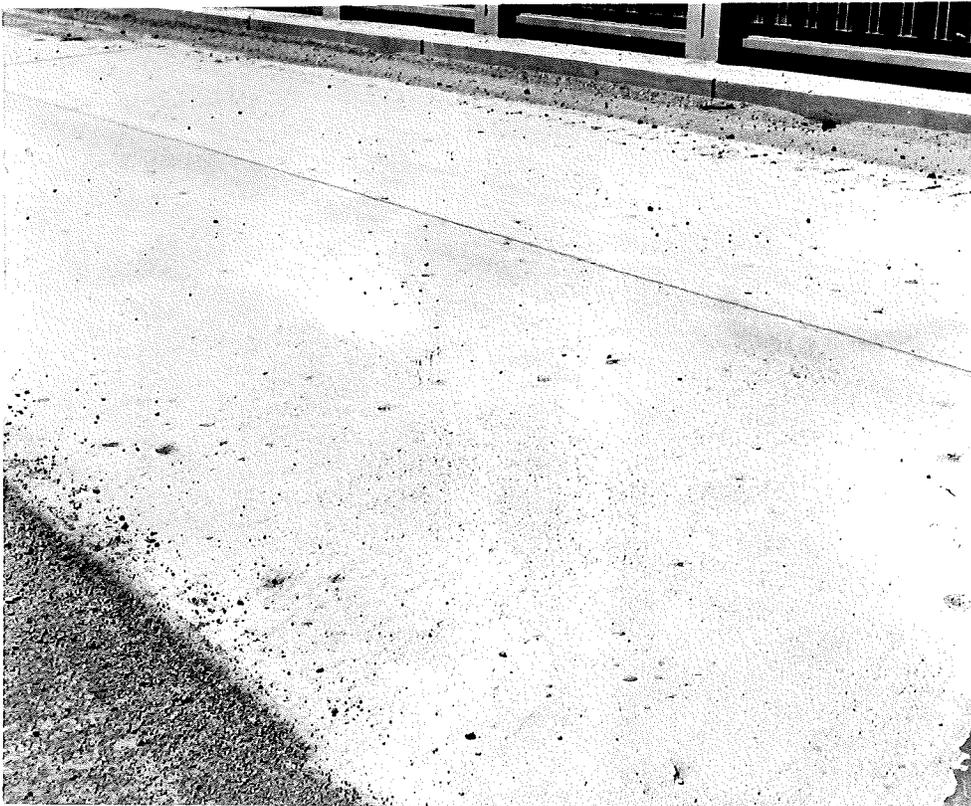
◀ Figure 16. Constructed in 1952 on M 65 in Alpena County, this structure is located about 7 mi south of the Presque Isle County line. The deck surface has medium to heavy incidence of popouts. The remaining surfaces are free of this defect. MB1 of 4-3-1, C1 (04012)

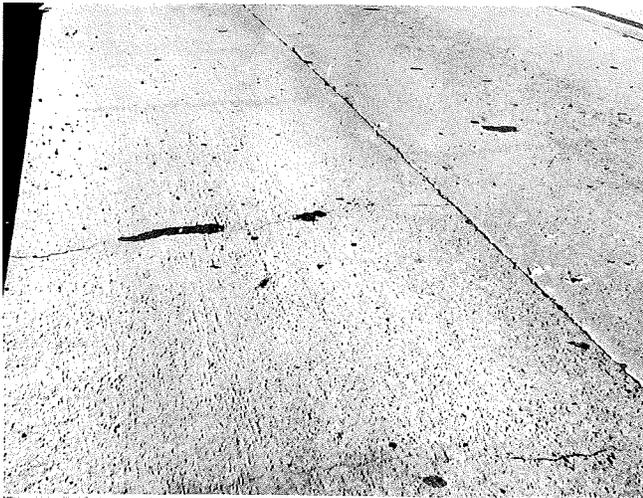
◀ Figure 17

This 1953 structure is located on US 16 (Grand River Ave.) in Lansing. The deck surface has light popouts (Figs. 17 and 18). Typical light scale on walks is shown in Fig. 19. Other surfaces are free of popouts. MB1 of 33-6-2, C1 (33081)

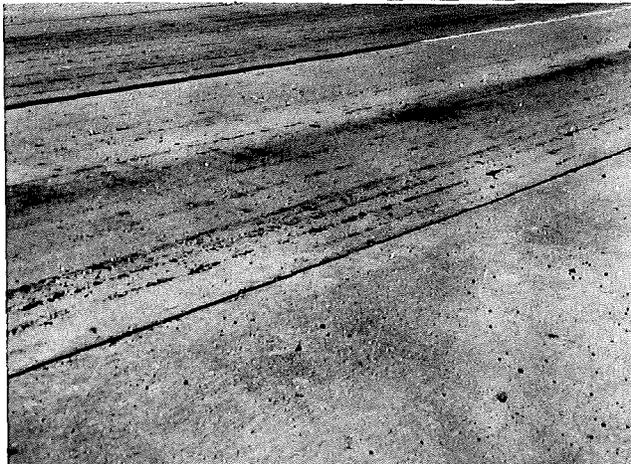
Figure 28. This 1954 structure is also located on M 68, 6.6 mi east of the Onaway village limit. A few small popouts are found on the deck surface, but other surfaces are free of this defect. FB1 of 71-5-2, C2R (71021).

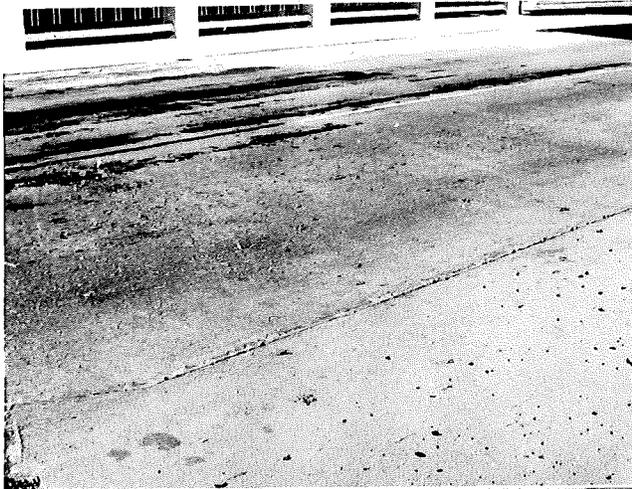
Figure 29. Small, scattered popouts are present only on the deck of this 1956 structure, located on M 171 in Alcona County, 5.8 mi south of the junction with M 72. SSB2 of 1-9-1, C3R (01031)

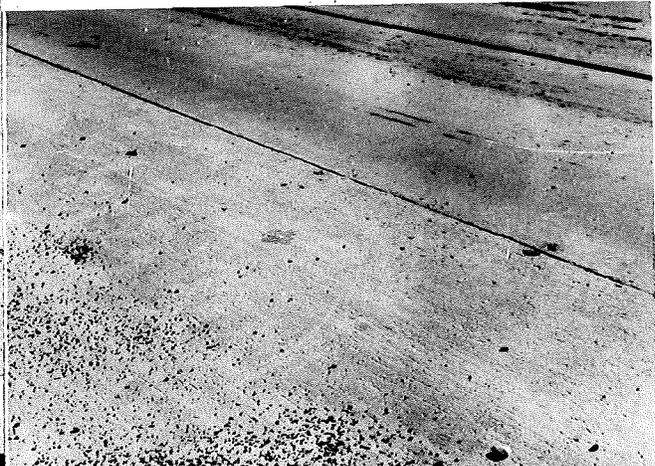
Figure 30. Another 1956 Alcona structure on M 171, 5.3 mi south of the M 72 junction, has light popouts on the deck surface, heavier popouts on curbs and railing posts, and a substructure free of deterioration. SSB3 of 1-9-1, C1R (01031)

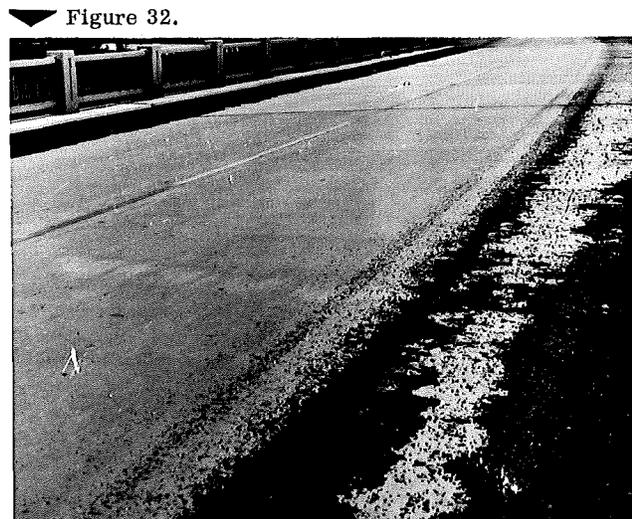
Figure 32.

This 1957 structure is in Gladwin County on M 30, 3.7 mi north of the junction with M 61. Although the general condition is good (Fig. 32) and the substructure excellent, scattered popouts are found on the deck and curbs. Cracked surface mortar is readily extracted from this concrete at popout locations (Fig. 33 before, Fig. 34 after). MB1 of 26-8-1, C2R (26032)

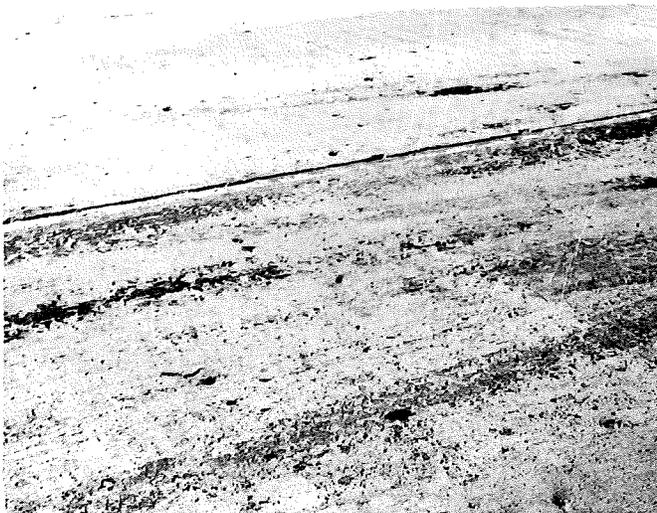
Figure 35

Another 1957 project, this structure is situated on M 33 in Cheboygan County, 0.2 mi south of the US 27 junction. The deck (Fig. 35) has some popouts, and curbs (Fig. 36) are in similar condition. One railing post displayed a notably large popout (Fig. 37). However, the substructure surfaces were in good condition. SSB1 of 16-3-1, C1R (16051)

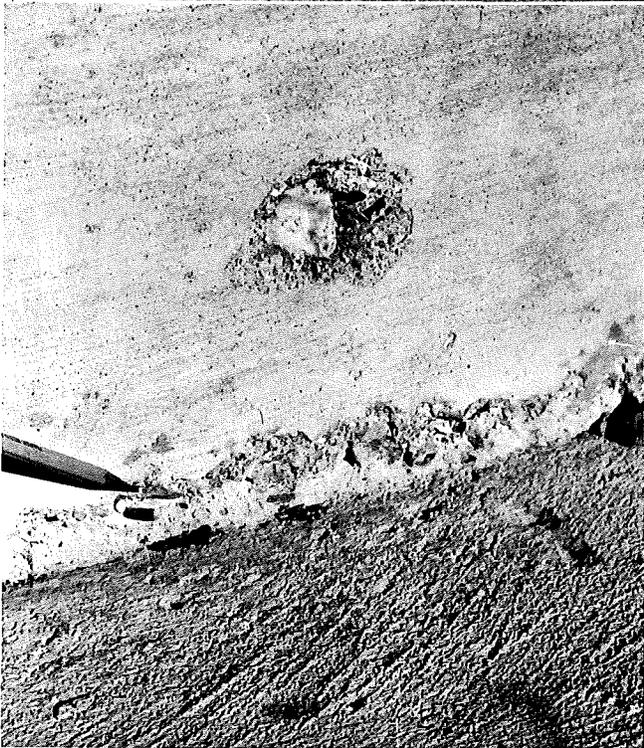
Figure 42

Popout action is occurring on the deck of this 1957 bridge on the new US 31 in Emmet County, part of the approach system for the Mackinac Bridge (Fig. 40). Figure 41 shows a deck popout, and Fig. 42 both a curb surface popout and the general deterioration at the curb base. The substructure was in very good condition. MB1 of 24-16-3, C1UN(24071)

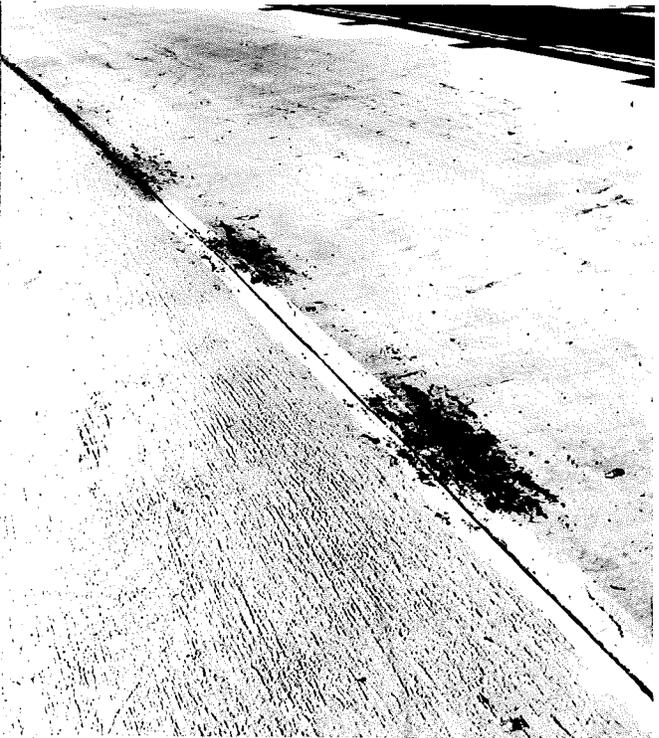
Figure 43. Nearby on US 31, another 1957 structure is in good condition, with only occasional popouts on the deck. MB2 of 24-16-3, C1 (24071)

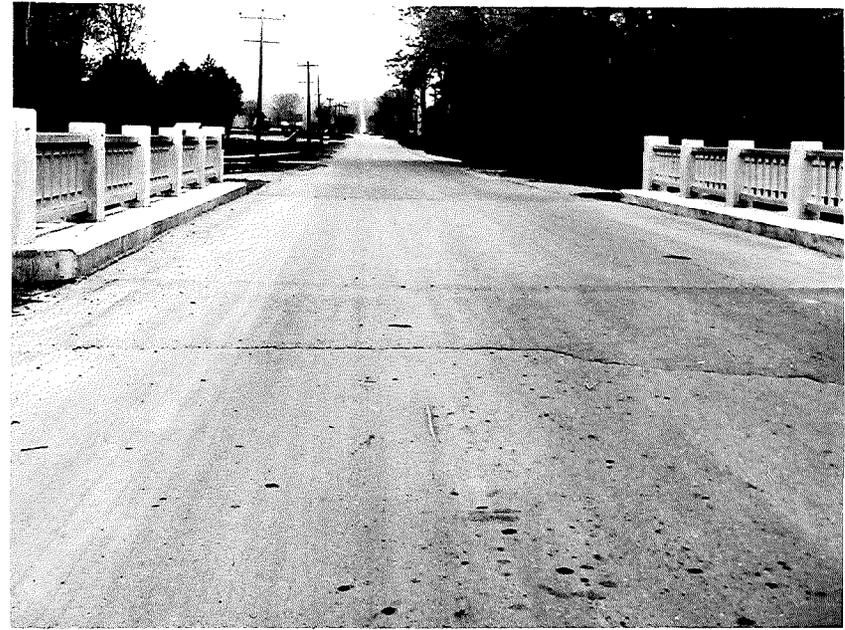
▲ Figure 52. Located on a Charlevoix County road in South Arm Twp., this bridge was built in 1958. The deck has been resurfaced with bituminous concrete, but all exposed surfaces have moderately frequent popouts. CSB1 of 15-13-24, C1R.

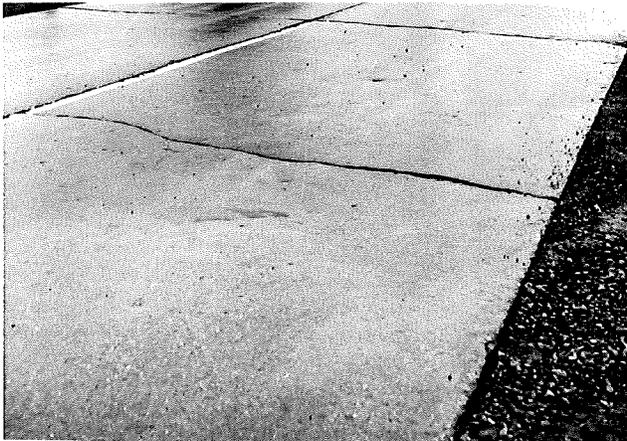
▲ Figure 59. On M 25 from the Bay City limits east to the Tuscola County line, 7.9 mi of 1925 pavement has light scale but remains free of popouts. M 9-13, C1 (09042)

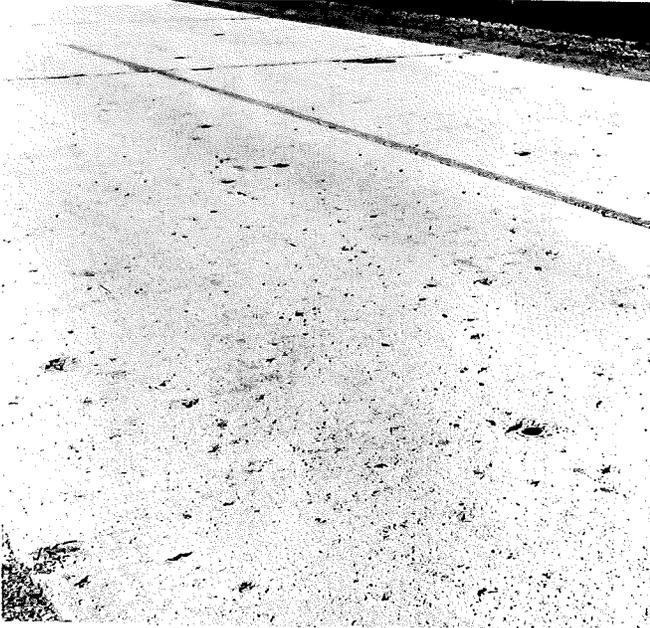
▲ Figure 61

In Alpena County on M 65, from the M32 junction north 1 mi, this 1930 project has moderate popouts (Figs. 61 and 62), and in one region, extensive longitudinal cracking (Fig. 63). M 4-12, C1 (04012)

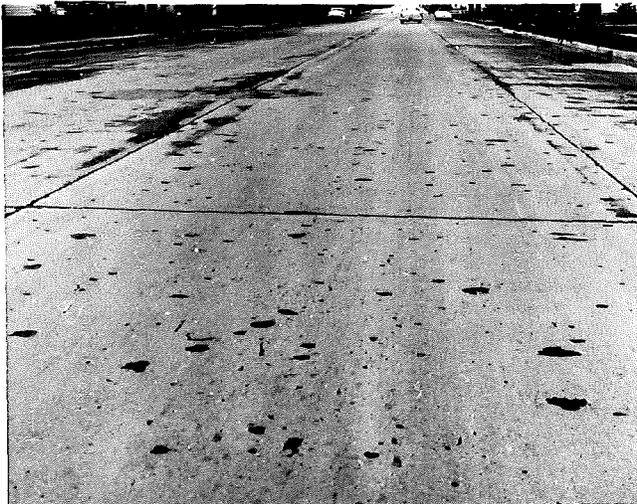
▲ Figure 80. In Arenac County at Standish, this 1950 pavement extends from the US 23 junction west for 0.4 mi. Popouts appear in fairly heavy concentration throughout the project. M 6-16, C1 (06021)

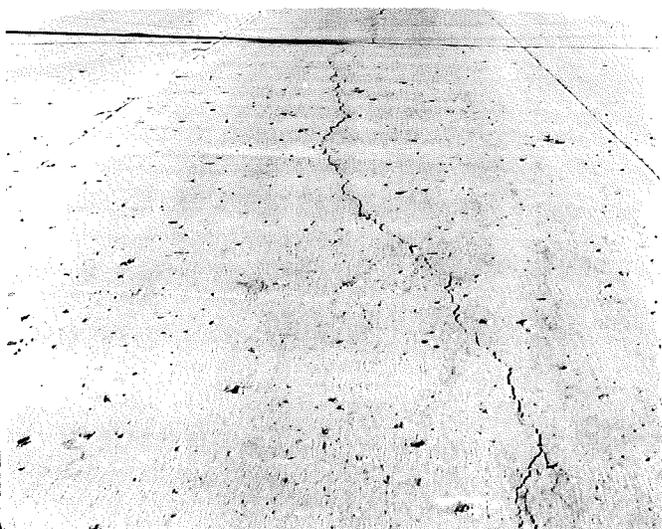
Figure 85

Located on US 23 — US 27 in Cheboygan, this 1956 project is 1.2 mi long. The entire surface is covered with heavy popouts. Note the longitudinal crack in Fig. 85. F 16-3, C2 (16033)
