PAVEMENT EVALUATION OF I-94 CONTROL SECTION 82021
Detroit Industrial Expressway from Rawsonville Road
(Washtenaw-Wayne County Line) to Hannan Road

Research Laboratory Division
Office of Testing and Research
Research Project R-39 F-7 (14)
Research Report No. R-465

Michigan State Highway Department
John C. Mackie, Commissioner
Lansing, July 1964

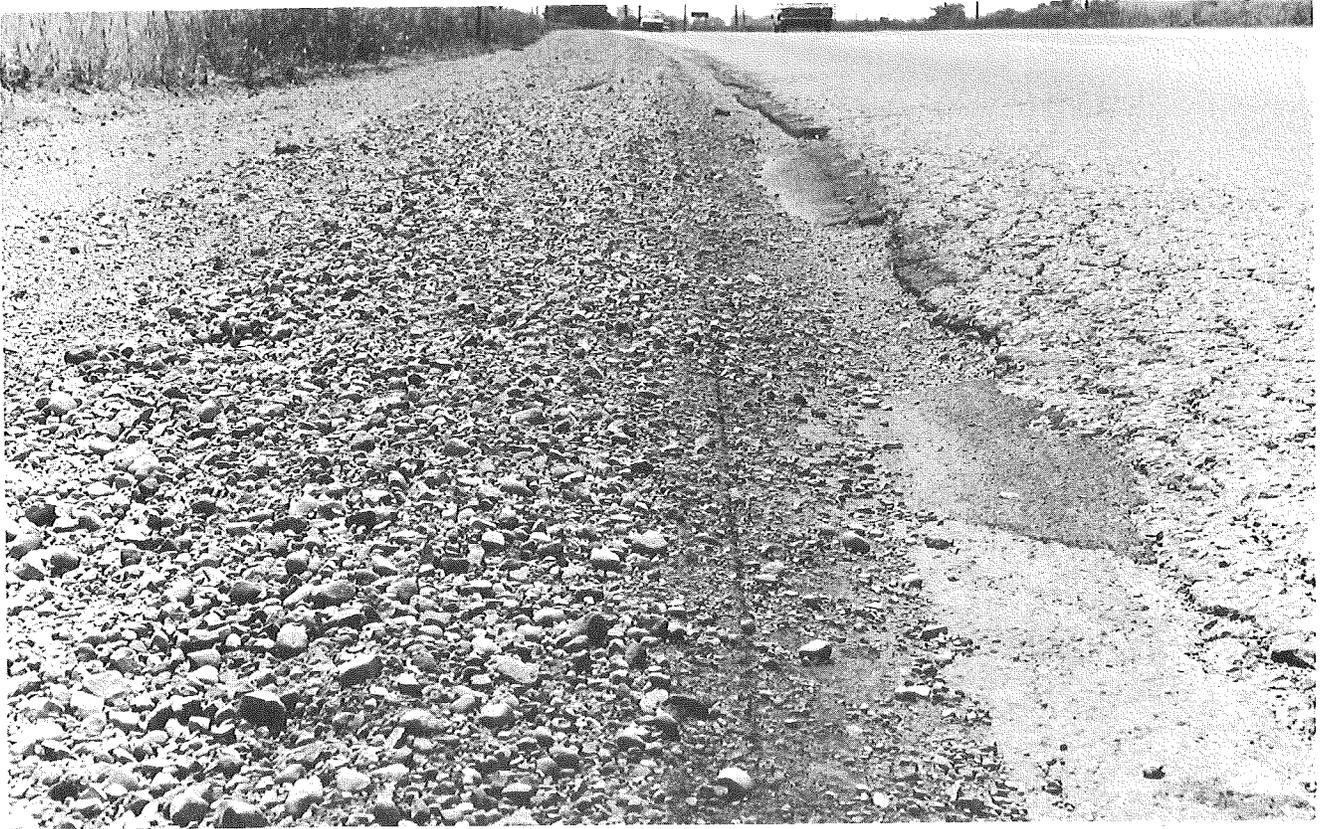
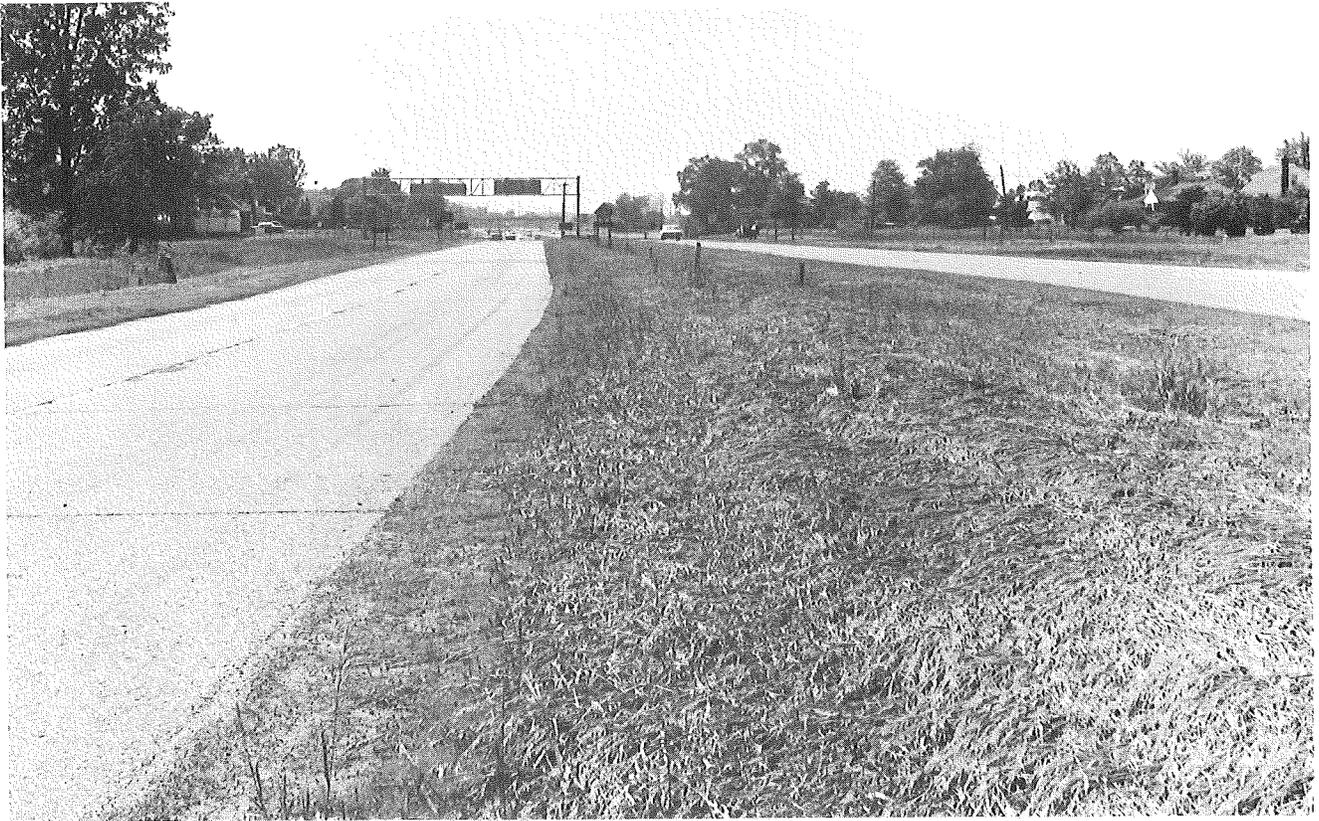
In the inspection and survey of the I 94 projects, it was evident that the pavement was poorly drained; the road bed was at a lower elevation than most of the adjacent area (Fig. 2). Although there were no load transfer dowels in the 1942 pavement projects and the slabs were only 20-ft long, no slab rocking was evident even when loaded by very large trucks.

Figure 2. Shoulder views illustrating poor drainage conditions.

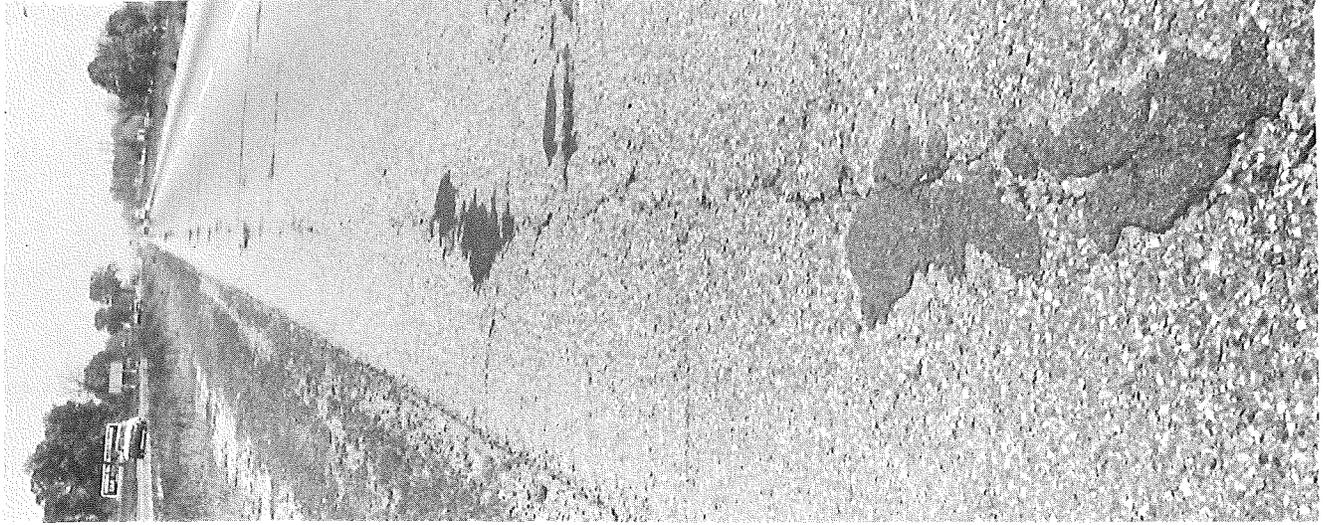
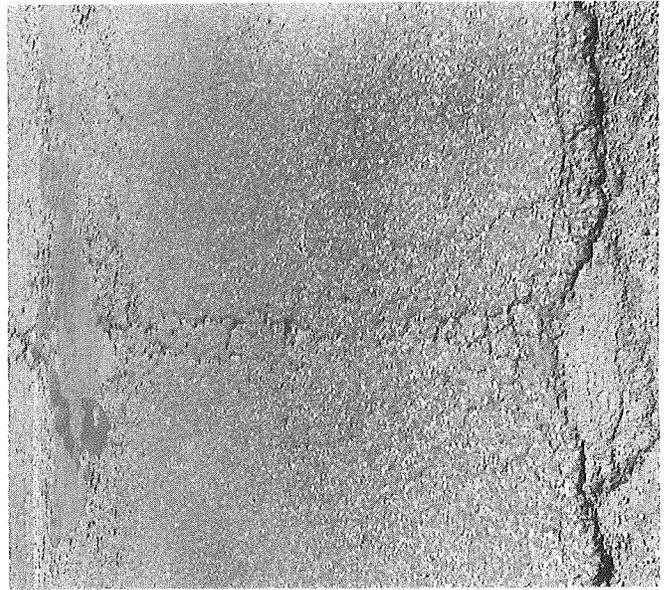
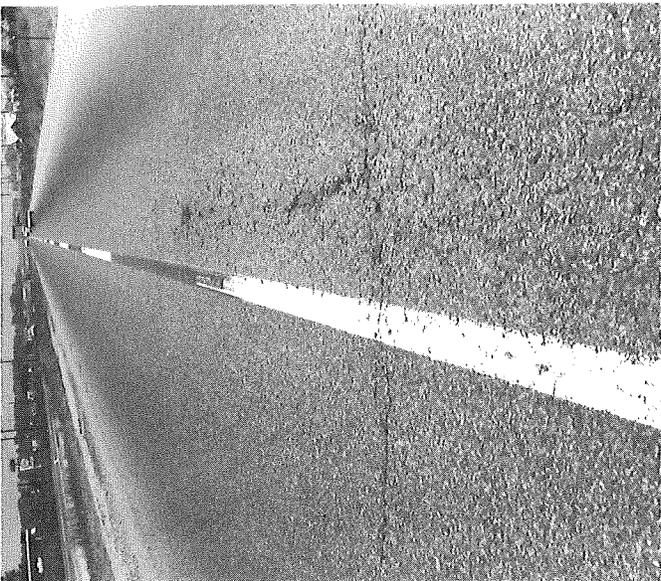
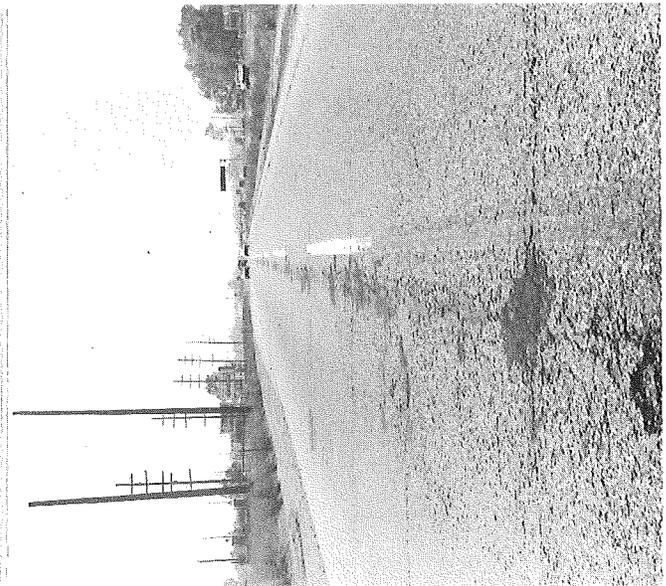
With regard to surface condition, all transverse joints had reflected through the asphaltic concrete, as had both the old longitudinal centerline joints and the longitudinal joints at the 1956 widening strip along their entire lengths (Fig. 3). On the other hand, there was little reflection cracking evident over transverse or longitudinal cracking of the old slabs. Transverse patches averaged approximately one per half-mile of pavement, and probably were constructed to repair joint blow-ups (Fig. 4). There was considerable alligator cracking adjacent to the reflection cracks (Fig. 5), and in some areas the entire surface course appeared to be disintegrating.

Figure 3. Reflection cracking over old centerline longitudinal joint (top left and bottom left), old transverse joint (bottom center), and joint widening strip (right).

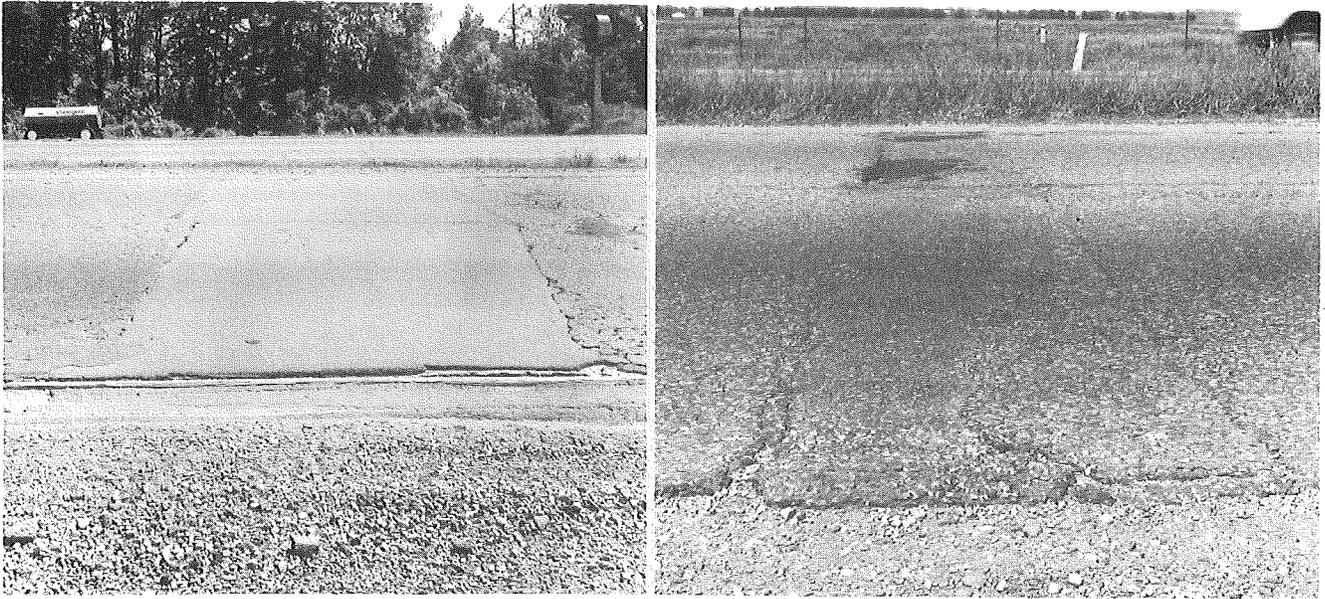
Figure 4. Typical transverse patches.

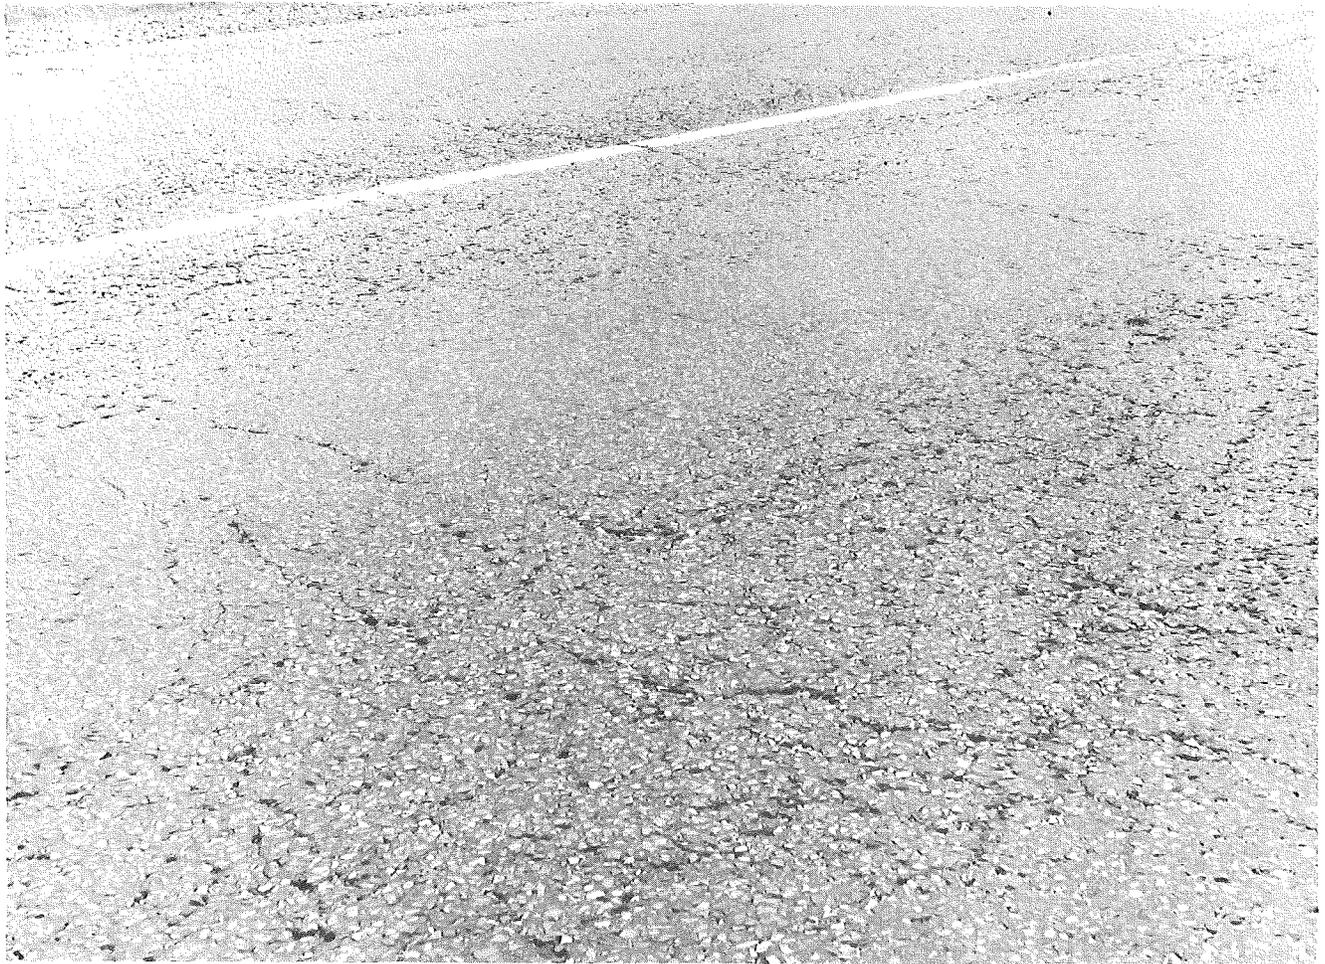
Figure 5. Typical alligator cracking.

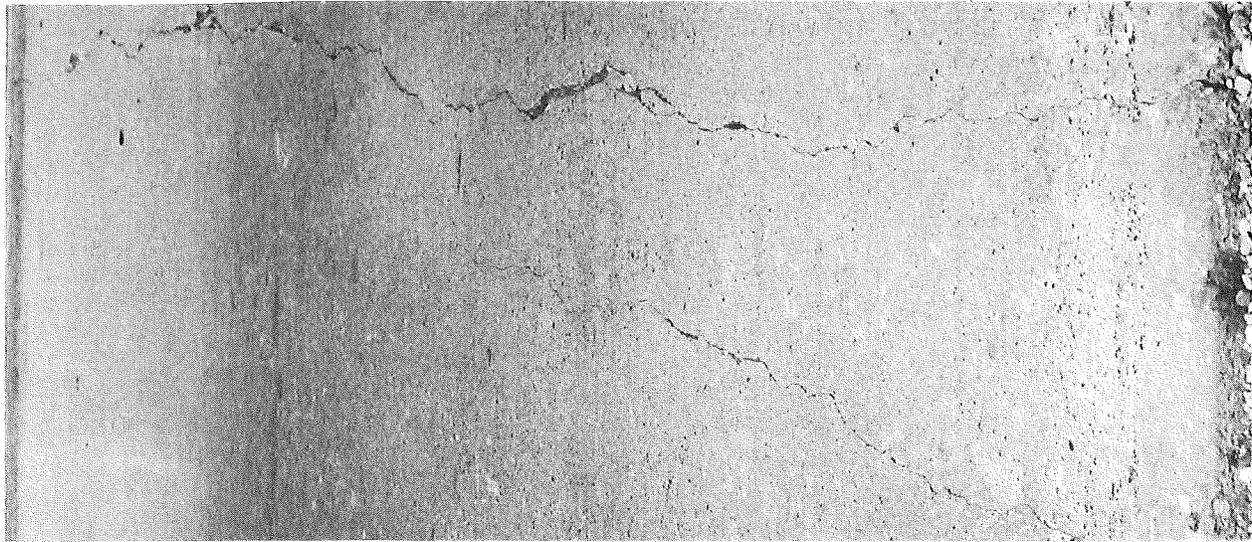
On the 1600 ft of 1958 concrete underpass pavement at the Belleville Road interchange, faulting of some transverse joints was noted, and one area of longitudinal joint was faulted (Fig. 6). Severe surface scaling and spalling were observed, particularly at the west end of this pavement, and the reinforcing steel was exposed in some areas (Fig. 7). On the average, there were about nine transverse cracks per 99-ft slab in the traffic lane of each roadway, and about five transverse cracks per slab in each passing lane (Fig. 8). Some spalling was in evidence at these transverse cracks.

Figure 8. Typical transverse crack on Belleville Road underpass.

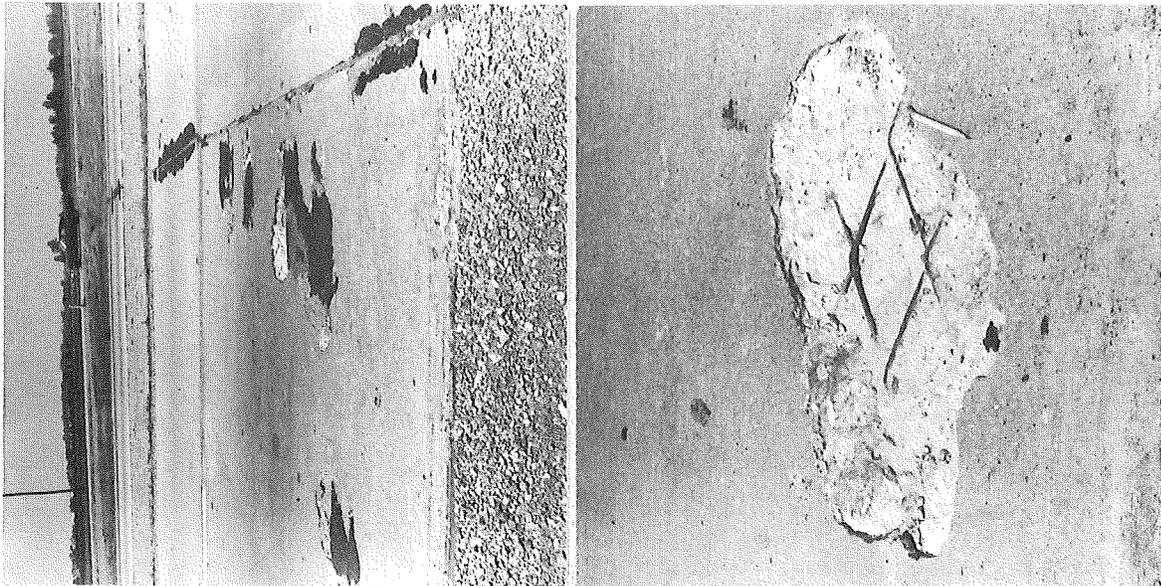
Figure 7. Surface deterioration and spalling (top), and exposure of reinforcing steel (bottom) on Belleville Road underpass; note proximity of steel to pavement surface.

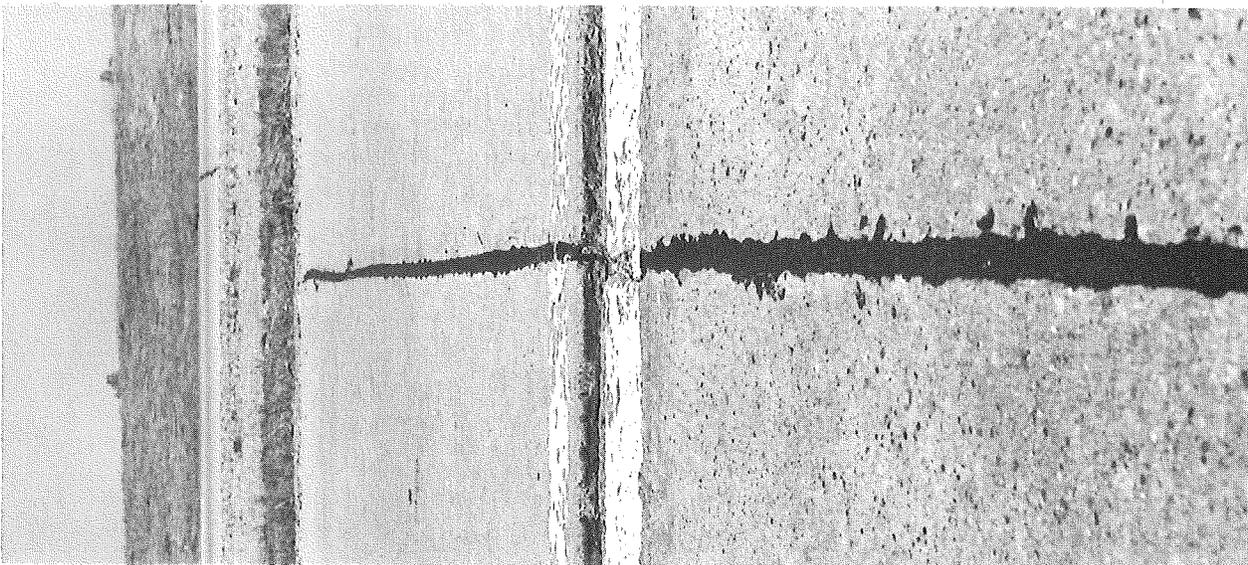
Figure 6. Faulting of longitudinal joint on Belleville Road underpass.

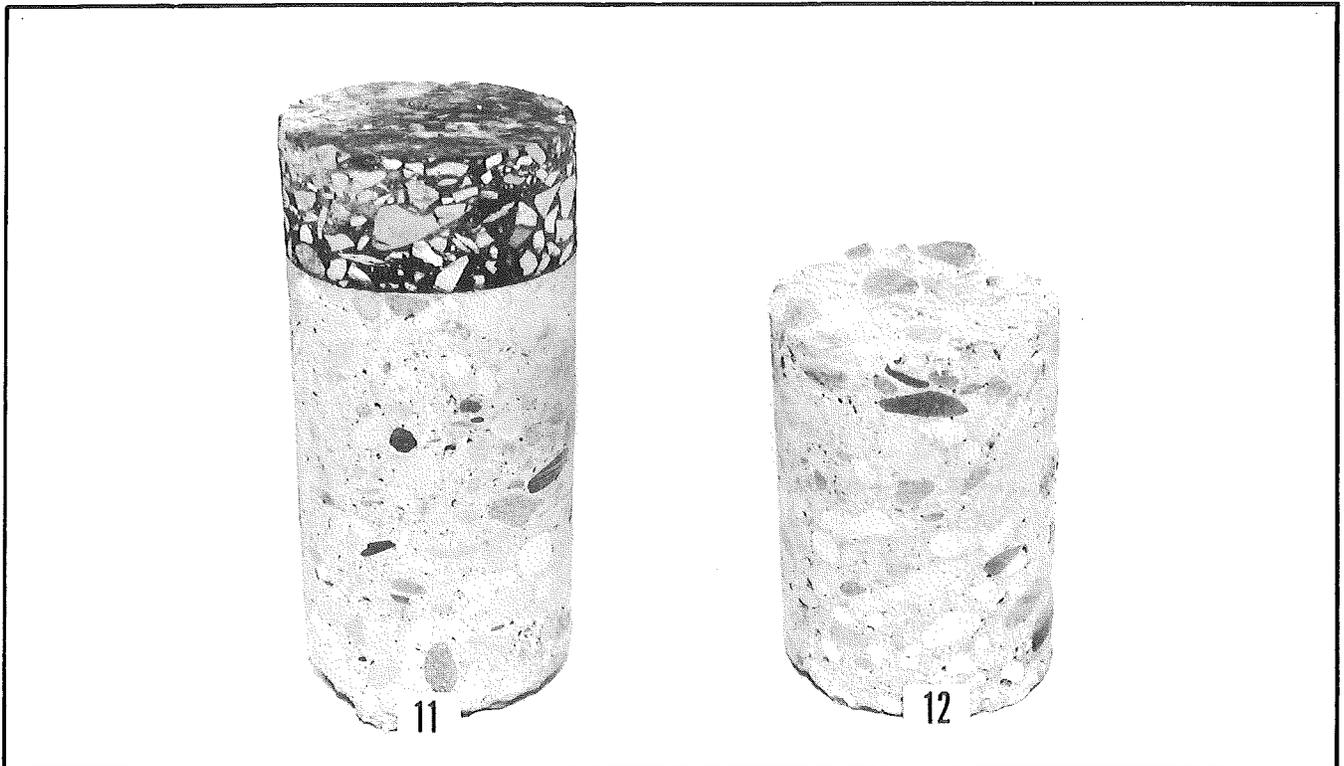
Concrete cores taken in the 1942 projects had an average compressive strength of about 8300 psi. The 1942 concrete appeared to be in very good condition except in cores taken from areas where alligator cracking had developed in the overlay (Fig. 9). There, salt had apparently soaked through the asphaltic concrete and caused disintegration of the old concrete surface to a depth of 1/2 to 1 in. Compressive strengths of cores taken from the 1958 concrete underpass at Belleville Road averaged about 6500 psi, and no salt action was apparent at the core tops (Fig. 10).

Figure 9. Cores from resurfaced 1942 plain concrete pavement; concrete is nominal 9-in. thickness and overlay is 2-1/2 in. Note good condition of concrete of Core 11 under sound bituminous cap, in contrast to Core 12 where concrete upper surface is disintegrated under alligator cracked bituminous which allowed deicing salts to soak through.

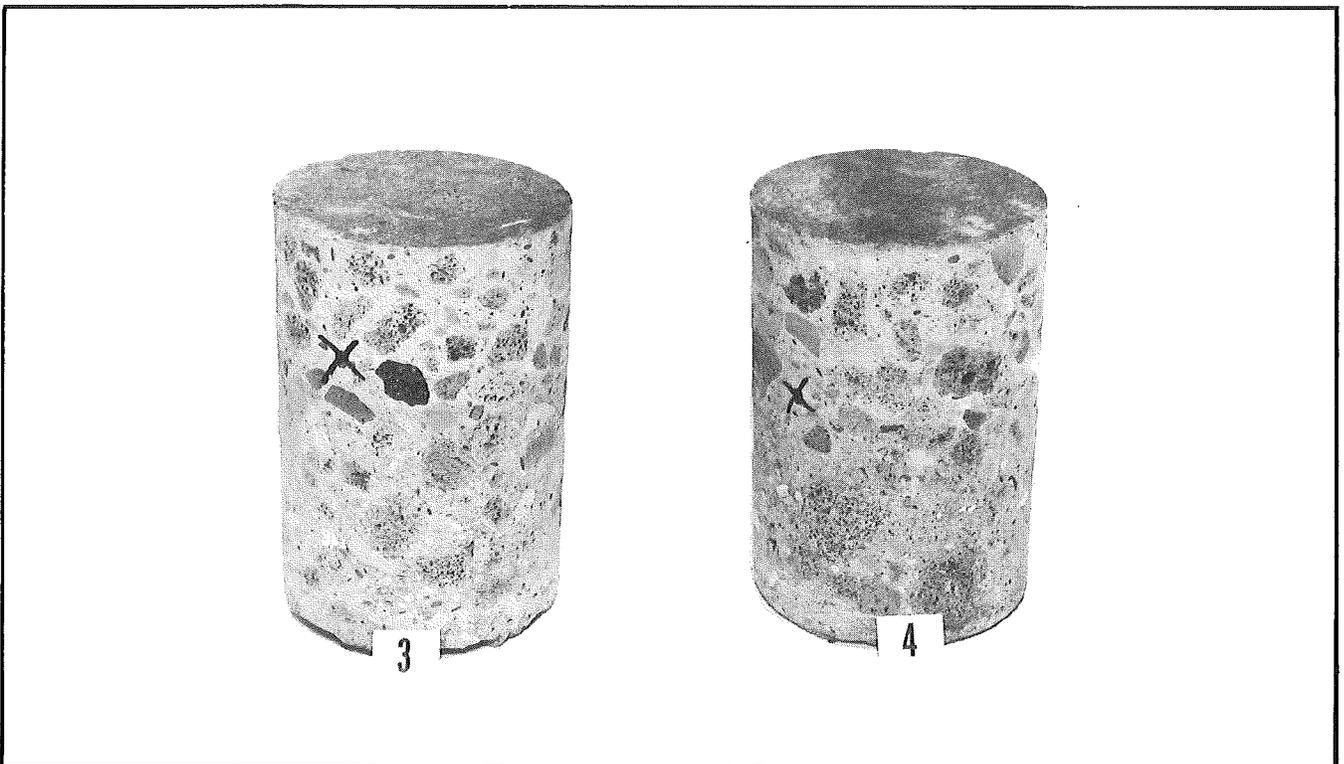
Figure 10. Cores from 1958 reinforced concrete underpass pavement on Belleville Road underpass, in which slag aggregate was used. Locations of reinforcing steel marked by X's.
