## OFFICE MEMORANDUM

STATE HIGHWAY DEPARTMENT

September 11, 1964

Subject: Second Annual Inspection of Epoxy Sealer between the Concrete and Bituminous Wearing Surface of the Approach Deck Spans of the International Bridge at Sault Ste. Marie (B01 of 17034). Research Project R-59 F-53(2). Research Report No. R-472.

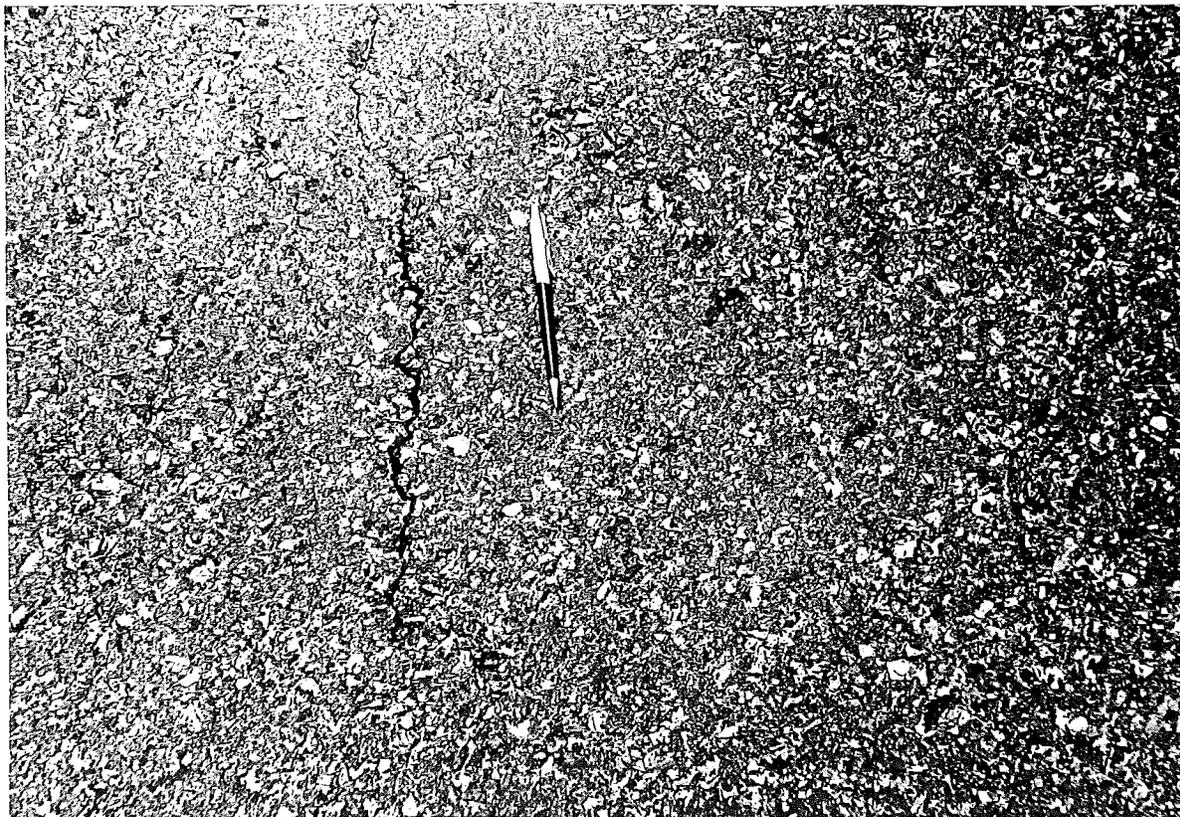
Figure 1. New crack appearing in the bituminous cap on southbound span 5 between the wheel tracks.

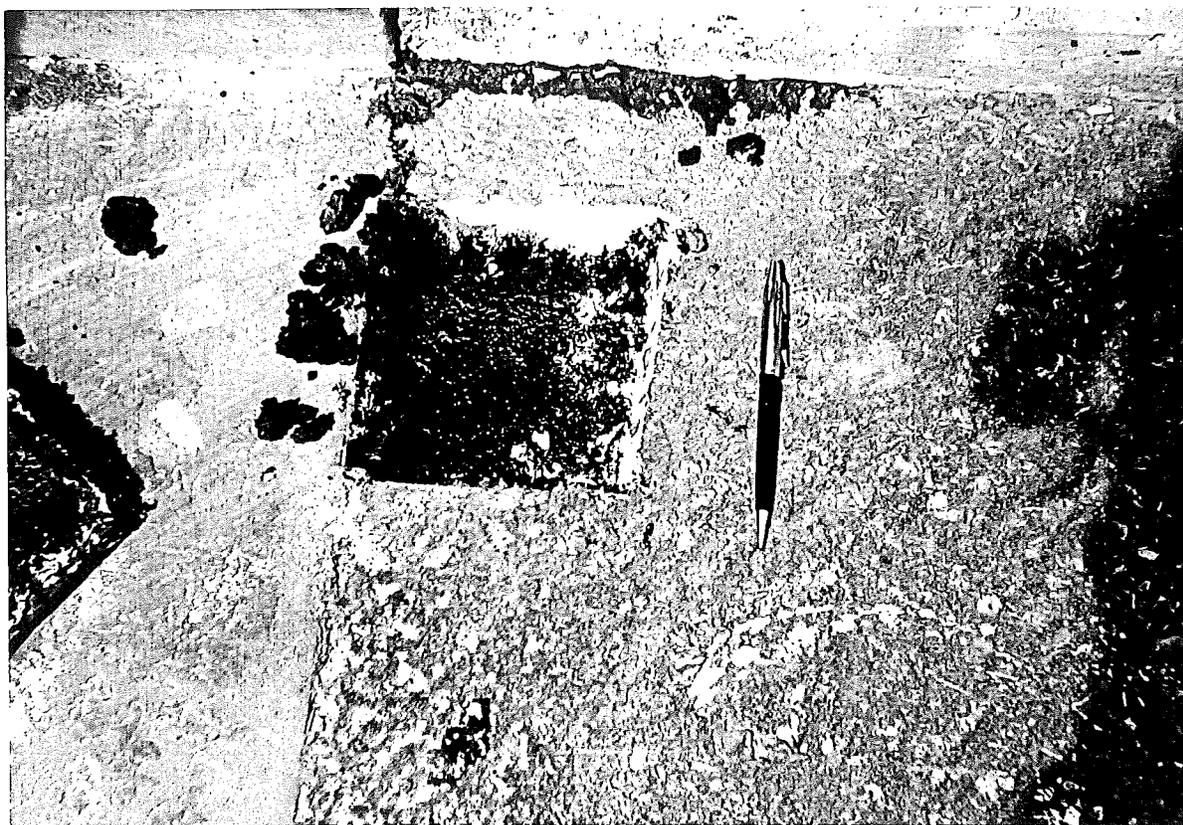
The condition of the two epoxy seal coats and the concrete surface of the uncoated control area were inspected by chipping out 6-in. square sections of the bituminous cap and observing the surface below (Fig. 2). In all cases where the two epoxies were uncovered, the sealers were found to be in excellent condition as were the surfaces of the uncoated control sections. The polysulfide epoxy was found to be much more brittle than the coal tar-modified epoxy and could be scraped off the concrete with little effort. This material would probably not span a crack in the concrete if one developed. The coal tar-modified epoxy could not be scraped from the concrete and has remained fairly plastic. A small amount of moisture, in a dew-like deposit, was found beneath the bituminous cap when it was removed, presumably as a result of water filtering through the cap.

Figure 2. Examination of the sealer by removal of the bituminous cap (black square), revealed a dew-like deposit of moisture (photo taken at Pier 10 west gutter).
