## OFFICE MEMORANDUM

STATE HIGHWAY DEPARTMENT

Subject: Galvanized (Zinc Alloy) Steel Base Plates for Joints. Research  
Project R-63 NM-98. Research Report No. R-474.

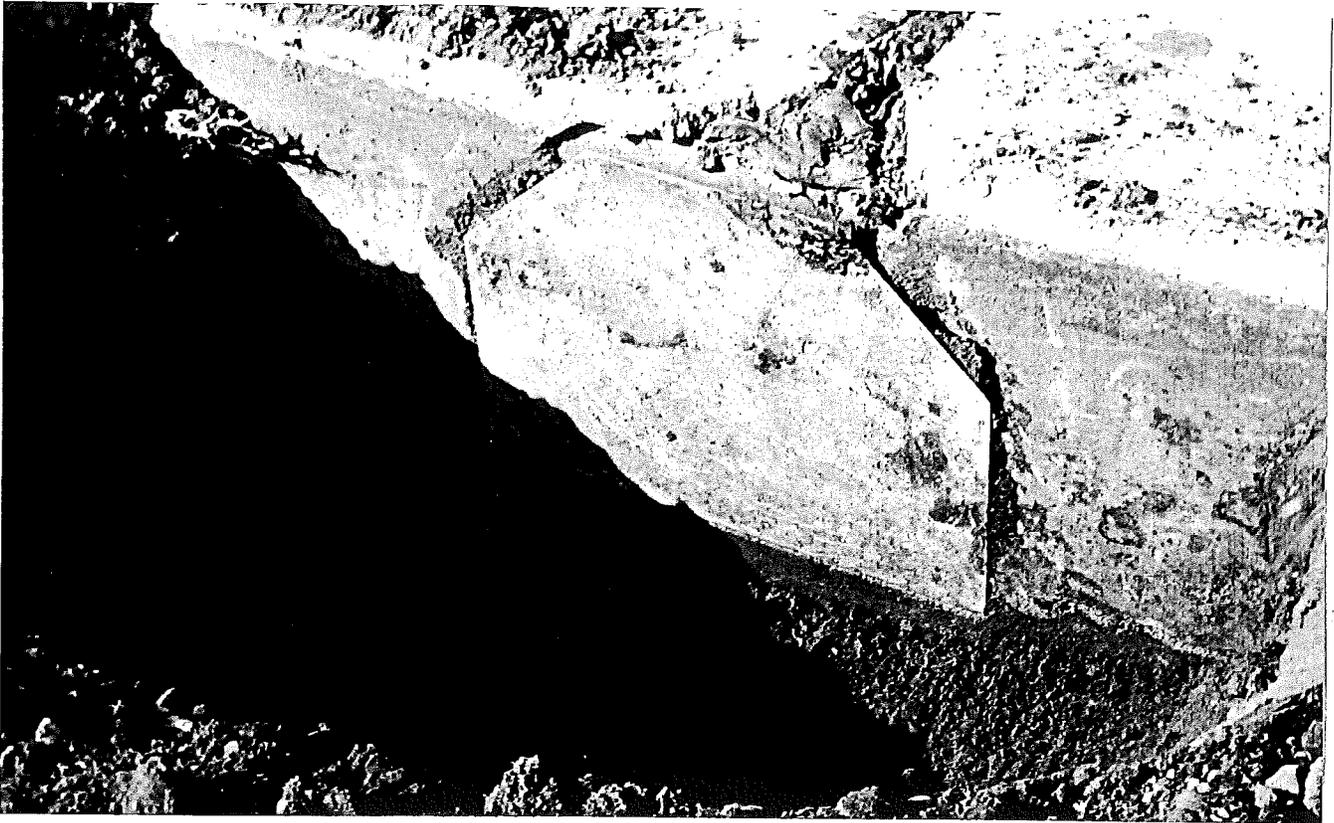
First, random sampling of plate condition by excavation, while allowing examination of only the end portion of the plates, did provide samples with several total periods of service. In the dozen or more projects so studied, all plates were sound but all had some surface corrosion (Figs. 1 and 2). On all these projects, the sealers appeared sound, and the joints appeared to be functioning correctly at the time of inspection.

Figure 1. Three-year old base plate in place (top) and opened to expose joint end (Project 39-40, C4).

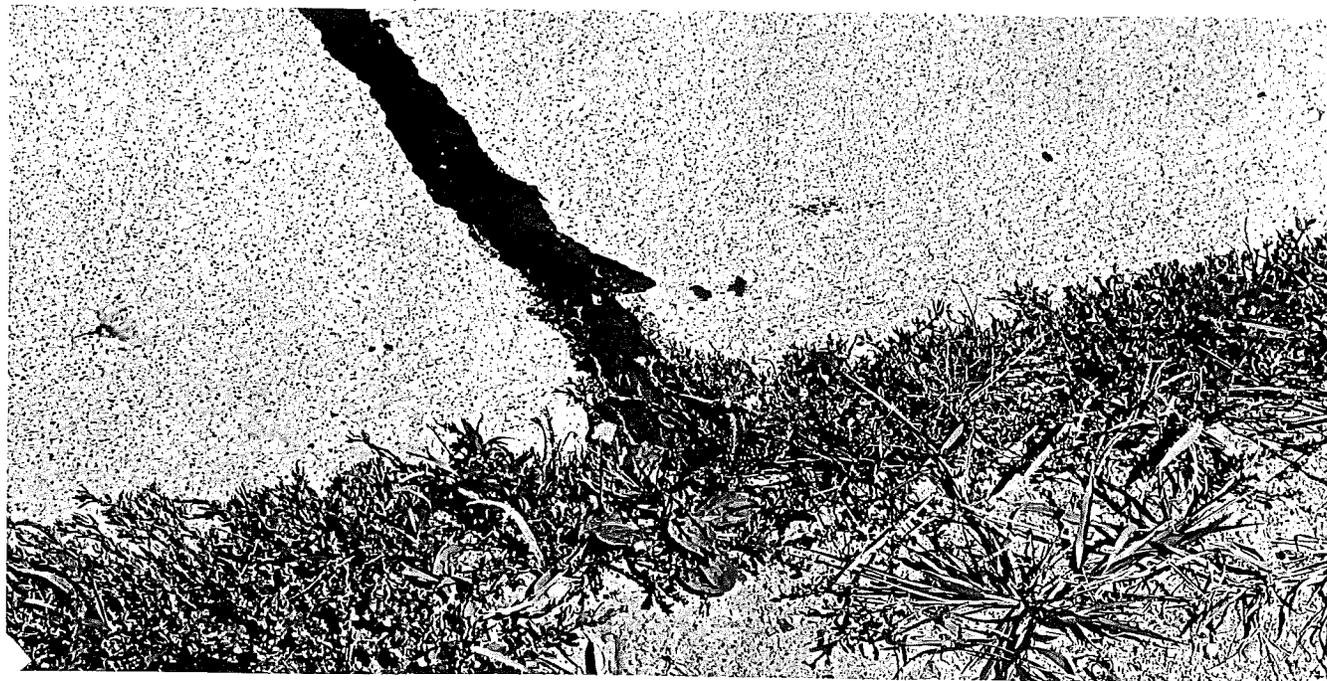
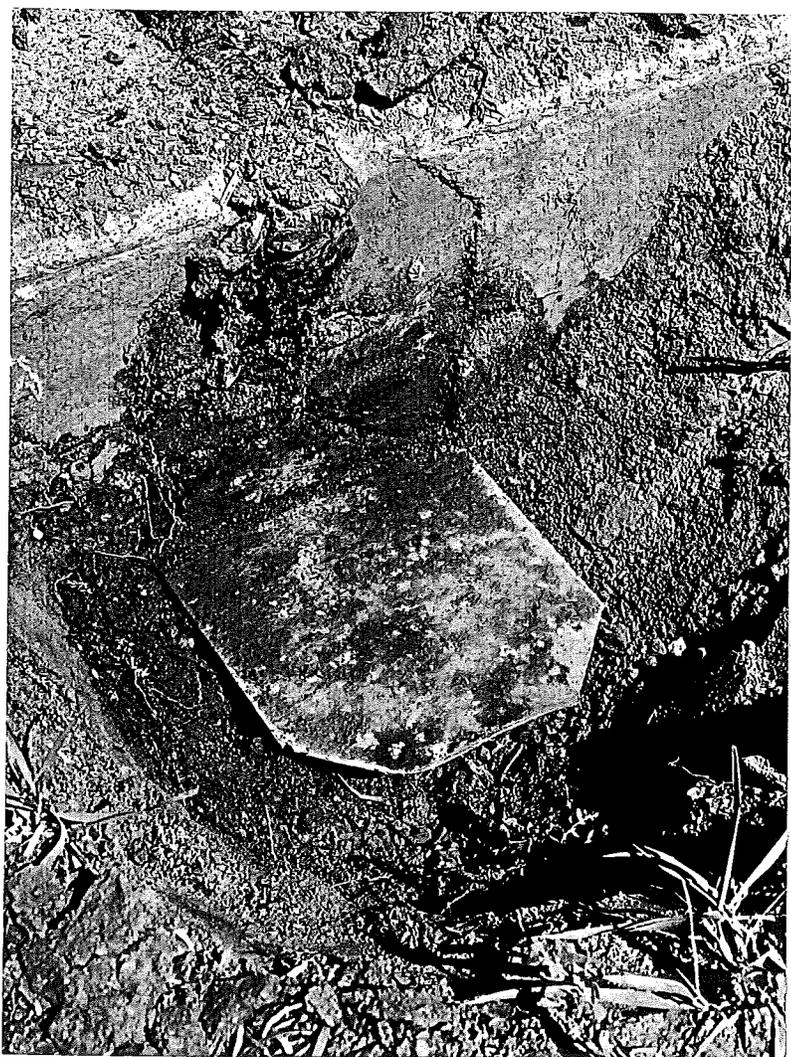
Figure 2. Six-year-old joint showing surface and base plate conditions (Project 23-17, C14).

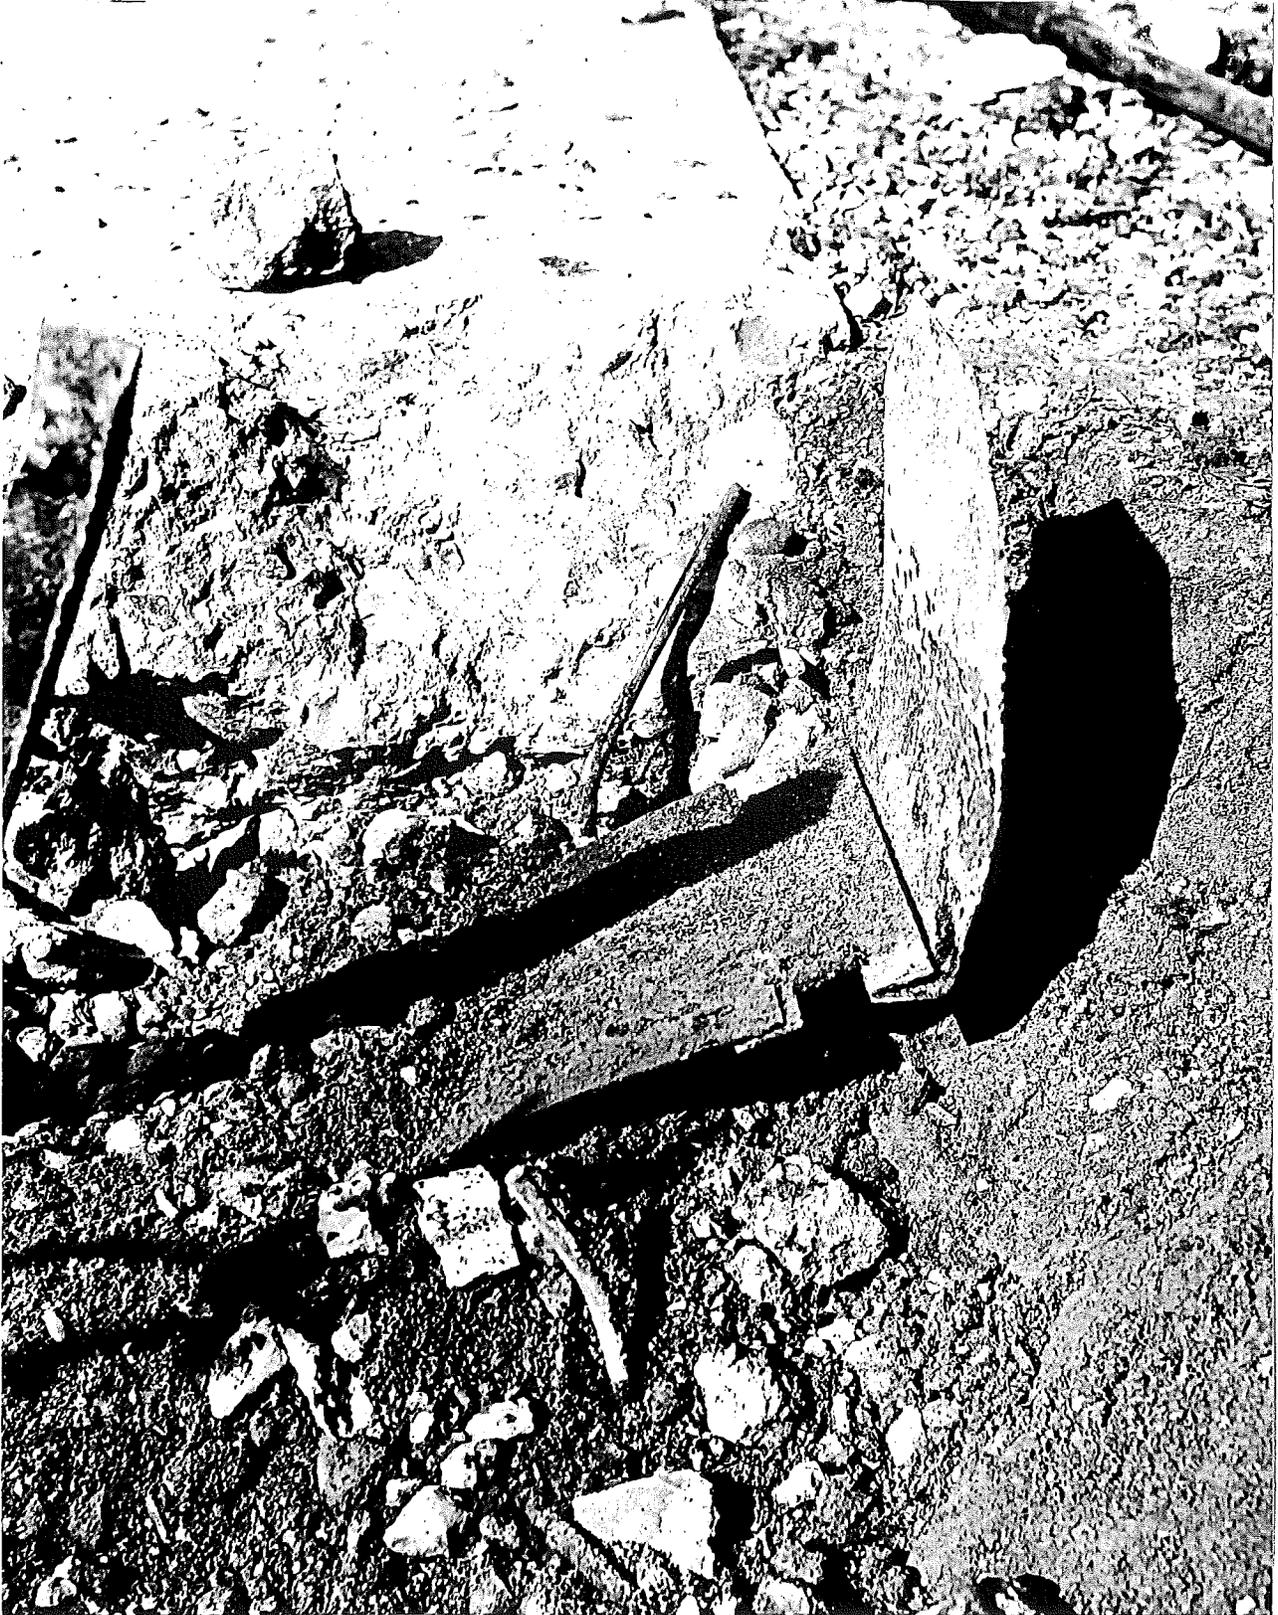
Second, base plates examined at sites where joint repairs were in progress generally were characterized by deeper corrosion than where joints were sound. In all, eight joints undergoing repair were examined, including five with 4 to 5 years of service, and three with 7 years of service (Figs. 3 and 4). In one joint with 10 years of service, however, where the sealer was still sound and the joint appeared from visual observation to be in fair to good condition at the time of shoulder repairs, the plate was sound with only slight surface corrosion (Fig. 5).

Figure 3. Seven-year old base plate, during joint repair (Project 23-17, C4).

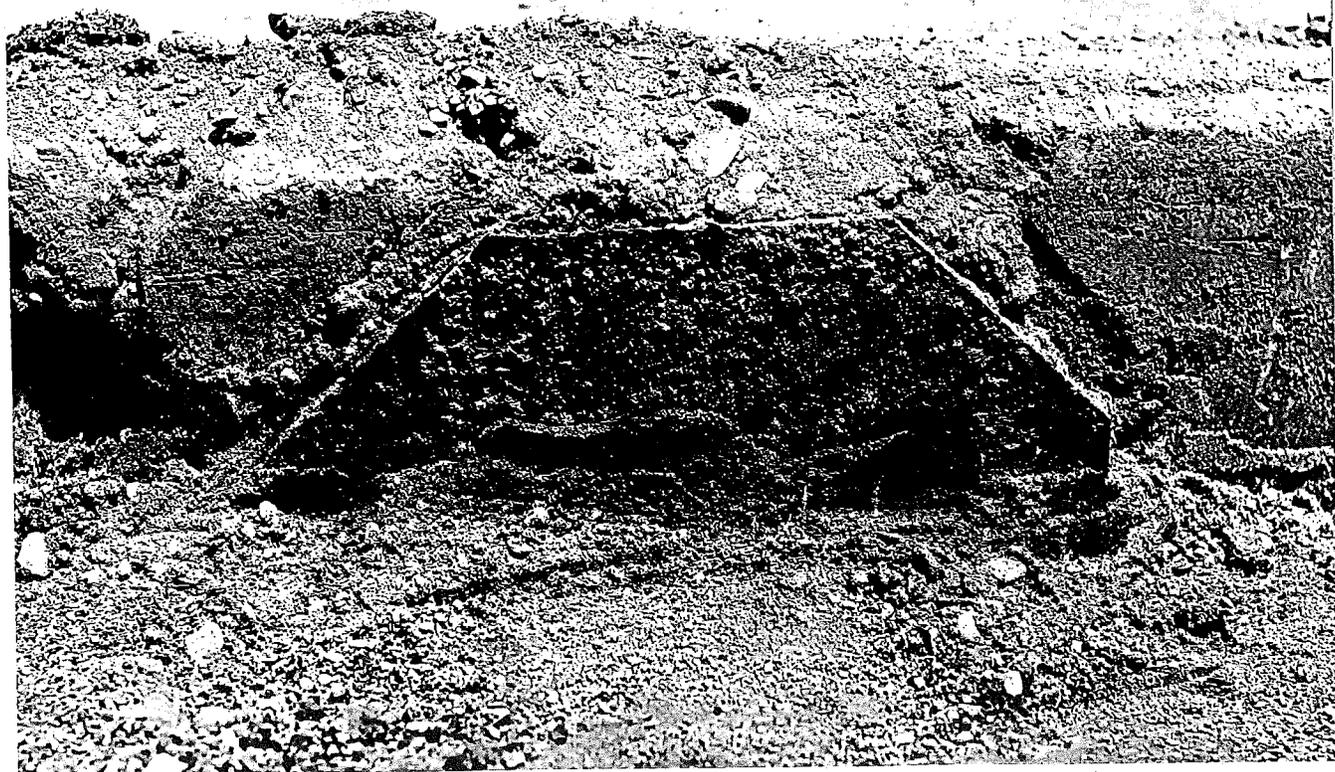
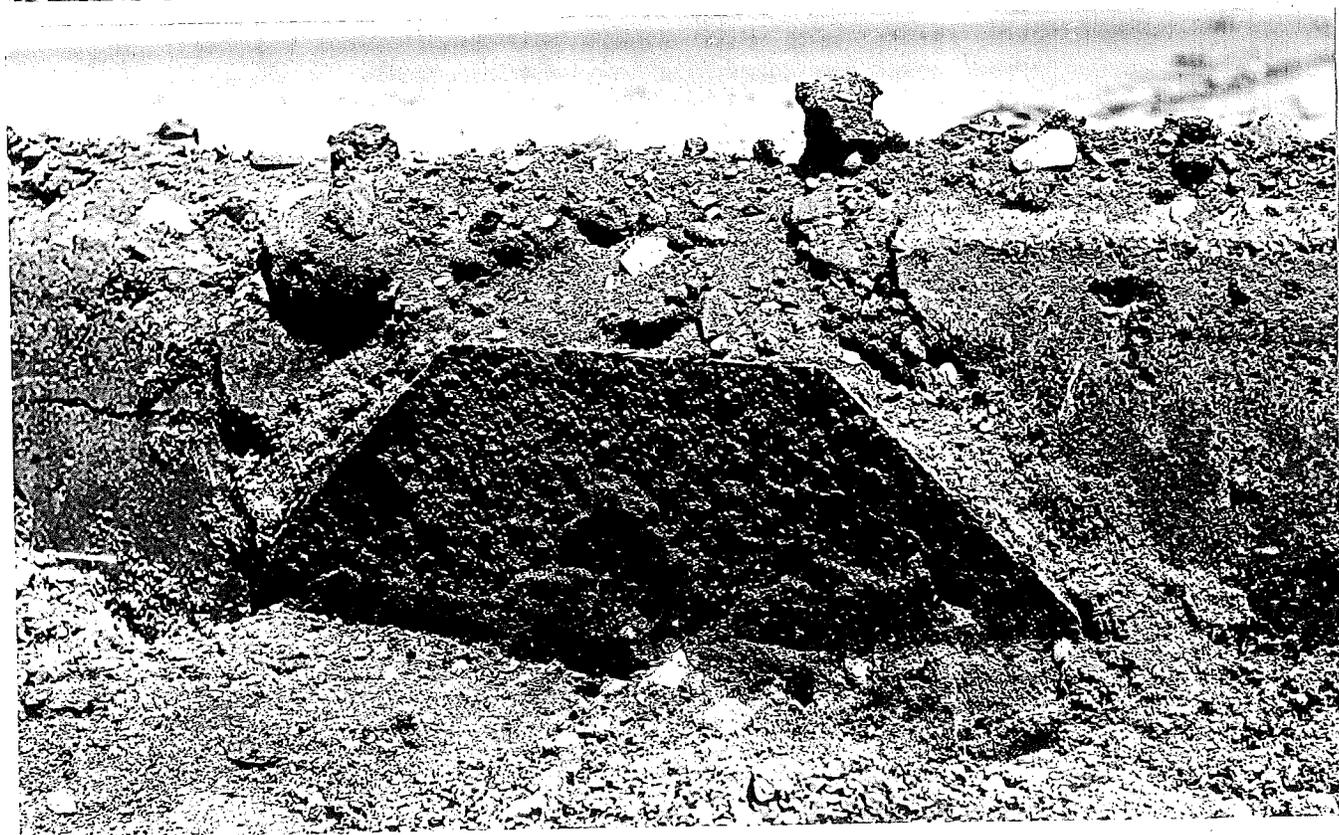
Figure 5. Base plates at two joints, after ten years service (Project 38-48, C9).
