STATE HIGHWAY DEPARTMENT

October 8, 1964

Subject: Alleged Damage to Dwelling of A. T. Schmidt, Vassar, Michigan.
Research Project 64 F-79. Research Report No. R-478.

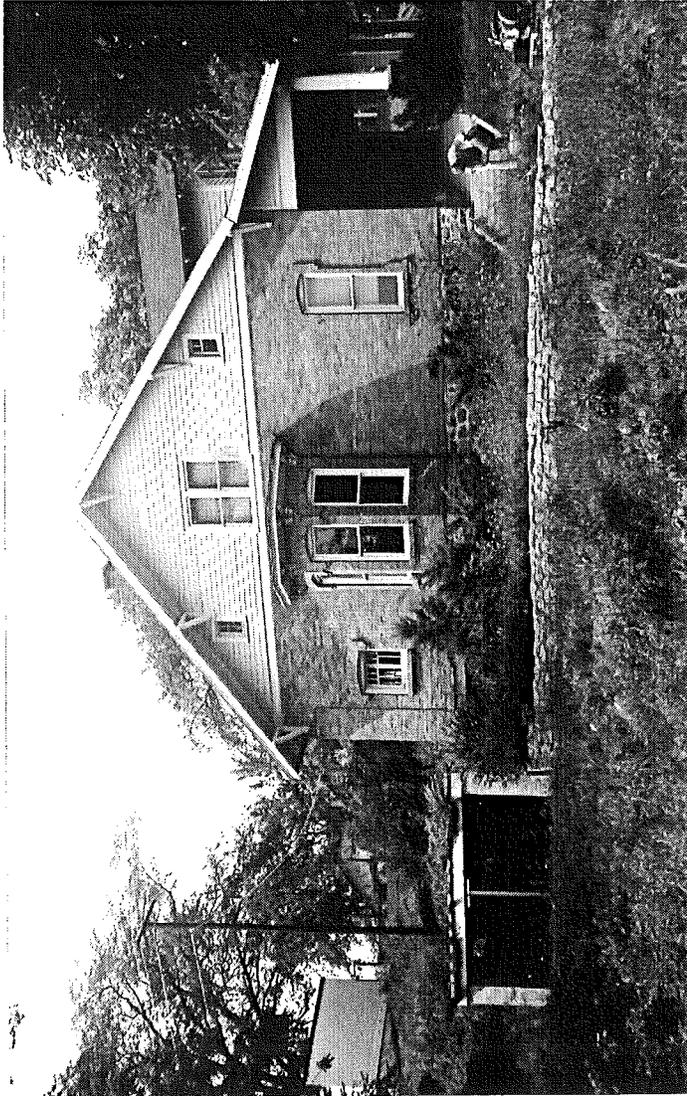
We believe, therefore, that the damage to the Schmidt house is the inevitable consequence of the unstable soil condition at the site, coupled perhaps with an inadequate foundation for the addition to the building. While it was possible to

Figure 2. SE side of house, showing 10 ft addition, and crack from large window to small kitchen window.

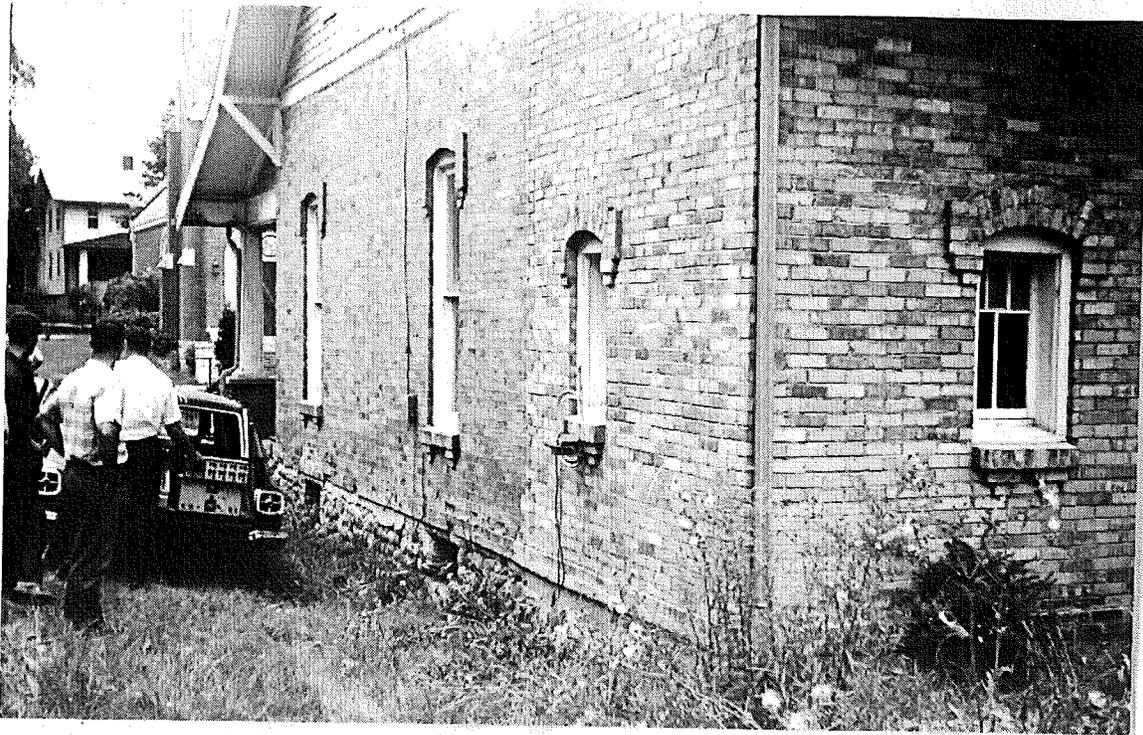
The maximum acceleration caused by vehicles was 0.03 g, while acceleration values of two to five times greater were caused by a man's jumping on the ground near the building, and by hitting the ground beside the building with a sledge hammer.

Figure 3. Accelerometers attached to brick window ledge. Instruments in station wagon.

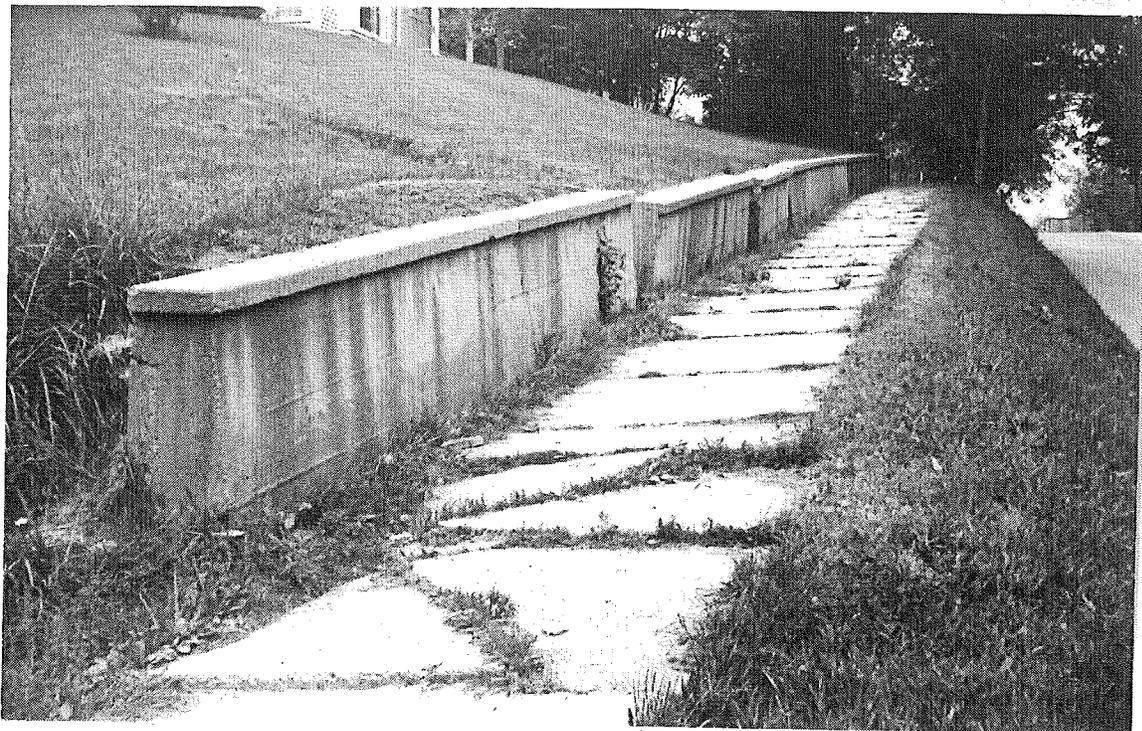
The unstable soil condition at the site can be seen from Fig. 4, which shows the condition of the sidewalk in front of the Schmidt house. A letter from P. R. Baumgartner, District Soil Engineer for the Department, states:

"An investigation of the soils at the subject house site revealed the presence of a considerable amount of clayey silt. Since the house is situated on the slope of the Port Huron moraine, a considerable amount of side-hill seepage results in producing a very unstable soils condition."

Figure 4. Faulted sidewalk and retaining wall adjacent to subject house.
