EVALUATION OF TWO-COMPONENT,
COLD-POUR JOINT SEALING IN I 75 REST AREAS
Construction Projects I 25032C, C7; BI 73171C, C19; I 09034C, C10
Federal Designations I-75-2(89), I-75-2(90), I-75-2(91)

Research Laboratory Division
Office of Testing and Research
Research Project R-62 G-138
Research Report No. R-496R

Michigan State Highway Department
Lansing, March 1965

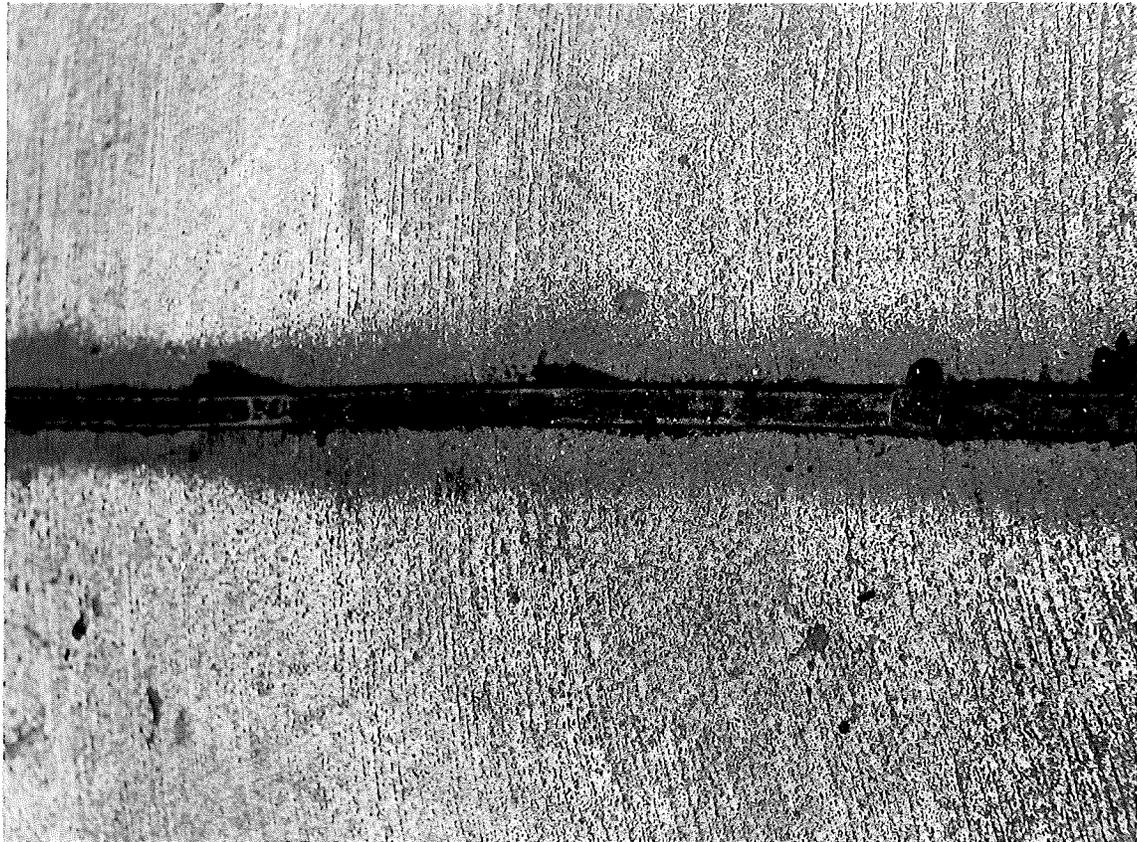
The area was inspected thoroughly including truck and car parking areas and entrance and exit ramps. The ambient temperature was 30 F, with contraction joints open an average of about 7/16 in. beyond their initial width of 1/2 in. Sealant cohesion failure to full depth in contraction joints, as shown in Fig. 1, was the most prevalent failure type, and existed to greater or lesser degree in at least 70 percent of all such joints. Since the sealant passed laboratory tests, quite possibly some sealer batches were inadequately mixed at the job site, resulting in cohesion weakness. Thorough mixing and proportioning are necessary for quality performance of two-component sealer.

Figure 1. Extreme cohesion failure in truck parking area. Light-colored areas on pavement in these photos are not membrane curing compound, but light snow which was broomed off along joints at the time of this inspection (Project I 25032, C7). (I-75-2(89))

Due to the extensiveness of cohesion failures and occasional adhesion failures, it is recommended that the old sealer be removed, all joint spalls be repaired, and the entire project resealed according to specifications.

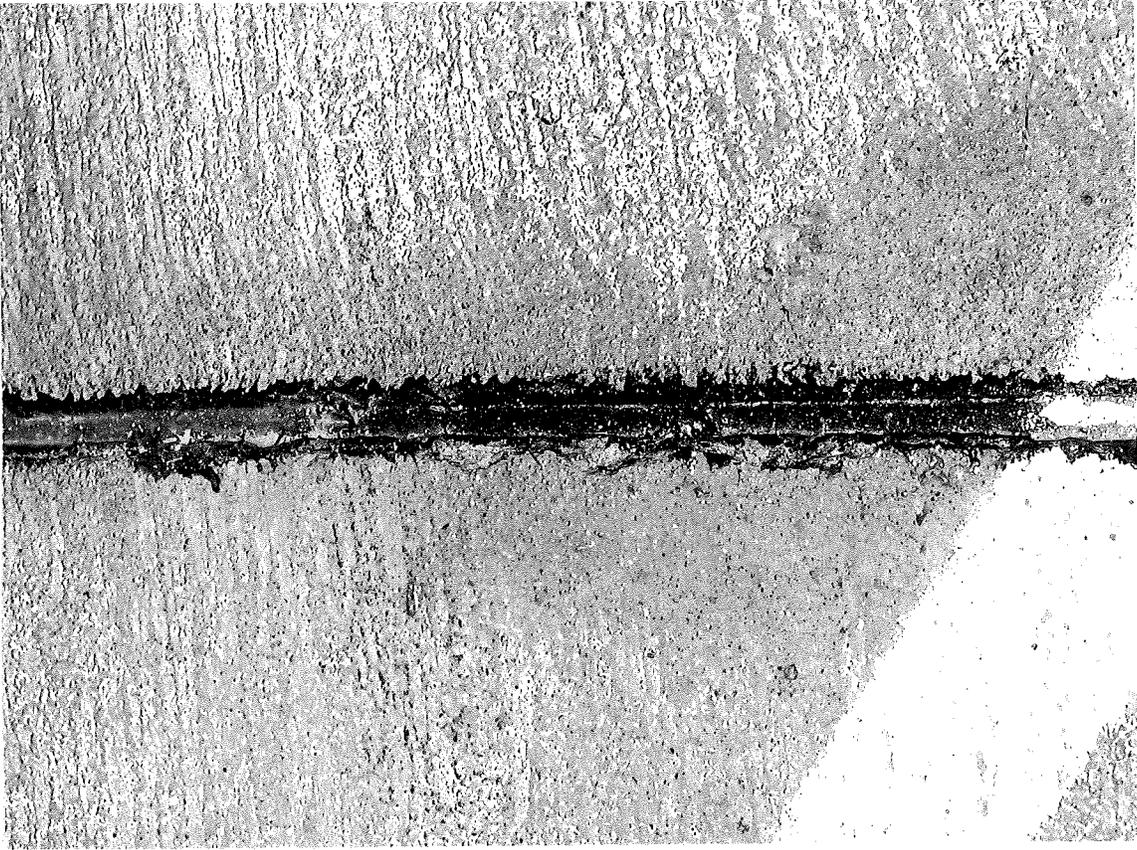
Evidence of adequate blast cleaning along the pavement surface and joint edges, which would be conducive to removal of laitance and fine spalling, was not evident in ramp areas but was found to varying degrees in the parking areas. Fine edge spalling extending 1/2 in. or less from the edges or lips of contraction joints is shown in Fig. 2. Such spalls may

have been caused by loosening while joints were being prepared for sealing, or may have occurred after joints were sealed. Fig. 3 shows a typical expansion joint in the truck parking area; considerable spalling along joint edges or lips was also encountered among expansion joints.

Figure 2. Spalling along contraction joint lip or edge (Project I 25032, C7). (I-75-2(89))

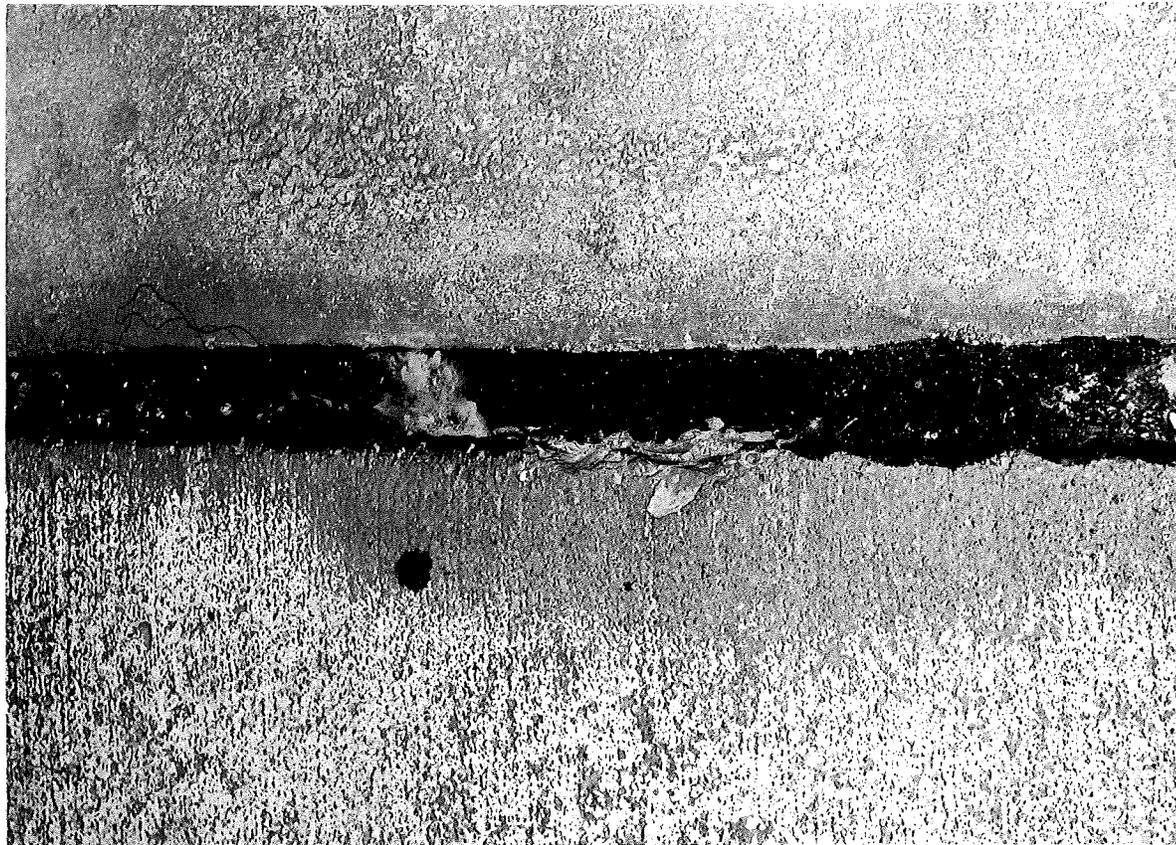
Figure 3. Spalling along expansion joint edge in extreme north portion of truck parking area (Project I 25032, C7). (I-75-2(89))

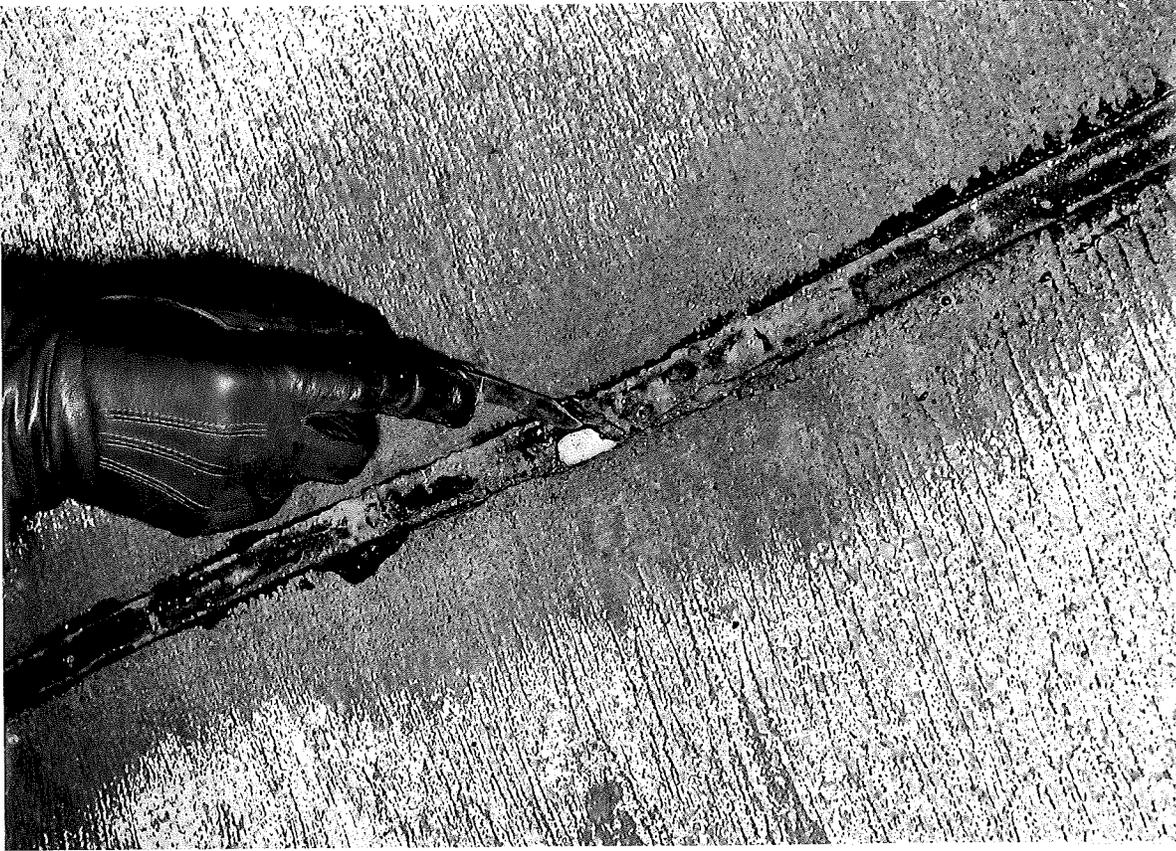
Certain isolated failures were observed to be attributable to placing of filler too high in the joint space, so that only a thin film of sealant covered it (Fig. 4).

Figure 4. Placement of filler (white exposed material) too close to joint surface (Project I 25032, C7). (I-75-2(89))

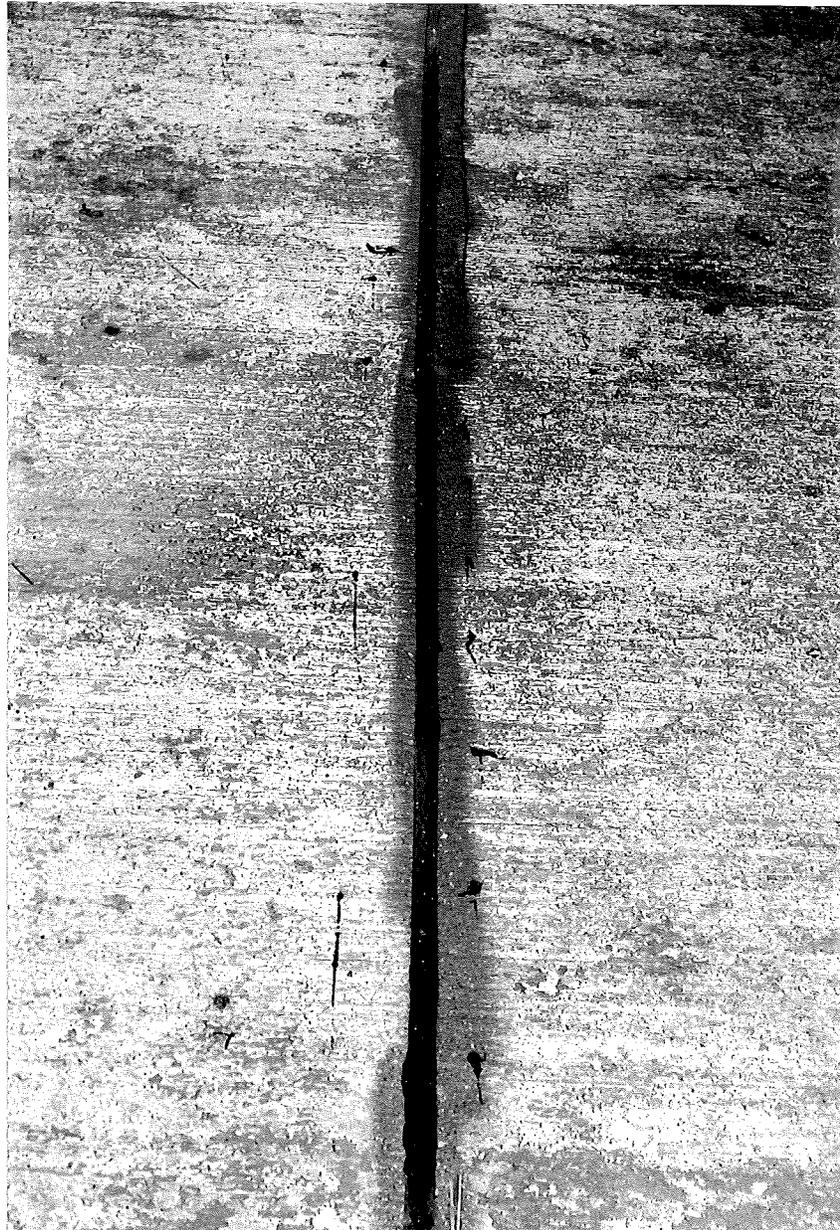
On December 29, 1964, when this evaluation was made, all joints looked very good with no evidence of any failure and negligible amount of spalling. Fig. 5 shows a typical joint. The ambient temperature was about 30 F and the average contraction joint opening was 3/4-in. A number of epoxy mortar spall repairs were noted and there was evidence that joints had been sandblasted prior to sealing. Although these joints appeared very good at this time, they were not sealed according to supplemental specifications, which require that a compressible filler and a bond-breaker be placed below the sealant. These joints were poured full depth. The purpose of the compressible material and bond breaker is not to conserve sealant, but to form a favorable "shape-factor" or cross-section in the sealant. This reduces stresses in the sealant, thus minimizing failures in adhesion and cohesion.

Figure 5. Contraction joint without adhesion or cohesion failure, typical of those in Projects I 09034C, C10 and BI 73171C, C19. (I-75-2(90) and I-75-2(91))

Since the joint cleaning and spall repair were in accordance with specifications and the performance of the sealer to date is satisfactory, no recommendation is being made relative to its replacement.
