PAVEMENT EVALUATION OF I 94 CONTROL SECTION 82022
Detroit Industrial Expressway from Ozga Rd. to US 24 - Telegraph Rd.

Research Laboratory Division
Office of Testing and Research
Research Project 39 F-7(14)
Research Report No. R-523

Michigan State Highway Commission
Ardale W. Ferguson, Chairman; Charles H. Hewitt, Vice-Chairman;
Wallace D. Nunn; Richard F. Vander Veen; Howard E. Hill, Director
Lansing, June 1965

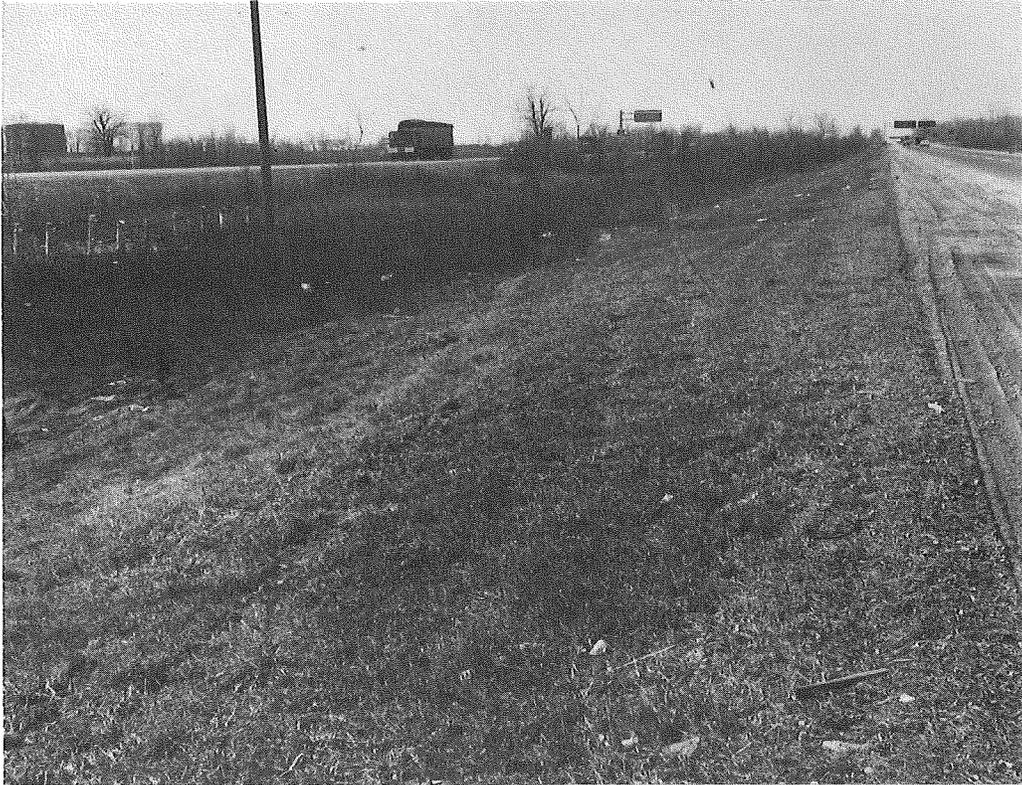
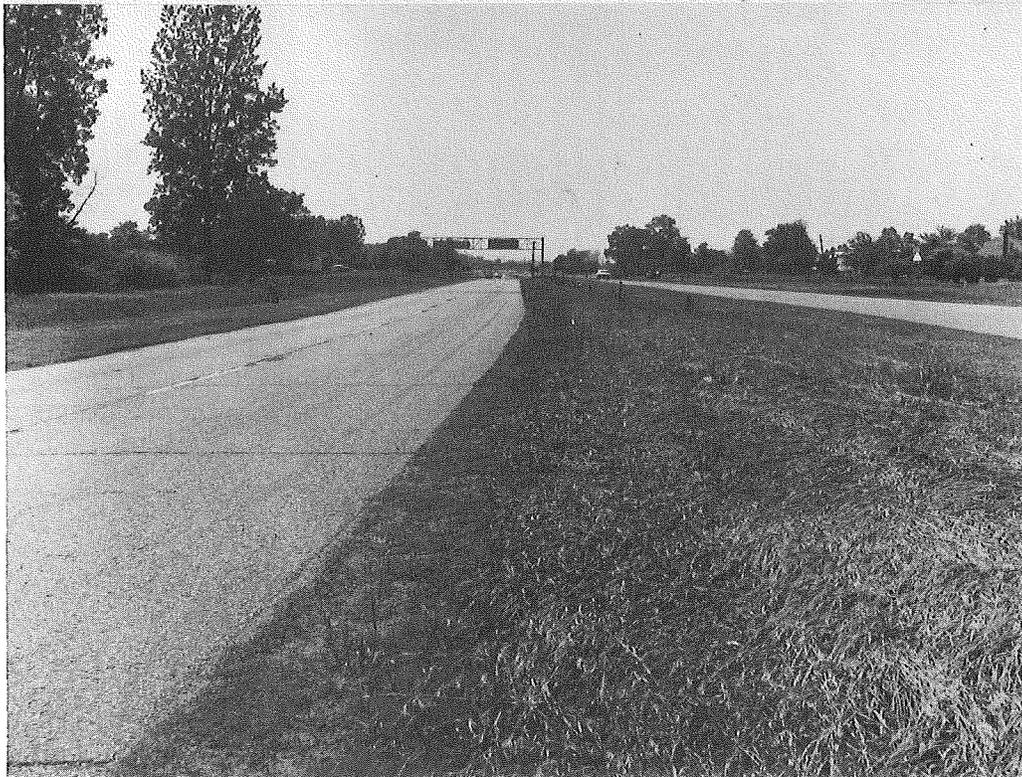
During the inspection of the I 94 projects, it was found that the pavement east of Ozga Rd. was in much better condition than that lying west of Hannan Rd., which was reported previously. (1) This superiority of pavement performance from Ozga Rd. to Telegraph Rd. was due probably to superior drainage as a result of construction on a fill material higher than the surrounding terrain. Fig. 2 shows the contrast with pavement west of Hannan Rd. which was constructed at about the same elevation as the existing subgrade. Another reason for the superiority of pavement east of Ozga Rd. was the reduction in surface disintegration resulting from the use of air-entrained concrete, as compared with the pavement west of Hannan Rd. which contained no air-entraining agent.

Figure 2. Typical view of median strip in Control Section 82022 (above) showing good drainage from roadways. This may be contrasted with typical poor drainage in Control Section 82021 (below).

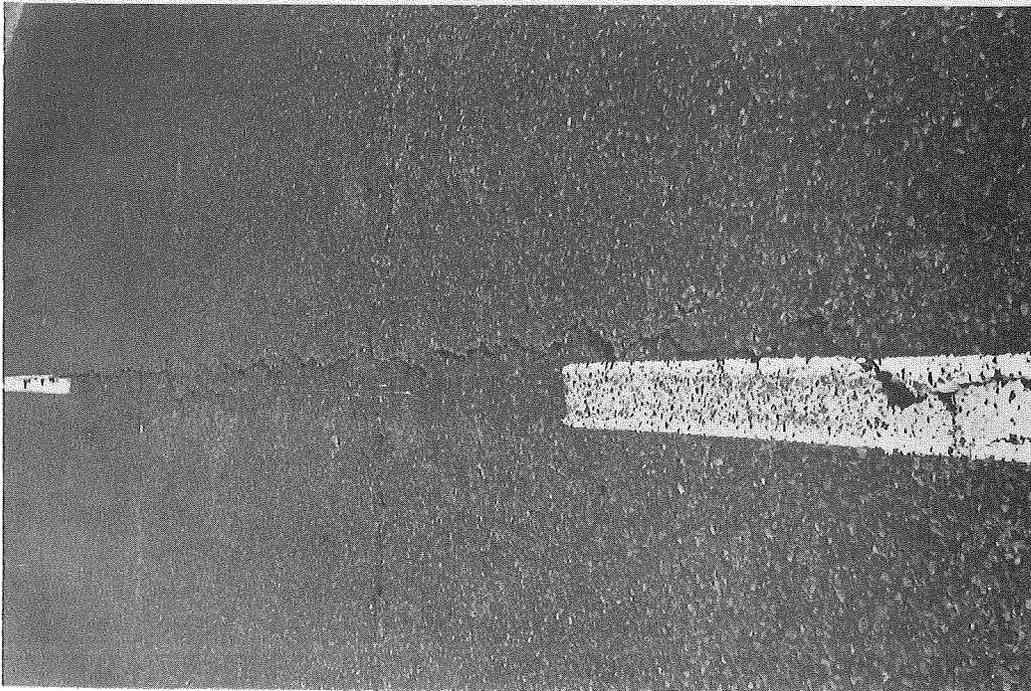
The condition surveys revealed that all joints, both transverse and longitudinal, had reflected through the bituminous surface (Fig. 3). In addition to joint reflections, transverse cracks averaged 20.6 per 500-ft pavement length in the traffic lane and 12.5 in the passing lane. This means that the traffic lane, which carries most of the heavy commercial vehicles, suffered about 62 percent more transverse cracking than the passing lane. There was no significant difference between the amount of transverse cracking in the eastbound and westbound roadways. Table 1 lists the transverse cracking data for each construction project. Including reflected transverse joints in the crack count, there is an average of about one crack per 12 ft of pavement length in the traffic lane and one crack per 15 ft in the passing lane.

Figure 3. Typical longitudinal and transverse cracks reflected from underlying rigid pavement joints.

However, unless a cushion is used over the old bituminous pavement, a new bituminous surface, constructed over the old, would probably show reflection cracks in less than one year.

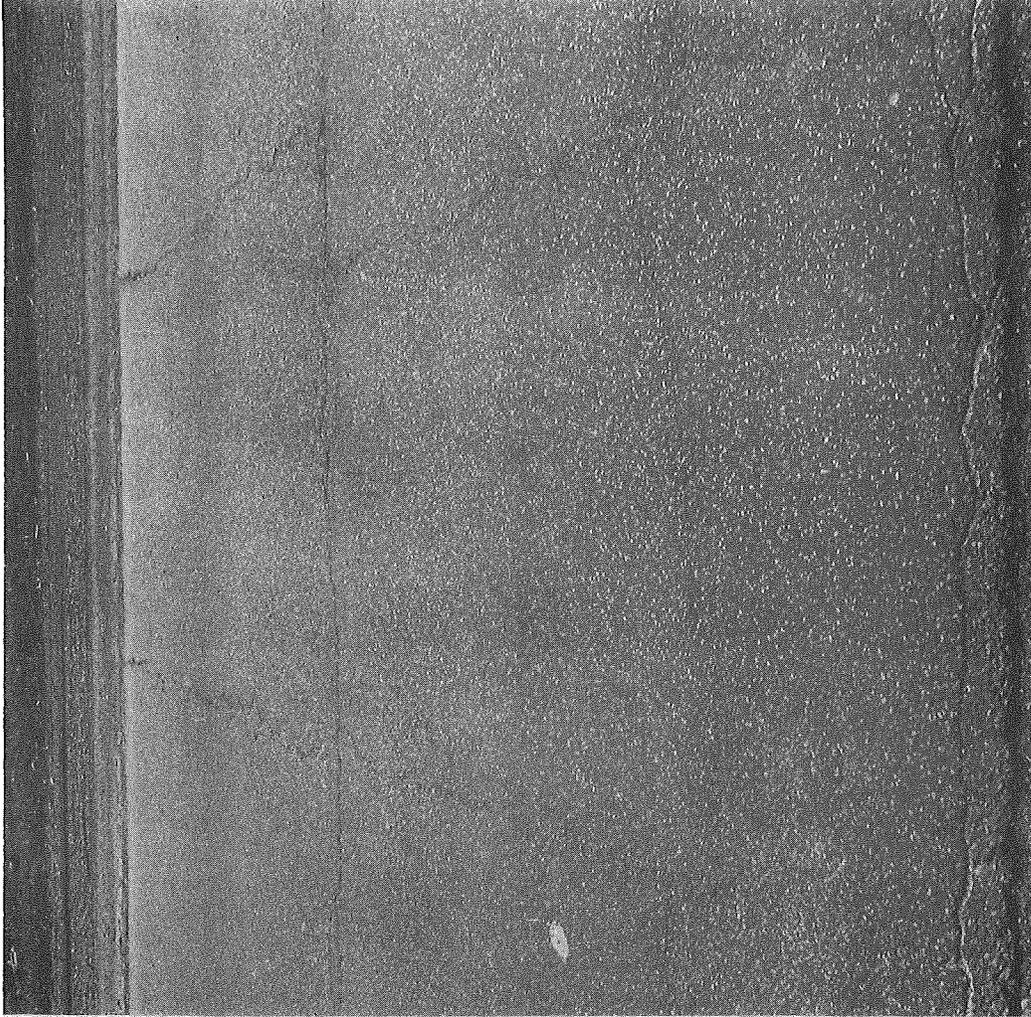
In addition to the longitudinal center joint, which had reflected through the bituminous surface for its entire length in both roadways, there were short lengths of transverse cracking, as shown in Fig. 4. Table 3 is a tabulation of transverse crack data, indicating that the westbound roadway suffered about twice as much longitudinal cracking as the eastbound.

Figure 4. Typical transverse and longitudinal reflection cracking. Note longitudinal cracking reflecting underlying centerline joint at center of pavement and short longitudinal cracks in foreground.
