MICHIGAN
STATE HIGHWAY DEPARTMENT

Subject: Sixth Progress Report on Special Painting of Steel Bridge Girders under Project "Bridges and Bridge Railings - Construction and Maintenance." Research Project 49 G-50(4). Research Report No. R-524.

A fourth inspection was completed in a program of observing the performance of 12 selected paint systems applied in 1960 on steel deck girders of two bridges on re-located M 78 near Durand. Results of the preceding inspection were presented in Research Report No. R-460, dated May 25, 1964.

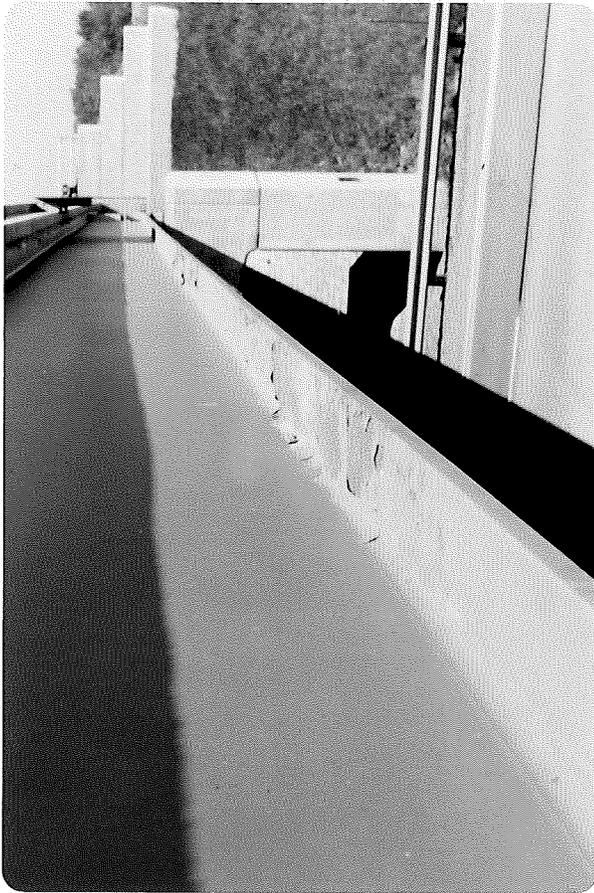
Four-Span M 71 Bridge over M 78. The eight test coating systems are performing satisfactorily, except System No. 5 (based on California specification two-component epoxy undercoats) which now shows spot failure on the lower flange of the fascia beam (Fig. 1). This system showed performance equivalent to others on interior areas of bridge steel. Localized leakage through deck joints has caused initial coating area failure, especially over the north pier where it was comparatively worse under the curbs (Fig. 2). The south pier area showed similar distress, but to a lesser degree. The construction joint over the central pier showed almost no leakage, and produced no significant rusting. Minor edge rusting on beam lower flanges has appeared dormant for the last two years. It was worse on Systems 1 and 2 (the control coatings), probably in part because their span is short and the lower flange comparatively thinner than in central spans. The other short span where the galvanizing and zinc-rich based systems are under evaluation showed no noticeable edge rusting. The small stripped spots, noted last year at north end of the galvanized fascia beam, have not worsened and show no red rusting. No one system stood out as "best performing" after 4-1/2 years of service.

Figure 1 (above). Spot failure of System 5, based on epoxy undercoats, with red rust evident where paint has blistered and peeled (lower flange of east fascia beam--M 71 bridge).

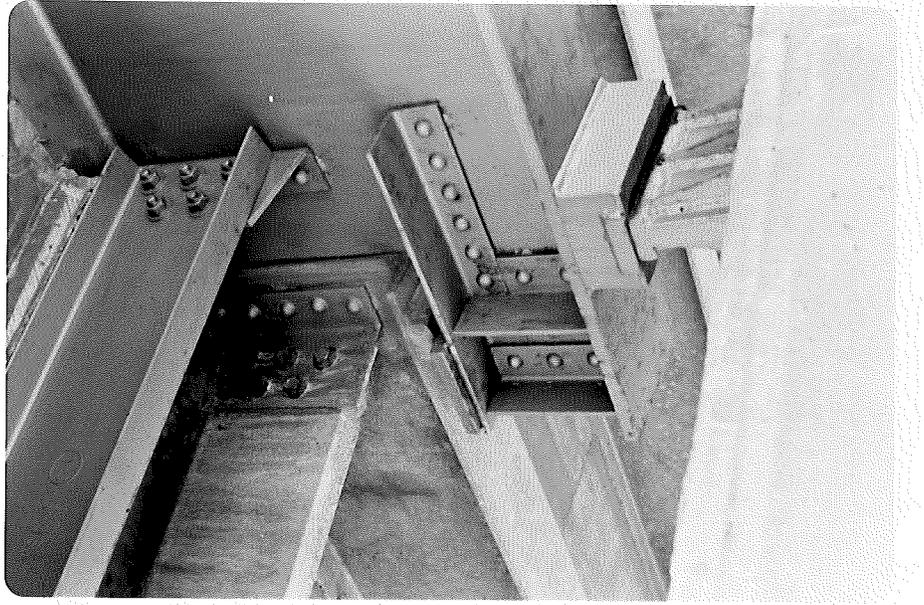
Of the two coating systems showing poor performance, one was based on two-component epoxy undercoats, while the other used a tar intermediate coat. Otherwise, no definite superiority was evident for the test coating systems. The galvanized coating is red-rust-free, although there is some surface deterioration, or white-rusting, in the joint area and on the bottom face of the lower flanges.

Figure 2 (right). Coating condition under joint area, with System 6 (paint) in foreground and System 8 (galvanizing) in background. Red rust is evident on paint system and white rust on galvanized system (M 71 bridge).

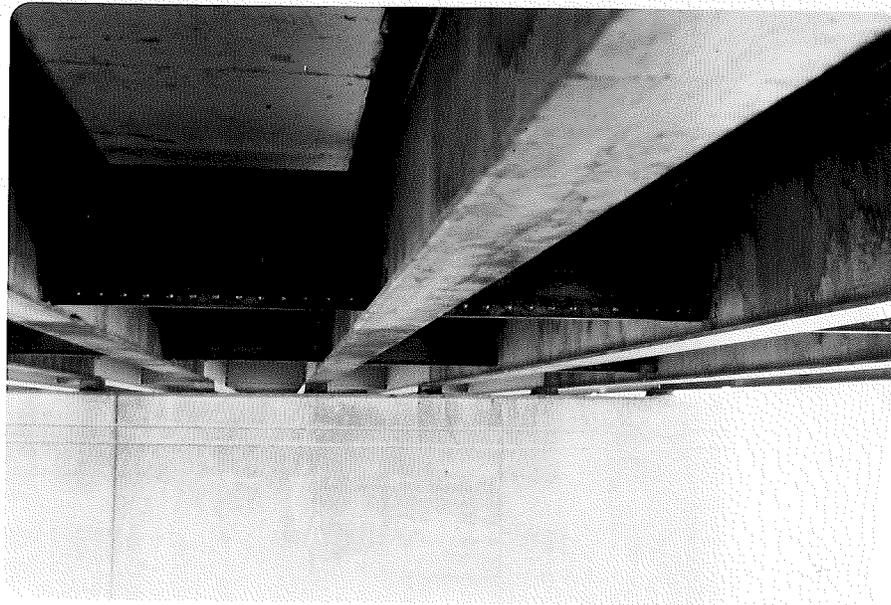
Three-Span M 78 Bridge over Shiawassee River. The six test coating systems are performing satisfactorily, except for Systems 4 and 5 which use a tar intermediate coat that is contributing to increasing and objectionable bleeding through the aluminum topcoat

(Fig. 3). The outside fascias of these systems showed significantly less bleeding, but did show distress from cracking and alligating. However, they showed almost no corrosion on edges of beam lower flanges, as reported from the previous inspection. Most deck joints, one sliding plate steel expansion dam, and one concrete expansion type over the central piers appear to have sealed themselves, thereby causing no recent addition to the almost negligible rusting in these areas. Joints over the abutments may be taking most of the movement. Minor edge rusting noticed on lower flanges of beams has appeared dormant for the last two years. The edge rusting was found mostly on Systems 1, 2, and 3, but not on Systems 4 and 5 as has been explained, nor on System 6 which utilizes a zinc-rich primer. No one system stands out here either as "best performing" after 4-1/2 years of service.

Figure 3. Bleeding and discoloration of aluminum topcoat over tar intermediate coat of System 4 (Shiawassee River bridge).
