MICHIGAN
STATE HIGHWAY DEPARTMENT

June 21, 1965

Subject: Failures of Two-Component, Cold-Pour Joint Sealant in New Pavement Construction. Research Project 62 G-116. Research Report No. R-525.

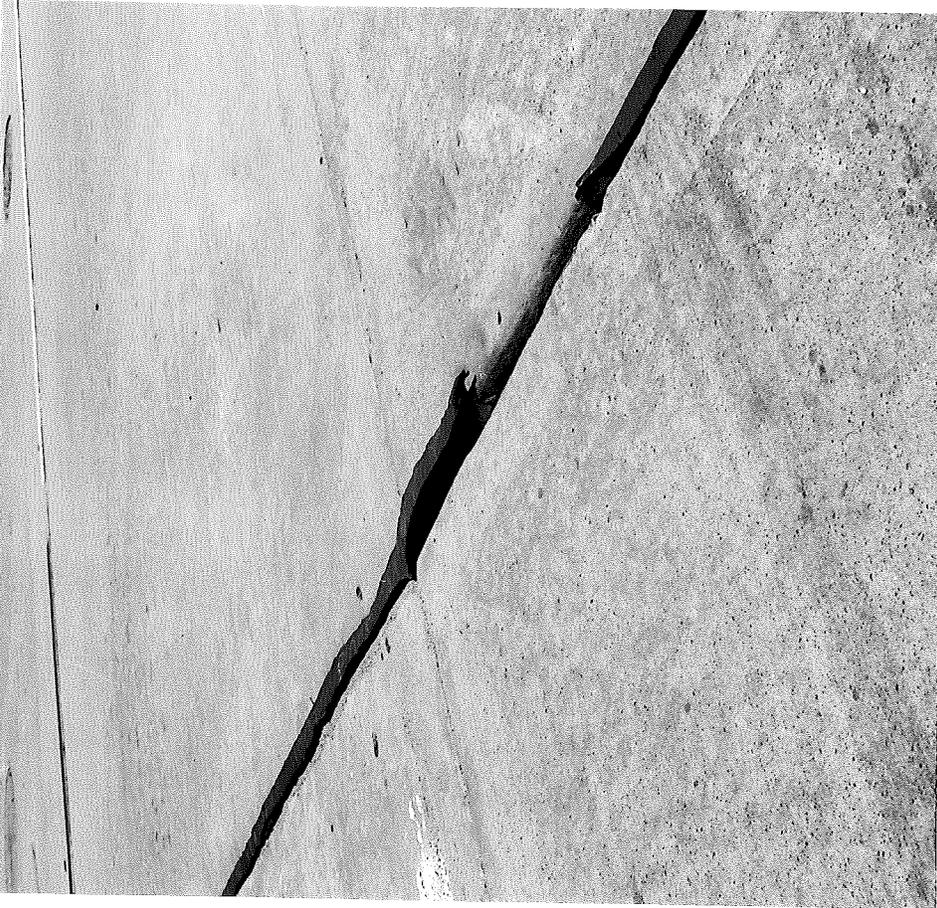
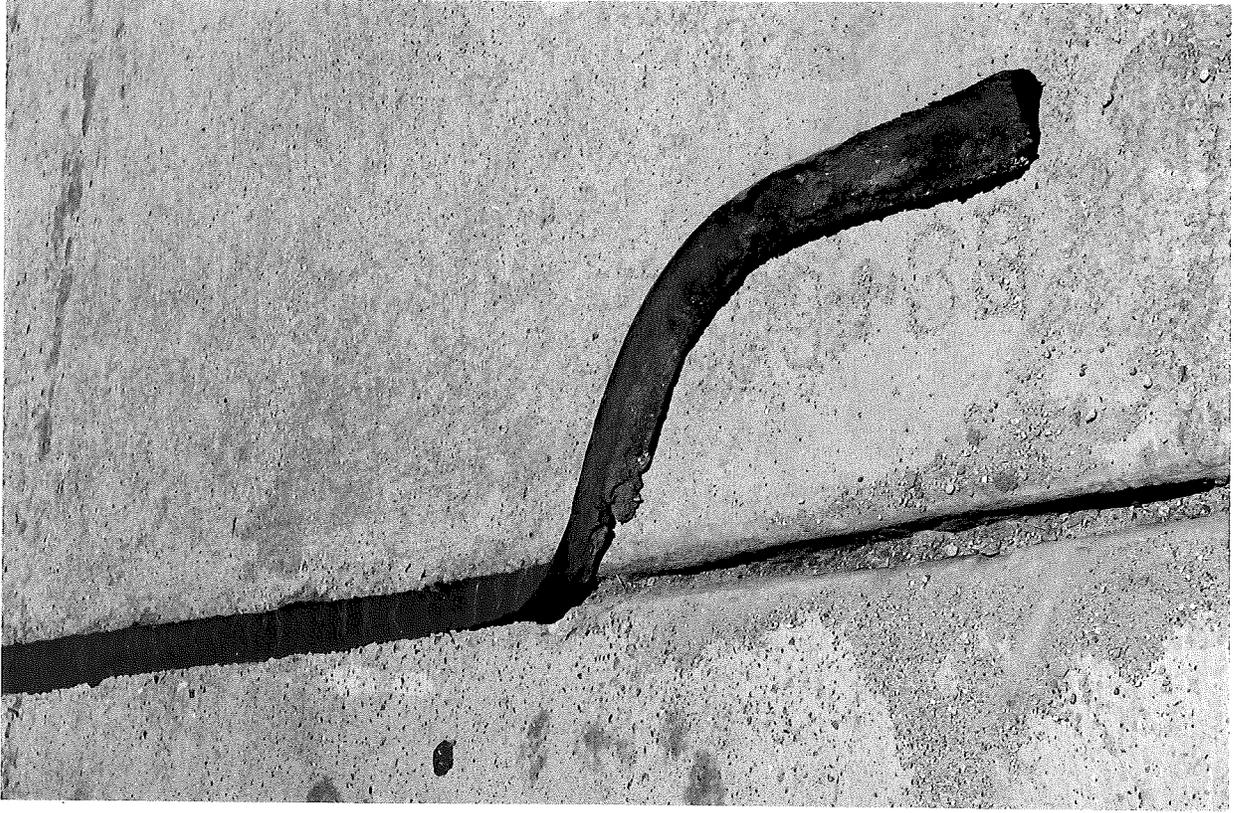
M 63201B, C1 (Southbound Wide Track Dr., from W. Huron St. 1/2-mile south, in Pontiac). This project was inspected with Oliver Smith, Project Engineer, and Lyle Lipp, Asst. District Road Engineer. It was constructed with 99-ft slabs, and the joint seal used was a hand-mix material (Type 2 or 3) installed in November 1964. All expansion joints were poured about 2-in. deep, more than flush with the pavement surface. There was severe loss of adhesion and lifting (Fig. 1). In most cases the seal was out of the joint or could be lifted out. Contraction joints in this area were in good condition, without extrusion of material above the surface, and adhesion was satisfactory.

Figure 1. Typical expansion joints on Wide Track Dr., filled too deep (2-in.) with sealant extruding from joint so that traffic pulls it free from groove. Joint faces at right possibly not adequately cleaned (Project M 63201B, C1).

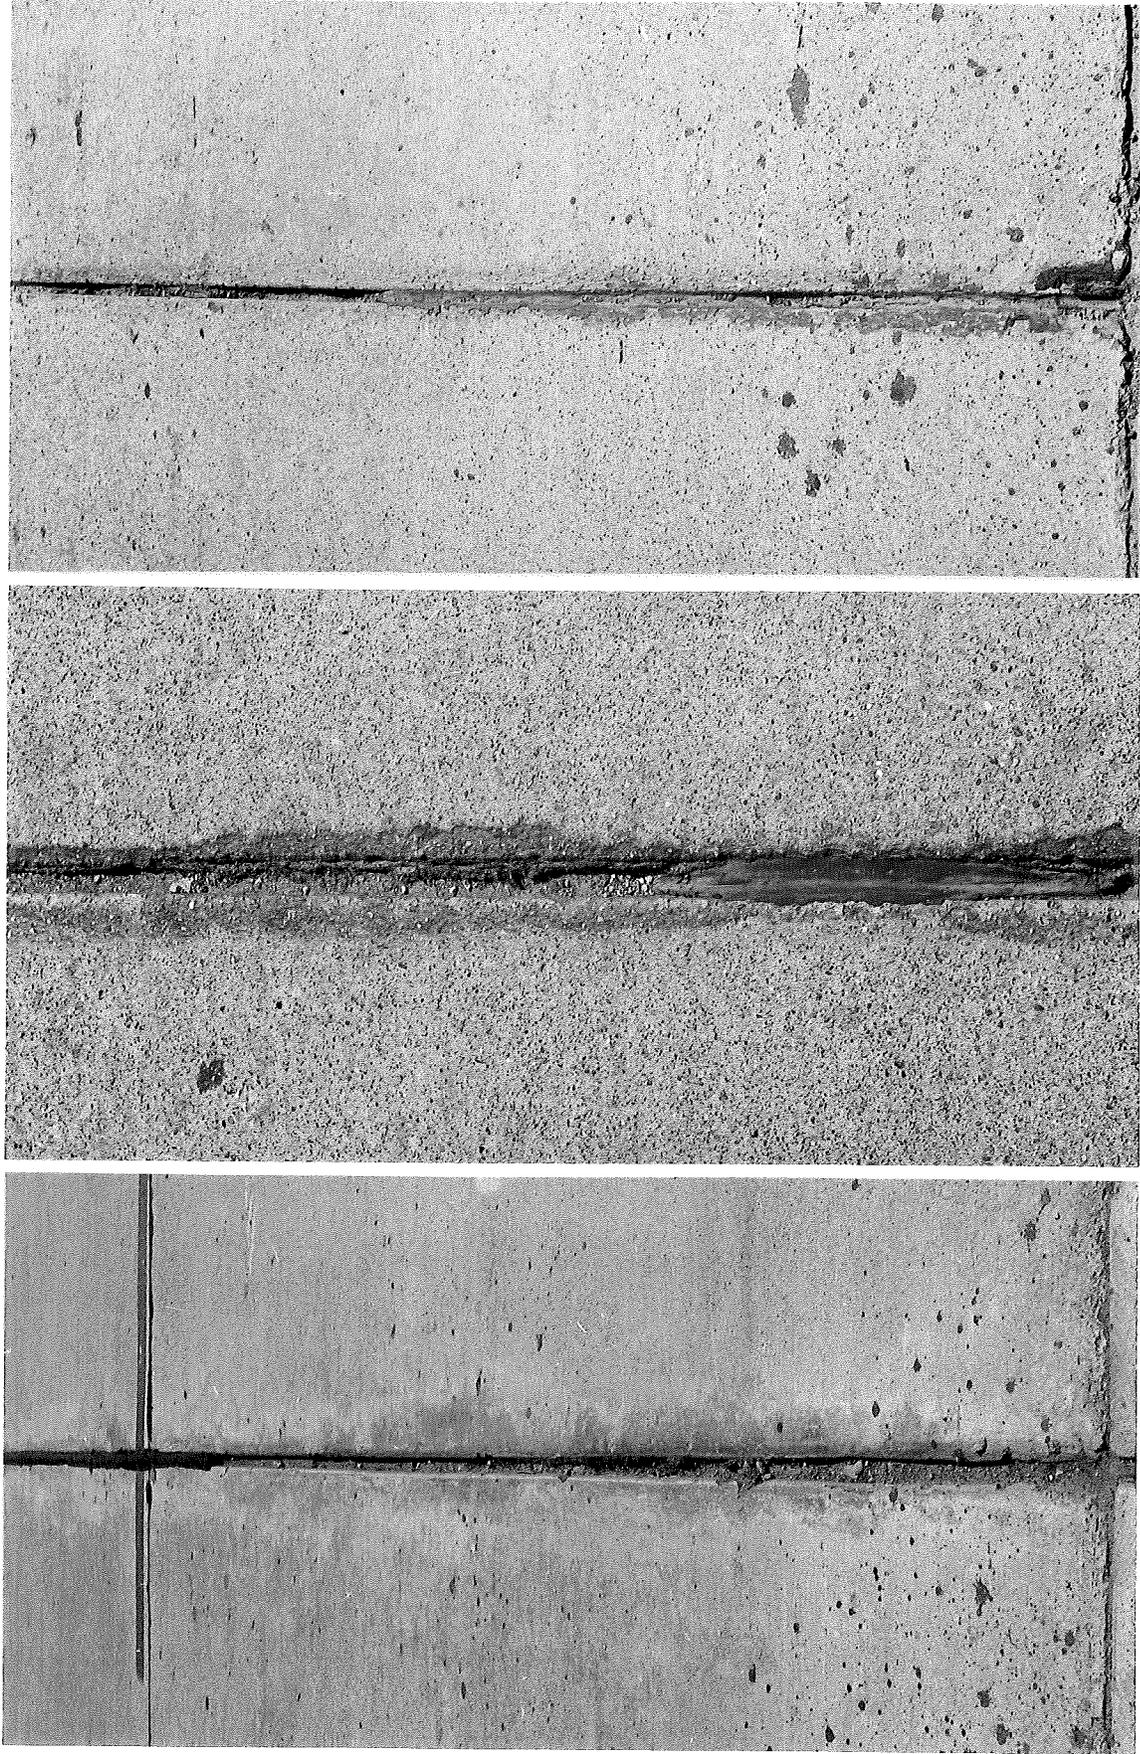
USS 63201D, C5 (Westbound Orchard Lake Dr., between northbound and southbound Wide Track Dr.). This project adjoins the previous one, was sealed at the same time, and includes two expansion joints and seven contraction joints. The sealant in both expansion joints was about 50-percent gone (Fig. 2). It had been poured to proper depth, but was too high above pavement. Two of the contraction joints were in poor condition; one had failed because the compressible filler had not been fully inserted into the joint, leaving little or no concrete face for the sealant to adhere to (Fig. 2). The other, which also appeared to have been filled more than flush, had been damaged by traffic and/or snow removal equipment.

Figure 2. On Orchard Lake Rd., expansion joint (left) with most sealant gone, contraction joint (center) with some sealant missing and compressible filler too high along one side of groove, and second contraction joint (right) with sealant missing and indications of sealing too high above surface (Project USS 63201D, C5).

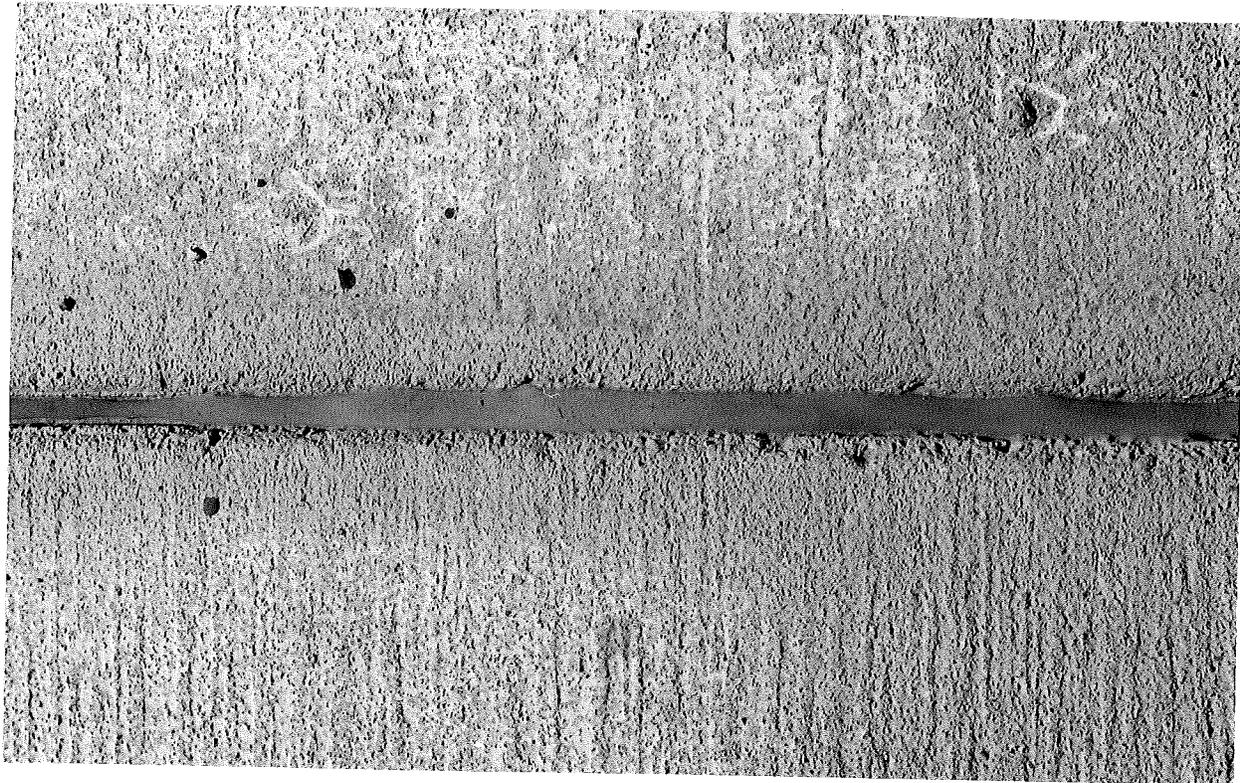
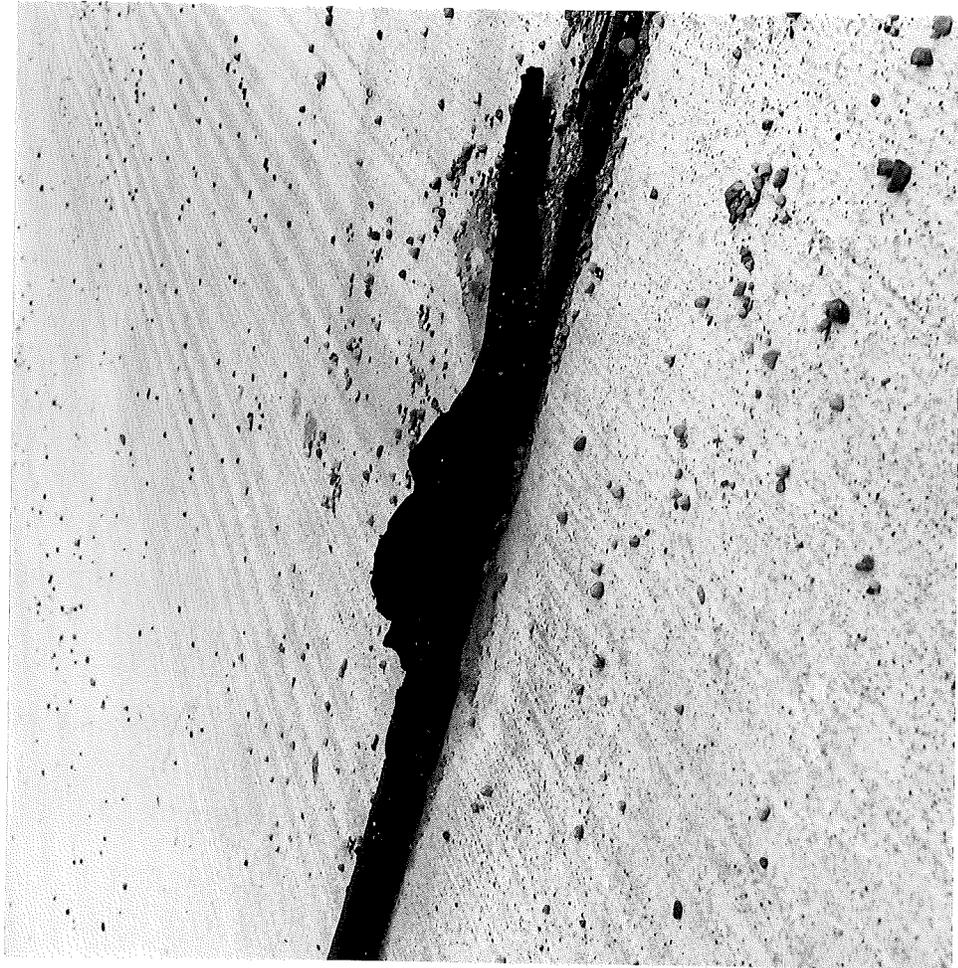
F 50013A, C1 (Relocated M 53 from 22 Mile Rd. to about 1/2-mile north of 23 Mile Rd., near Utica). The third area inspected was relocated M 53 and the structure carrying M 59 over relocated M 53 (S06 of 50011F). New M 53 was under construction using 99-ft slab lengths. The joints had been sealed in some areas late last year using Type 1 two-component joint seal (fast setting, machine applied). The expansion joints on M 59 adjacent to the structure were sealed in 1964. In all joints the sealant

was either loose or in certain areas totally removed by traffic. Subsequently, George Pingel, Senior Inspector, stated that the same situation prevailed at the expansion joints adjacent to the structure carrying 23 Mile Rd. over relocated M 53 (S01 of 50013A). We stopped at the field office on 22 Mile Rd. and discussed the problem with John Bramer, Project Engineer and Mr. Pingel, who both seemed to have a good understanding of the problem. Mr. Pingel and another inspector showed us one section of relocated M 53 not yet open to traffic (22 Mile Rd. to about 1/2-mile north of 23 Mile Rd.) which was sealed under their supervision. Here all transverse contraction joints were in good condition (Fig. 3). They pointed out that joints must be well sandblasted, well cleaned, and as dry as possible to obtain good adhesion of the two-component sealant to concrete. They have tried to keep the sealant level below the pavement surface, although some joints are still too full. Since this type of material, once cured, does not smear and level out when forced out of the joint as temperature rises, they felt it should be initially filled to a level similar to that specified for the placement of neoprene preformed material. They also showed us another area about 1-mile long not yet open to traffic (northbound relocated M 53 north of 23 Mile Rd.) but completed earlier this year and sealed full depth. The seals have been forced out as much as 1 in. and more (Fig. 3). This area is to be resealed, according to Bramer, since no inspector was present during sealing, which was done improperly.

Figure 3. Contrasting conditions on relocated M 53 pavement not yet open to traffic. At left, typical good contraction joint with sealant below pavement surface and evidence of good sandblasting. At right, expansion joint with sealant poured too high and torn by construction traffic (Project F 50013A, C1).

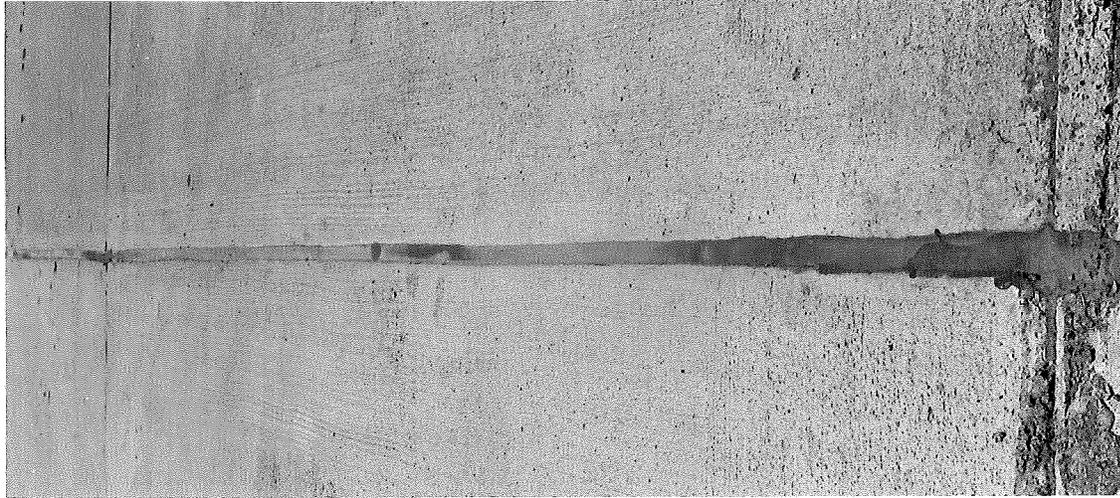
Mob of 82211C, C21 (M 85, about one block north of Pennsylvania Rd.). This project includes only two contraction and six expansion joints and was completed in 1963 using variable slab lengths. With few exceptions, the cold pour material was kept low in the joints. At a few spots where the material was high, damage by snow plows and traffic was evident. With these few exceptions, the general condition of the sealant was good (Fig. 4).

Figure 4. Properly sealed M 85 expansion joint, with sealant below pavement surface (Project Mob 82211C, C21).

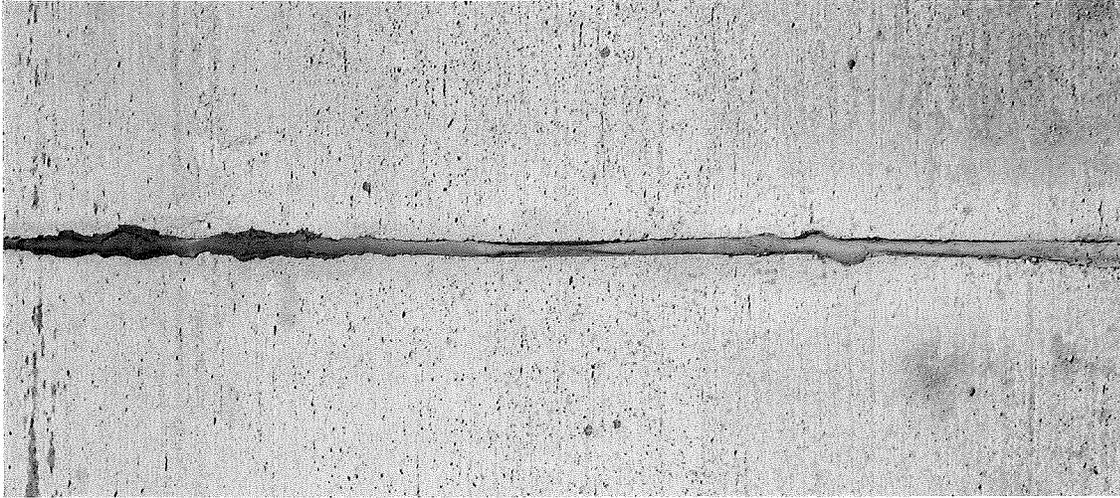
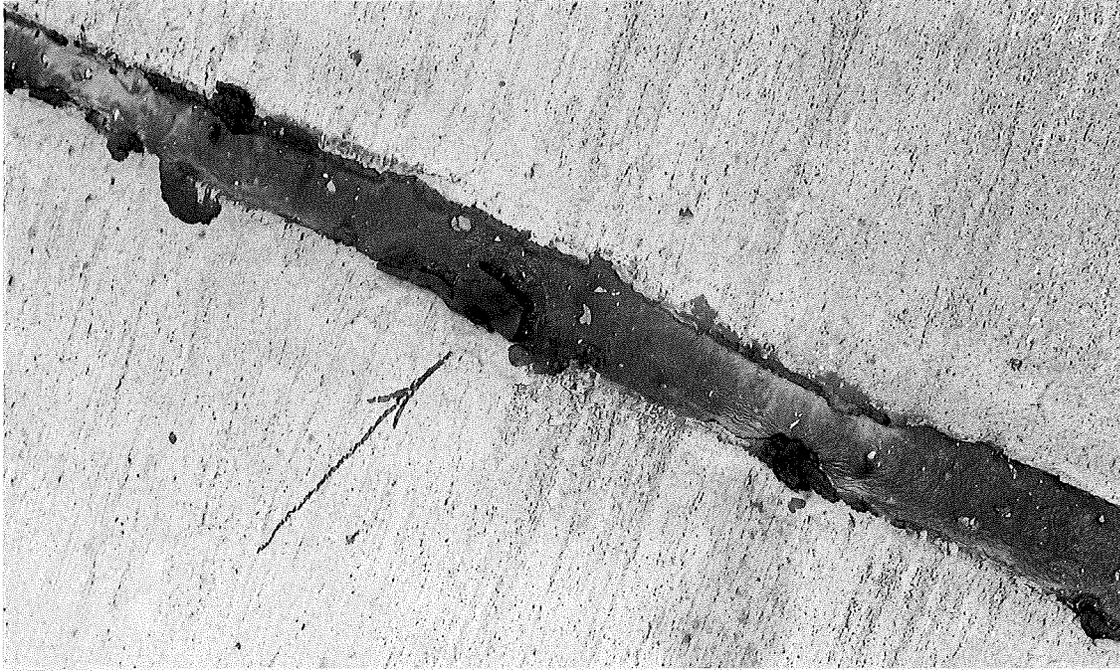
CS 82-60, C3 (Eureka Rd. from US 24 to I 75). This project (99-ft slabs) was sealed this spring with two-component cold pour. The sealant level reportedly was high when initially poured, causing rapid failure of the expansion joints in recent hot weather. These joints have subsequently been resealed with hot-pour material without removing all the cold pour (Fig. 5). The contraction joints are still in good condition although the material rising above the pavement surface is being removed by traffic (Fig. 5). Examination of one contraction joint showed that the compressible filler was placed too low in the joint, so that the correct shape factor of seal could not be obtained and too large a volume of sealant was available for extrusion.

Figure 5. Original cold-pour sealant in contraction joint (left) with some extrusion on joint edge in background. Expansion joint (right) resealed with hot-pour sealant, still contains remnants of original cold-pour sealant (Project CS 82-60, C3).

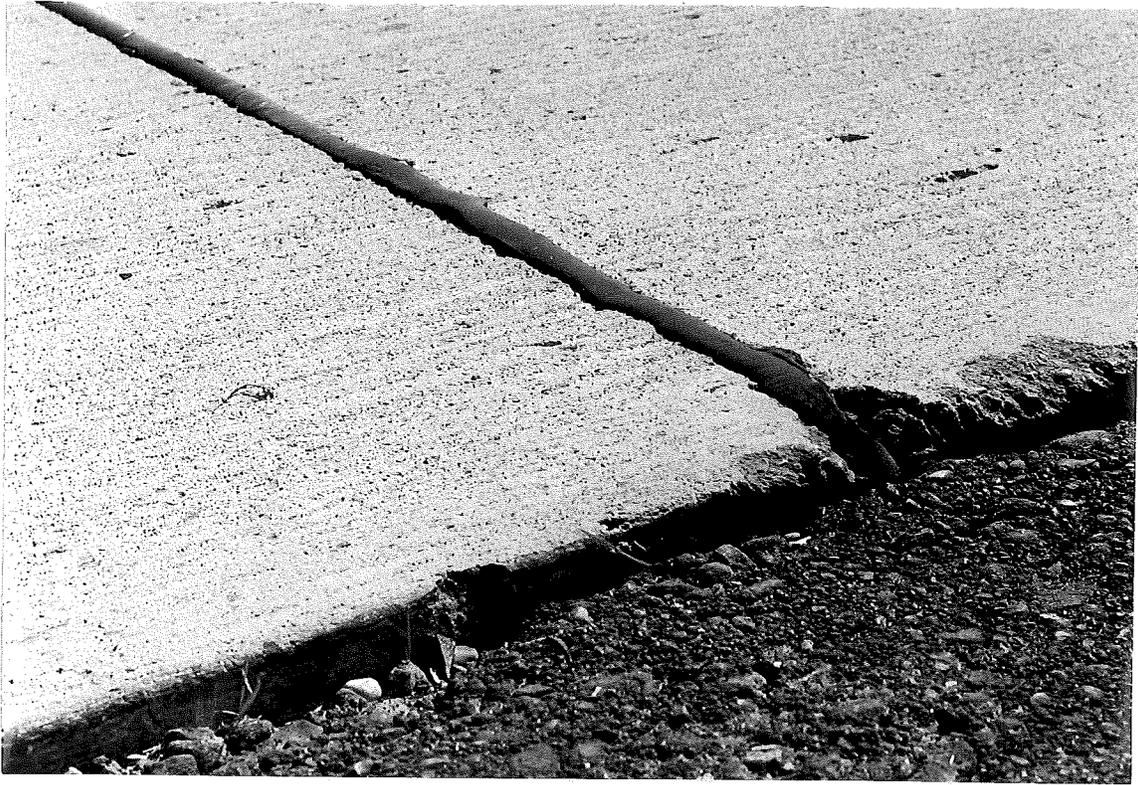
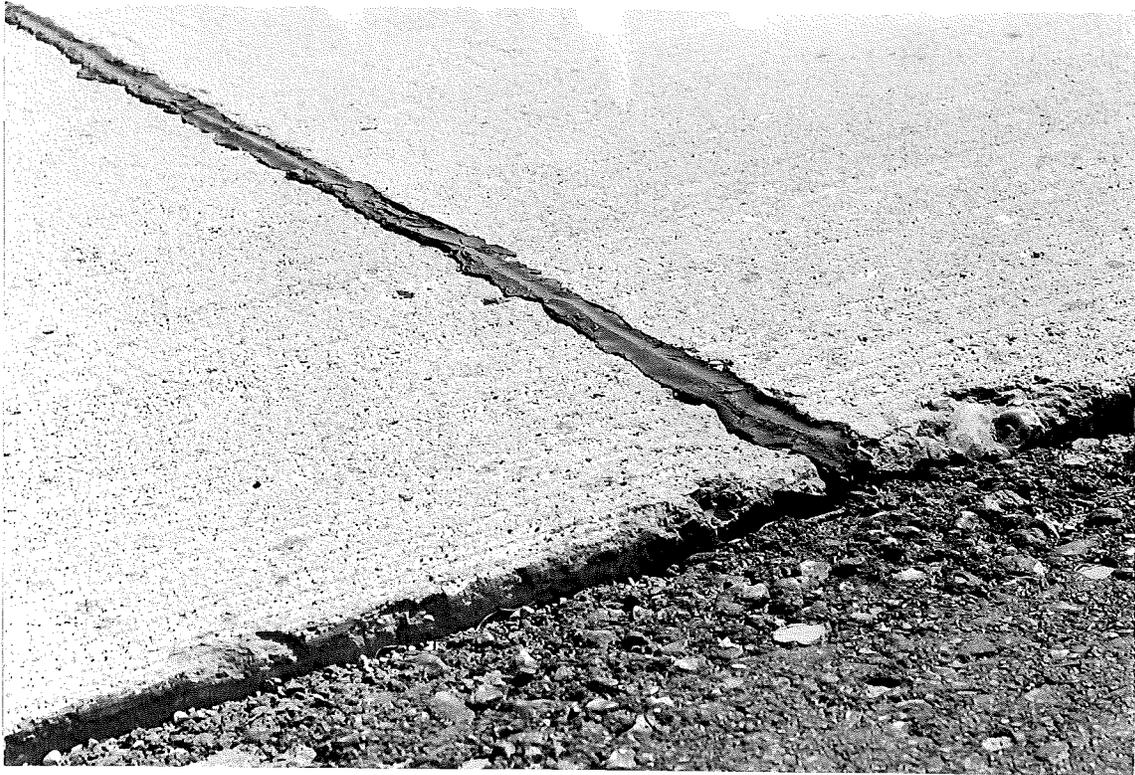
F 81121A, C2 (M 153 from M 14 to Ford Rd.). This project consists of about 1-1/2 miles of divided highway constructed with 71 ft 2 in. slabs. All expansion joints are hot pour and contraction joints cold pour (Type 1). Contraction joints on the east-bound section were poured full 2-in. depth while those on the westbound were poured over a jute filler with polyethylene tape as bond breaker. Those poured full depth were expelled from 1/8 to 1/4 in. above the pavement surface, but those poured over filler had not noticeably risen (Fig. 6).

Figure 6. Typical cold-pour-sealed M 153 contraction joints, with sealant poured full 2-in. depth and extruding above surface in eastbound lanes (above), and retaining good adhesion in westbound lanes (below) where poured over compressible filler (Project F 81121A, C2).
