MICHIGAN
DEPARTMENT OF STATE HIGHWAYS

March 1, 1966

Subject: Inspection of Pavement Joints on US 127: Hudson to Ohio State Line.
Project 39 F-7(14). Research Report No. R-555R.

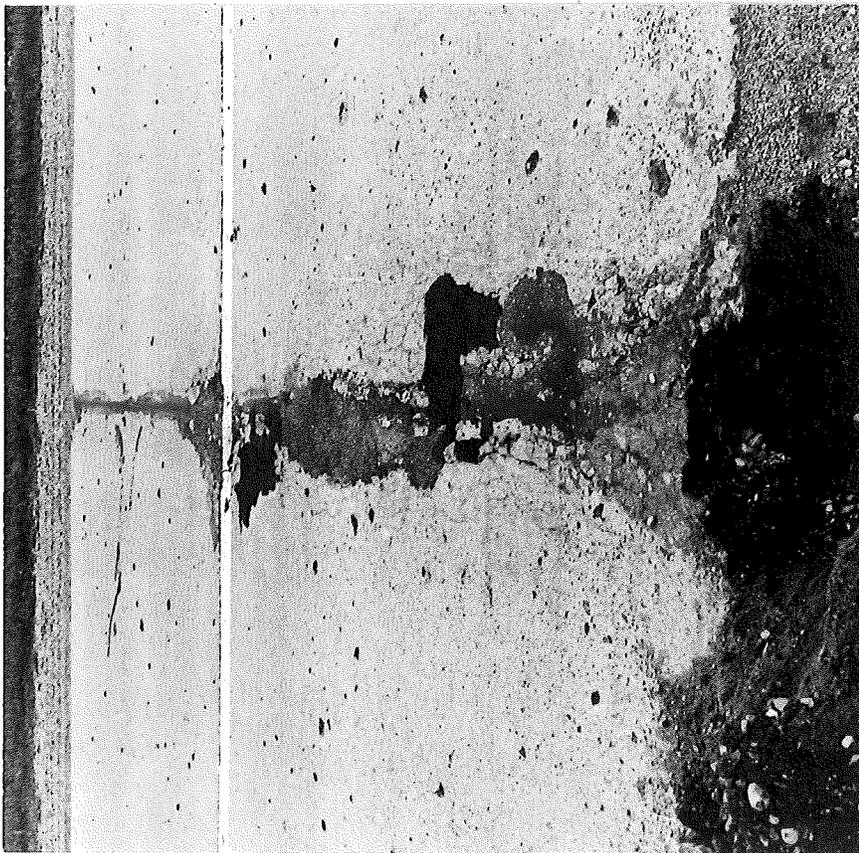
Almost every joint in this project, which extends about 5 miles south from Hudson, was distressed to some degree, with about 50 percent of the joints in very bad condition. Figure 1 shows a badly distressed joint typical of this project with its profile revealed through a hole dug in the shoulder.

The concrete at the joint had disintegrated in a wedge shape, tapering up to the dowel bars from the plastic base plate. The concrete above the dowels was fractured into small pieces, as though subjected to severe compression. The surface of this project had numerous popouts (Figs. 1 and 2).

Samples of the crumbly concrete material were taken from the rotted wedges of joints in both construction projects. Analysis of this material indicated 0.34 lb of free sodium chloride per ton of concrete in Project C3 and 0.62 lb per ton in Project C5. These results support the theory that concrete deterioration in the lower section of joints is aggravated by the penetration of salt solutions (from ice control chemicals) into the pavement joints, and their subsequent impoundment by joint base plates.

Figure 1. Distressed joint with end exposed: Construction Project 30-04, C3.

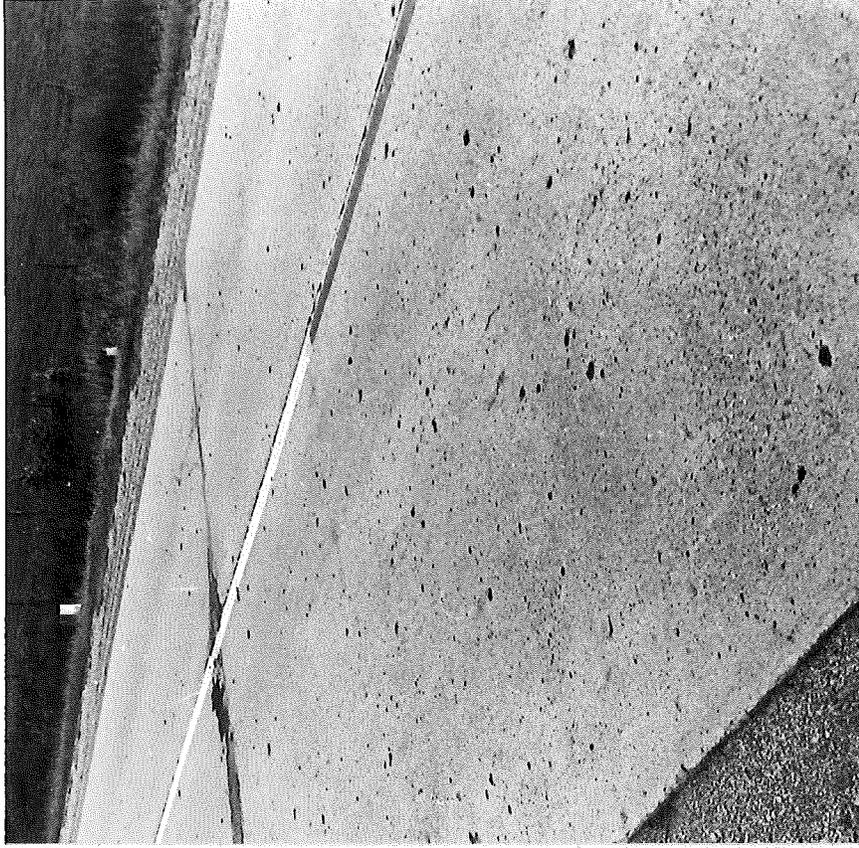
Figure 2. Numerous popouts in pavement surface: Construction Project 30-04, C3.

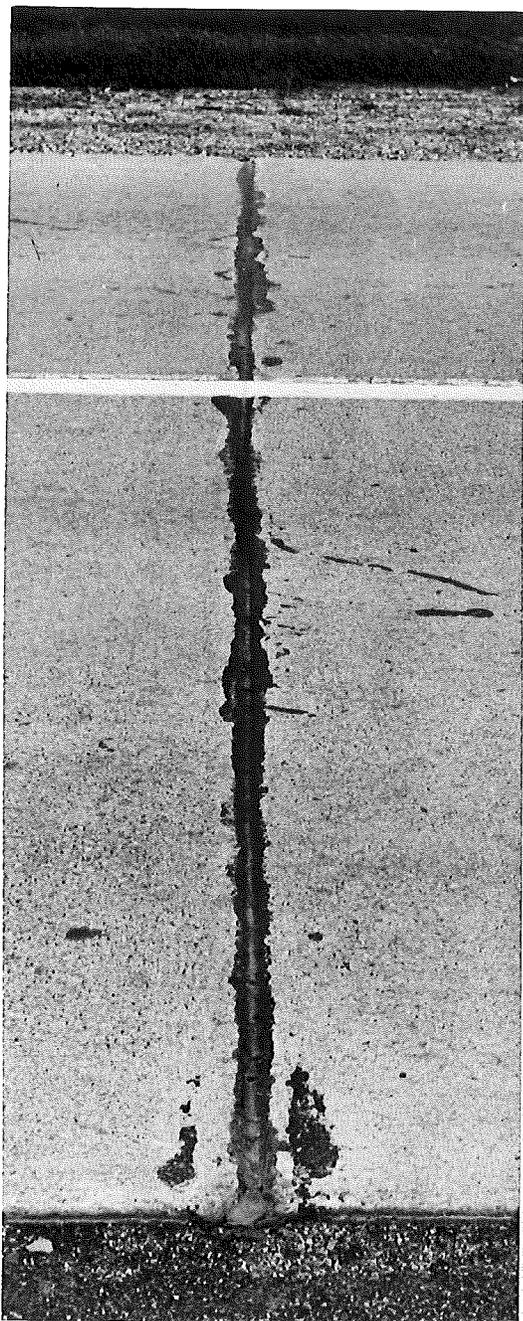
Joints in the northern portion (Sta. 105+27 to 266+00) of this project were in excellent condition with almost no distress evident. Figure 3 shows a typical joint in this area. However, from Sta. 105+27 south to the Ohio border, numerous joints had serious spalls where maintenance was required.

Figure 3. Typical joint in Construction Project 30-04, C5, between Stations 105+27 and 266+00.

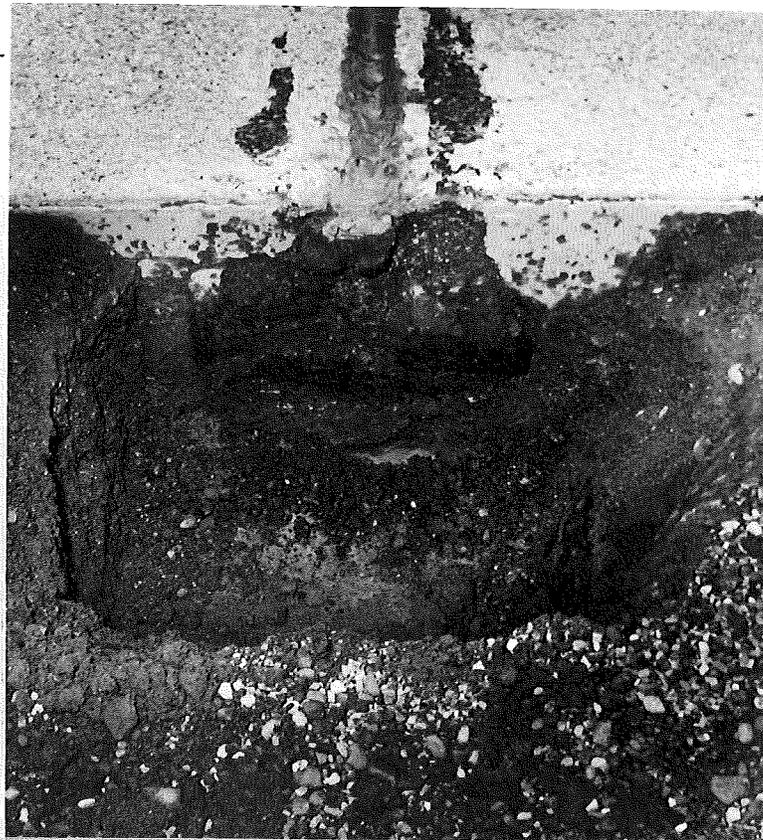
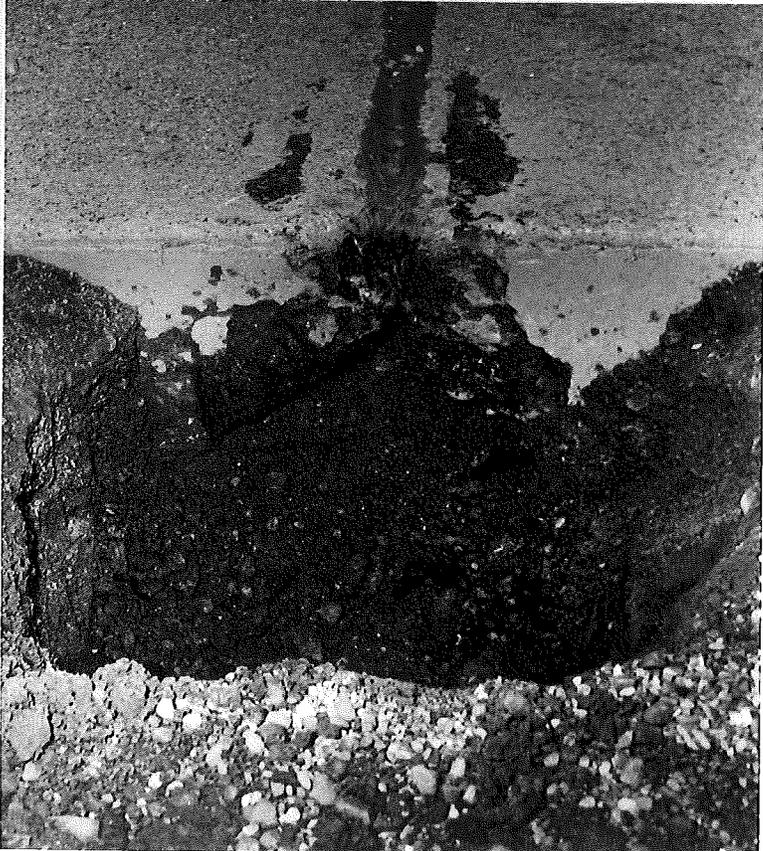
By digging through the shoulder, the profile of an apparently sound joint in the northern portion was revealed as shown in Figure 4. In this area, the concrete had disintegrated in a typical wedge, with its wider end across the plastic base plate, tapering to an apex near the dowel bars. This suggests that a series of joint failures may be imminent in the currently satisfactory northern portion of this project.

Figure 4 (right). End view of sound joint in Construction Project 30-04, C5, before removal of end plate (top), and after removal of end plate (bottom). Note disintegration of concrete above base plate.

It is proposed to make an annual condition survey of sample lengths of Project 30-04, C5 to determine if and when the joints begin to fail.

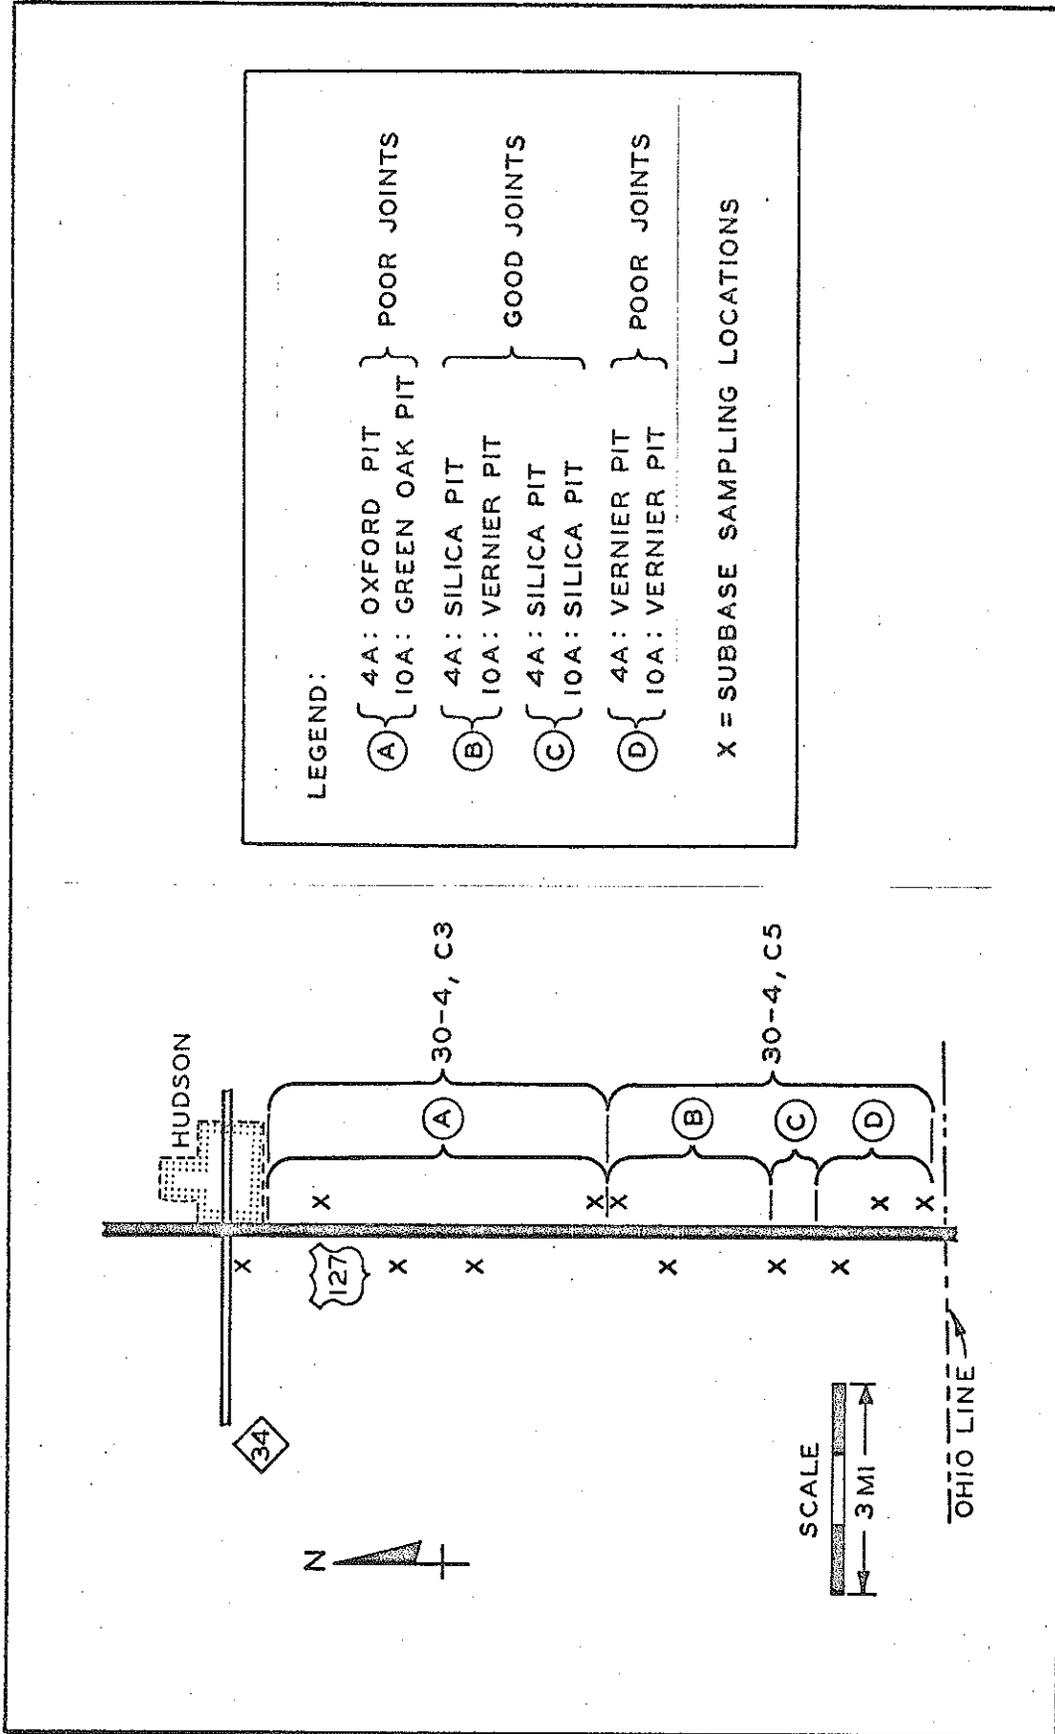
Comparison of these three data tabulations shows that the only apparent difference in the construction factors of pavements with excellent and poor joints is the coarse aggregate used in the concrete. The pavement constructed using coarse aggregate from the Silica Pit (limestone) had joints that performed excellently. Figure 5 shows the distribution of the various sources of concrete coarse aggregate used in the projects.

Figure 5. Distribution of coarse aggregates used in concrete on US 127 projects from Hudson to Ohio State Line.
