MICHIGAN DEPARTMENT OF STATE HIGHWAYS

March 28, 1966

Subject: Accident Damage to Aluminum and Steel Guard Rails.
Research Project 54 F-36. Research Report No. R-573.

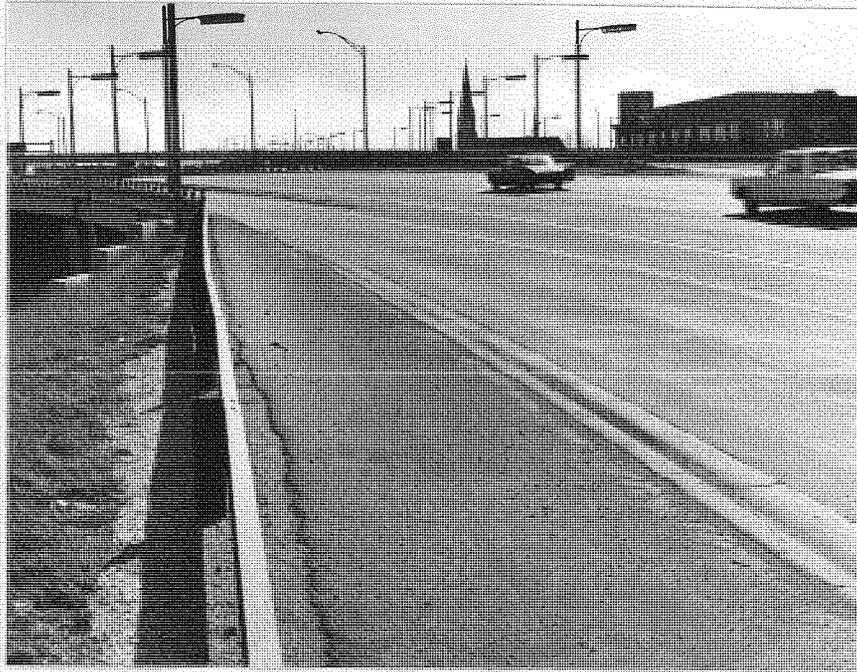
The accident site was on southbound I-296 just past the exit ramp to westbound I-196 (Fig. 1). The car involved went through the guard rail, rolled down the embankment, and stopped along the entrance ramp to northbound I-296. Details of the accident were not available, because the police report had not yet been received.

Figure 1. Site of accident on southbound I-296, Grand Rapids. The guard rail involved is at center, partially hidden by the first car.

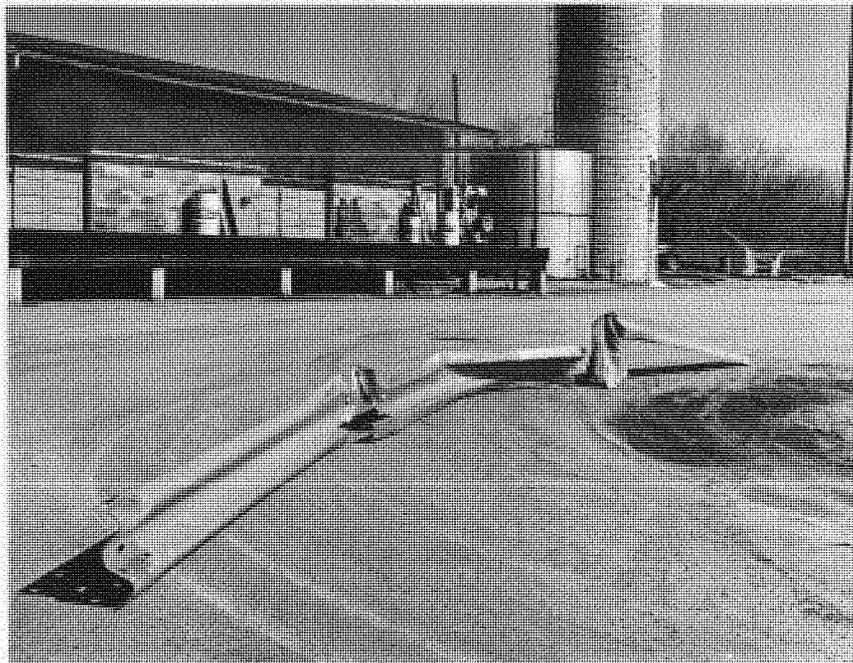
The damaged rails are shown in Figure 2, the buckled rail being steel. During the impact, the aluminum rail was completely fractured at both ends at the splice connections and the loose section was found at the toe of the embankment. Details of the fractures are illustrated in Figures 3 and 4.

Figure 2. Damaged rails. Rail at right is galvanized steel.

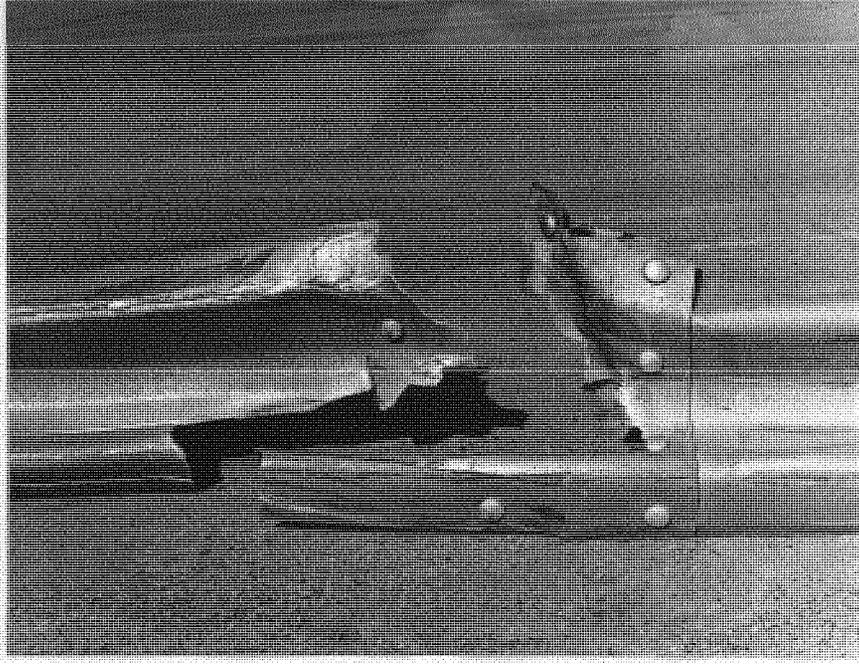
Based on Mr. Morgan's experience with aluminum guard rail, this type fractures easier than the galvanized steel rail, but in most cases the failure occurs as a shear-out fracture at the bolt holes. Since no two accidents involving guard rails have exactly the same characteristics, it would be impossible to determine the performance of the two rail types using the amount of damage as a criterion. It is well known that of the two types of materials in question, the steel rail has a considerably greater resistance to fracture under impact loading.

Figure 3. Fractured aluminum guard rail.

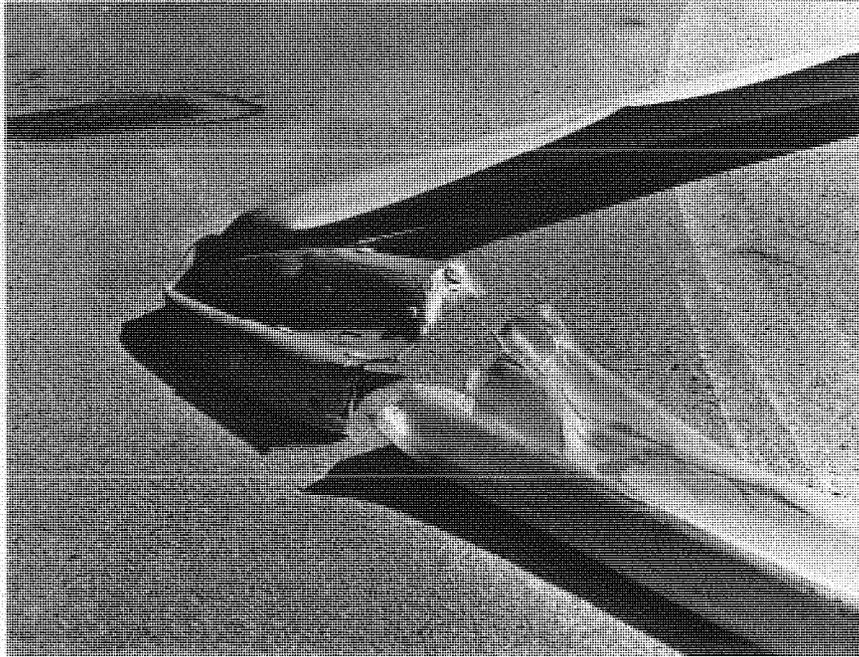
As stated on previous occasions with regard to guard rail design, the three essential requirements for an effective barrier are as follows: 1) to prevent the vehicle from going through, under, or over the barrier, 2) to prevent the vehicle from rebounding back into the traffic lane, and 3) to bring the vehicle to a safe stop within tolerable deceleration limits. Full-scale tests on guard rail barriers, reported by J. L. Beaton and R. N. Field in HRB Bulletin 266 (1960) demonstrated that the steel single beam type guard rail mounted on posts spaced at 12 ft 6 in. is ineffective, as the rail pockets the vehicle, or the vehicle snags a post resulting in pitching or rolling, extremely high decelerations, and total loss of the vehicle after impact. For the case of an aluminum alloy single beam type rail of the same shape and post spacing, since the material is essentially brittle, and the toughness or energy absorbed to fracture is quite small, the probability of a fracture of the beam rail under impact would be high, allowing the vehicle to go through the barrier as was the case here.

Figure 4. Buckled steel rail and fractured aluminum rail.
