MICHIGAN  
STATE HIGHWAY DEPARTMENT

Subject: Presstite Tape for Protection of New Joints Before Sealing.  
Research Project 66 NM-156. Research Report No. R-594.

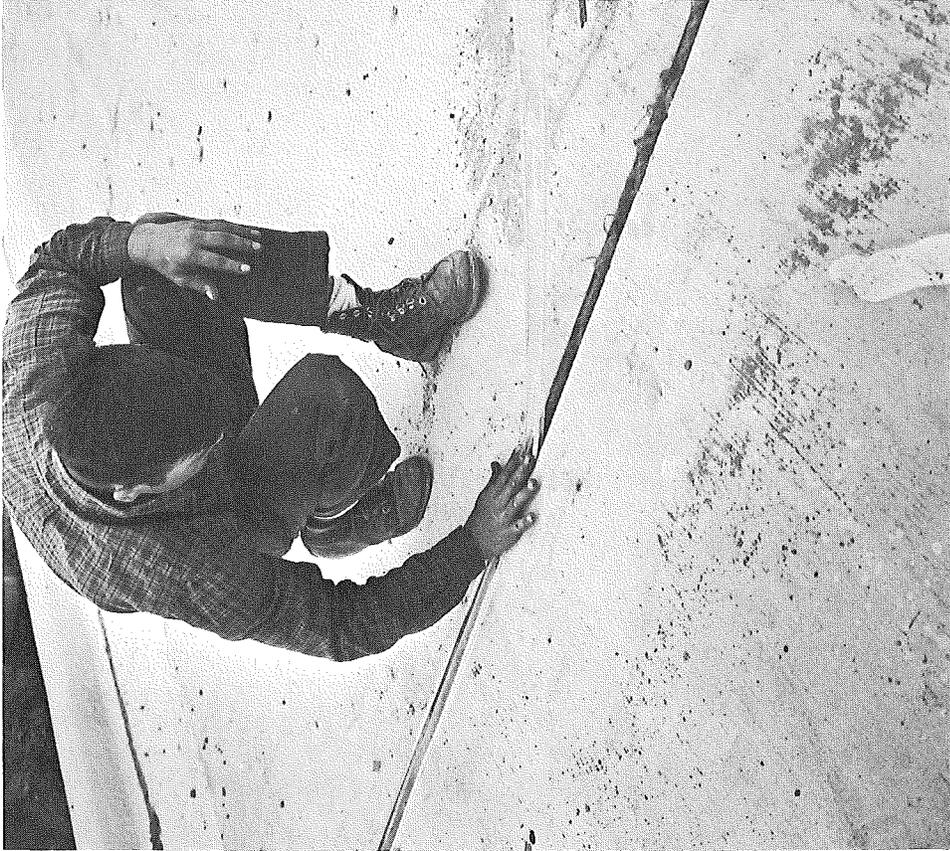
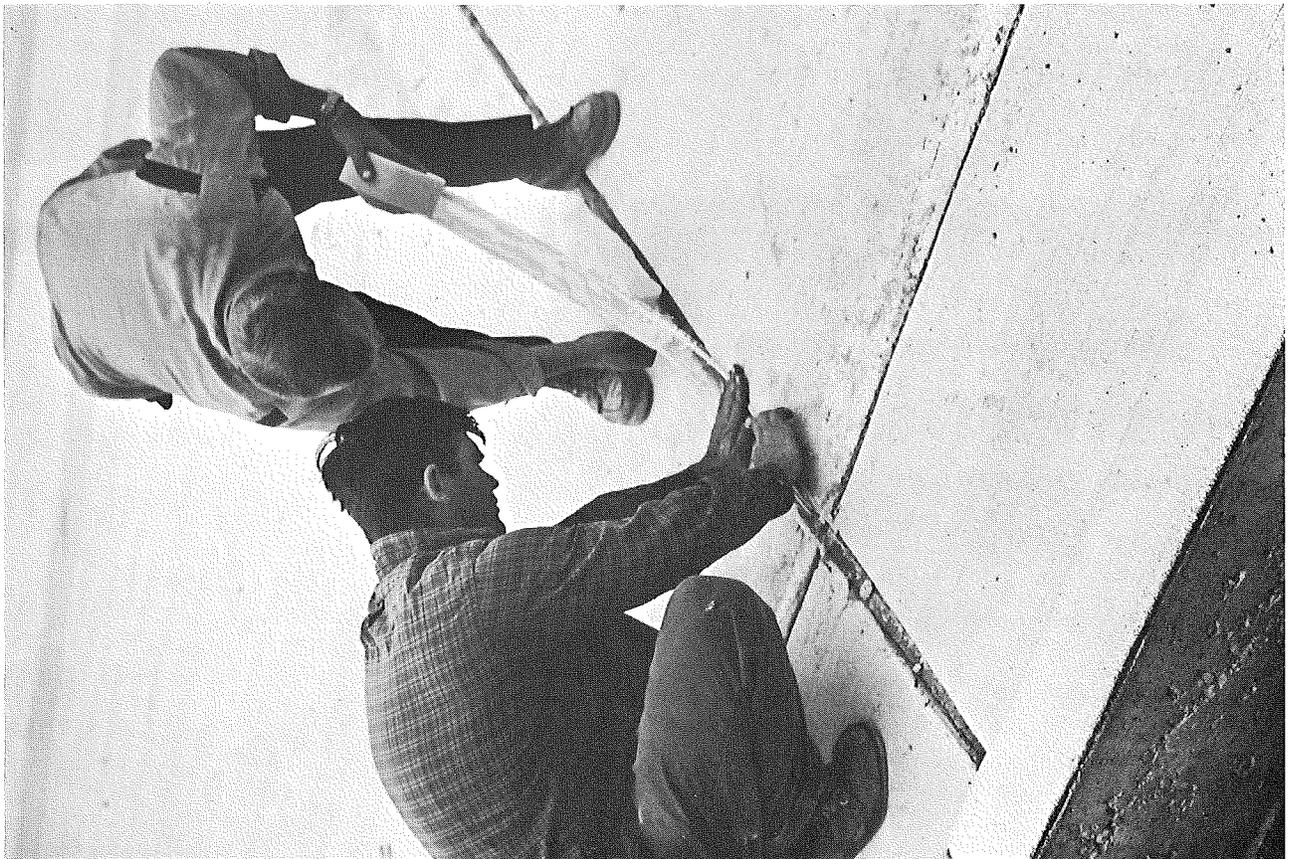
The tape used was actually designed for ~~2~~1/2 in. contraction joint openings, but since this sample material was available, it was used on these unsealed expansion joints for purposes of observation. On June 1, the tape was placed after the joints had been cleaned with compressed air and the 1-1/4 in. wide openings filled with oakum. Figure 1 shows how the tape was placed and the adhesion effected by hand pressure.

Figure 1. Tape was applied by two workers (left) and bond to pavement surface effected by hand pressure (right).

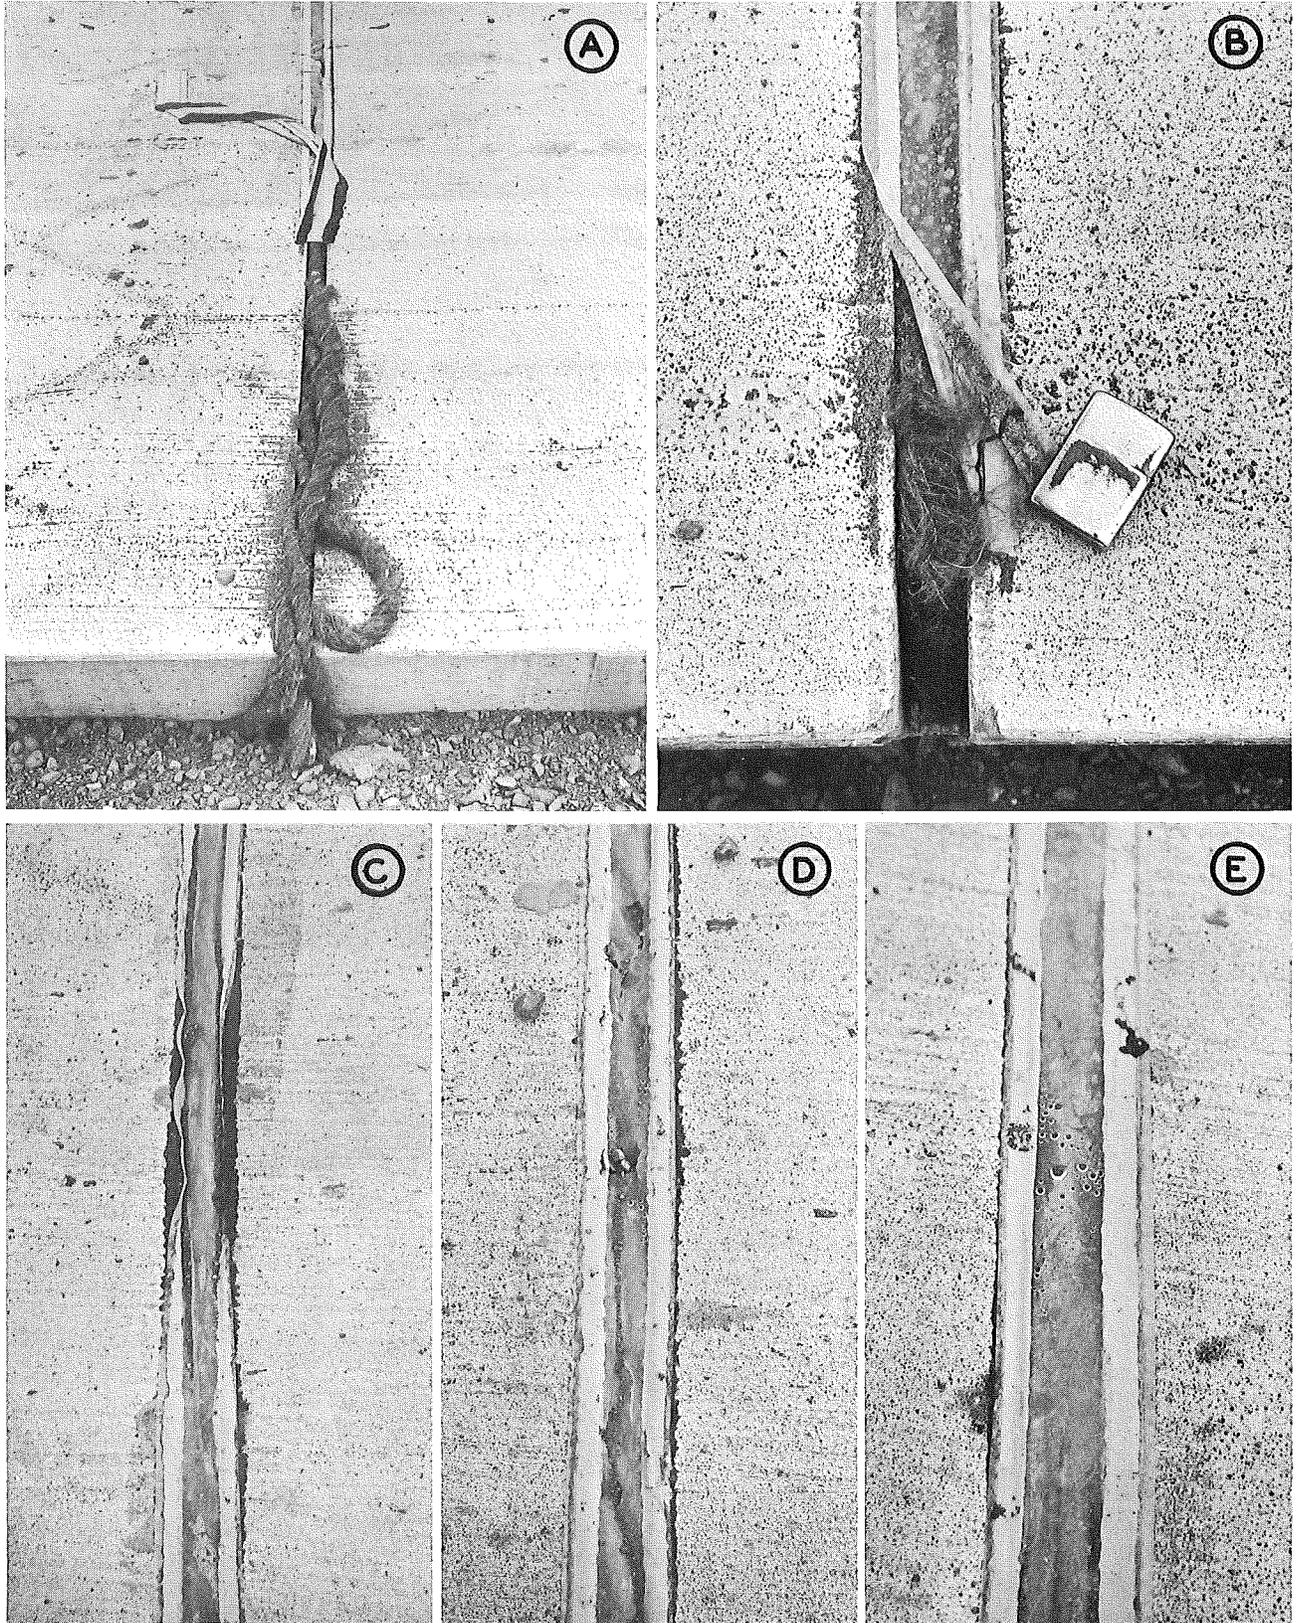
The taped joints were inspected after 2 and 37 days, with traffic on the pavement during this period consisting only of local construction vehicles. After 2 days, several types of failure were found, as shown in Figure 2. Adhesion failures appeared in various locations across the 24-ft width of roadway, including 2-ft failures at three joints, 4-ft failures at four joints, and one joint with a full 24-ft failure. These were traced to dirty contact areas, or the tape's having been forced down into the joint and then pulling loose from the pavement surface. In a few instances, stones which had punctured the tape were found in the joint. Moisture was noticed under the tape even in areas of stone punctures.

Figure 2. Conditions encountered after two days under local construction traffic included: a) tape pulled off and oakum pulled out of joint, b) dirt infiltration of adhesive, c) tape pulled off at the joint faces, d) punctures in tape caused by stones, and e) moisture trapped under tape.

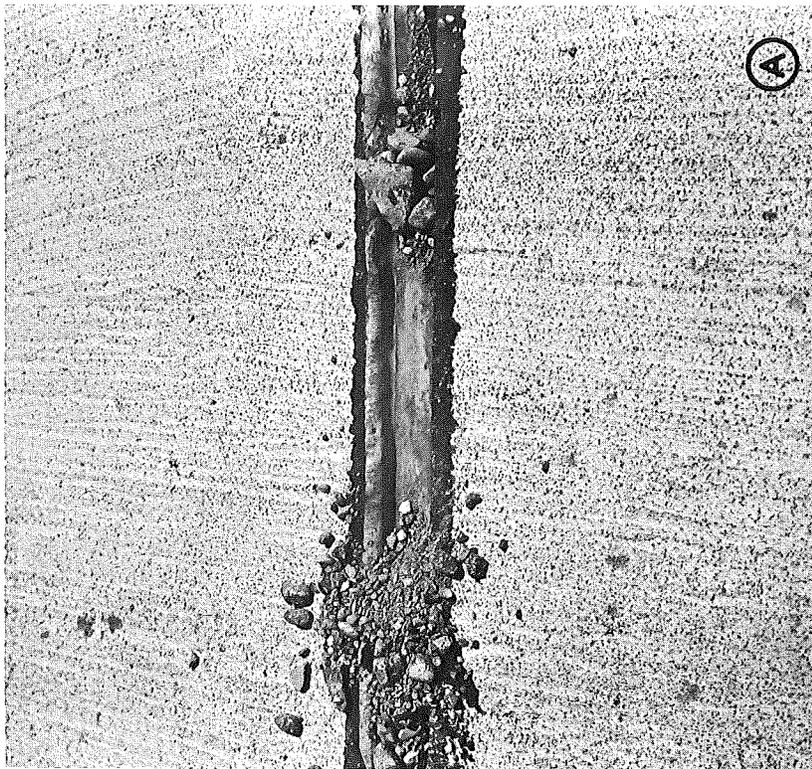
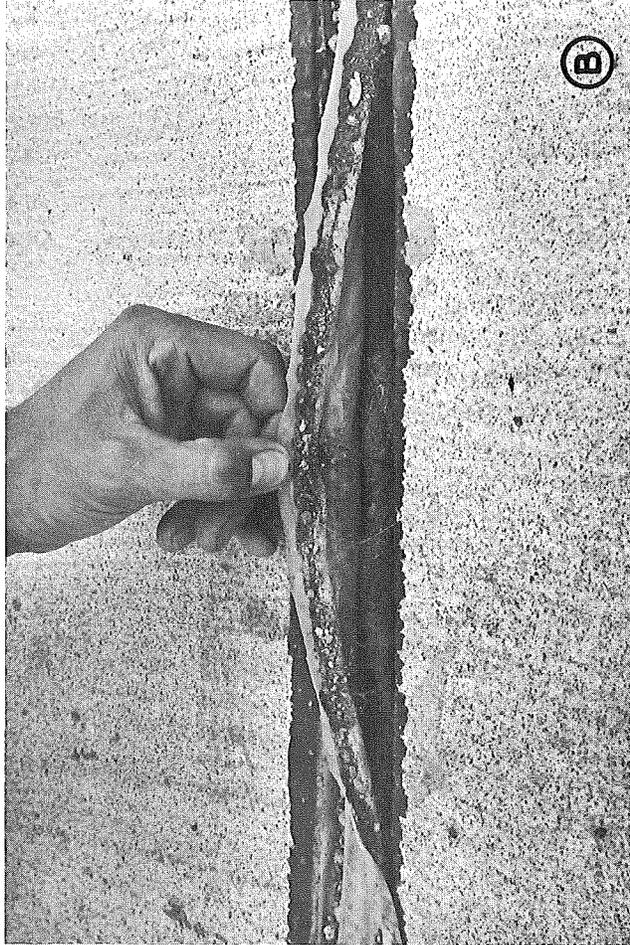
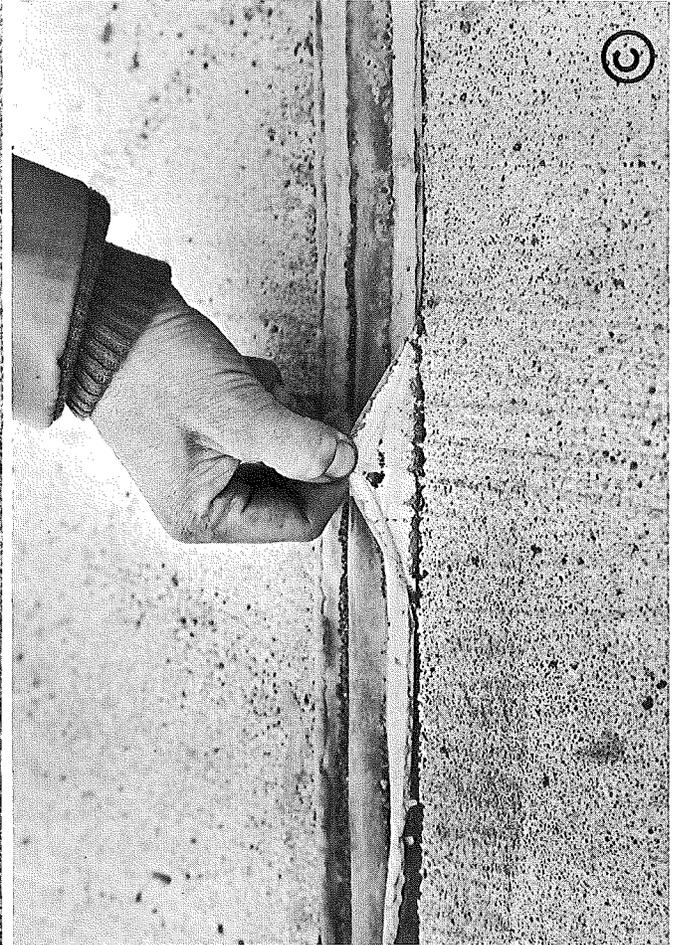
After 37 days, the joints were inspected again. Stone punctures had increased slightly, but were still located in only about 3 percent of the tape. The number of small pebbles cradled in the tape had increased significantly (Fig. 3a). In most cases, however, these stones had not punctured the tape, and adhesion to concrete was still good. The number and lengths of adhesion failures had not changed since the first inspection.

In summary, as indicated in Figure 3, it appears that Presstite No. 579.15 tape provides an effective barrier against most debris, adheres well to the concrete when properly installed, and retains moisture in the joint for curing. Its effectiveness, however, might be increased by more careful cleaning of joints immediately before application, and by applying pressure to the tape by some means other than by hand, e.g. a small rubber roller. Finally, if tape of the proper width had been used, as was not the case here, perhaps even better adhesion would have been obtained.

Figure 3. Conditions encountered after 37 days under local construction traffic included: a) good adhesion to joint faces, b) joint openings free from dirt, and c) adhesive holding well in areas where it had not been infiltrated with dirt.
