# OFFICE MEMORANDUM

MICHIGAN  
STATE HIGHWAY DEPARTMENT

Subject: First Progress Report on Evaluation of Experimental Paint Coatings for Bridge Steel on S01 of 33031, S02 of 33032, and S07 of 38131. Research Projects 49 G-50(4) and (5). Research Report No. R-602.

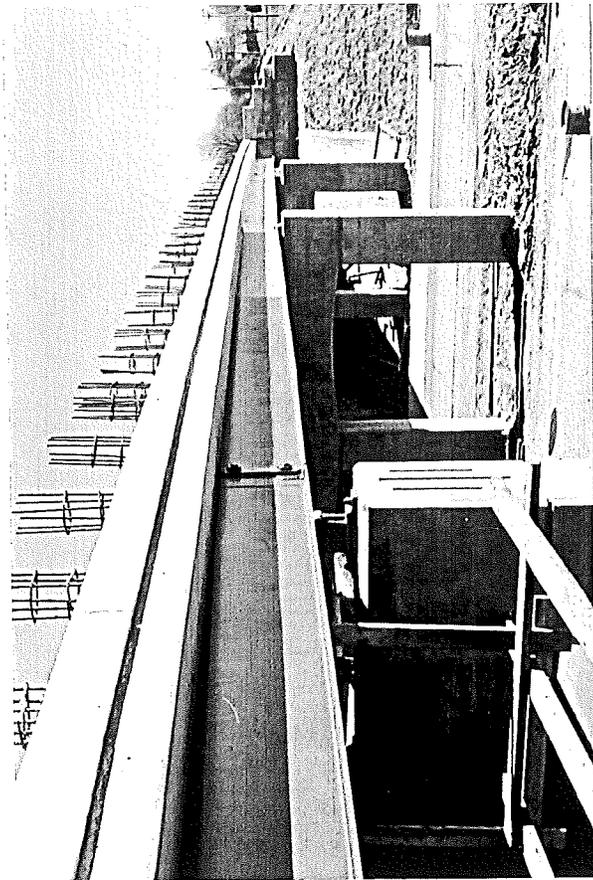
3. Field repair of the primers and application of field coats, as follows:
  - a. Before onset of winter, complete application of the test control system first field coat at Bellevue Road (Fig. 1), and at Columbia Road except for the outer portion of the fascia beams. The No. 2A(2) paint was applied by roller and brush.

Figure 1. First field coat of No. 2A(2) Brown being applied over red lead primer on October 29, 1965 on two west spans of Bellevue Road. White vinyl primed east spans are in background.

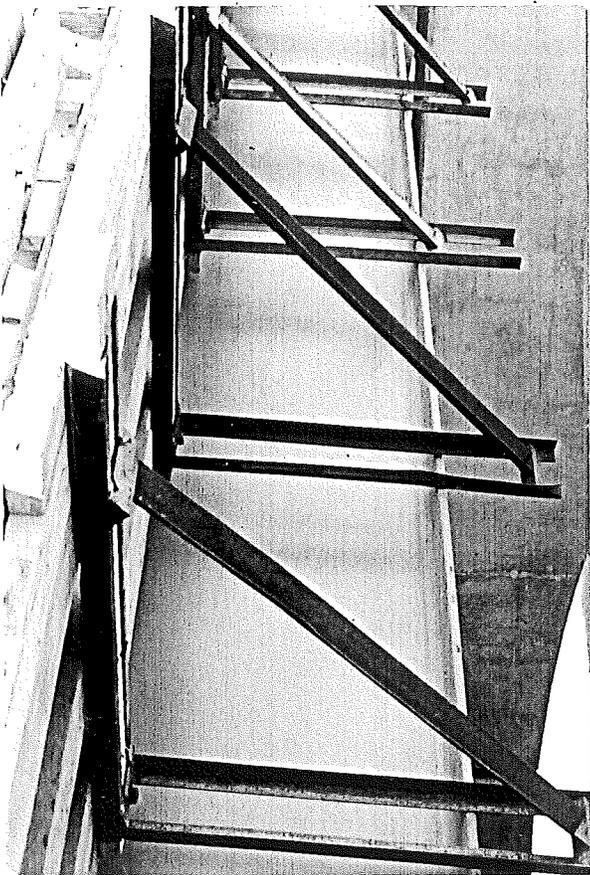
b. The No. 1A(1) primer on the Columbia Road fascia beams gave almost rust-free protection over a winter of exposure, at a 1.5-mil minimum dry film thickness (Fig. 2).

Figure 2. Almost rust-free condition of No. 1A(1) Red Primer over blast-cleaned steel after a winter of exposure on north fascia of Columbia Road (photographed spring 1966).

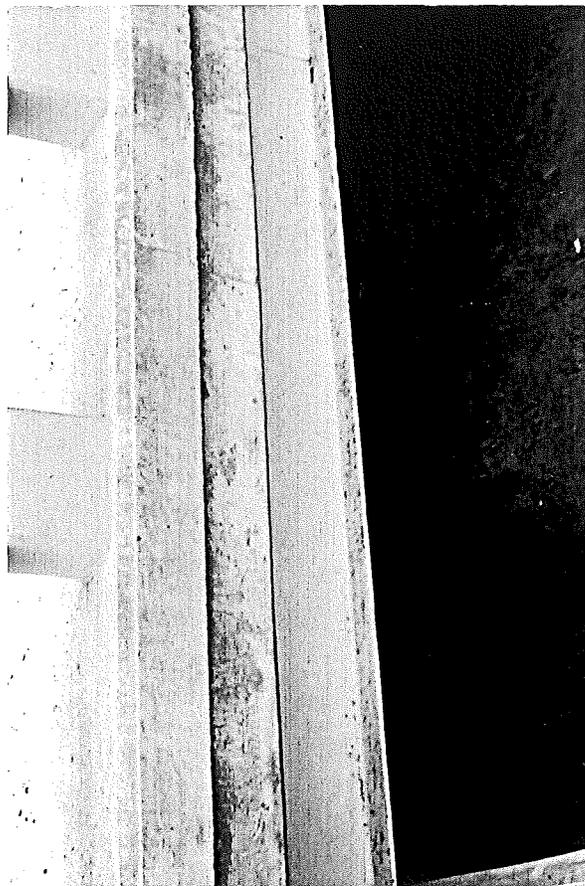
c. The white vinyl primer, at a 2-mil minimum dry film thickness, gave the poorest protection of the three test primers, especially at Bellevue Road where about 20 percent of the steel had to be recleaned due to rust-back over the winter of exposure (Fig. 3).

Figure 3. Rust-back on white vinyl primer over blast-cleaned steel after a winter of exposure on north fascia of Bellevue Road (photographed spring 1966).

- c. From May through July 1966, field repair of the other two primers (including cleaning of over-winter rust-back of the steel by sandblasting), and application of remaining field coats with an airless spray gun (Binks equipment).
