INVESTIGATION OF CONCRETE OVERRUNS
ON I 69 TWO-SPAN CONTINUOUS-TYPE BRIDGES
Pearl Beach Road Over I 69 (S11 of 12033A)

Research Laboratory Division
Office of Testing and Research
Research Project 66 F-89
Research Report No. R-621

State of Michigan
Department of State Highways
Lansing, February 1967

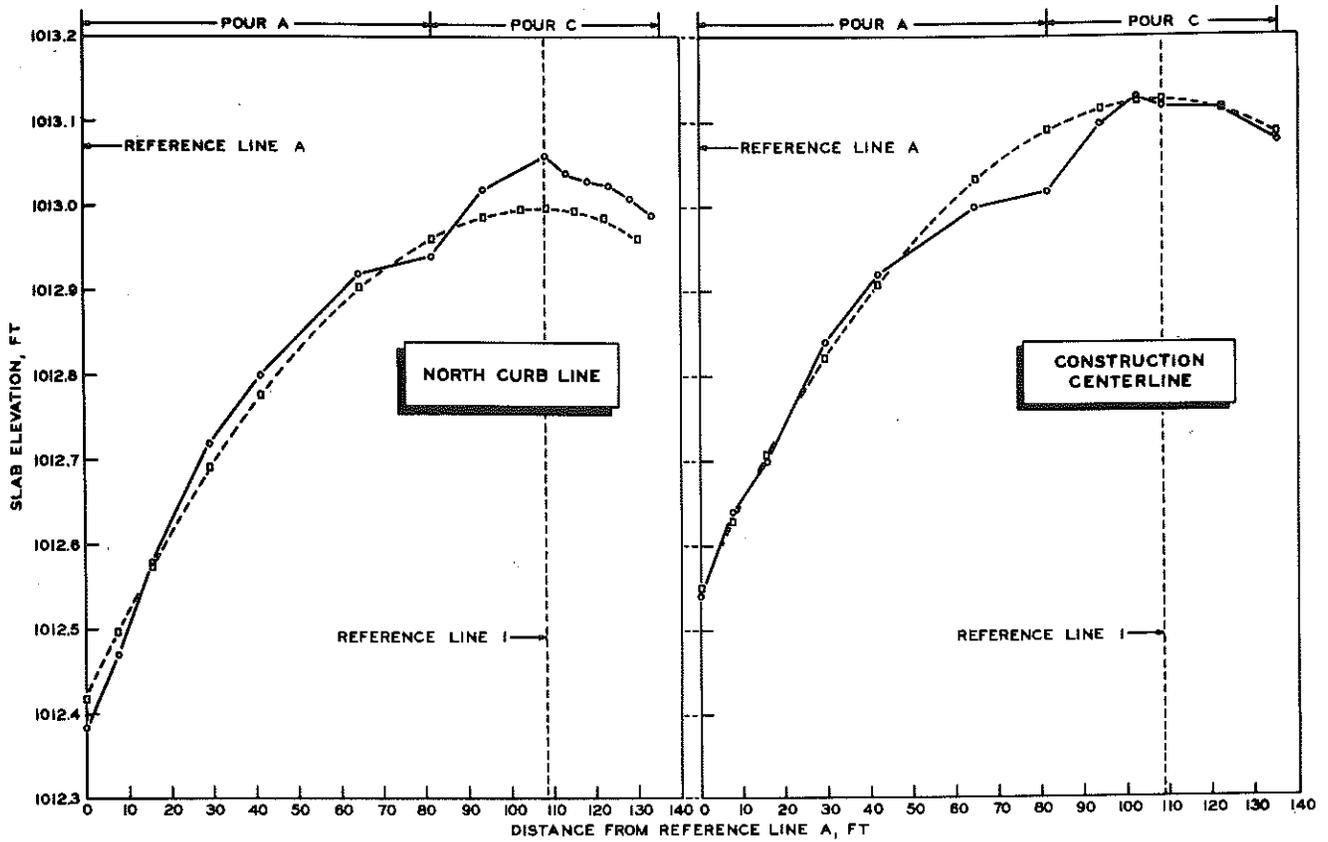
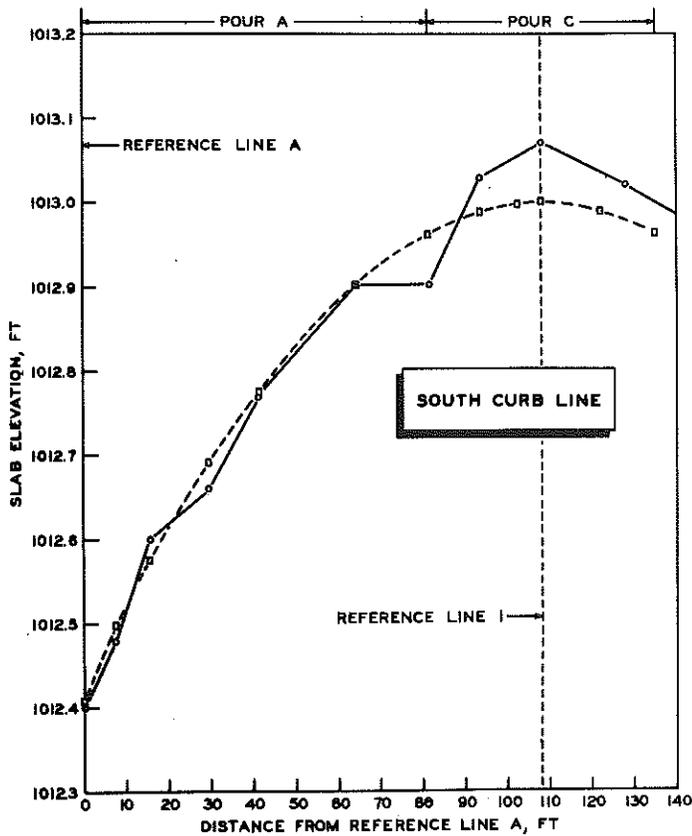
Figure 4. Profiles of top of slab. Locations of reference lines and concrete pours are shown in Figure 1.

The theoretical and measured longitudinal profiles in Pour C as depicted in Figure 4 show that a hump occurred in the top of the slab in each gutter, and that along the bridge centerline the slab rises from the low point at the joint adjacent to Pour A to the theoretical grade elevation at Reference Line 1 over the pier. The cause of these humps at the curb lines can be determined by considering the mid-ordinate of the profiles of the top of slab in Pour C. It can be seen that a mid-ordinate screed camber of 7/8 in. occurred in most of Pour C. This screed ordinate is 3/8 in. greater than the 1/2-in. screed camber called for on the bridge plans. This additional 3/8-in. screed camber was required to insure that the roadway centerline profile would match the theoretical profile at Reference Line 1. In other words, the 3/8 in. corrected for the dip at the construction joint. Now, studying the theoretical and actual profiles at the north curb line, shown in Figure 4, it is noticed that the dip at the first joint here is much less than at the centerline and that the top of the slab is high at the left end of Pour C. These two factors combined with the 3/8-in. extra camber to cause the hump that occurred along this curb line. Considering

the south curb line, it was found that a 1-3/8-in. longitudinal camber occurred here. Primarily, this must be attributed to some irregularity occurring in the finishing of the concrete at this location, since the mid-ordinate of the surface profile here exceeds that found at other longitudinal sections in Pour C. It was mentioned during the preliminary discussions that the longitudinal screeding machine seemed to ride up on the concrete surface in Pour C in one location and caused the surface of the concrete to tear. This area where the surface was torn was finished with hand tools. It is possible that this is the cause of most of the hump at the south curb line.

High spots were found along the curb lines in Pour C over Pier 1. These humps in the slab are attributed, at least in part, to excess camber in the longitudinal screed profile. If this was caused by adjusting the screeding machine to match the centerline grade of the reference line, it

5. Concerning screed machine riding up on slab surface. It was observed that on some subsequent projects, the screed ordinates were reduced from 1/8 to 1/4 in. to compensate for the screed's riding up on the concrete slab surface. On the Pearl Beach Road structure, this was done in Pour B in Span 2. The actual top-of-road profile measured there showed that no hump occurred in the slab along the centerline of the roadway. However, it was noted that high spots occurred along the curb lines. Based on these observations, it appears that this practice of slightly reducing the screed ordinate offers at least a partial solution to this problem. This practice should be carefully controlled, however, to insure that minimum concrete cover over the reinforcing bars will be maintained throughout the entire slab.

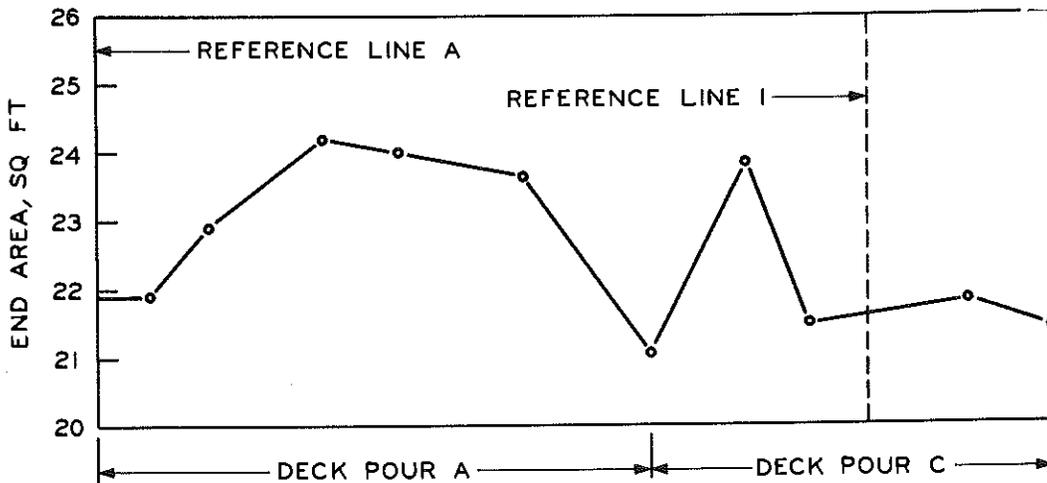
Figure 5. Measured bridge deck end areas.

The actual volume of concrete in the deck was found to be 76 cu yd in Pour A and 42 cu yd in Pour C. These volumes include allowances for variable factors, such as deck length and width variations, possible slab thickness variations under the sidewalks, and concrete shrinkage. The volume of the steel reinforcing bars was deducted from the gross volume measured. The bridge concrete proportioning reports (Appendix B) indicated that 78.5 cu yd of concrete was used in Pour A and 43.5 cu yd in Pour C.

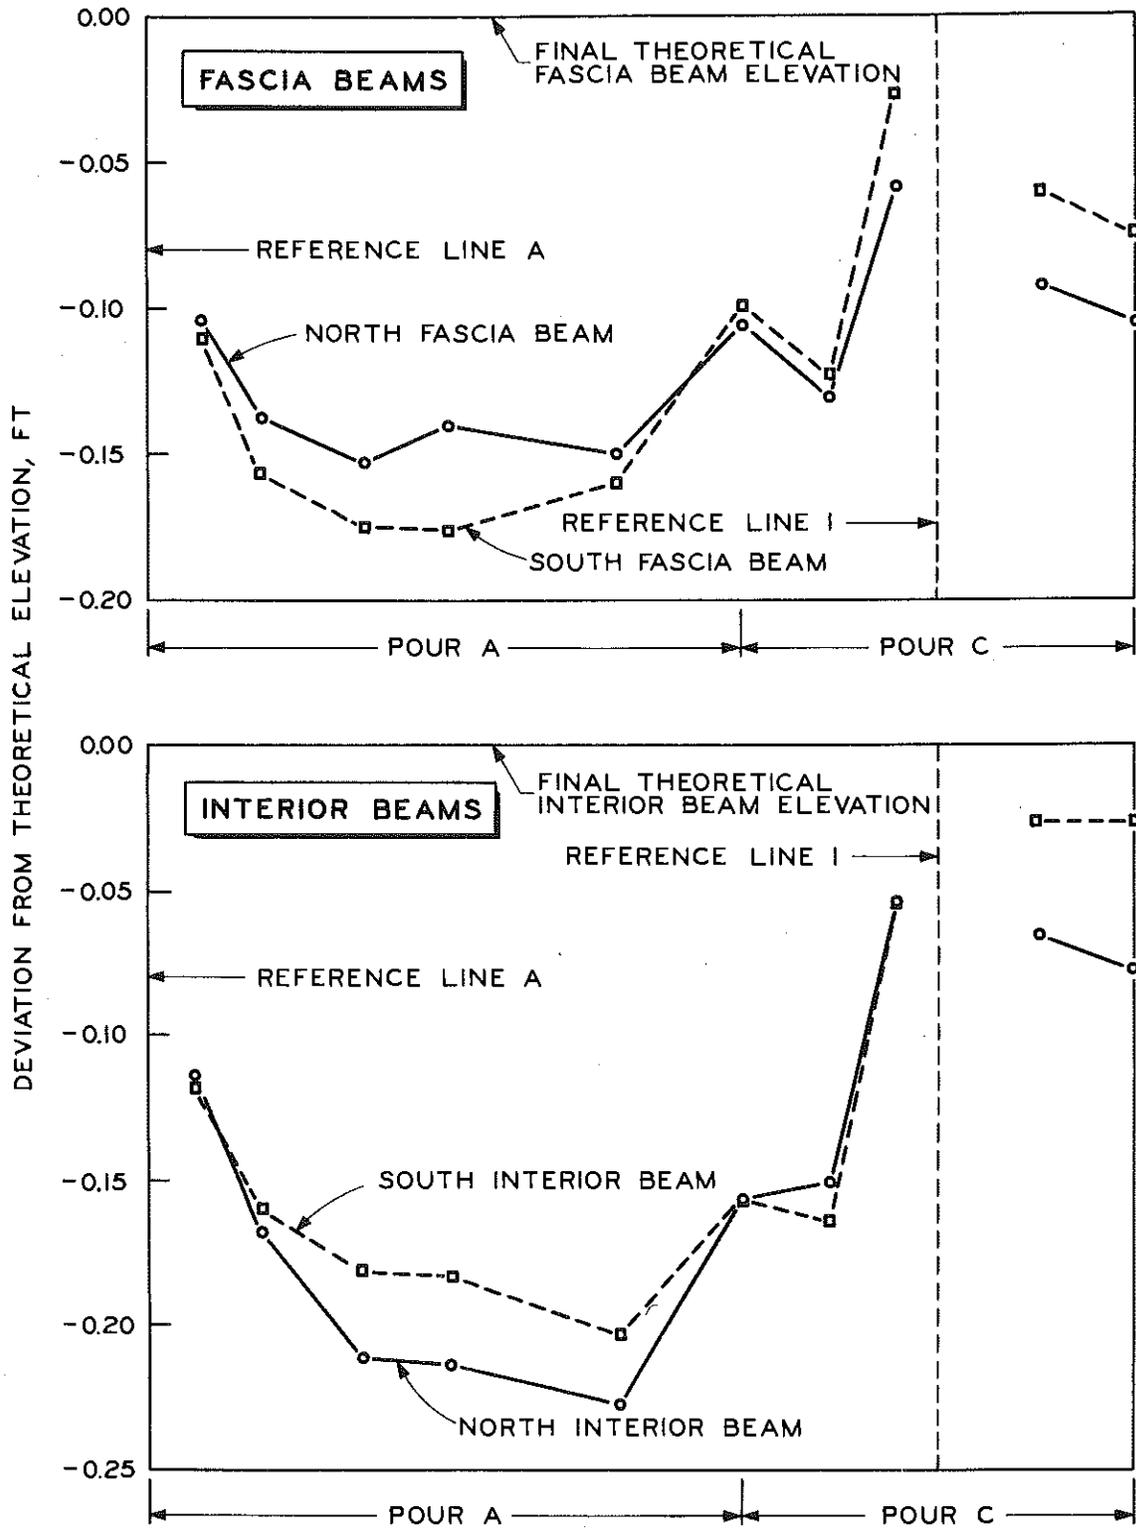
Figure 6. Variations of tops of beams from theoretical final positions.

Variation of the elevation of the top of each beam from that theoretically predicted is illustrated in Figure 6. The theoretical value is taken as zero variation and is plotted as a horizontal straight line. Slab thickness measurements were correlated with slab profile measurements to obtain this variation information. It was assumed for the purpose of computing this information that the bottom surfaces of the top beam flanges were flush with the bottom surfaces of the concrete haunches. This assumption introduces a possible error of about 0.01 ft. However, this is not significant because of the magnitude of the top of beam variations. Figure 6 indicates that the beams are low at both Abutment A and Pier 1. Furthermore, it is noticed that an average sag of about 3/4 in. occurred in the beams under Pour A. Some of this sag in the beams was caused by the extra dead load of the thickened slab. The extra slab thickness along the centerline of the bridge and the south curb line was found to be about 1 in., and at the north curb line to vary from 0 to 1-1/2 in. Figure 7 illustrates the measured values of slab thickness at the Pour A locations discussed here. The slab thickness shown on the bridge plans was 7 in. Based on a positive variation in slab thickness of 1-1/2 in., it is estimated that 1/4-in. sag should have occurred in the beams between Reference Line A and the construction joint. Therefore, it is surmised that most of the sag that occurred in the beams in Span 1 was caused by other factors.

loads induced by placement of Pour B on Span 2. Figure 6 illustrates, for example, that the final elevation of the top of the north interior beam at the left construction joint of Pour C is about 0.075 ft lower than at the right construction joint. The Project Engineer's top-of-beam measurements prior to the placement of Pour A indicated that the left joint was then only 0.02 ft lower than the right joint. It is thought that most of this rotation resulted from a reduction in anticipated upward deflection of Span 1 under the Pour B slab loading in Span 2. This reduction in upward deflection is believed to have been caused primarily by the development of composite beam stiffness in Span 1. This composite response under Pour A probably caused most of the sag in the beams under Pour A.

It was determined that the beams were slightly low under Pours A and C. Although corrections were made to the haunch depths above the beams, overruns still resulted because of the extra concrete required in the thickened haunches, and because in some cases where the adjustments were not sufficient, resulting slab thickness above the haunches was greater than the plan dimension of 7 in.

3. Concerning composite beam stiffness. This study indicates that if a delay of 24 hr occurs between placement of Pours A and B, the beams and slab in Pour A will act compositely to resist the negative bending moment induced in Span 1 by placement of Pour B in Span 2. This loading places the top of the slab in Pour A in tension, and increases the probability of crack development in Span 1. Placing Pours A and B simultaneously would eliminate this problem, but this does not seem practicable. The modified computer program being prepared to facilitate analysis of this problem should provide the bridge designer with an adequate means of predicting these deflections.

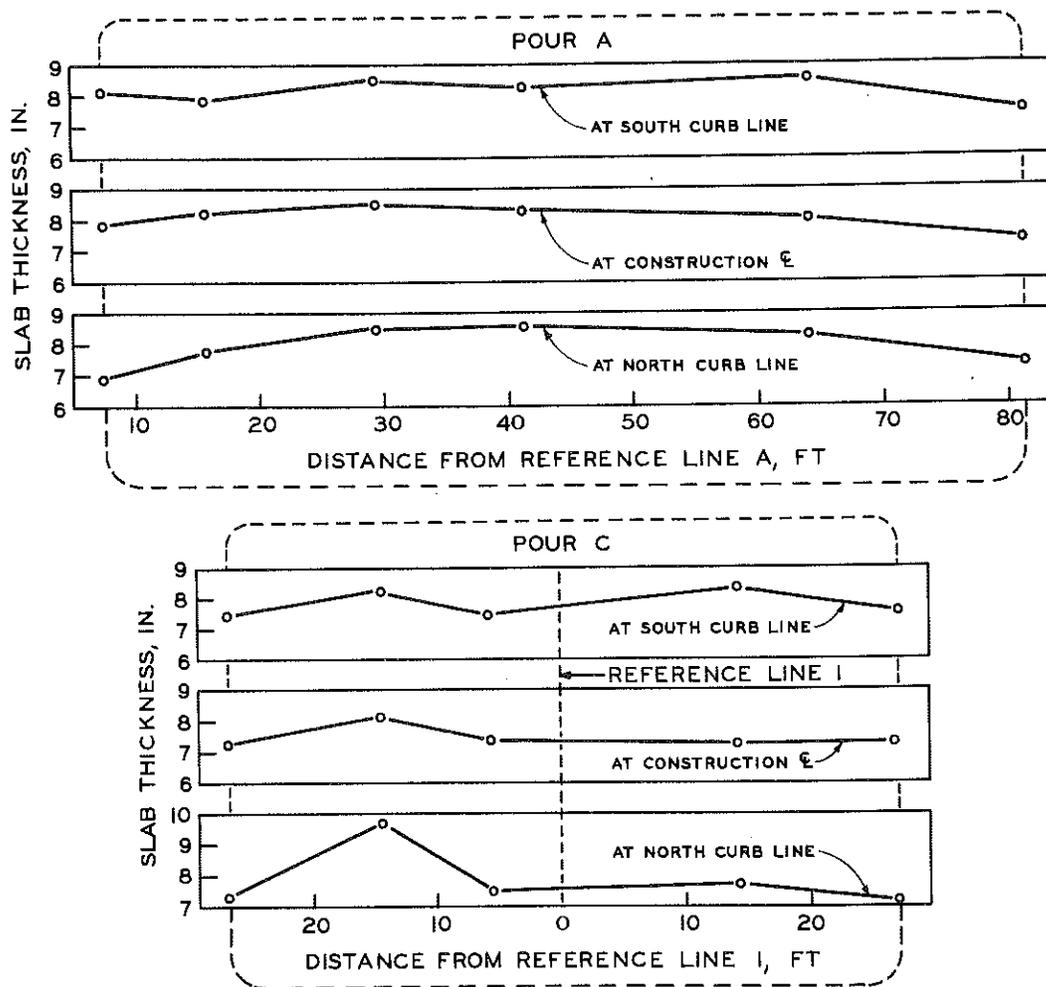
Figure 7. Measured slab thicknesses.

Near the pier, slab haunch thicknesses over the beams were all about 2 in., or 1/2-in. deeper than shown on the bridge plans. The slab thickness there (Fig. 7) was about 7-1/2 in. It appears that an additional increase of 1/2-in. haunch depth was required there. By comparing Figures 4, 6, and 7, haunch adjustments that would have been necessary to insure a uniform slab throughout the deck could be determined. It appears that proper adjustment of haunch depth over the beams is the most important factor involved in obtaining a uniform slab thickness.

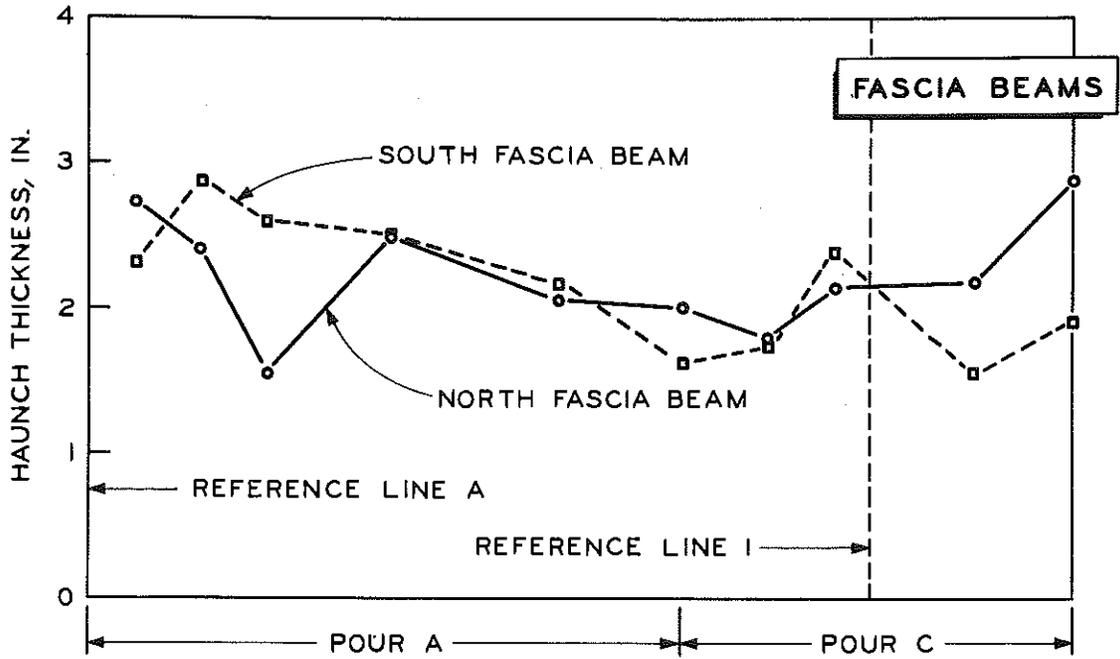
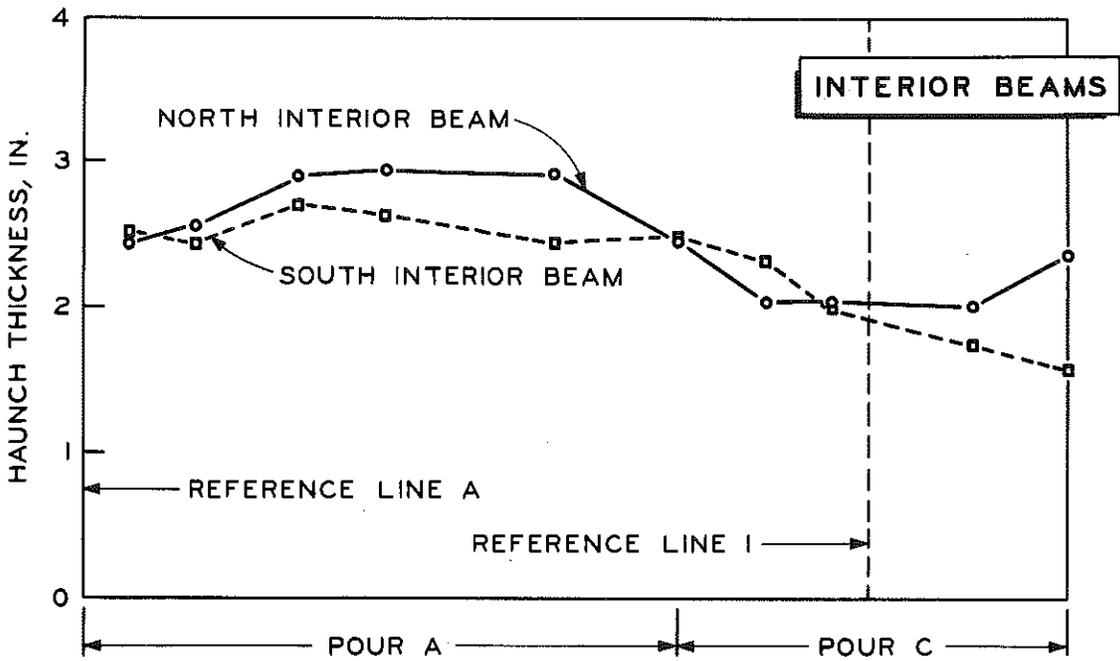
Figure 8. Longitudinal profiles of actual concrete haunch thicknesses.

It was found that haunch depth in the concrete slab over the beams was adjusted considerably throughout Pours A and C. The actual average haunch depth measured along each beam is shown in Figure 8. The haunch depth indicated on the bridge plans is 1-1/2-in. uniform thickness. This specified uniform haunch thickness is based on the assumption that the beams are precambered exactly as planned, that the tops of beams are at the exact elevations indicated over the pier and abutments, and that beams will deflect under slab loads as predicted. Haunch thickness along the beam is therefore adjusted as required to insure that the uniform specified slab thickness will be obtained.

Near Abutment A, haunches over the interior beams are 2-1/2 in. deep, or 1 in. in excess of the plan dimension. At the same location, haunch depth over the north fascia beam is 2-3/4 in. and at the south fascia beam, 2-1/4 in. It is also noted in Figure 7 that slab thickness above the top of the haunch at Abutment A is 8 in. at the south curb line and construction centerline, and 7 in. at the north curb line. It is apparent that the haunch adjustment here was adequate over the north fascia beam, but should have been about 1-in. greater over the interior beams and south fascia beam.

It can be seen now that a large adjustment in haunch thickness was required at the construction joint in Span 1 between Pours A and C where the low spot occurred. For example, it is estimated that a total haunch depth of 3-3/8 in. was required on the interior beams there. The measured haunch depth there was about 2-1/2 in., averaged transversely across the beams. The Project Engineer's records indicate that an average haunch depth of 2-3/8 in. was set there. Based on the top-of-beam elevations measured by the Project Engineer, and the predicted slab load deflection, assuming the beams acted in a non-composite manner, this haunch setting of 2-3/8 in. was correct. However, upon considering the Project Engineer's midspan measurements of deflection, it is apparent that the portion of the beam from Reference Line A to the end of Pour A acted as a composite beam when Pour B was placed in the adjacent span. This composite action of the beam reduced the upward deflection under Pour A from the value predicted by considering only the stiffness of the steel beams. It is estimated that the composite stiffness of the beam caused the joint to be 1/2-in.

1. Concerning slab haunch thickness corrections. Proper adjustment of haunch thickness appears to be the most promising method of correcting for the uncontrollable factors affecting slab thickness, and consequent overruns. The procedure used, as explained by construction personnel during the preliminary discussions, consists first of determining the top-of-beam elevations of beams in place on the bearings before deck concrete is placed. Then an estimate of theoretical slab dead load deflections is subtracted from these elevations and the plan slab dimension (7 in. in this case) is added to the value obtained, giving the final predicted top-of-slab elevation. The theoretical top-of-slab elevation is then computed and compared with the predicted elevations. Finally, the haunch depth is adjusted to correct for deviations between the theoretical and predicted elevations, to insure that the slab will be of proper uniform thickness. It was mentioned that this is a difficult job involving considerable manual calculations. It is thought that this procedure would be considerably refined if the available electronic computer programs, such as in this case the two-span continuous beam deflection program and the straight bridge elevations program,

could be utilized by project engineers. It is recommended that if the haunches are to be adjusted, theoretical deflections be determined exactly along the entire beam length and the prorating or estimating of deflections be avoided.

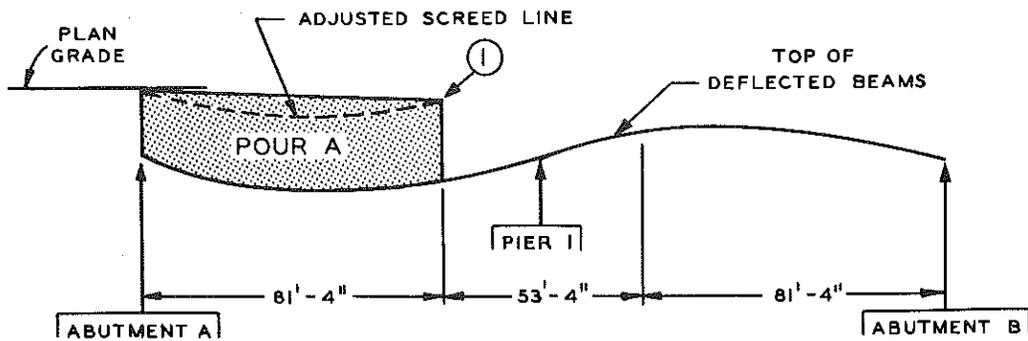
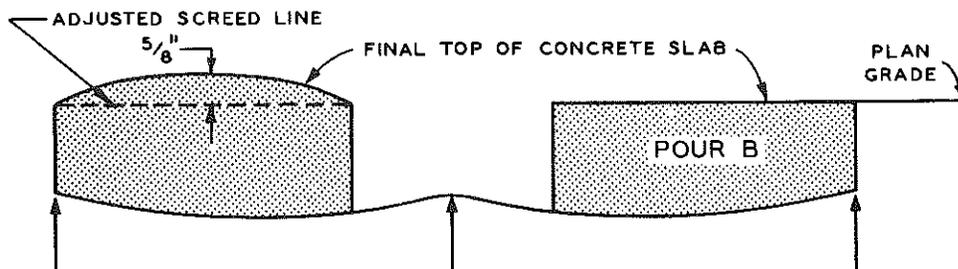
When Pour A concrete is placed, the top of the bridge deck slab is screeded to the final plan grade, neglecting for the purpose of this discussion the small deflection that occurs at Point 1. Then Pour B is placed, and because of the continuous action of the beams, the added slab load in Pour B causes the beams under Pour A to deflect the deck slab upward, causing the top of the deck slab in Pour A to rise above the planned final grade.

It was determined by the Office of Design that on actual two-span continuous bridges with 26-ft roadways this rebound under Pour A would cause an overrun of about 5 percent in that pour. To correct this problem the longitudinal screed over Pour A was adjusted on subsequent projects, as illustrated below by the dashed line.

BEAMS DEFLECT WHEN POUR A IS PLACED

BEAMS REBOUND UNDER POUR A WHEN POUR B IS PLACED
