# OFFICE MEMORANDUM

STATE HIGHWAY DEPARTMENT

Subject: Investigation of Pavement Damage Caused by Gasoline Truck Fire  
on Northbound US 23 near Fenton (Construction Project 25031, C2).  
Research Project 66 B-83. Research Report No. R-622.

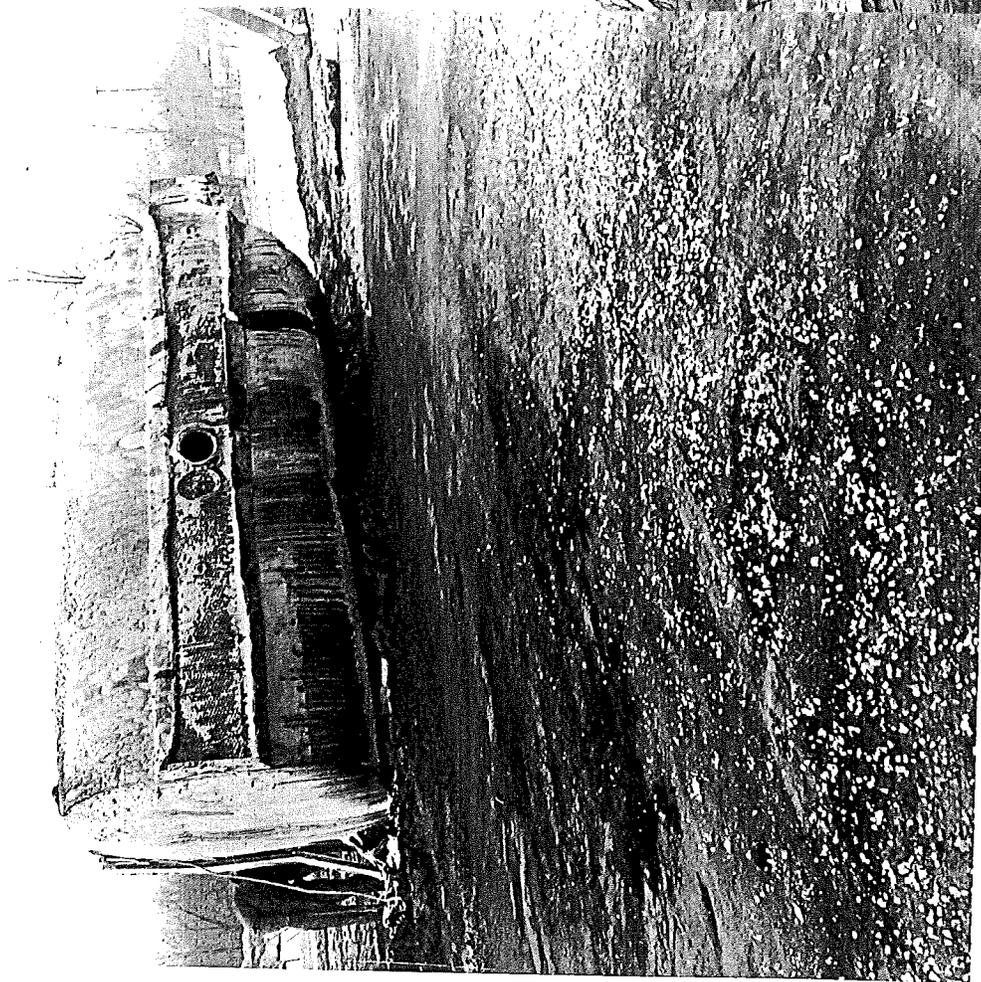
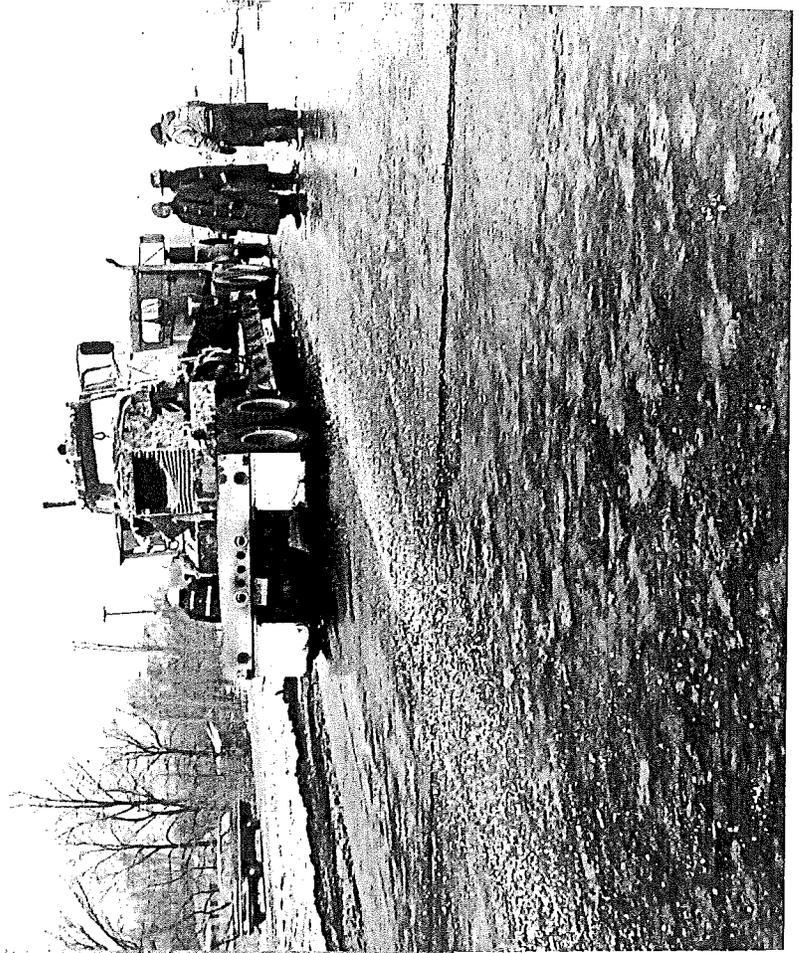
The nature of the damage resembled severe weathering or deep scaling. The sudden intense heat caused a rapid thermal expansion at the surface, producing a horizontal shear plane at a depth of about 1 in. Most concrete above this shear plane dynamically "popped out," resembling popcorn jumping out of a skillet. The tractor and trailer and extent of damage are shown in Figures 2 through 4, in photographs taken the day of the accident. The concrete was placed late in 1957.

Figure 2. Overturned trailer is shown in area of severe damage (left). Truck tractor was loaded on lowboy for removal from site (right). Rock salt crystals were spread to prevent ice formation.

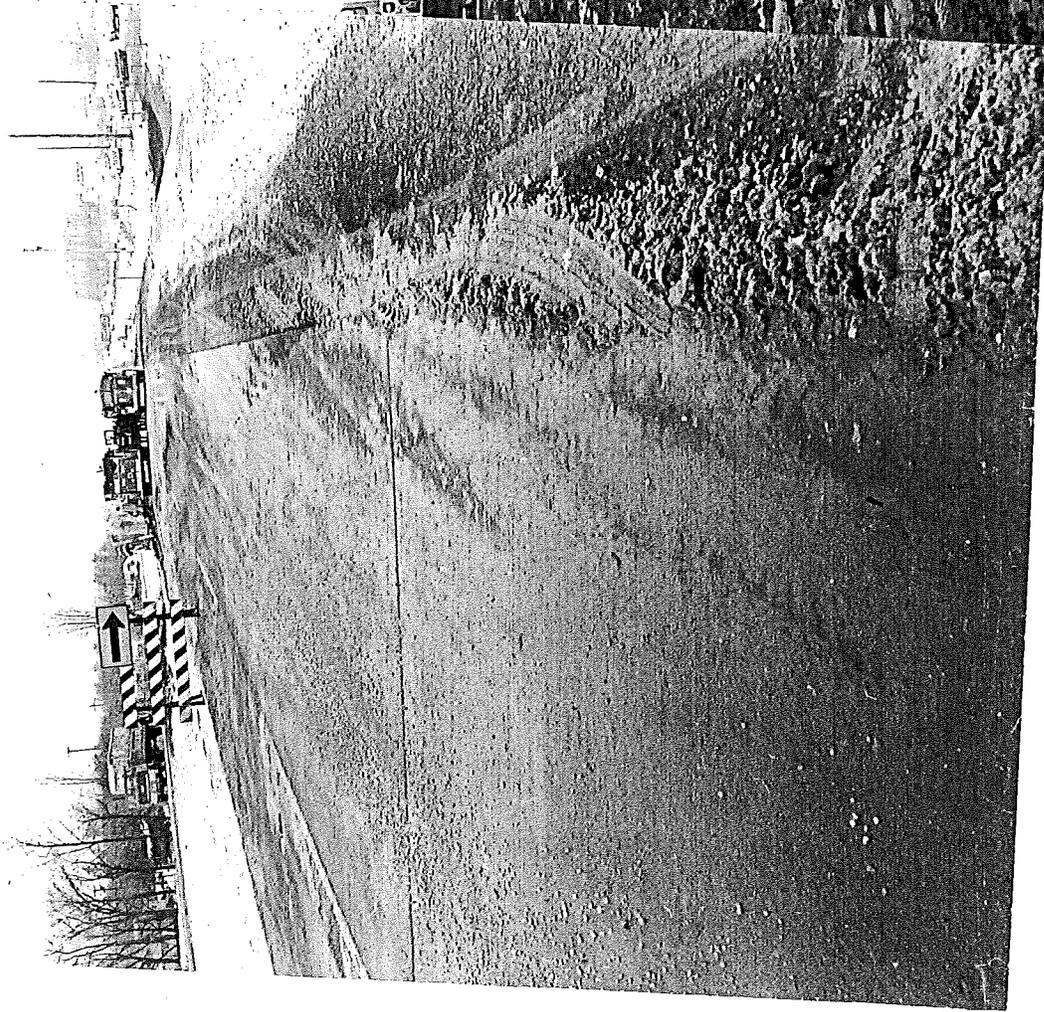
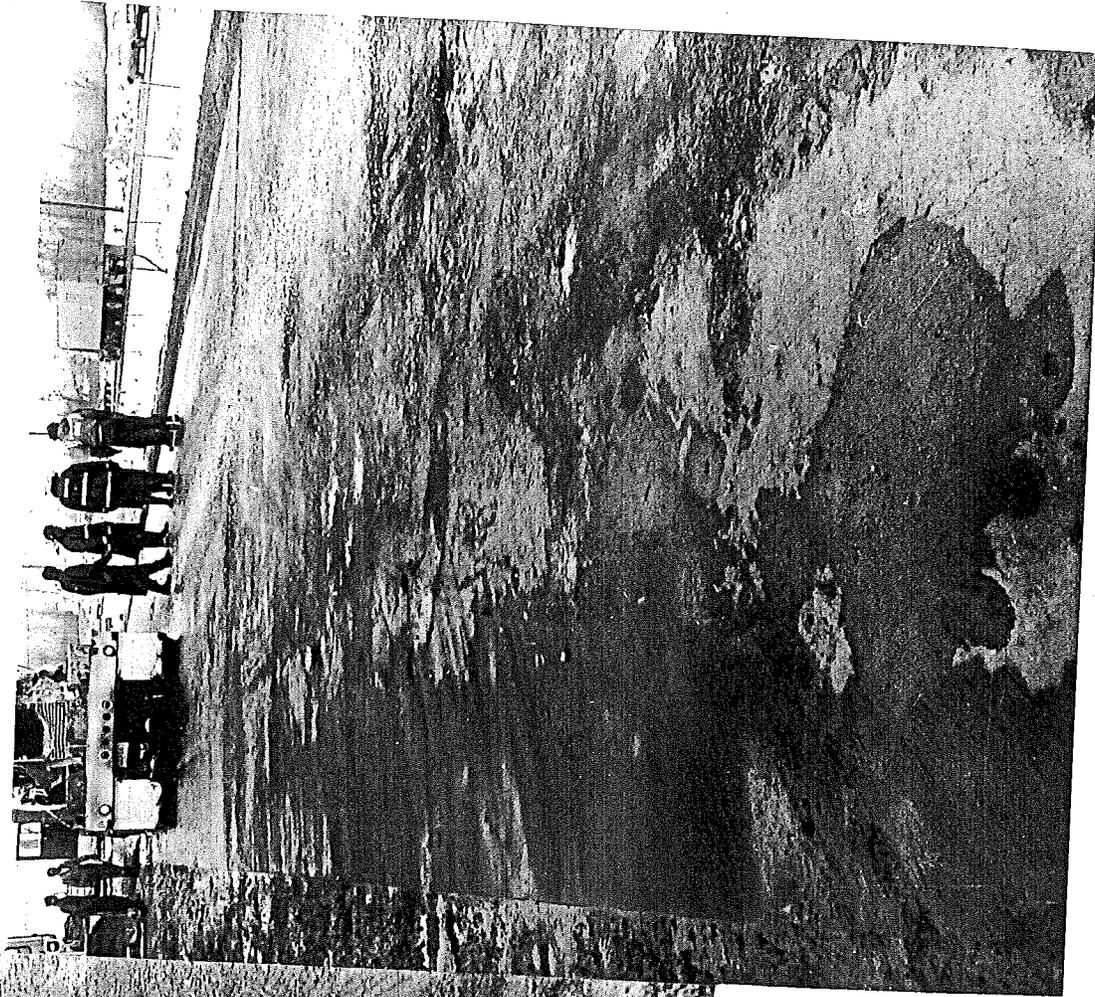
Upon close examination, the damage was found to begin on the northbound roadway at the east side of the pavement at about Station 147+00. From there a damaged strip about 5 ft wide ran diagonally across the pavement to about Station 148+80 at the west side of the road. At this point the major damaged area began and ran for 70 ft to Station 149+50. The severest damage occurred between a heavy crack at Station 148+90 and an expansion joint at Station 149+40. The damaged area is shown schematically in Figure 1.

Figure 3. Path of vehicle is indicated (looking northwest) by burned strip running diagonally across pavement (left). Area of severest damage is shown at right (looking north). Note service road in background at right, used for detour.
