OFFICE MEMORANDUM

MICHIGAN
DEPARTMENT OF STATE HIGHWAYS

Subject: Laboratory Testing of Bituminous Base Course Samples: I 75 North of Wolverine (Construction Project EBI 16093, C3RN). Research Project 67 E-40. Research Report No. R-630.

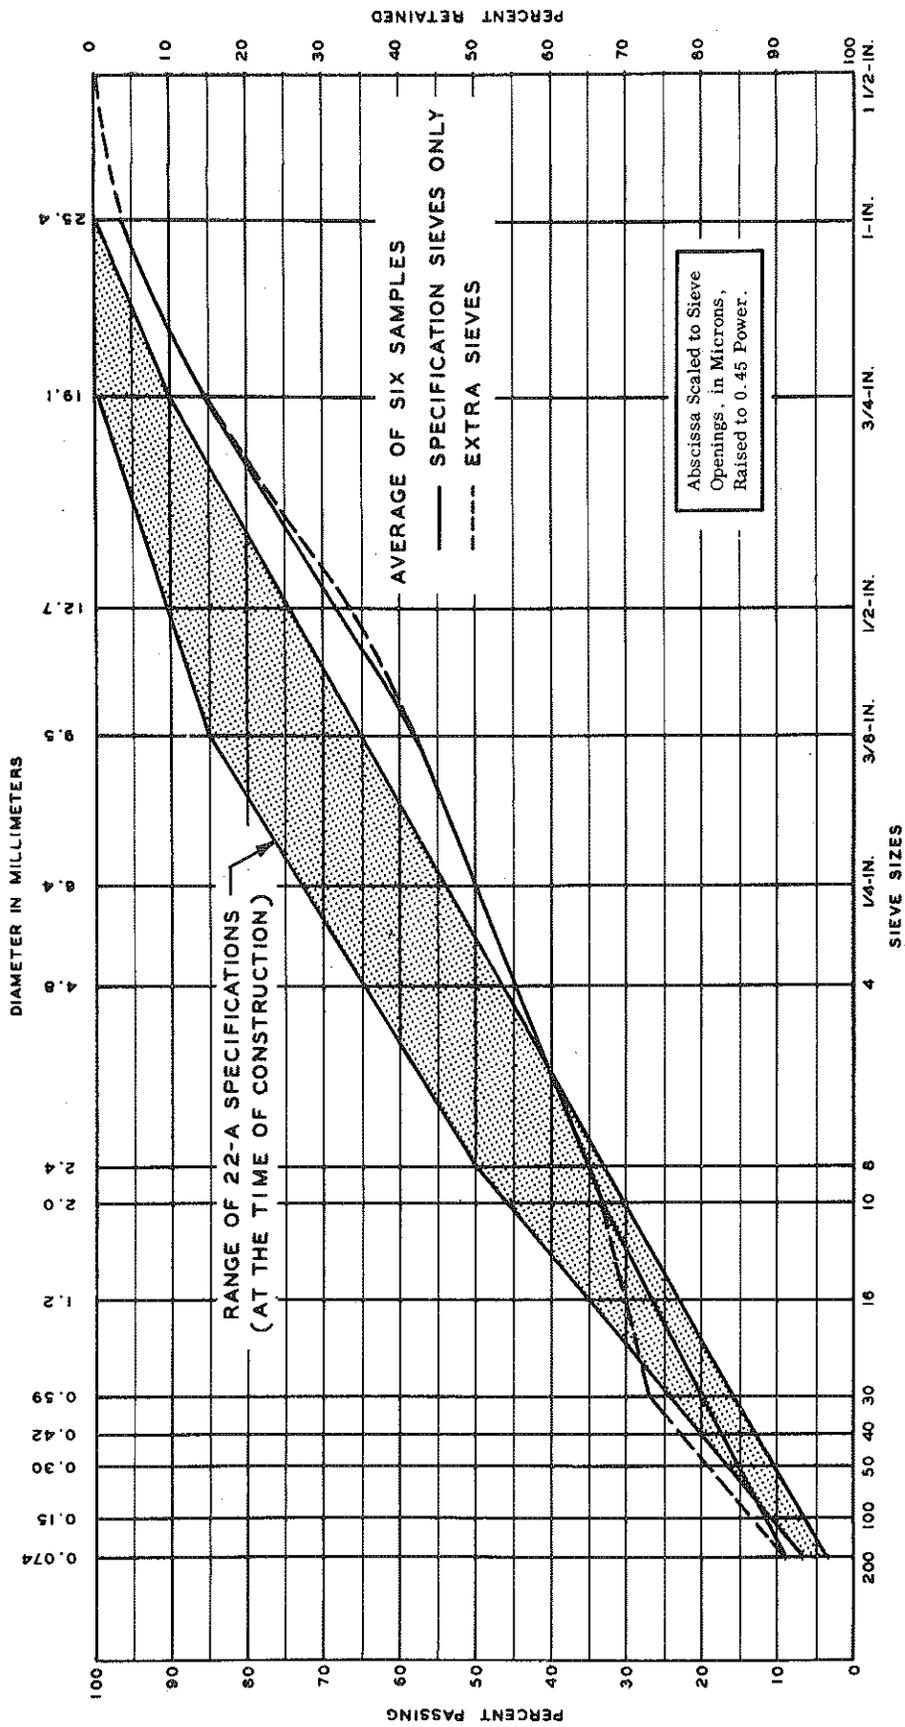
The grain size distribution curve shows the base aggregate to be outside specification limits in certain areas, but not in an amount likely to cause inadequate support. Salt contents were low in all samples, being about one-fourth of the original specification amount of 6 lb per ton. The top and bottom halves of the base contained about the same quantity of salt, indicating no recent build-up of salt on top of the base due to infiltration from surface treatment. Moisture content of the base was quite high, averaging about 6.2 percent.

Figure 1. Grain size distribution of base course aggregate.

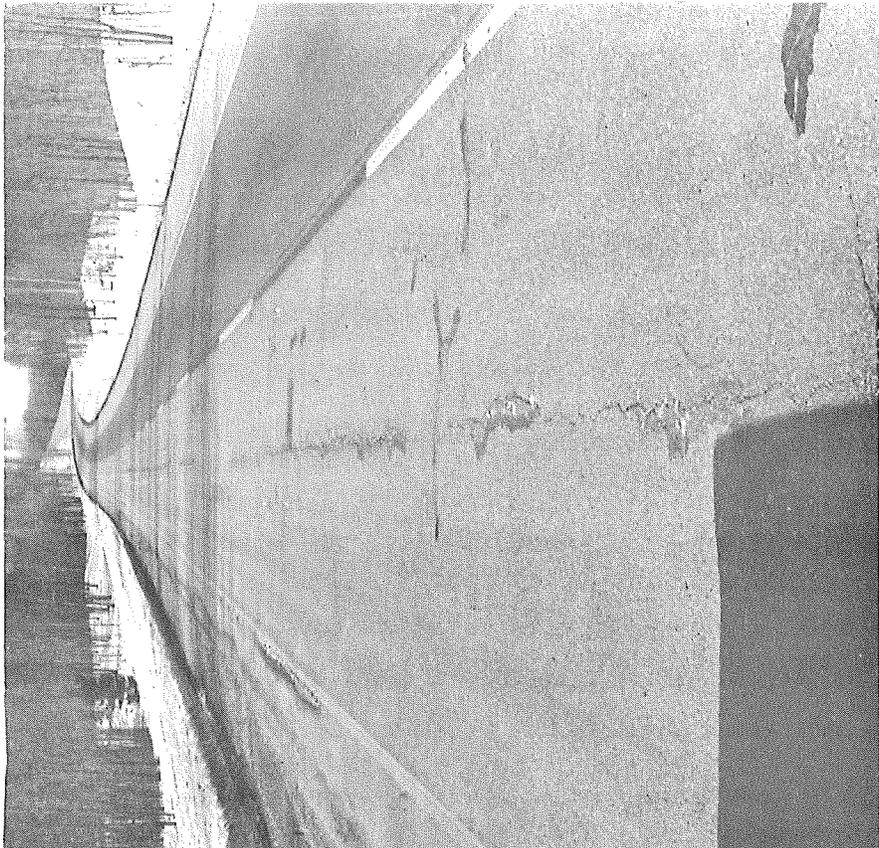
A review of the history of cracking in this area indicates that during the summer of 1964, only a few short longitudinal cracks were present. Now, however, numerous additional longitudinal cracks have appeared (Fig. 2). The shorter longitudinal cracks now seem to be linking up to form one continuous longitudinal crack. In addition, transverse cracking has also begun (Fig. 3). These and the longitudinal cracks extend all the way to the base, but not into it.

△ Figure 2. Typical longitudinal crack pattern.

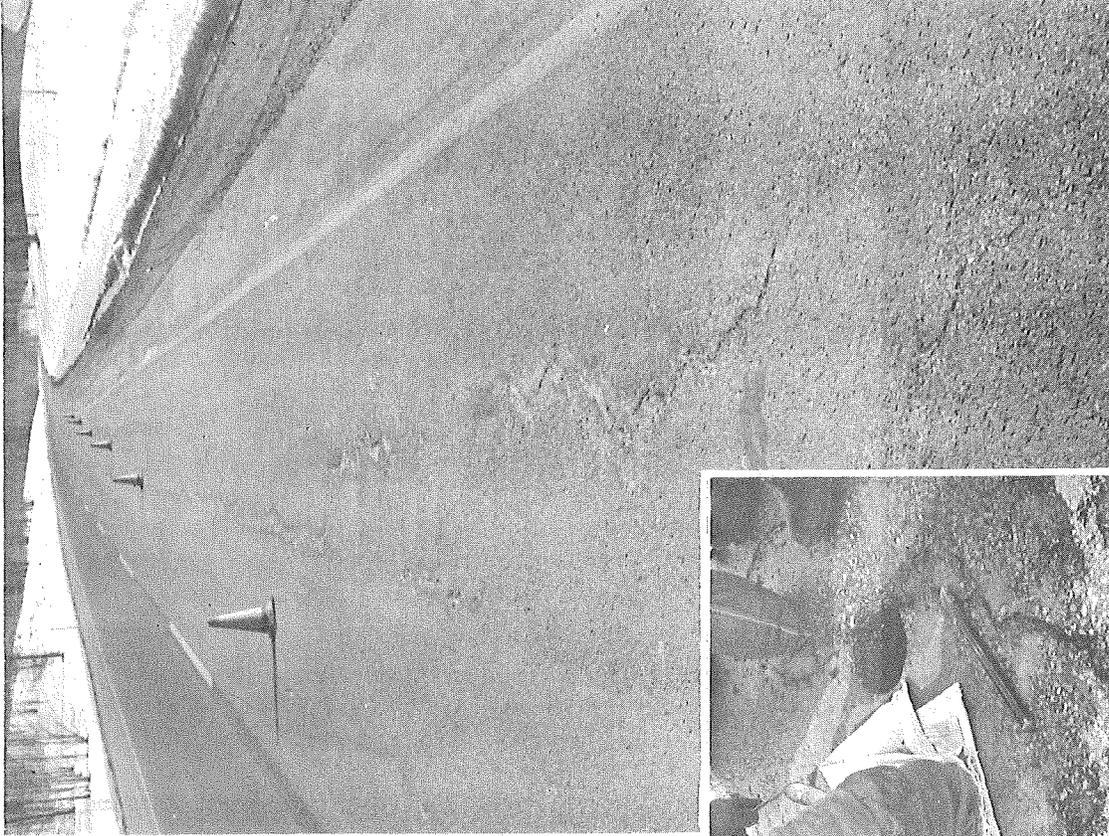
Figure 4 shows that the pavement surface in the immediate vicinity of the cracks has been abraded by snow removal equipment, indicating that the crack area has heaved at some time above the normal pavement surface level. Because the abraded area is quite narrow and follows the crack closely, it is probable that the heaving was due to frost action within and immediately below the crack, most likely caused by the entrance into the crack of moisture from rain or melting snow and ice. This moisture could be either water or a weak brine solution formed by ice-control chemicals. In either case, the pattern of frost action would be the same.

△ Figure 4. Abrasion along cracks due to snowplow blades.

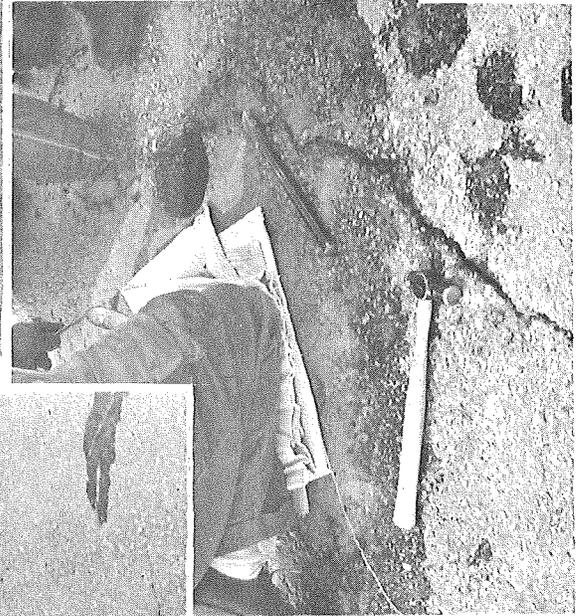
△ Figure 3. Transverse cracking and sample hole.
