MICHIGAN DEPARTMENT OF STATE HIGHWAYS

June 19, 1968

Subject: Second-Inspection Report of Field Application of "Speed Crete" Patching Mixtures. Research Project 65 NM-140. Research Report No. R-676.

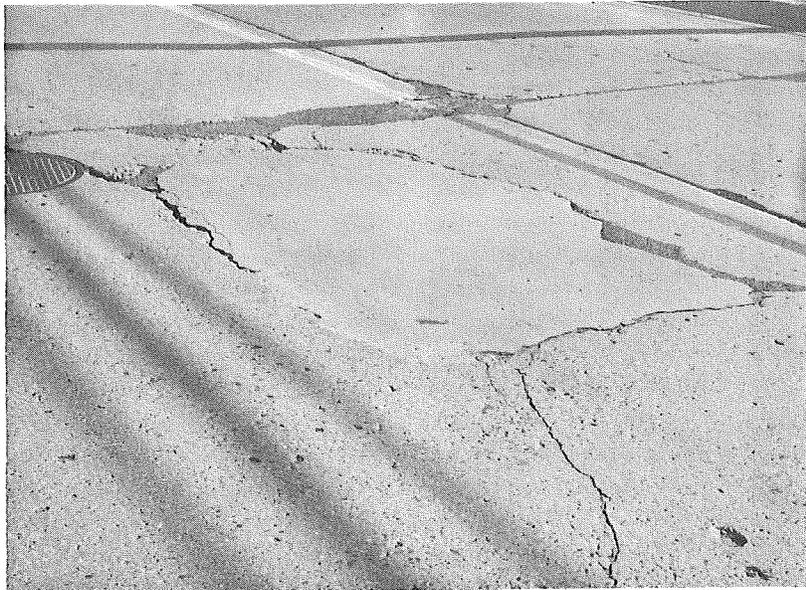
A general view of this 4- by 6-ft full-depth patch after two years exposure is shown in Figure 1. It's condition did not appear to have greatly changed since June 6, 1967. Some of the fine surface cracking has become more prominent around the edges of the patch and some small pieces have broken loose adjacent to the old pavement.

Figure 1 (left). Full-depth pavement patch in NB US 23 BR, Ann Arbor, showing extensive cracking around perimeter of patch (placed mid-April, 1966).

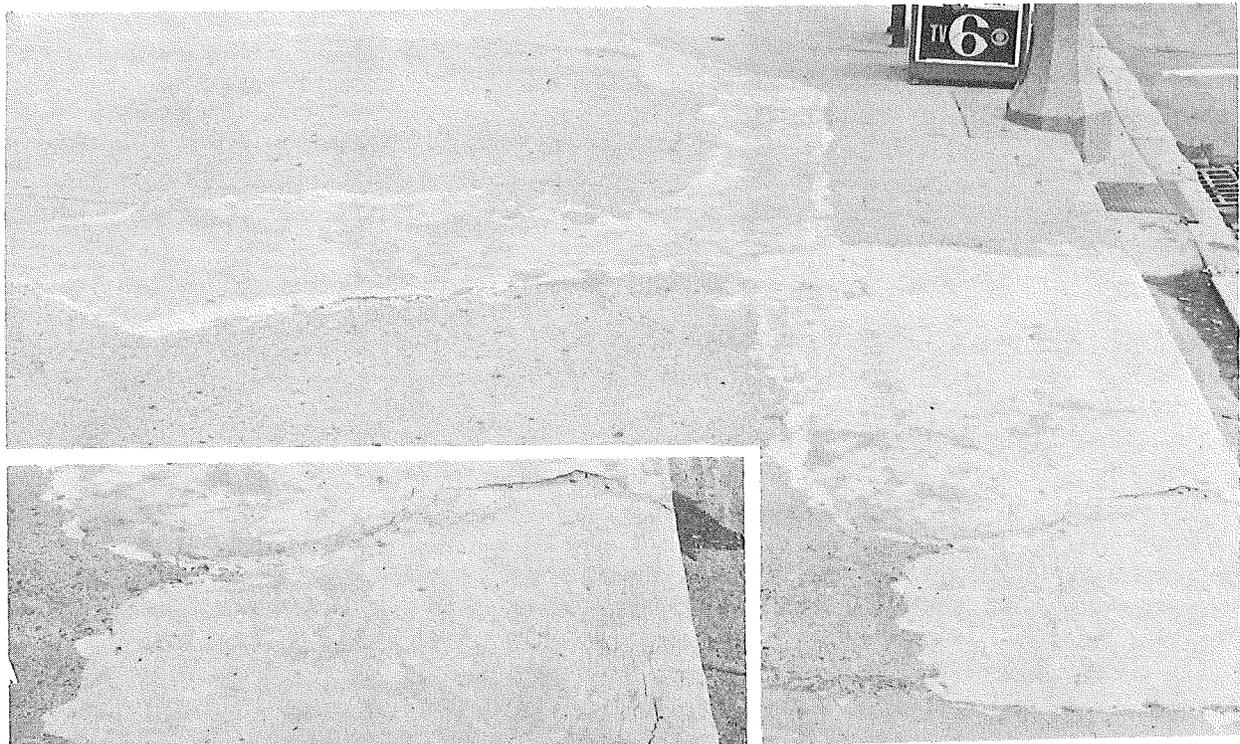
Figure 2 illustrates the condition of the original test patch placed April 29, 1966 and the later patching done in September, 1966. Visually, the patches appeared quite sound and in much the same condition as they were at the time of the June 1967 inspection. However, the original patch is full of fine cracks, especially near the curb, and has extensive hollow areas, indicating loss of bond. The later patching did not appear to be cracked as badly but has many hollow areas. After two winters, the patches still remain in place even though there is considerable bond loss indicated.

▲ (placed September, 1966).

Figure 2 (above). Sidewalk patches in front of Gladmer Theater in Lansing.

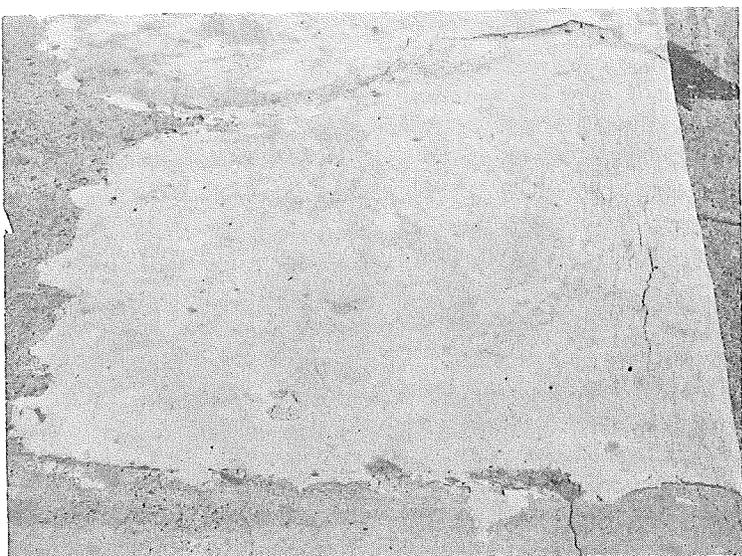
◀ Extensive cracking near edge over hollow area in original patch (placed early April, 1966).

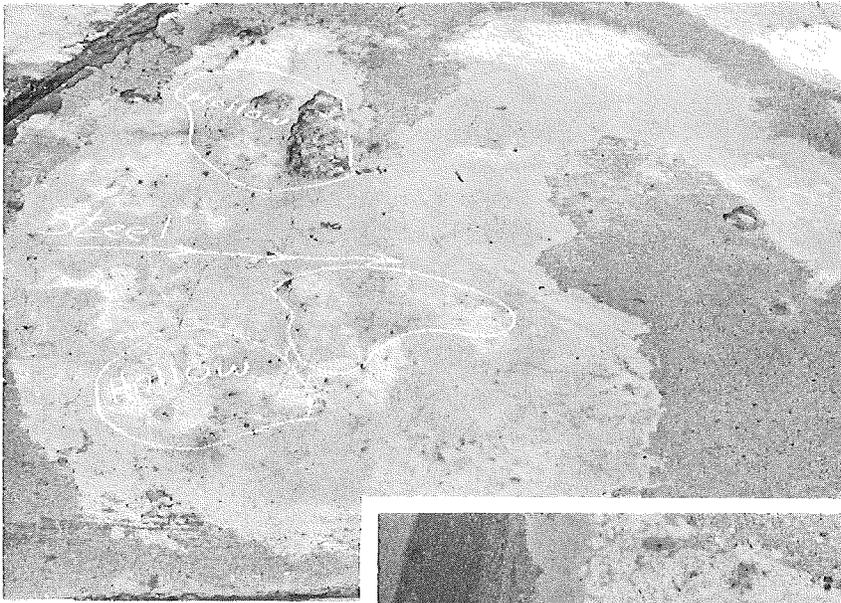
Figure 3 illustrates the general condition of three of the largest patches on this test bridge after two winters. The only significant change from a year ago is

the loss of a small piece of the large patch at the north end of the structure. Moreover, the hollow areas and cracking appear to be more pronounced in this patch. This advancement in cracking and bond loss also appear to be occurring in some of the other patches. Except for the patch loss mentioned, and one large pop-out repair in the east curb, the patches are remaining in place after two years.

Large patch in NW corner of Span 3. Note broken piece, cracking over steel, and hollow areas.

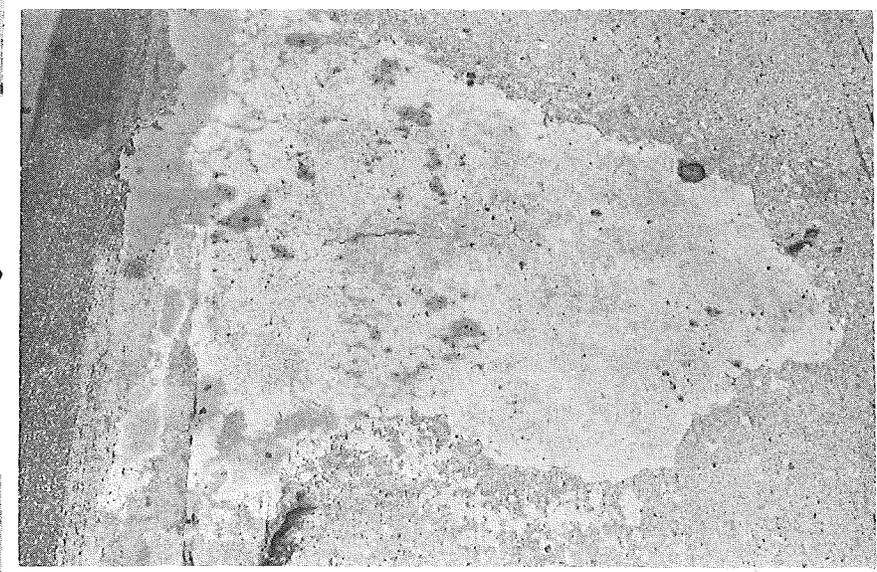
Patch at centerline of Span 1. Note fine cracking over steel.

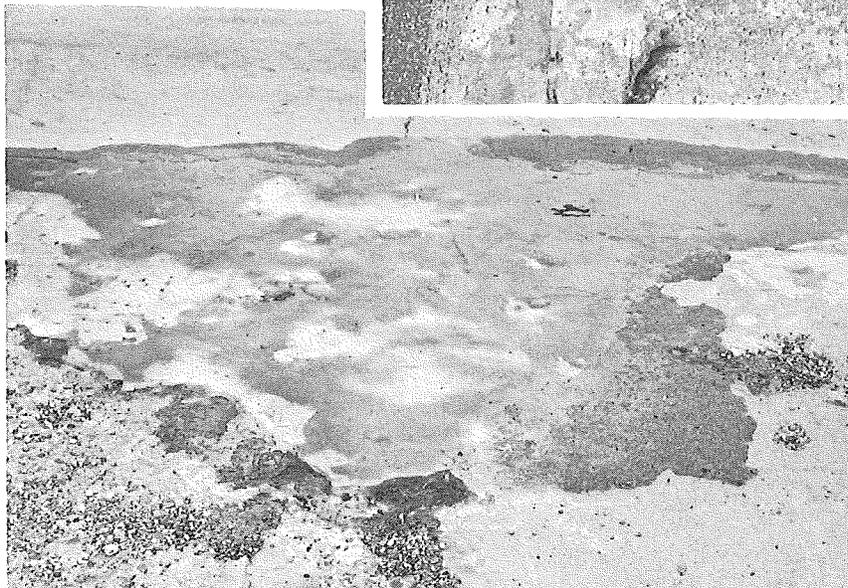
Deep patch over lapped re-bars near east curb, Span 3.

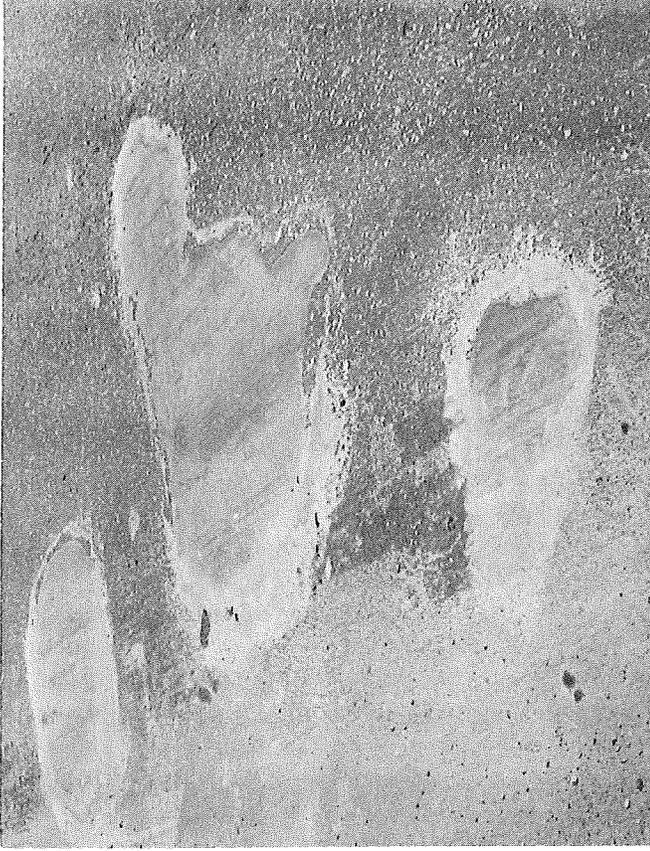
The large patch and three smaller ones placed July 1966 in the northeast corner of Span four are shown in Figure 4. As in the cases already mentioned, these patches appear sound and in place but have some hollow areas when sounded-out with a hammer. Figure 4 also shows two new areas in the southbound side of the deck, placed in mid-May 1968, by the Lansing DPW. The large patch in Span three appears to have been opened to traffic too soon because it has been depressed by traffic down to the top steel, especially at the south end of the patch. These new patches will continue to be observed for performance, along with the older ones.

Original patches in NE corner, Span 4 (placed late July, 1966). Small patch (upper left) breaking out, new spalled areas north of large patch.

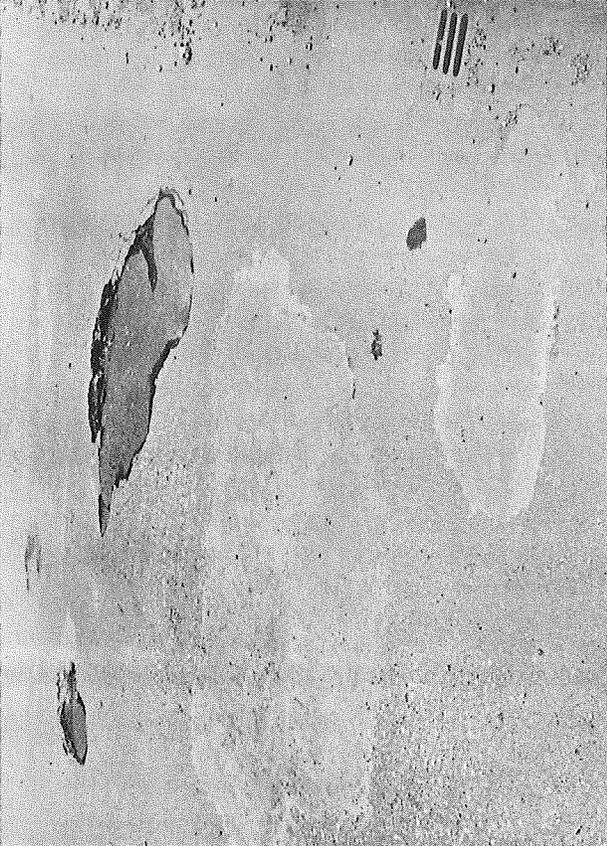
New patches in SW corner, Span 4 (placed May, 1968).

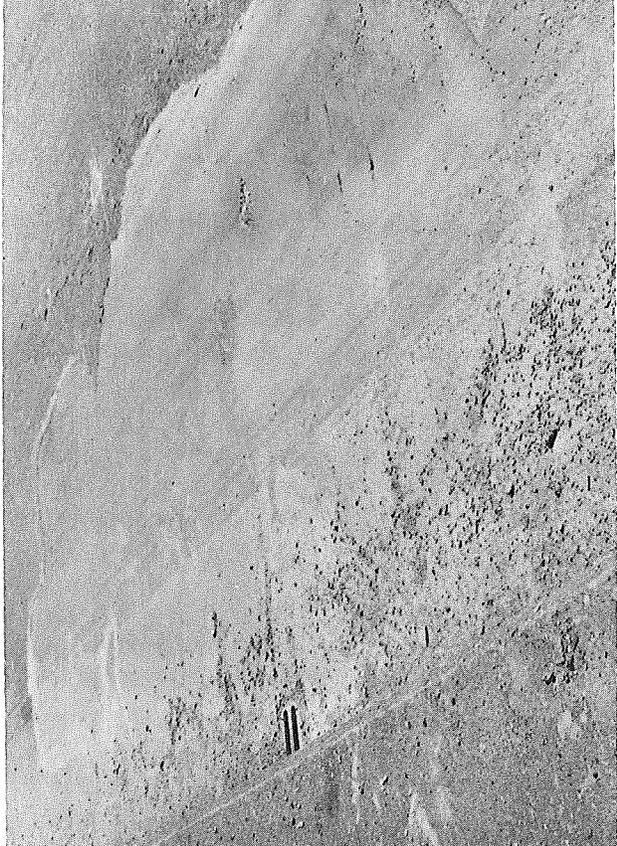
Large patch in NW corner, Span 3, shows shallow area and exposed steel near south end of patch (placed May, 1968).

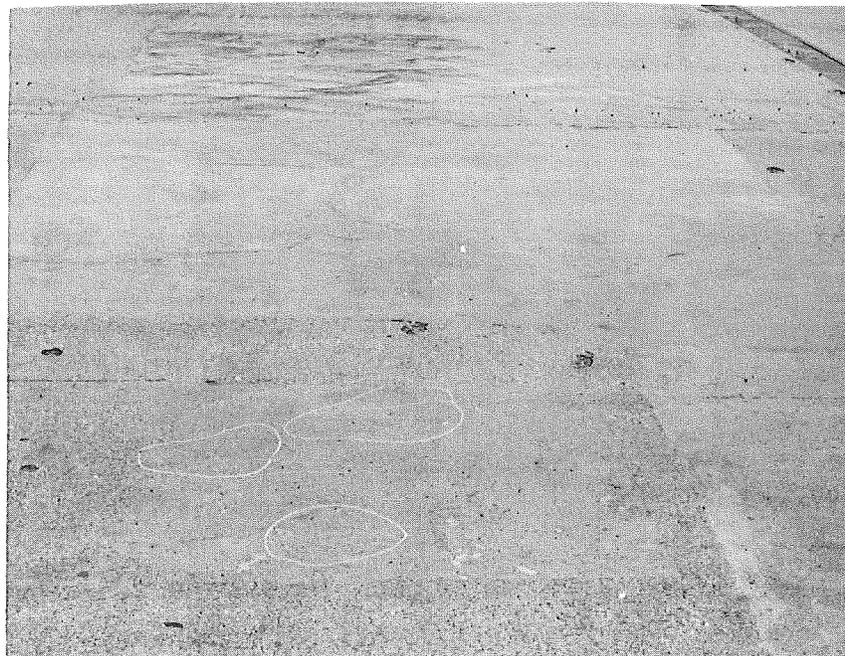
This bridge deck has been extensively patched with Speed Crete since the first three patches were placed in the westbound side of Span four in July 1966. The original three patches appear in good condition except for some small hollow areas (Fig. 5). All four spans were patched further in July 1967 by Kalamazoo DPW, using the original procedure of saw-cutting the perimeter of the patch. Most of these newer patches appear in good condition except those along the transverse joint at Pier two. Figure 5 shows extensive failure and loss of patch along the joint opening. Water entering the joint opening or joint movement, or both, probably has caused the patch to break loose from the substrate.

Original patch with hollow areas outlined (placed late July, 1966). Newer patches above and to the right (placed July, 1967). Span 4, west end.

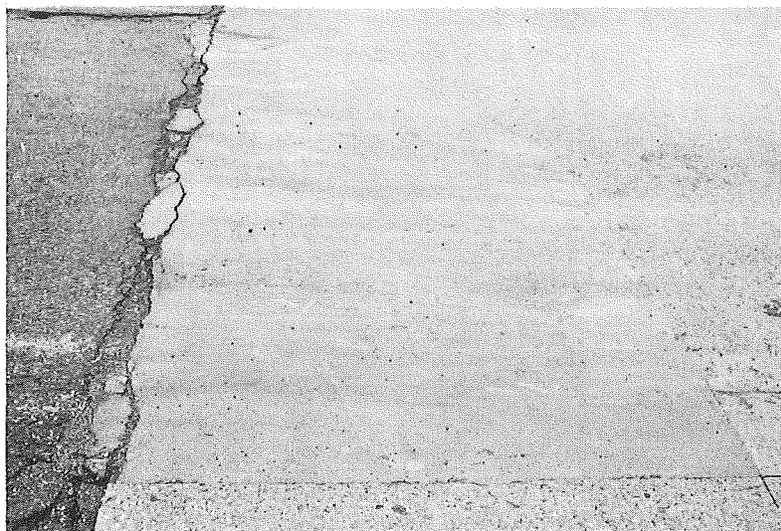
▲ Patch at east abutment has hollow areas adjacent to joint at left (placed July, 1967).

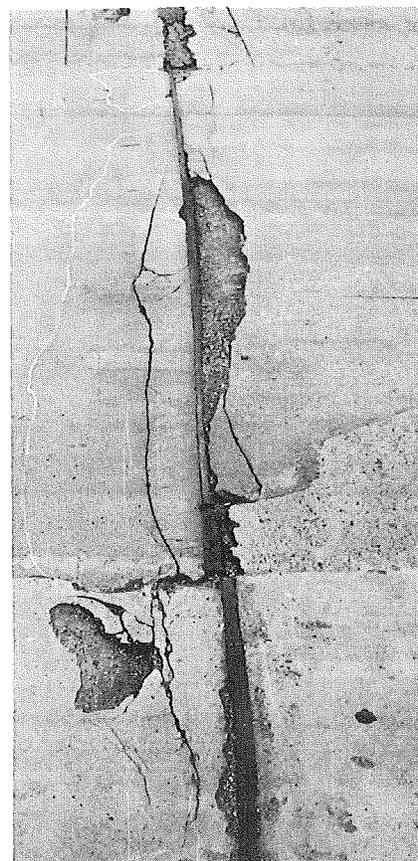
Extensive failure of patches at joint over Pier 2. Hollow areas outlined.

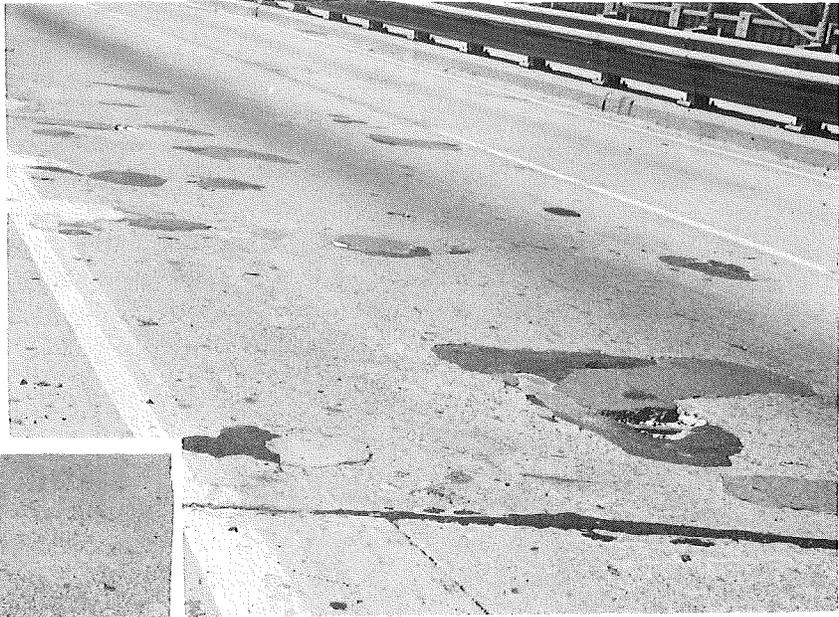
Since the inspection and report of last year (R-646) information was obtained on two locations of Speed Crete patching in Wayne County in 1966. One of these areas, a three-span structure carrying northbound I 75 over the Huron River Drive (S01 of 82191), had been patched extensively with Speed Crete in September 1966, and epoxy mortar in 1967 (Fig. 6). About thirty or so small Speed Crete patches were hand mixed and placed in September 1966 by a Wayne County bridge maintenance crew. Some of these failed and were replaced with epoxy mortar in 1967. All of the patching has been done in the east half of all three spans. It was noticed that this structure vibrates considerably under the heavy truck traffic, making it a difficult test site for any patching material. Many of the Speed Crete patches are holding in place but about one-third of them exhibit cracking and bond loss.

Light patches are Speed
Crete, others are epoxy
mortar and cold patch,
Span 3.

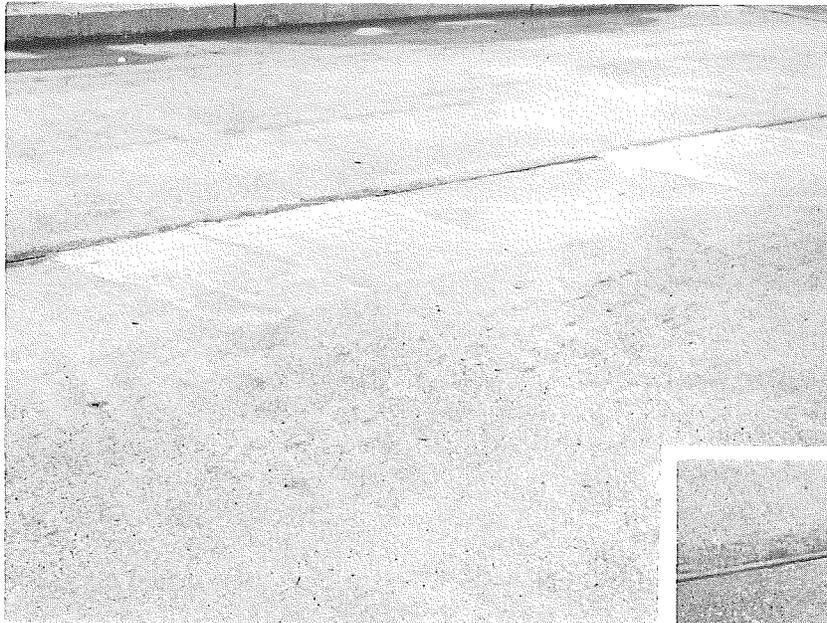
This last field application was inspected with C. H. Voss, District Engineer, in June 1967, and then patched by the District on August 2, 1967. Two spalled areas had developed in Span two of the southbound structure (X01 of 39014) along a longitudinal construction joint. The spalled areas and the two completed patches are shown in Figure 7. Good preparation and patching procedures were used, in that the patch boundary was saw-cut, loose concrete was chipped away, the area was sandblasted, and the finished patch was sprayed with membrane curing material. The finished patches, at present, are sound and in good condition after one winter.

After one winter, mem-
brane curing still vis-
ible.

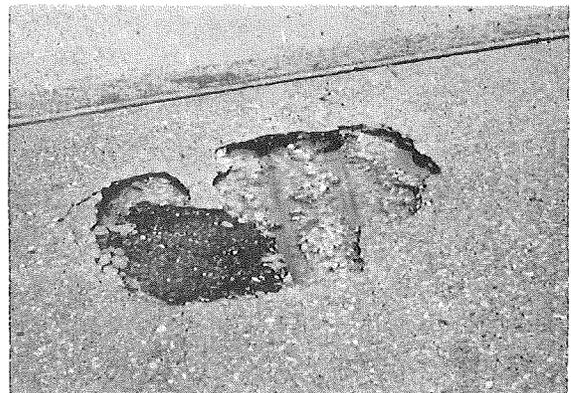
Typical spalling over lap-
ped re-bars, Span 2.
