# OFFICE MEMORANDUM

MICHIGAN  
DEPARTMENT OF STATE HIGHWAYS

Subject: Joint Spalling on State Project BI 49025G, C22, Mackinac County on I 75 from Junction with M 134 Northerly 6.9 Miles. Research Project 39 F-7(14). Research Report No. R-693.

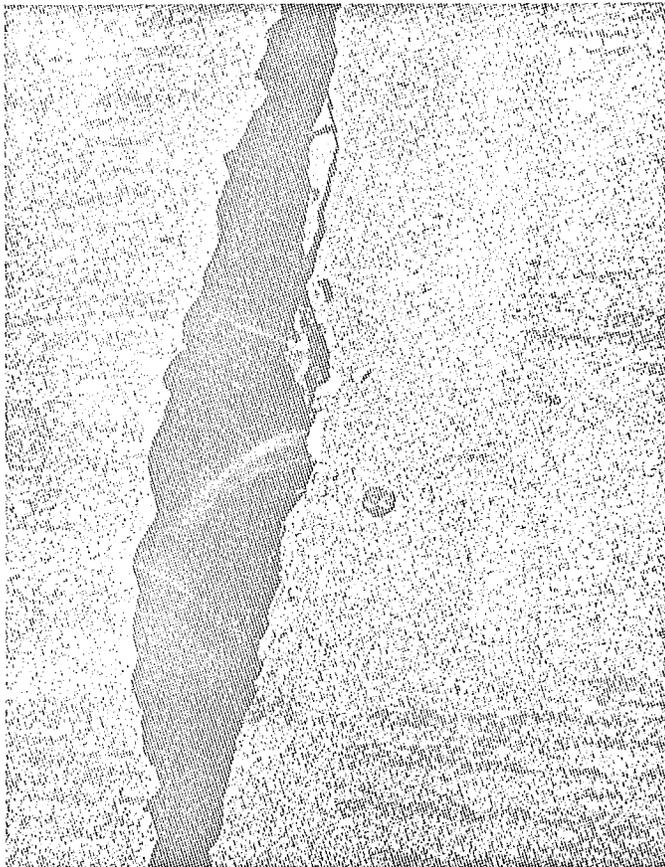
and non-durable particles (shale) were encountered during aggregate production. It was also noted that significant quantities of aggregate were accepted, although exceeding the maximum specified allowable percentage of three percent for soft and non-durable particles. Chert and shale are both absorbent aggregates with very small pores. These small pores hold the water which has been absorbed and, upon freezing, the trapped water expands, causing the aggregate to burst and form a spall. It was also noted in the aggregate inspection reports that most objectionable materials were in the larger size aggregate. Larger aggregate, due to larger area and volume, would create greater pressures and damage upon bursting. (Spalling shown in Figs. 1-6).

On the basis of this evidence, it appears that the spalling of the joints on this project is due to the freezing and consequent expansion of water which has been absorbed in the soft shale and chert present in the concrete.

Figure 2. Spalling along joint at 837+25, NB.

To repair these joints, it is recommended that the spalls be removed and the joints filled with hot-pour sealer. Since the hot-pour would have to stretch only a small percentage, the chances for successful performance would be high.

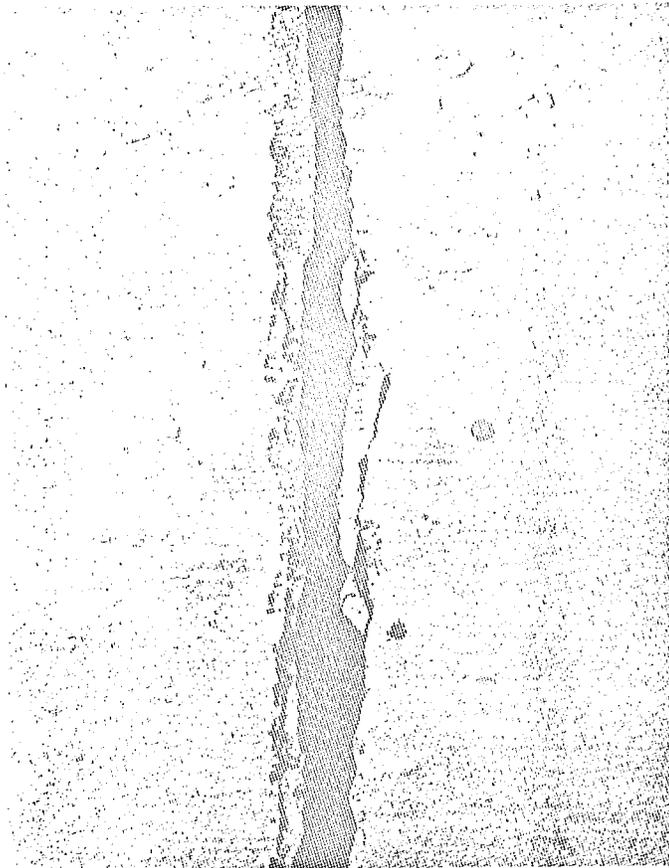
Figure 3. Spalling along joint at 975+35, SB. Note width of spall.

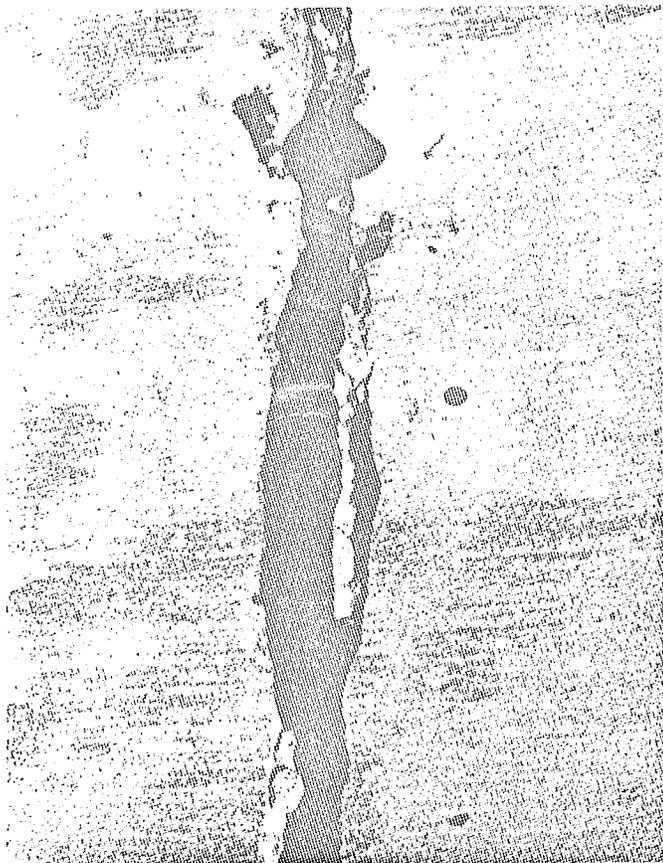
Figure 4. Spalling along joint at 975+35, SB. This is a later stage of spalling similar to that shown in Figure 3.

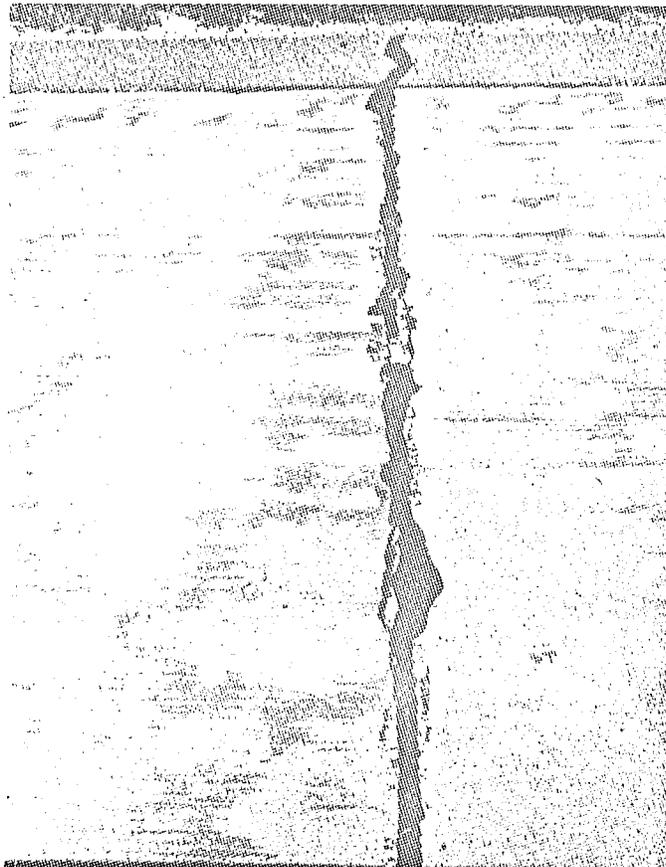
Figure 6. Typical joint.
