MICHIGAN
DEPARTMENT OF STATE HIGHWAYS

May 2, 1969

Subject: Pavement Cracking on I 75 in Hamtramck: Research Project
39F-7(14). Research Report No. R-700.

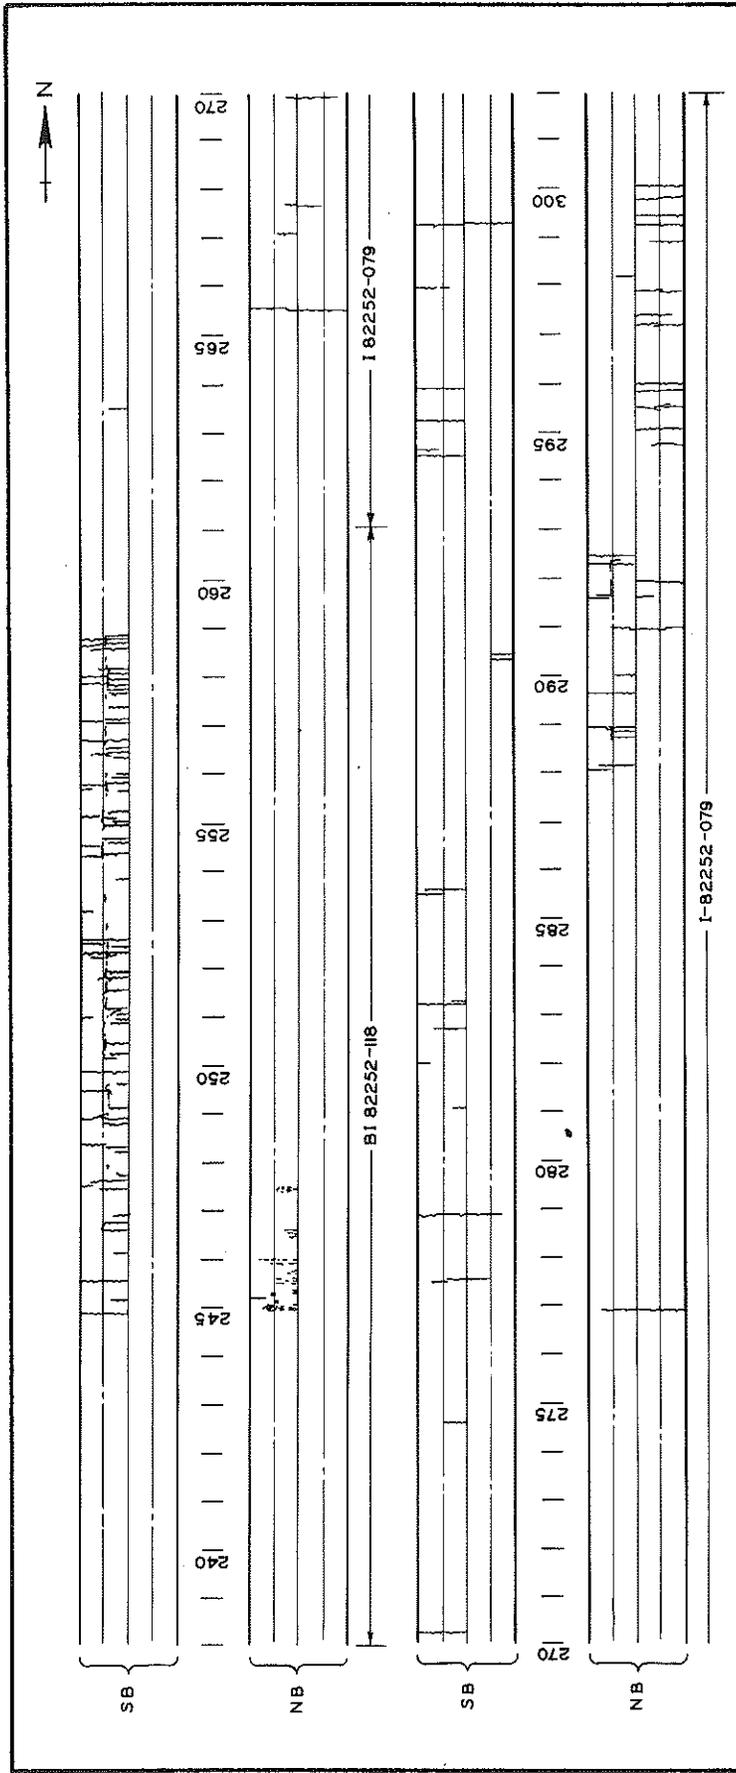
Cracking was first noticed approximately two weeks after all pouring operations were completed. The extent of cracking is shown in Figure 1. This cracking pattern is of a random nature, as shown in Figures 3 through 8, which is not characteristic of normal shrinkage cracking but rather suggests excessive vertical movement caused by loading or settlement. Cores taken September 23, 1968, in the cracked areas show the cracks extend to the depth of the reinforcing steel. Compression tests on the cores met or exceeded 28 day strength requirements.

Figure 1. Layout of project showing extent of cracking. Survey taken October 1968.

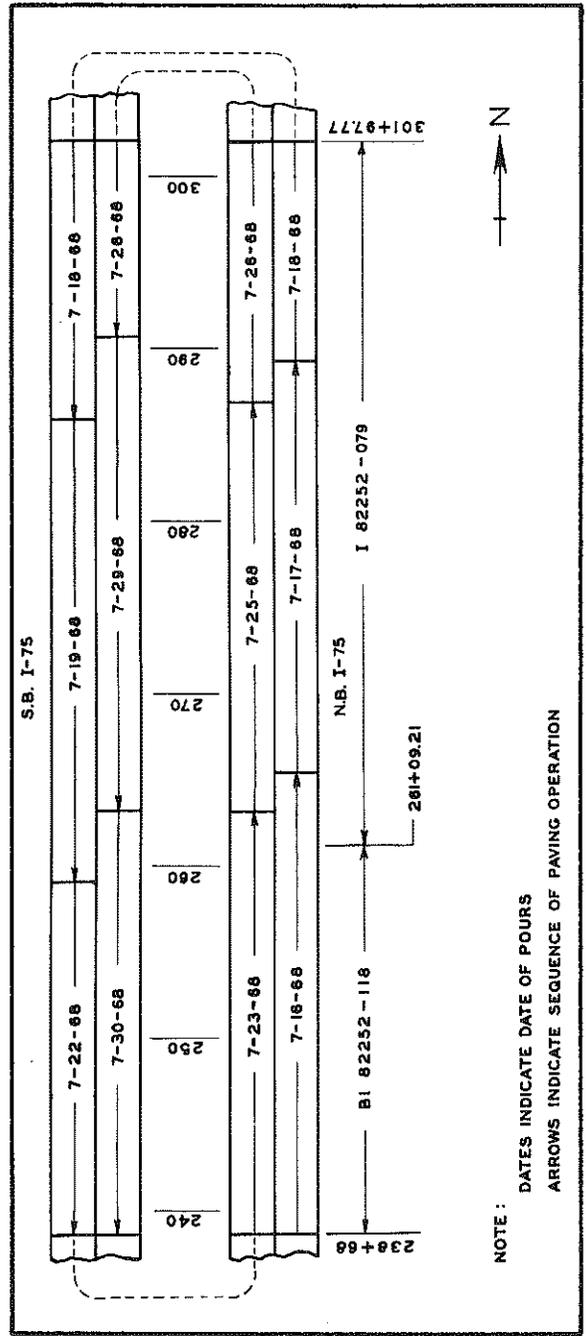
The paving operation was sequenced as shown in Figure 2. While placing the inside pours the paver and batch trucks traveled on the outside pours which were only from seven to eleven days old. Standard specifications allow the paver to operate on new concrete only after full design strength has been attained unless written permission is granted by the Project Engineer. Although dependent upon curing conditions, design strength is normally attained in 28 days. It is also noted that all major cracking occurs at the beginning of a pour. This "morning sickness" or evidence of lesser quality in concrete near the beginning of a pour has been observed in a number of projects studied in the past.

Figure 2. Schematic of control section showing sequence of paving operations.

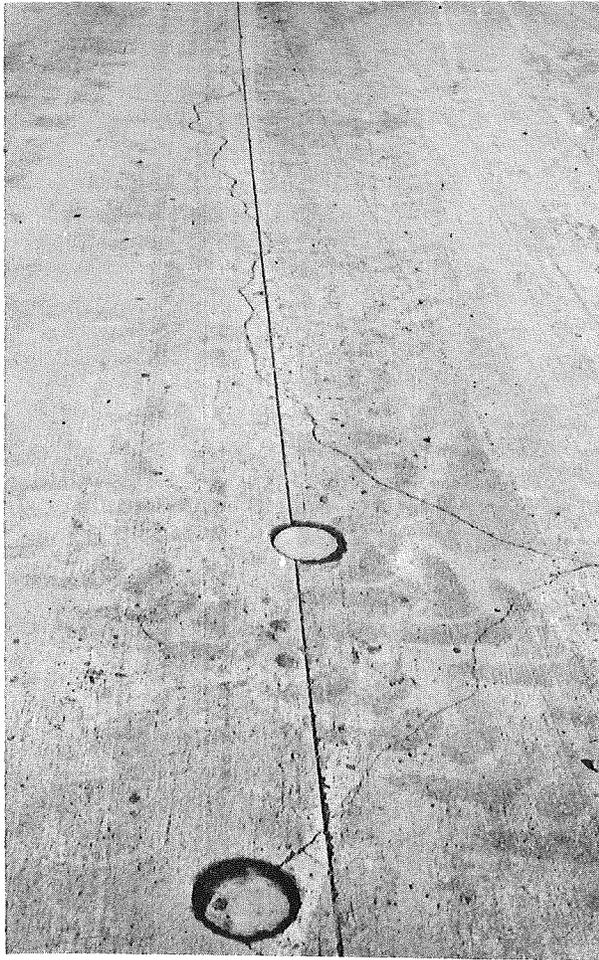
Figure 3. Typical cracking pattern.
Sta. 253+40 SB, BI 82252-118.

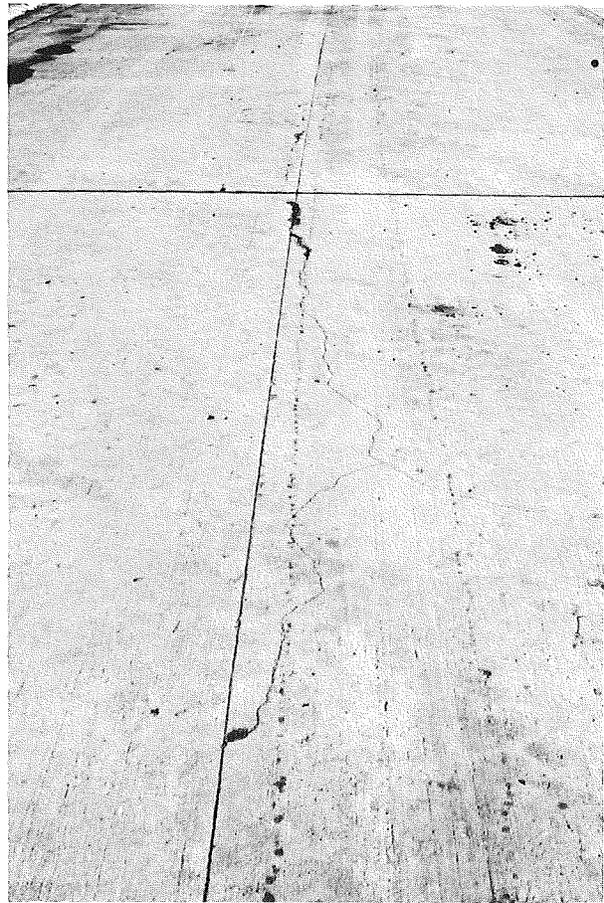
Figure 4. Typical cracking pattern.
Note how cracks appear uninterrupted by
center longitudinal joint. Sta. 254+50
SB, BI 82252-118.

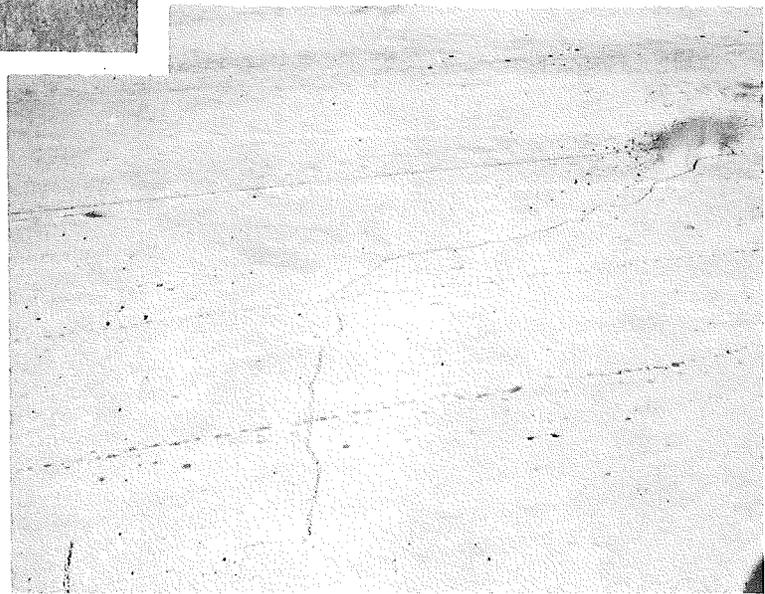
Figure 5. Typical cracking pattern.
Sta. 255+20 SB,
BI 82252-118.

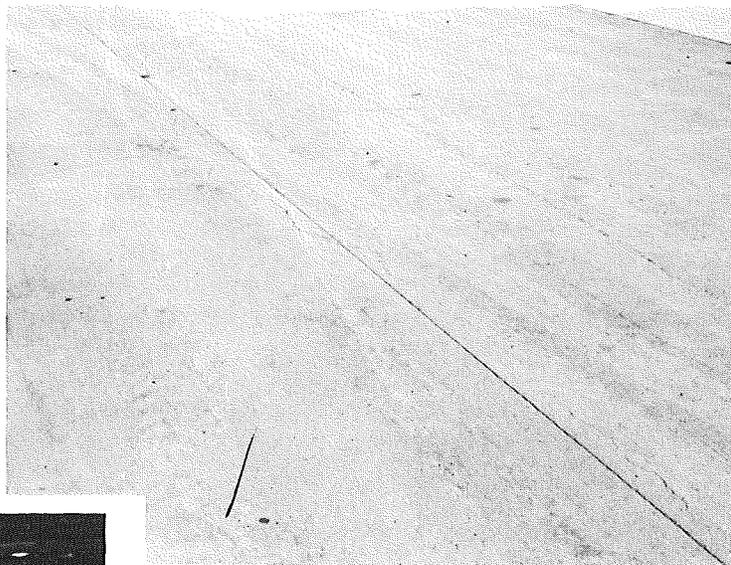
Figure 6. Typical cracking pattern. Note uninterrupted path of crack across center longitudinal joint. Sta. 255+80 SB, BI 82252-118.

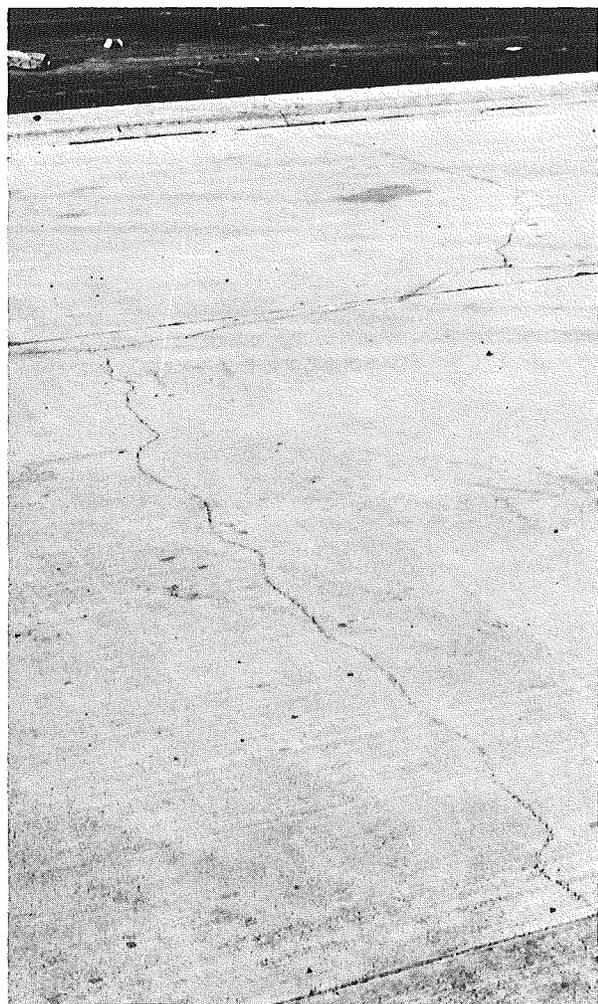
Figure 8. Typical cracking pattern. Sta. 288+90 NB, I 82252-079.

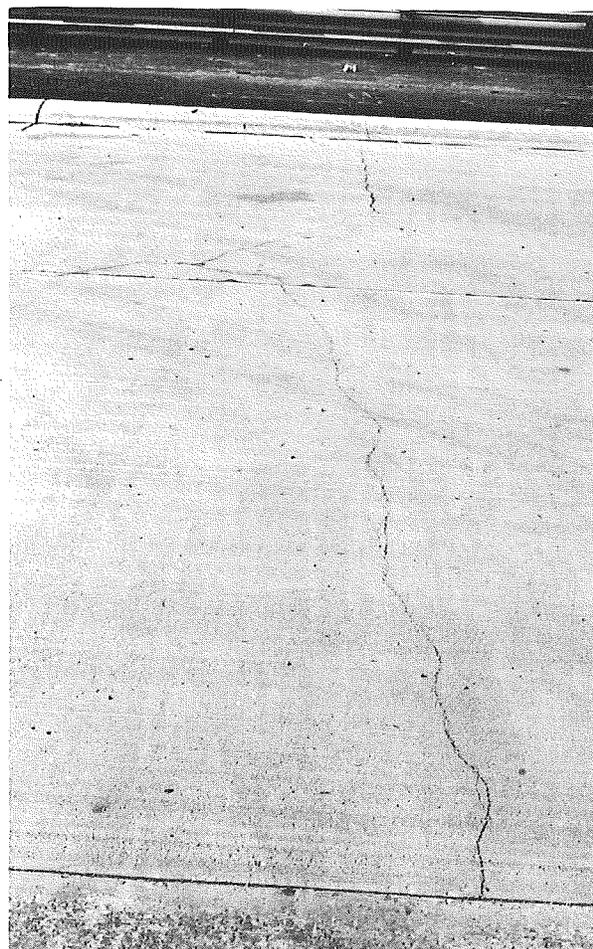
Figure 7. Typical cracking pattern showing random nature of cracks. Sta. 288+80 NB, I 82252-079.
