INVESTIGATION OF
ALLEGED RESIDENTIAL VIBRATION DAMAGE

Research Laboratory Section
Testing and Research Division
Research Project 69 F-106
Research Report No. R-707

State of Michigan
Department of State Highways
Lansing, June 1969

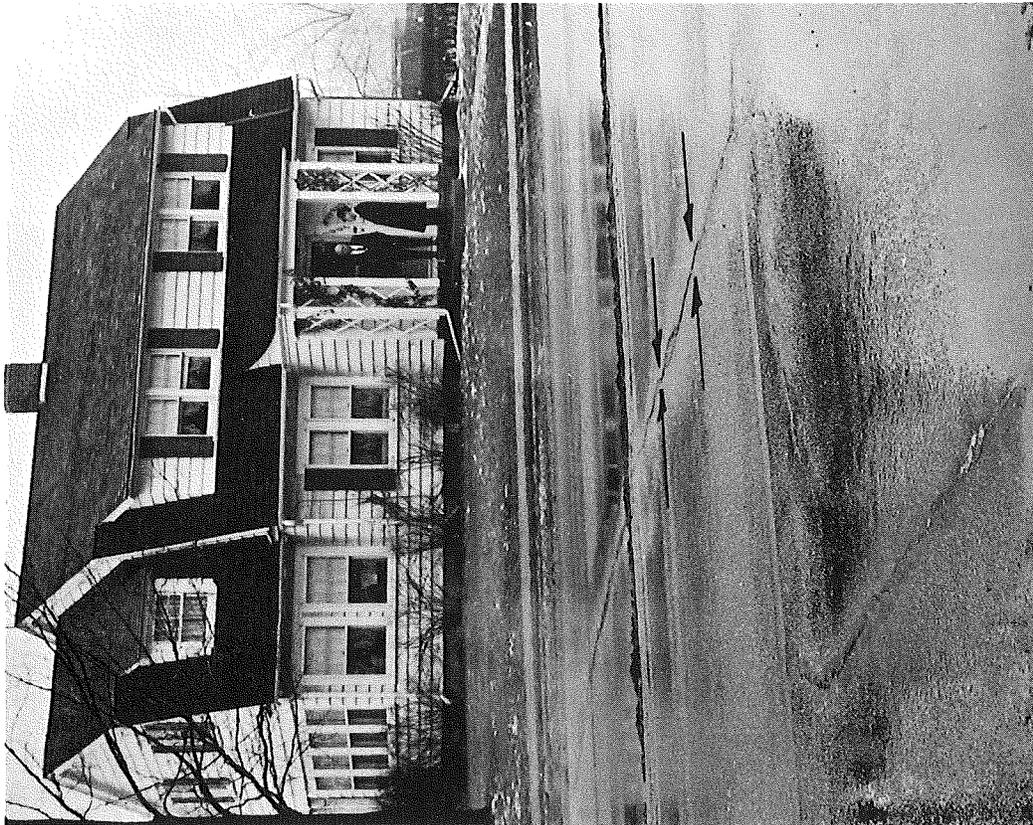
Mr. Storrer's property is located on M 47, approximately five blocks inside the north city limits of Owosso. The house is approximately 40 years old, and generally in good condition (Fig. 1). The pavement in the area is four lanes wide. The original two-lane concrete pavement was built in 1924, and was widened and resurfaced in 1965. Bumps in the inside lanes result from bituminous overlay on deteriorated joints in the old two lane concrete pavement. The raised joint near Mr. Storrer's house is shown in Figure 2. This causes northbound truck traffic to produce vibration and noise, when operating in the passing lane. The height of the bump has varied during this year from approximately 1/2 to 3/4 in. Variations in the road profile are caused by thermal expansion of the slabs, frost heave at the joints, and traffic action.

Figure 1. R. Storrer residence, Owosso. Raised joint shown in foreground.

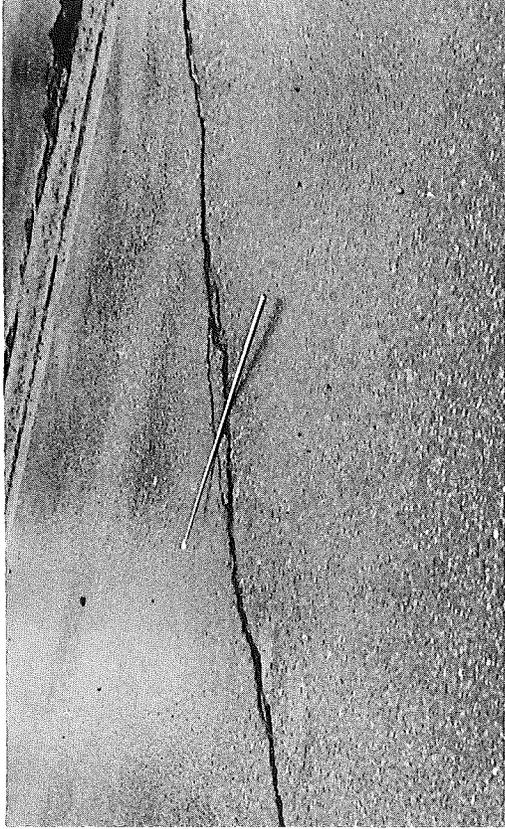
The bump was slightly less than 1/2 in. high on the day of testing, and the measured accelerations were quite low. Since the bump had been somewhat higher during the past winter, it was decided to simulate a larger bump by the use of impact boards placed on the roadway. The only boards readily available were two inches in height. These boards were used, and traversed by the Laboratory's weight truck at approximately 25 mph. The largest peak acceleration and particle velocity for these tests were approximately 0.03 g and 0.08 in/sec respectively. Average values for eight tests were approximately 0.02 g and 0.06 in/sec. Based on these limited test results and the published critical values for damage listed above, we conclude that traffic should not have caused damage to Mr. Storrer's house. It is evident, however, that the magnitudes may be approaching values that could be objectionable to some people. Therefore, the following suggestions are offered.

Figure 2. Raised joint, northbound passing lane.

It is suggested also that the joint near Mr. Storrer's house be cut out full-depth, and repaired, if maintenance funds can be made available. There are a few more joints in the area that should also be repaired. Two or three are in the southbound passing lanes and in the immediate vicinity of the Storrer residence. These joints are in worse condition than the one in question, and may bring complaints from other residents if not repaired.

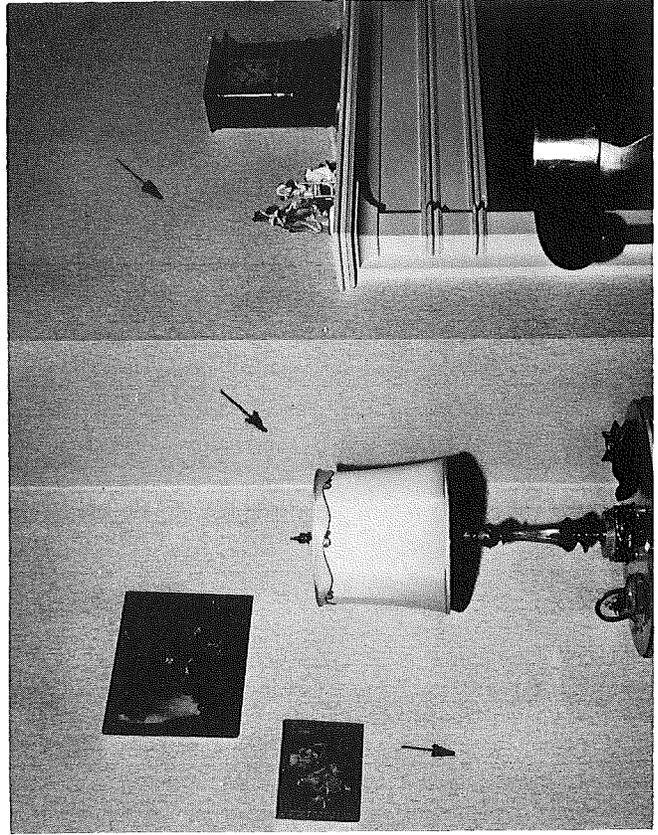
The owner's main complaint of damage to the house is based on cracks that have appeared in the wallpaper near the fireplace. The fireplace is brick, framed above and on the sides, and finished with plaster and wallpaper (Fig. 3). The fireplace and foundation seem to be sound, and the cracks appear to be only in the surface of the plastered wall. Other smaller cracks, at various locations in the house, seem to be only in the wallpaper. In talking with the owner, our representative became convinced that he was more concerned about the irritating noise and vibration, than the alleged damage to the building.

Figure 3. Interior of Storrer house, location of cracks indicated.
