OBJECTIVE V

DETAILED INVESTIGATION OF SPECIFIC TYPES OF PAVEMENT DISTRESS

Joint Failures

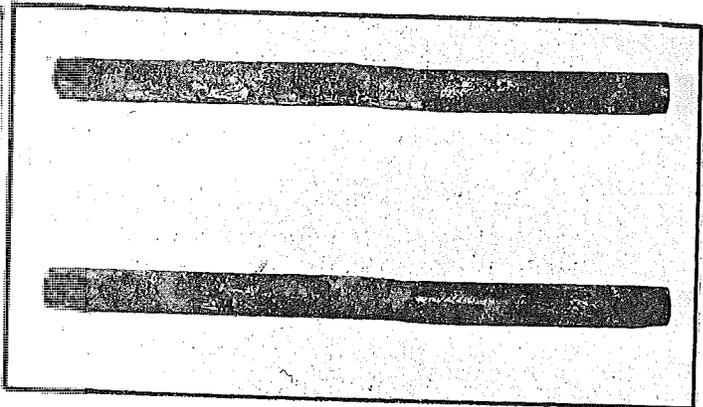
1. The metal expansion caps, installed on the end of dowels to permit pavement expansion, were never installed. Therefore, the compressive force on the end of the dowel shattered the concrete and bent the bar (Fig. 72).

▲ Physical condition of two dowels; note bending due to compressive force.

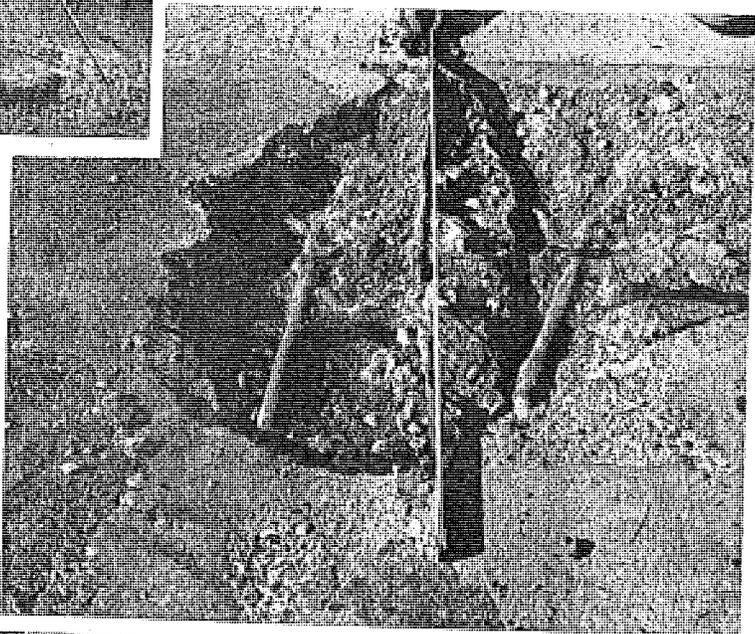
Horizontal misalignment of two dowels next to longitudinal center joint. ▶

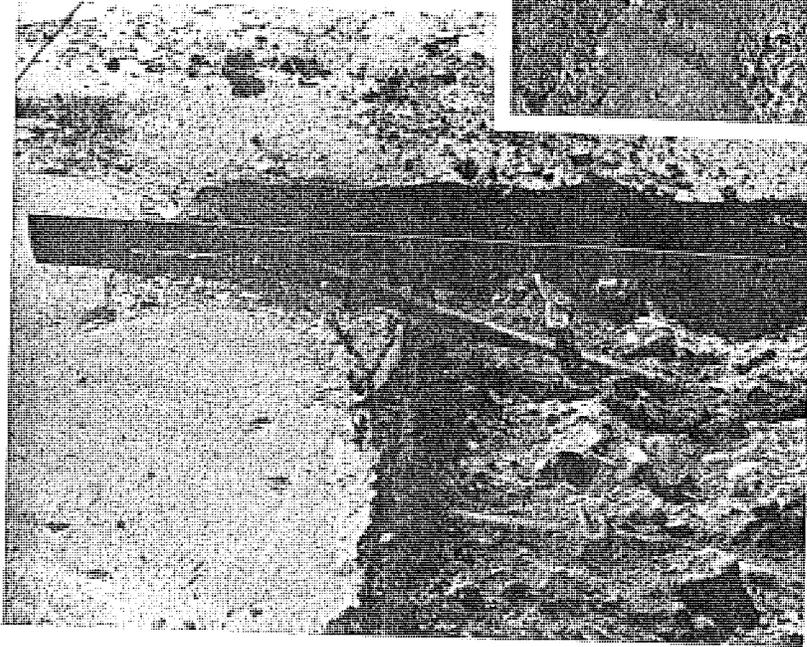
◀ Vertical misalignment due to dowel slipping out of dowel assembly clip.

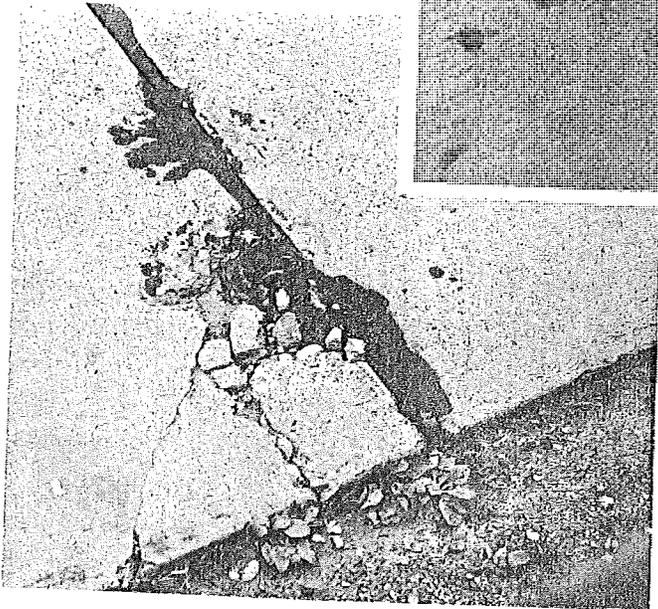
Concrete spalling; external corner.

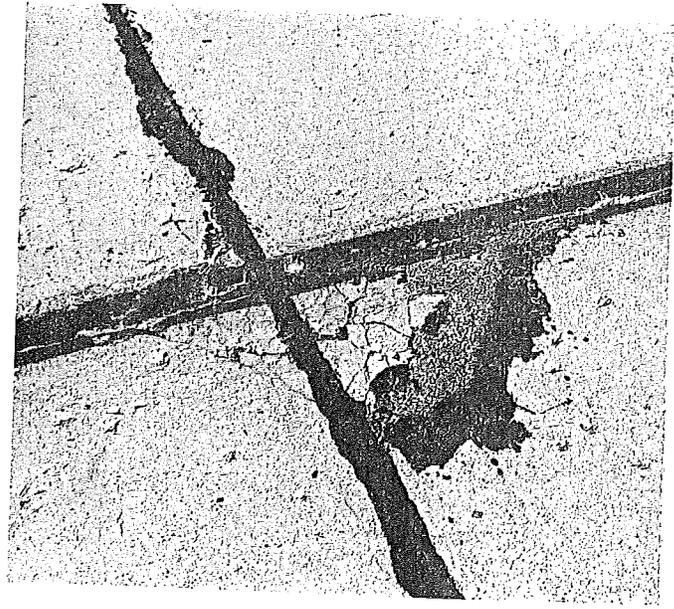
Concrete spalling; interior corner.

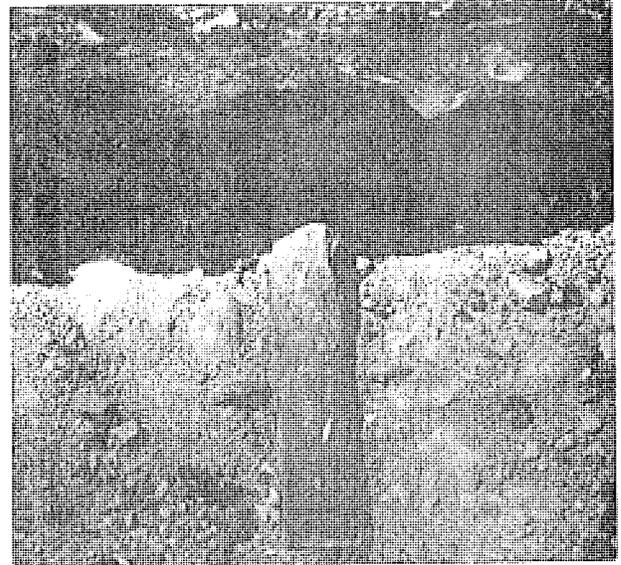
▲ Corroded dowels in place in 9 year old pavement.

The extent to which dowel bar corrosion may influence joint failures is difficult to determine; however, such corrosion can be expected to restrict slab movement and at least be a contributing cause for poor joint performance.

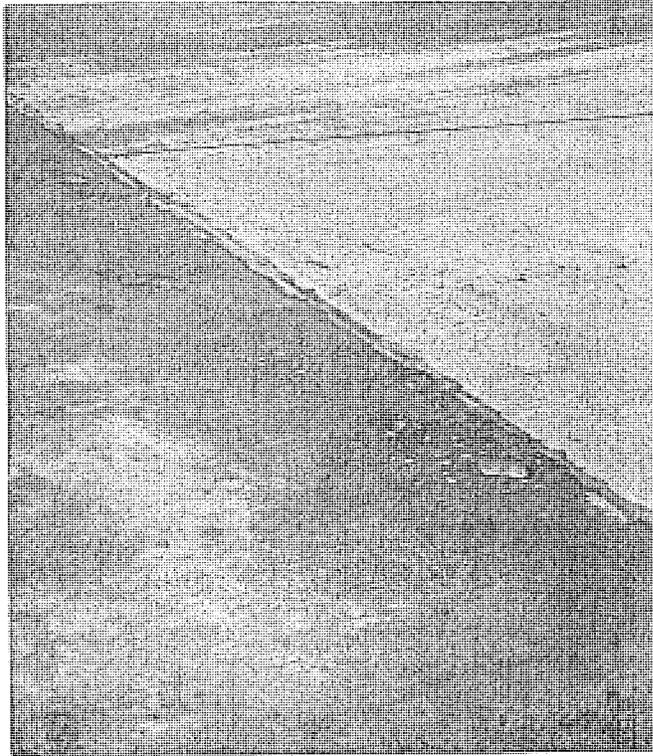
▲ Difference in appearance and performance of concrete at each side of construction joint.

Quite often when a pavement joint is investigated due to its poor performance it is found to be a construction joint used at the end of a day's pour. Invariably the pavement surface which has deteriorated is on the side of the construction joint poured at the end of the day. This is apparently due to the fact that this concrete is inferior in quality to that placed at the beginning of the day or during regular operations throughout the day. Also, misalignment of dowels placed through a joint bulkhead is another source of trouble (Fig. 74). A more recent method of correcting this situation has been to use a complete expansion dowel-bar assembly and place the bulkhead in place of the expansion filler. By this method both sides of the dowel bars are properly supported and do not get displaced or bent.

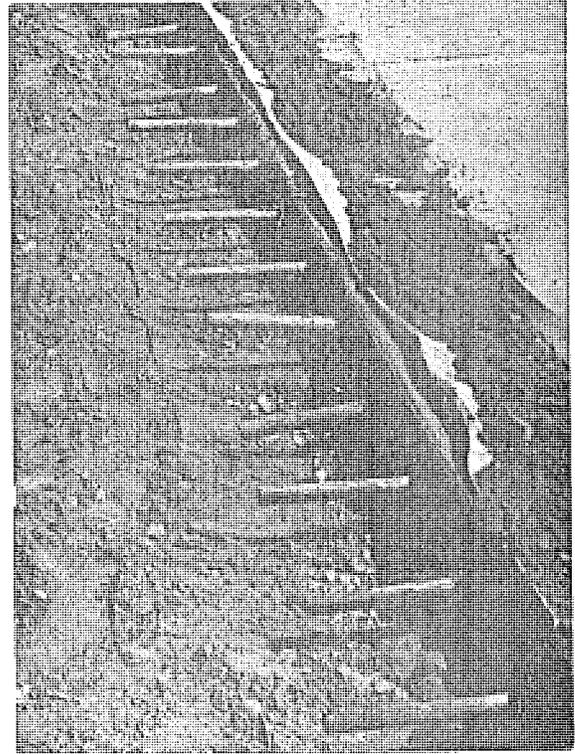
▲ Misalignment of dowels at construction or night joint.

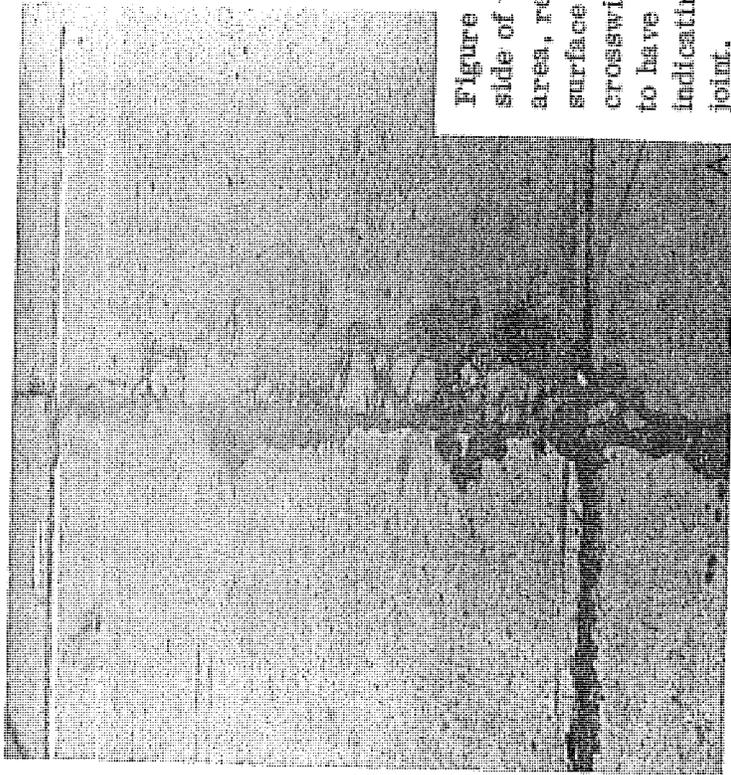
The third joint was another construction joint where, at the south side of the joint, the pour ended against month-old concrete on the north side (Fig. 75). The slab reinforcement was found to be only 7/8 to 1 in. from the surface on the spalled side of the joint. The joint was not moving properly, but was opening 6 in. further south where a crack had opened sufficiently to rupture the steel. The fact that the movement took place 6 in. south of the joint meant that only a few inches of the dowel extended across one side of the opening, resulting in absence of proper load transfer. Undoubtedly this condition was partially responsible for the pavement break-

Figure 75. "Joint 3" where opening had occurred about 6 in. on the spalled side of the joint groove, is shown in an overall view (A). In the spalled area, reinforcement was embedded only 7/8- to 1 in. beneath the concrete surface (B). The reinforcing mat here was found to have been placed crosswise at the time of construction (C). A No. 4 gage wire was found to have broken within the slab, probably soon after construction (D, E), indicating that the pavement was opening at this point rather than at the joint.

age at this point. In addition, after more of the reinforcing steel was exposed in the slab south of the joint it could be seen that the mat was not correctly oriented, being crosswise with the transverse and longitudinal axis of the mat and the pavement opposed. The No. 00-gage wires at 6-in. spacing were oriented transversely, giving 0.688 sq in. to the lin ft, the No. 4-gage wires at 12-in. spacing were oriented longitudinally, giving only 0.159 sq in. to the lin ft, or less than a fourth of the proper steel area. This incorrect orientation of the steel mat undoubtedly caused the opening of the crack south of the joint and the early failure of the steel at this point. The load transfer system, however, must have caused considerable binding and freezing at the joint, and resulted in the slab movement taking place 6 in. away from the joint.

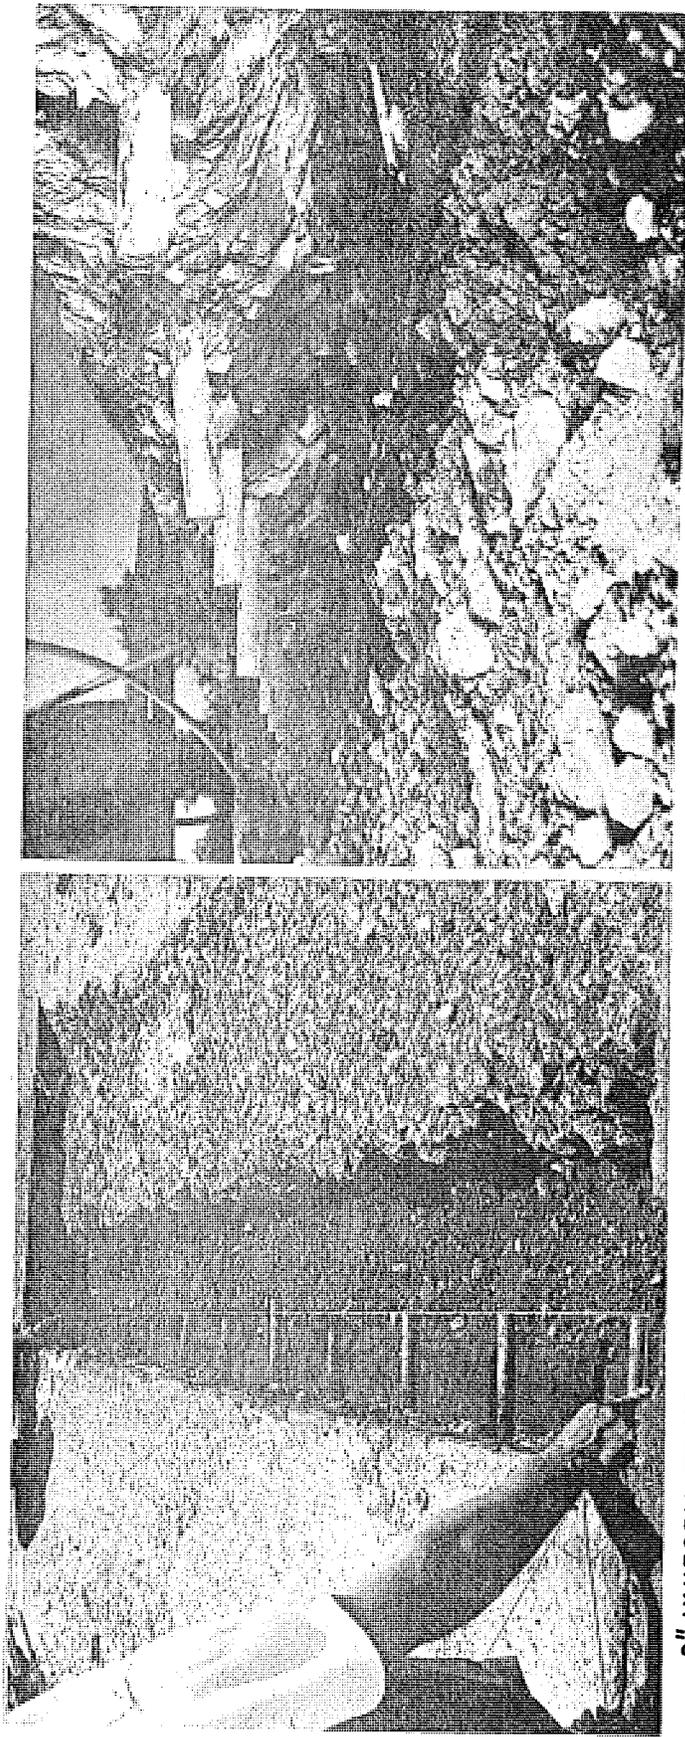
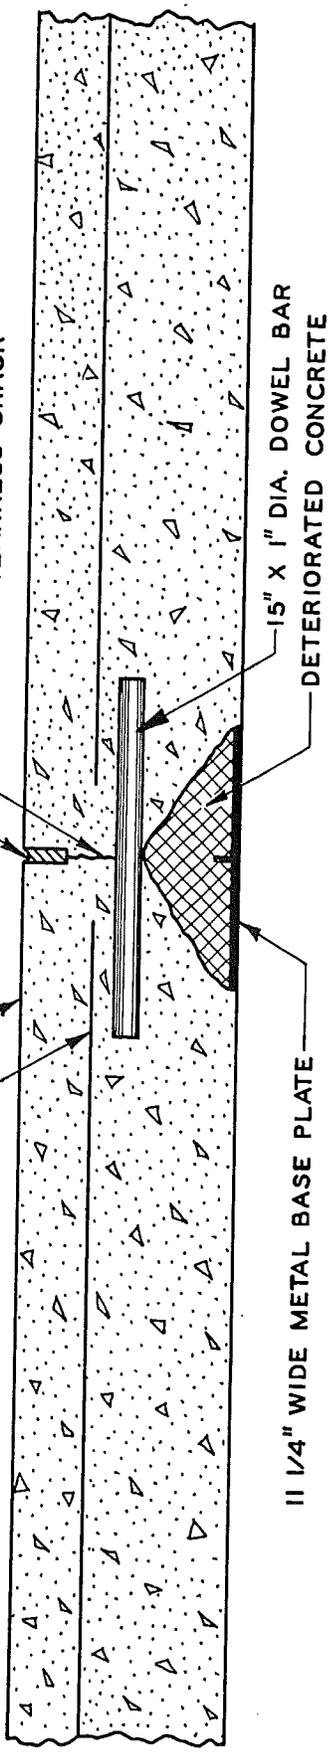
Figure 76. Pavement joint blow-up, dowel and joint groove misalignment observed during repair (upper left), concrete deterioration found below dowel bars (upper right) and schematic cross-section of deterioration.

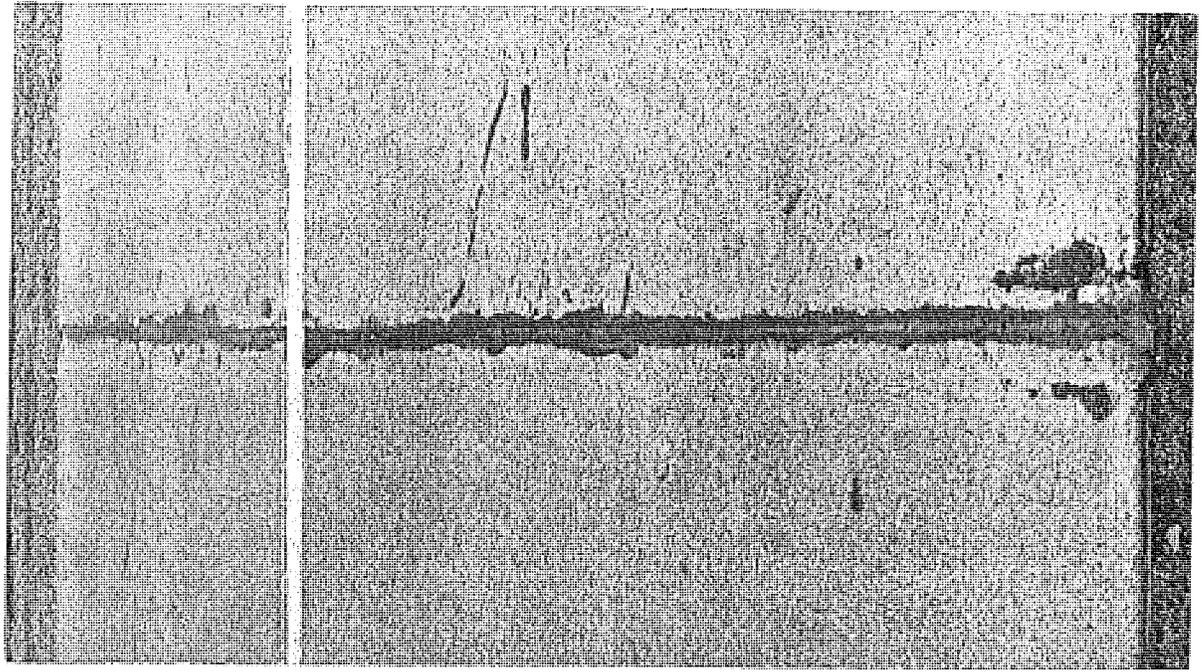
In September 1965, two adjacent construction projects on US 127 were investigated intensively. The first project was constructed in 1947 and the second in 1949. Almost every joint in the 1947 project showed distress to some degree, with about 50 percent of the joints in very bad condition. A typical joint is shown in Figure 77. The concrete at the joint had disintegrated in a wedge shape, tapering up to the dowel bars from the plastic base plate. The concrete above the dowels was fractured into small pieces, as

▲ Figure 77. Distressed joint with end exposed.

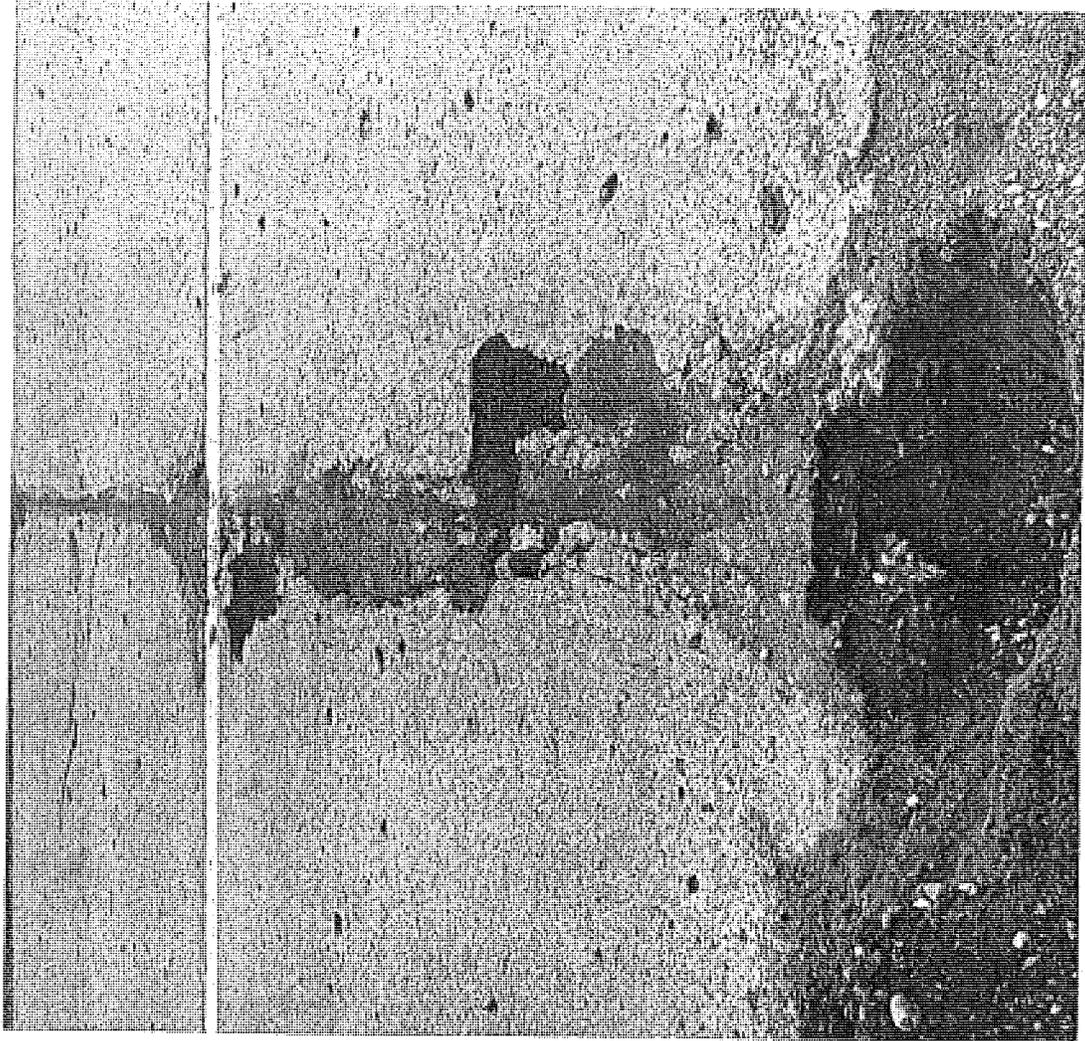
▲ Figure 78. Typical joint in good performance area.

though subjected to severe compression. The joints on the second project, constructed in 1949, were in excellent condition for approximately 3.1 miles with almost no distress (Fig. 78). On the remaining 1.6 miles of this project the joints had serious spalls where maintenance was required. A study of the design and materials factors as well as a study of the subbase material indicated that the only apparent difference in the performance of the pavement joints could be associated with the sources of coarse aggregate used in the concrete. The area of the second project where the performance was excellent after 16 years of service had a limestone coarse aggregate in the concrete. As shown earlier, however, this good performance on a larger statistical sample correlates with the generally lower amount of soft, non-durable material found in limestone sources.

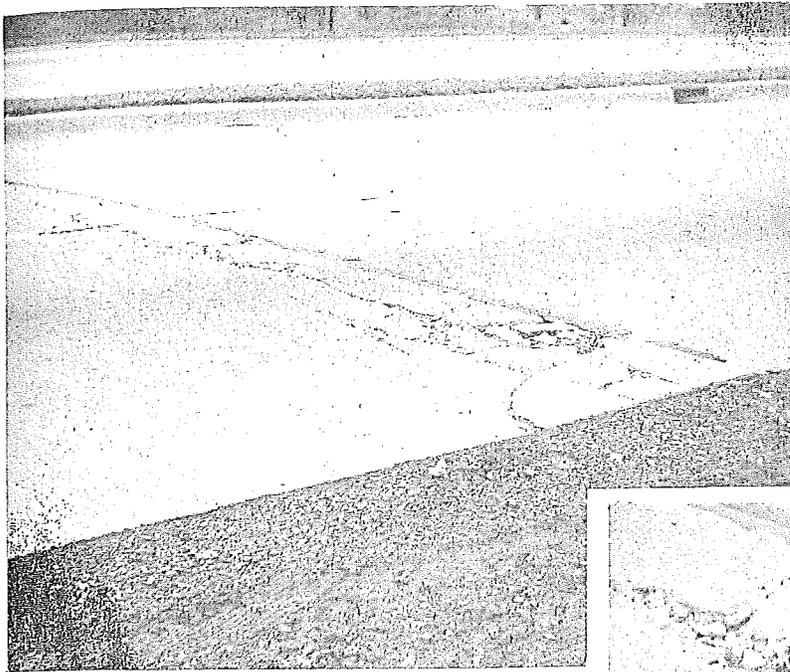
Condition of pavement joint on October 30, 1957.

Broken concrete removed to level of reinforcing steel. Reinforcing steel was twisted and tilted upward at joint.

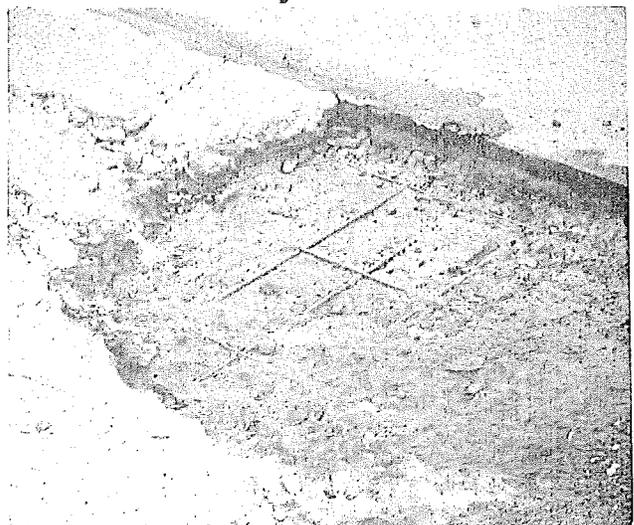
Detailed view at pavement edge showing reinforcing steel passing through joint and dowel extending 1-1/2 inches across joint.

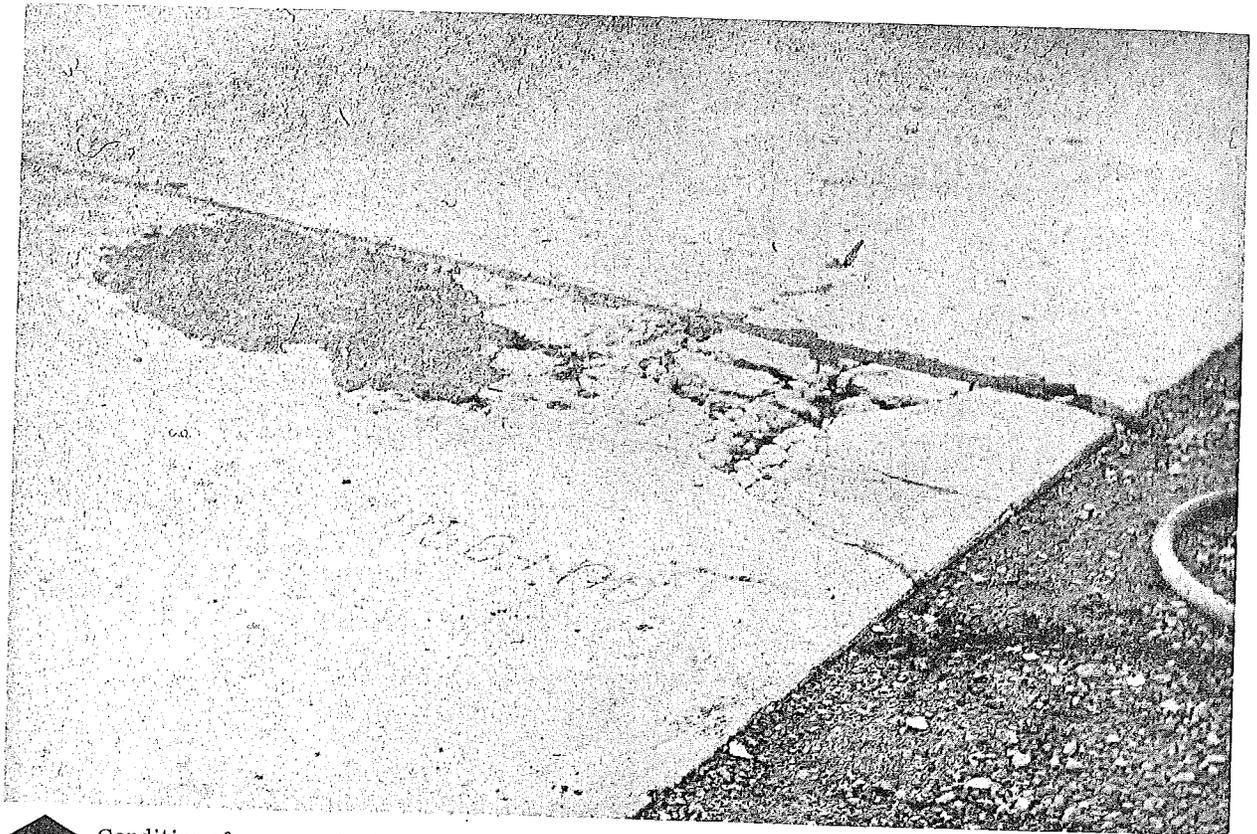
▲ Condition of pavement joint on October 30, 1957.

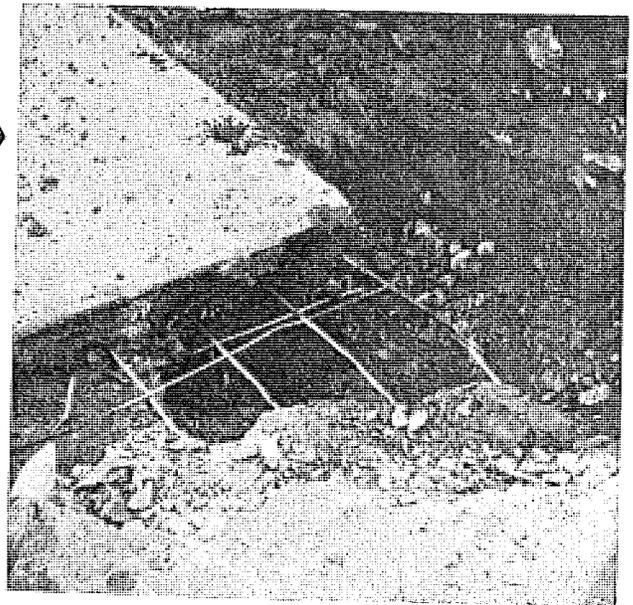
◀ Edge dowel exposed showing 1-1/2 inches of lap across joint. Reinforcing steel passes through joint and although "necked down" was not broken.

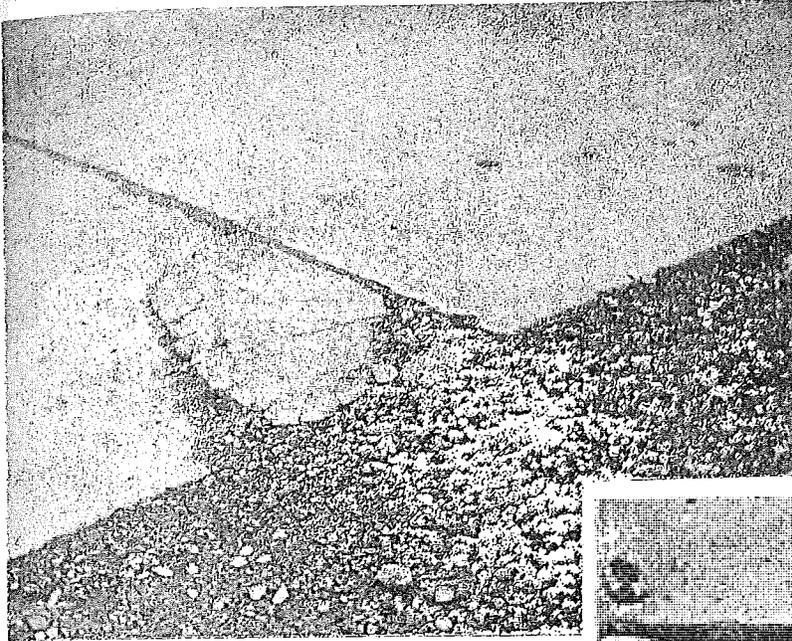
Condition of pavement joint, October 30, 1957.

Broken concrete removed to level of reinforcing steel.

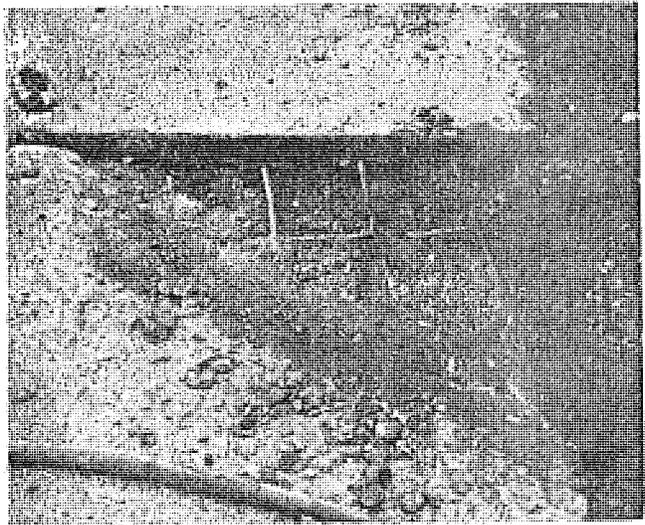
In 1957, three damaged joints on I 94 were called to our attention by county maintenance personnel. This pavement was six years old at the time of the examination. The reason for the failures of the first two joints shown in Figures 79 and 80 was the misplaced joint groove, approximately 6 in. too far west. This resulted in reinforcement extending through the joint and dowel bars embedded 13-1/2 in. into one slab and only 1-1/2 in. or less into the adjacent slab. The reason for the concrete spalling at the corner of the third joint was no doubt due to the twisting and misplaced reinforcement at this point which resulted in only 3/4 in. of concrete cover (Fig. 81).

Reinforcing steel shown to be within 3/4 inch of pavement surface at transverse joint.

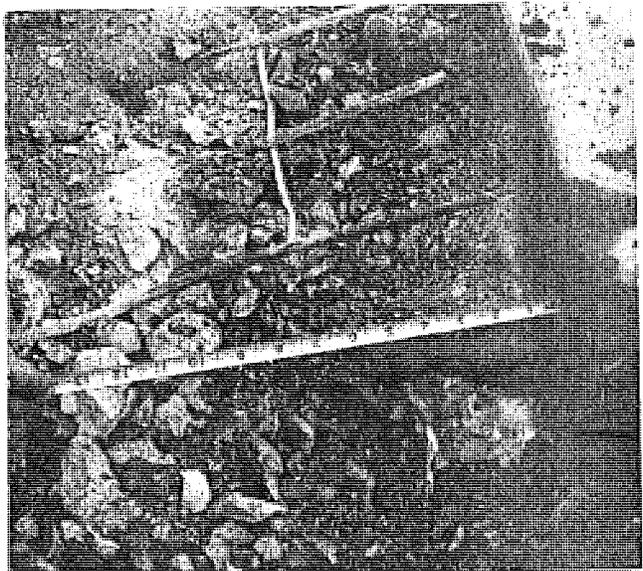
Edge dowel exposed showing 5-1/2 inch rather than 7-1/2 inch extension into adjacent slab.

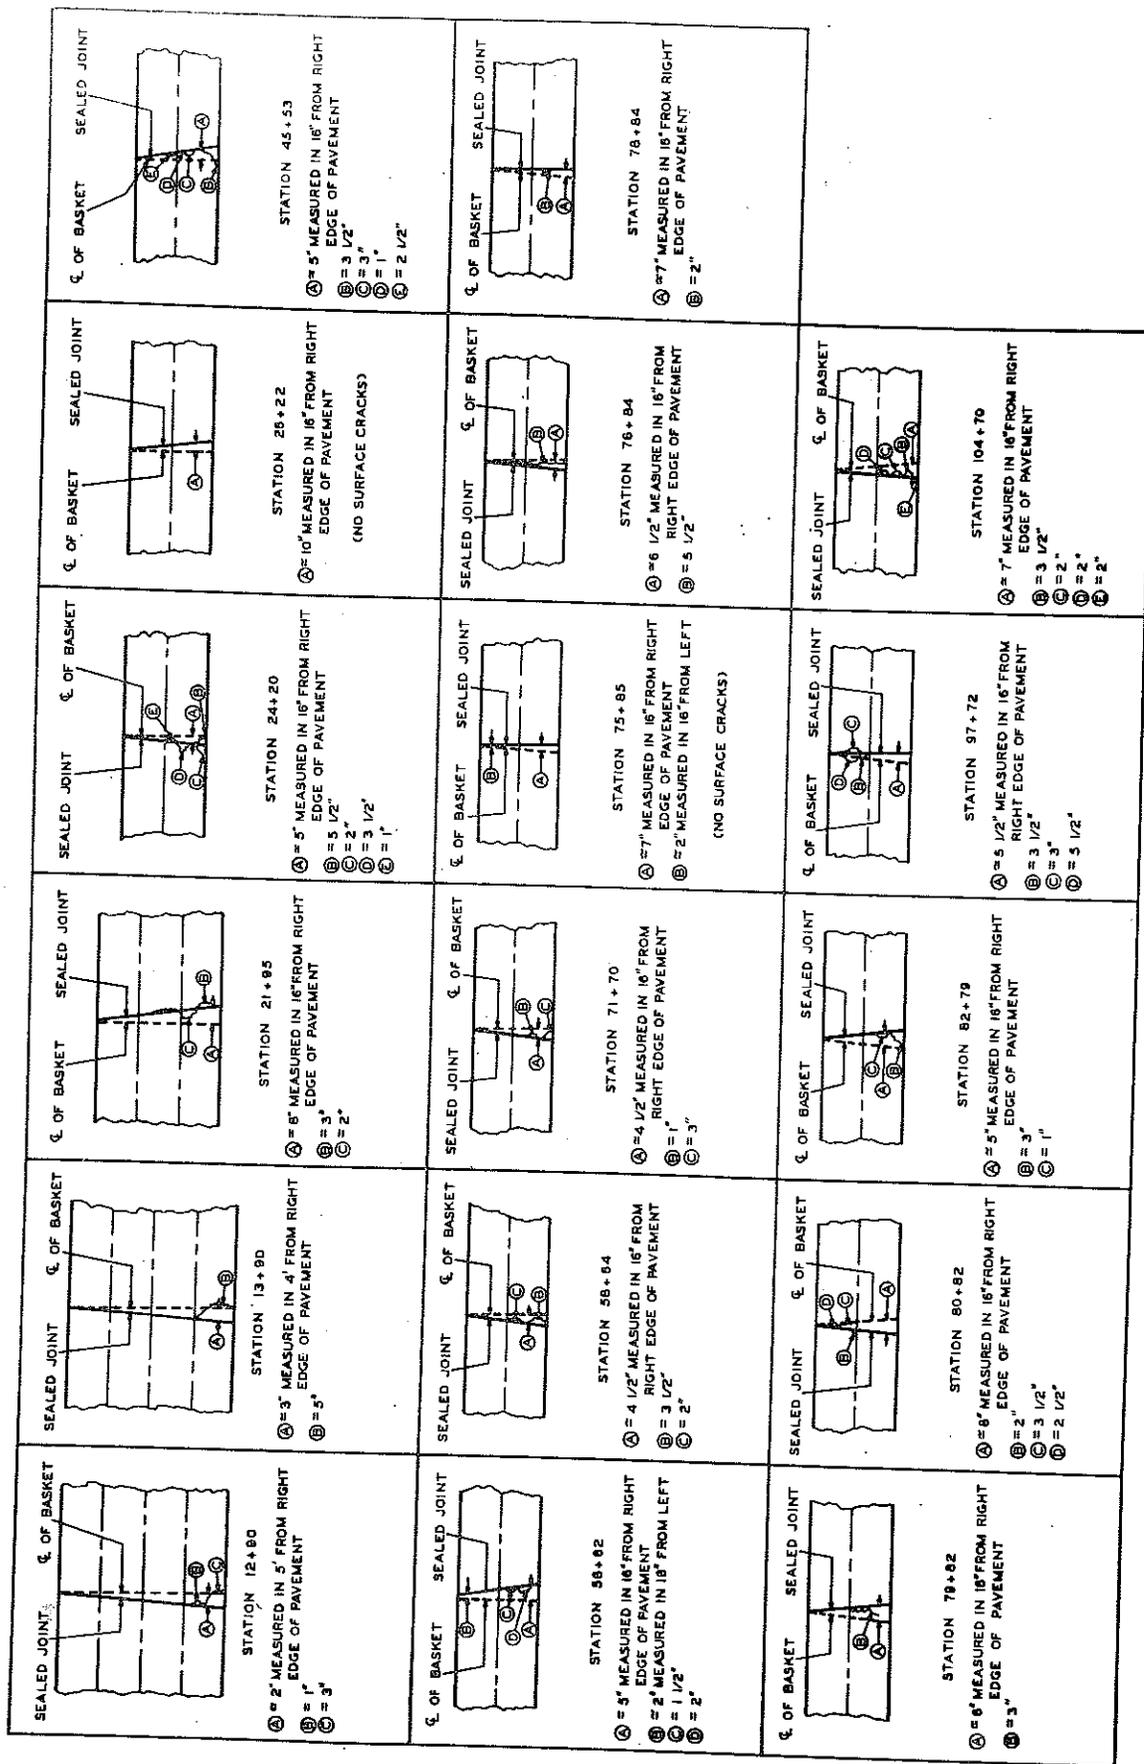
In 1954 unusual cracking at joints was investigated on a project on US 2 in the Upper Peninsula. This pavement was placed between July 16 and 30, 1954. It was first noted by excavating the shoulder alongside the pavement joint that the baseplate assembly was not in the proper location with respect to the joint groove in the pavement. A survey of 17 contraction joints was made on this project by means of a Research Laboratory designed electronic instrument which would indicate the position of steel embedded in the concrete pavement. As shown in Figure 82, it was determined that the sealed joint groove had been skewed to the location of the dowel bar assembly from approximately 3 to 10 in., thus the formed plane-of-weakness in some cases completely missed the dowel bars at one end of the pavement, and in other cases only a small portion of the dowel bar extended into the adjacent slab.

Figure 82. Condition and cause of cracking at various joints on project on US 2.
