EXPERIMENTAL CONCRETE AND BITUMINOUS
SHOULDERS
(Progress Report)

MICHIGAN DEPARTMENT OF STATE HIGHWAYS

Research Laboratory Section
Testing and Research Division
Research Project 68 F-101
Research Report No. R-898

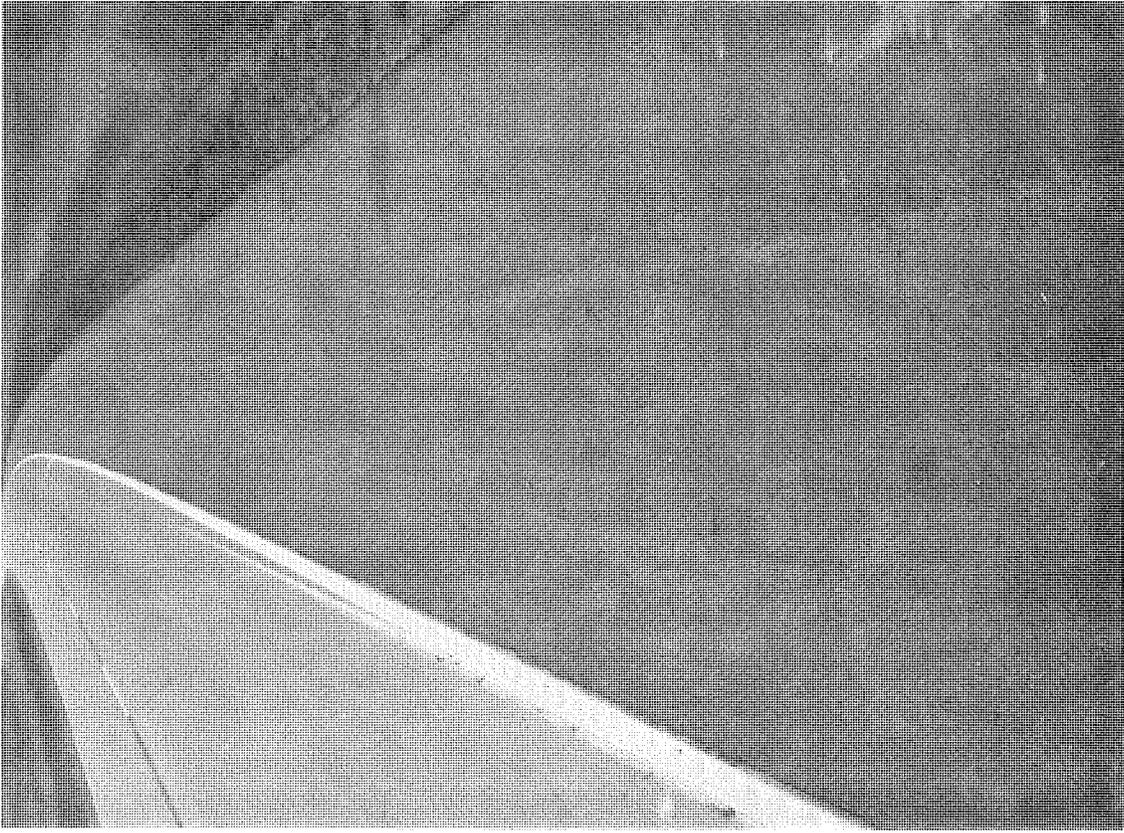
"Type B" bituminous shoulders - Figure 5 shows a typical portion of the "Type B" shoulder. This type shoulder does not show any visible deterioration after approximately one year of service.

Figure 5. Typical condition of "Type B" shoulder after approximately one year of service.

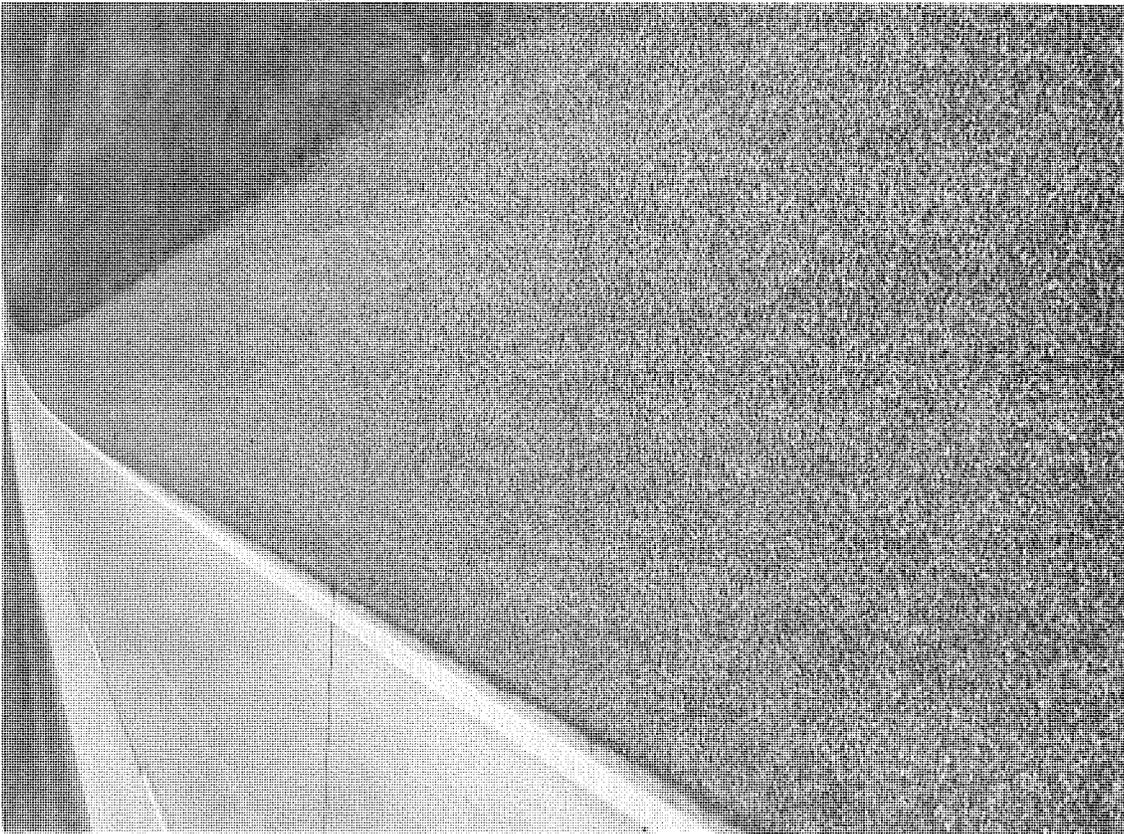
"Type A" bituminous shoulders - After approximately one year of service, there is no visible deterioration of any portion of this type shoulder. Figure 4 shows the typical condition of "Type A" shoulders in the fall of 1973.

Figure 4. Typical condition of "Type A" shoulder after approximately one year of service.

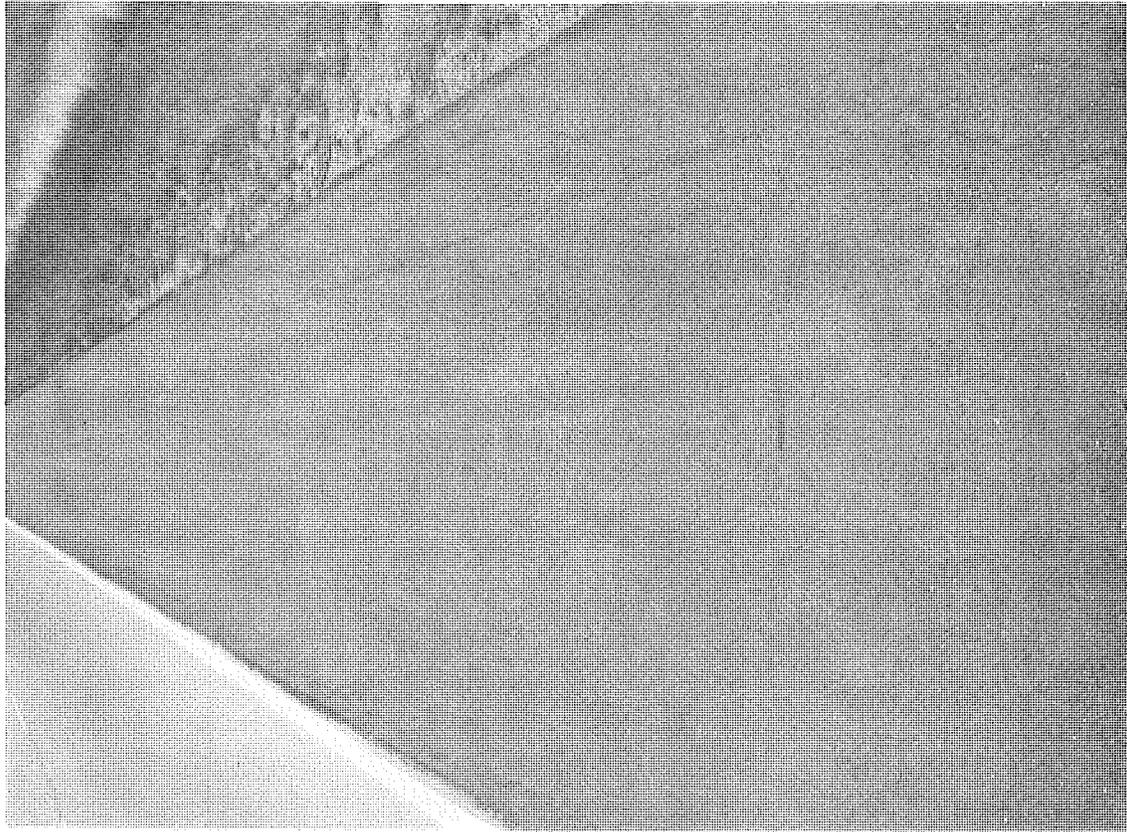
Standard bituminous shoulders - After one winter, the standard shoulders used for Michigan Interstate freeway construction have developed longitudinal cracking throughout the entire sections under observation. Cracking has occurred longitudinally along both edges of the shoulder. Near the pavement, a single longitudinal crack is present approximately six inches from the edge. On the outside edge, "alligator cracking" of the shoulder has occurred in an area approximately two feet wide. The center portion of the shoulder shows no evidence of deterioration. A typical portion of the standard shoulders is shown in Figure 6.

Figure 6. Typical condition of standard shoulder after approximately one year of service.

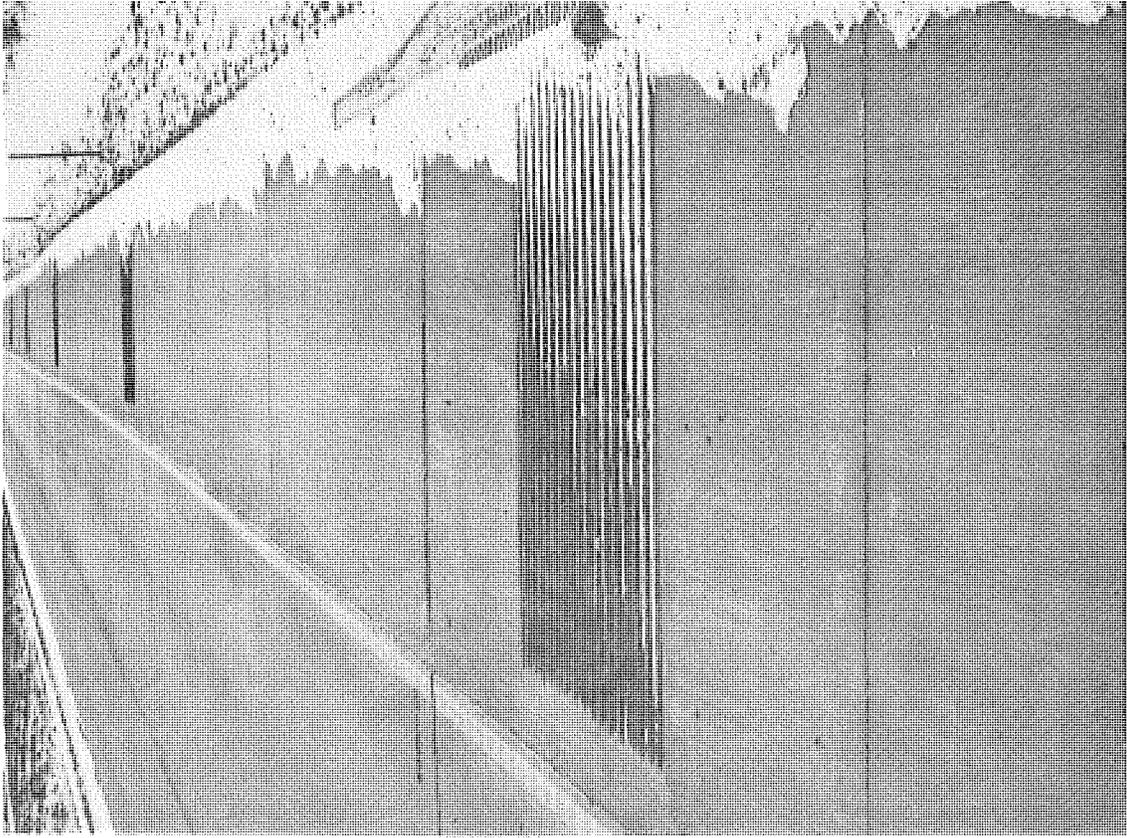
Concrete shoulders - Figure 7 shows the typical condition of concrete shoulders in the fall of 1973. After approximately one year of service, the concrete shoulders show no visible deterioration except at four isolated locations. Three of these locations are at expansion joints, near the pavement edge, and one is at a contraction joint on the outside edge.

Figure 7. Typical condition of concrete shoulder after approximately one year of service.

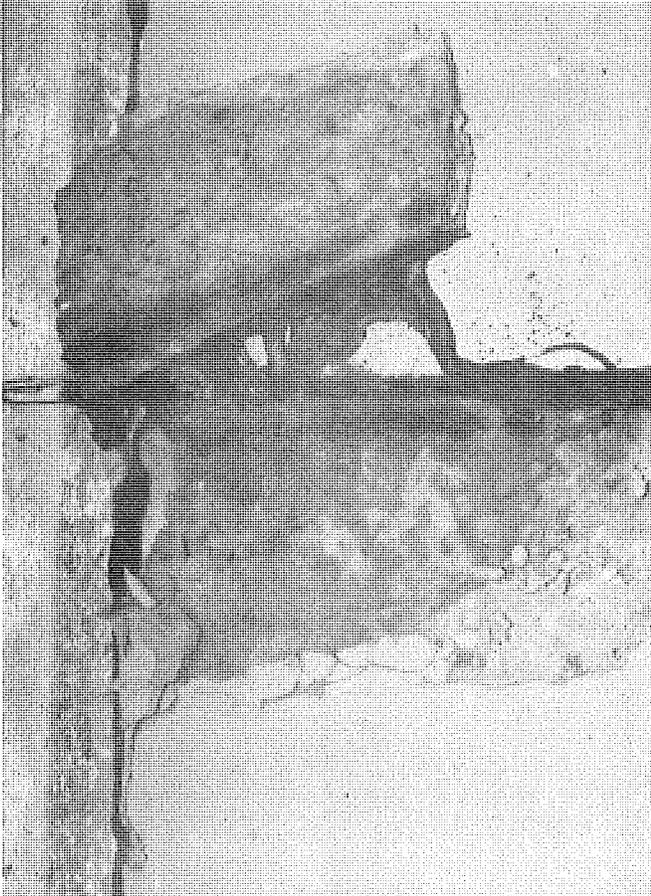
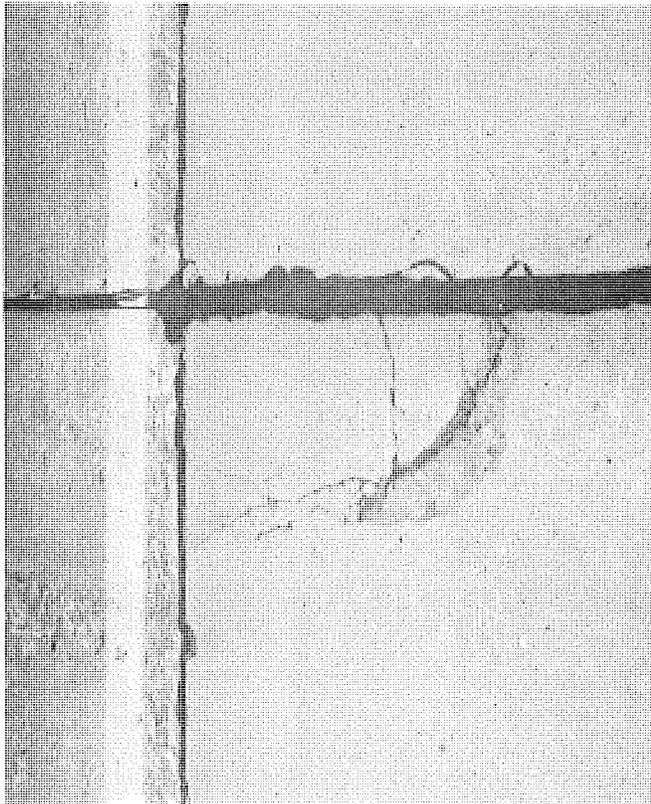
Further investigation of the failures at expansion joints has revealed the cause. Figure 8 shows one of the expansion joint failures. As can be seen, the expansion joint filler is offset from the sawed joint groove. At this location, the offset is approximately two inches; the other expansion joint failures are similar.

Previous laboratory investigations involving this type of joint distress have verified the detrimental factors. As the pavement expands, the induced horizontal compression of the filler causes it to extrude vertically. Since in this case the filler is now restrained on all sides, where ordinarily it would be free to move upward in the joint groove, the extrusion exerts an upward force on the concrete above it, and initiates the failure.

Since the culpable factors were present at the time of construction, none of the mentioned distressed areas can be classified as performance related failures.

▲ Figure 8. Failure at shoulder expansion joint. Extent of failure (left) and removed portion of concrete (right). Note filler offset, both in the pavement and on the removed portion of concrete.

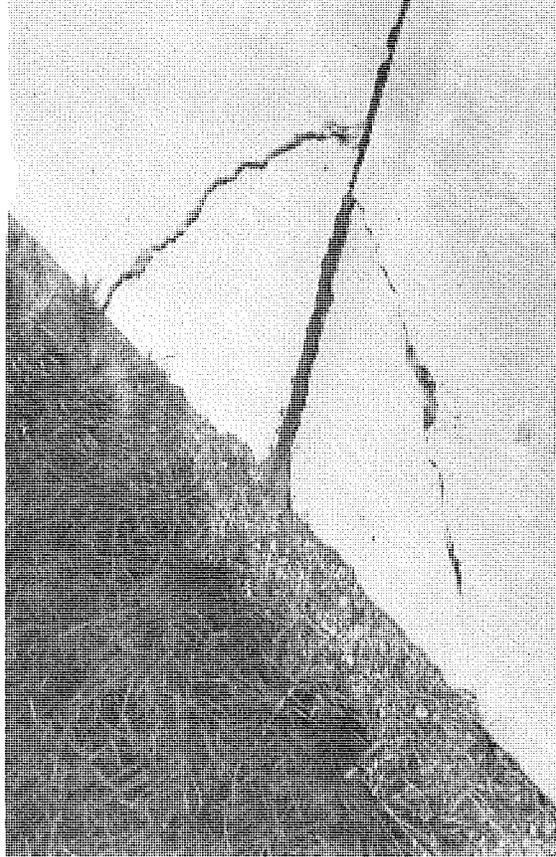
Figure 9 shows the failure at a shoulder contraction joint which appears to have been caused by grade settlement.

▲ Figure 9. Grade settlement at concrete shoulder joint.

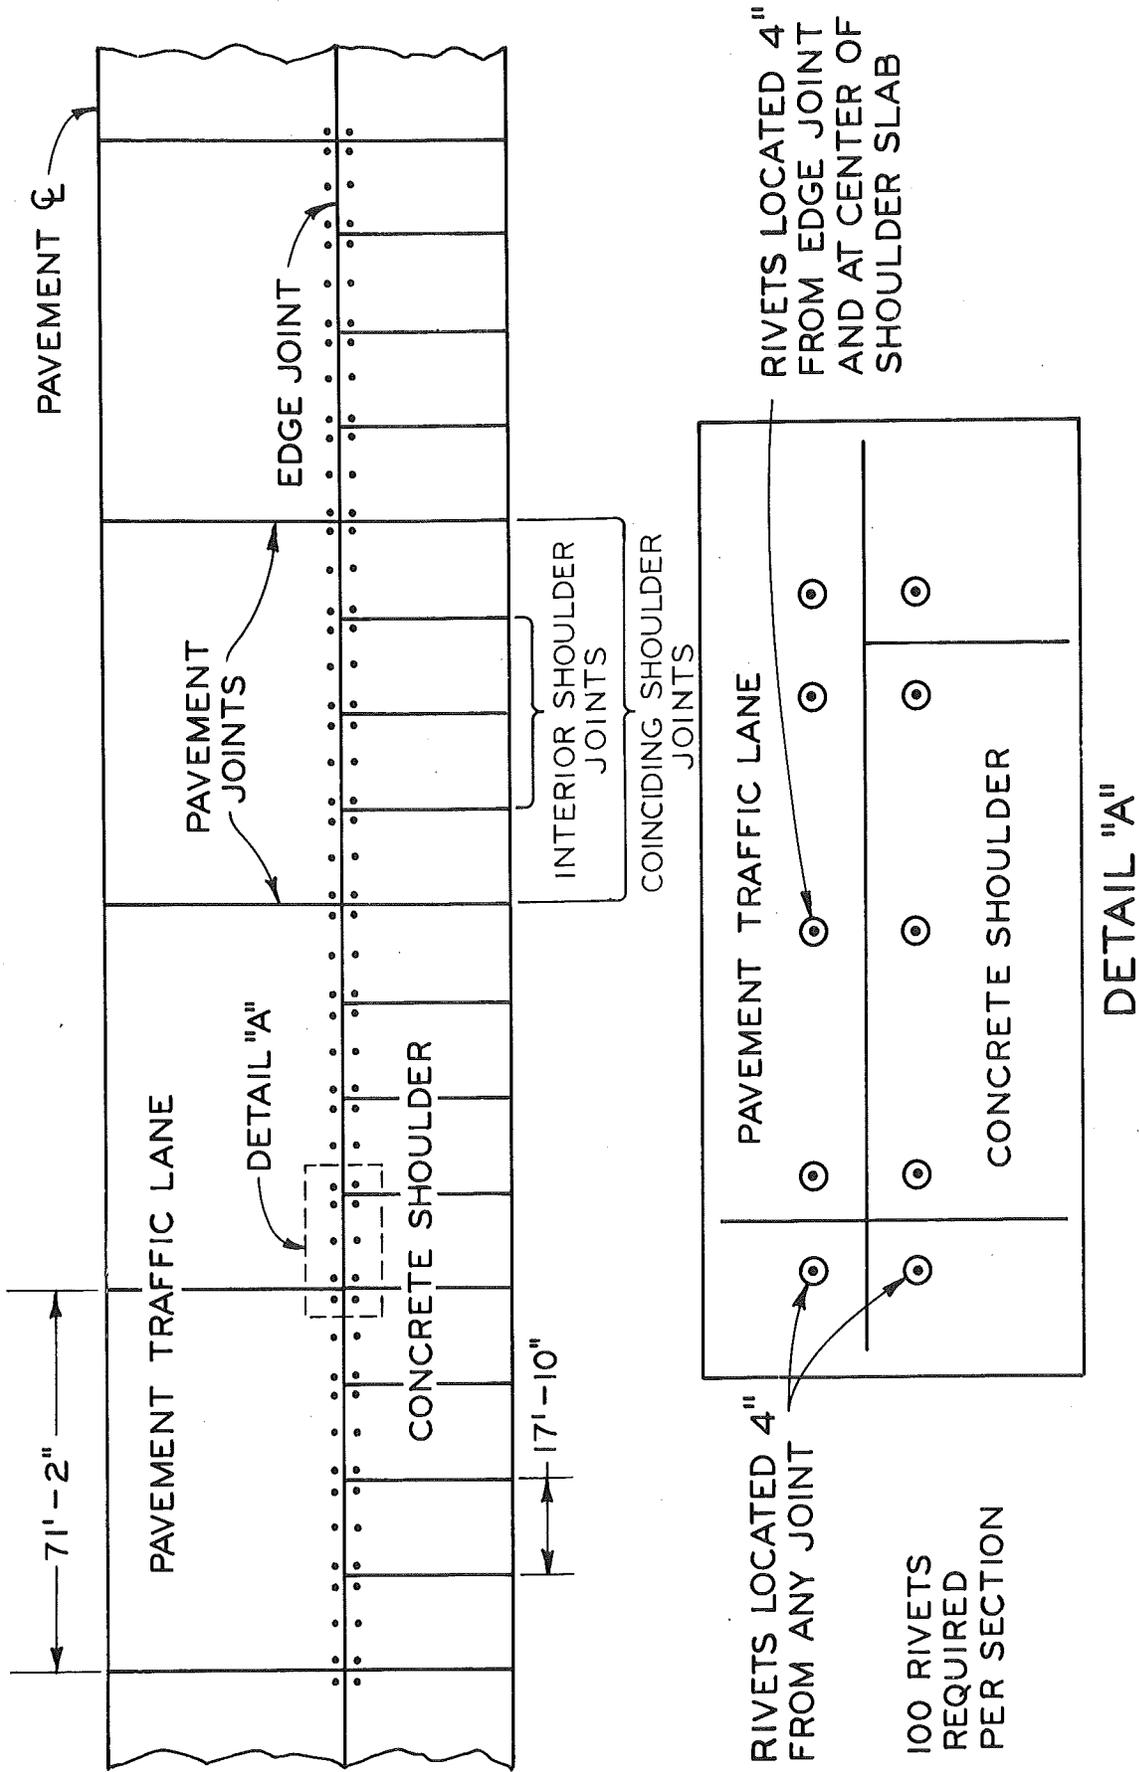
Figure 10. Rivet locations for instrumented sections of concrete shoulder project. One section of 16 shoulder slabs was instrumented as shown in each of 3 half mile test sections.

For ease of comparison, longitudinal movements at contraction joints have been separated into three categories. These are, mainline pavement contraction joints, shoulder joints coinciding with those on the mainline, and interior shoulder joints, that is, those joints on the shoulder between the mainline pavement joints (Fig. 10).

At the time of the last measurements (August 1973), the average seasonal movement of the mainline pavement contraction joints was 0.123 in. The maximum movement exhibited was 0.184 in. and the minimum 0.007 in. The small value comprising the lower end of the range is caused by a joint which is resisting movement. There is one such joint evident in the instrumented portions of the concrete shoulder sections, which include 15 joints in total.

Shoulder joints which coincide with contraction joints on the mainline show average seasonal movements of 0.102 in., with a range from 0.034 to 0.185 in. The movement of coinciding shoulder joints is approximately 80 percent of the movements exhibited by mainline pavement joints.

Interior shoulder joints have average movements of 0.015 in. from summer to winter. The range of movements is from zero to 0.063 in. Independent slabs of the size involved in the concrete shoulders would be expected to exhibit more uniform movement. However, it appears that there are considerable differences in the amount of bond between the pavement slabs and the short shoulder slabs that are attached by lane ties. In some cases, the shorter slabs are being "dragged" by the longer pavement sections.
