MICHIGAN  
DEPARTMENT OF STATE HIGHWAYS

July 9, 1971

**Subject:** Extent of Gasoline Fire Damage to B02 of 63031, US 24 and US 10 Over the Franklin River in Bingham Farms. Research Project 71 TI-30. Research Report No. R-770.

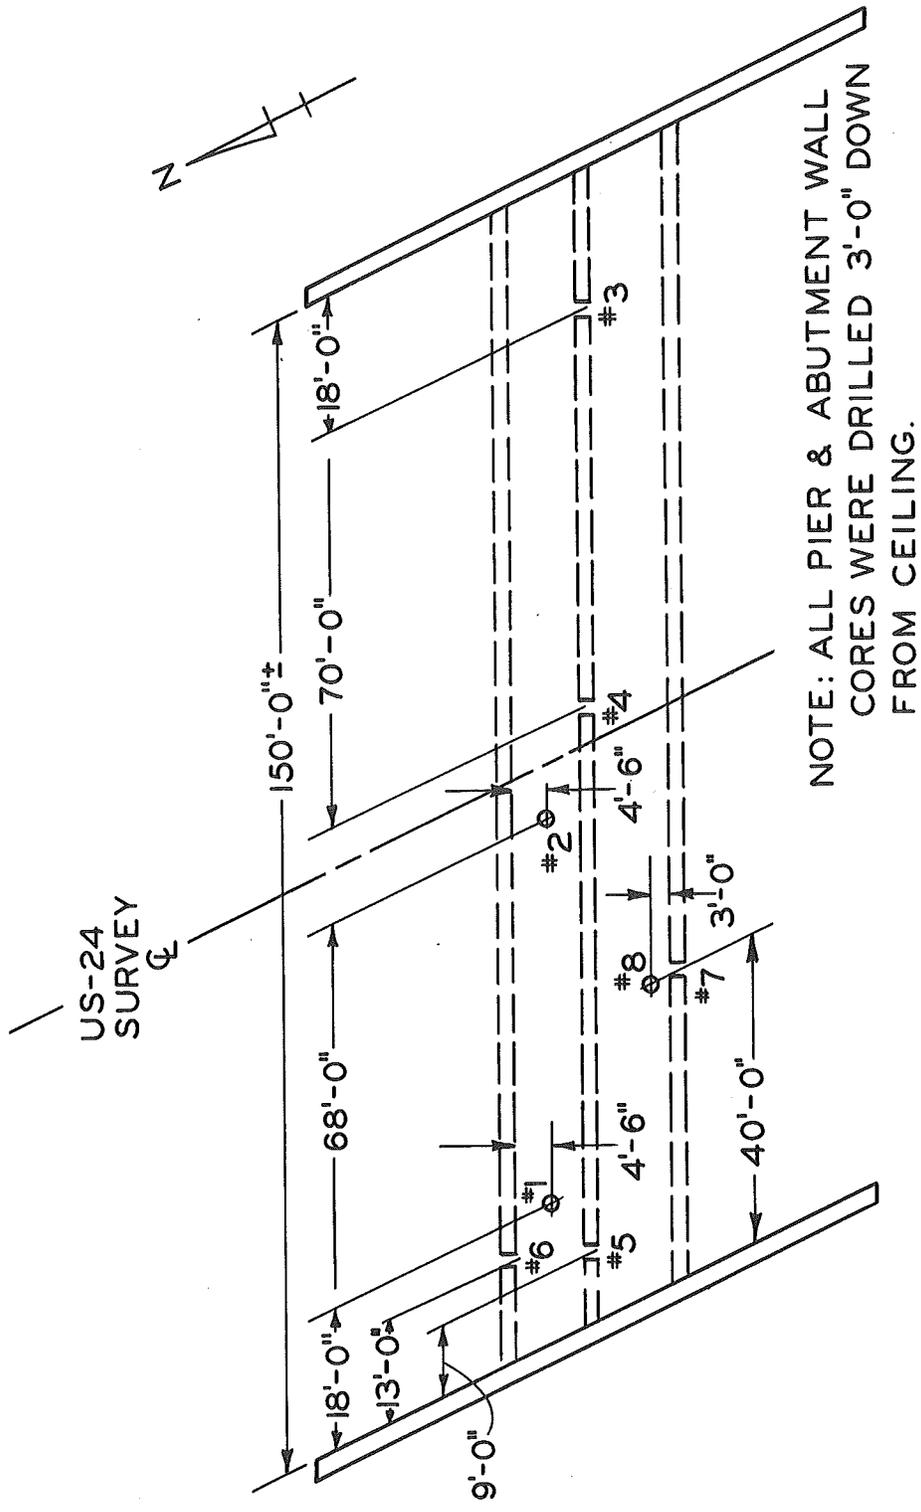
Figure 1. Core location plan  
 B02 of 63031  
 US 24/Franklin River

The cores were cut on April 7, 1971, from the locations shown on the sketch in Figure 1, and were received in the Research Laboratory on April 12, 1971. The cores were inspected, an initial measurement of their resonant vibration frequencies was made, and freeze-thaw testing was begun. Cores too short to produce a reliable resonance were not tested. After 84 freeze-thaw cycles in air-water, (ASTM C 291), the cores were removed for a second resonance measurement and were found to be in an advanced state of deterioration. Further freeze-thaw testing was suspended and the cores were closely inspected.

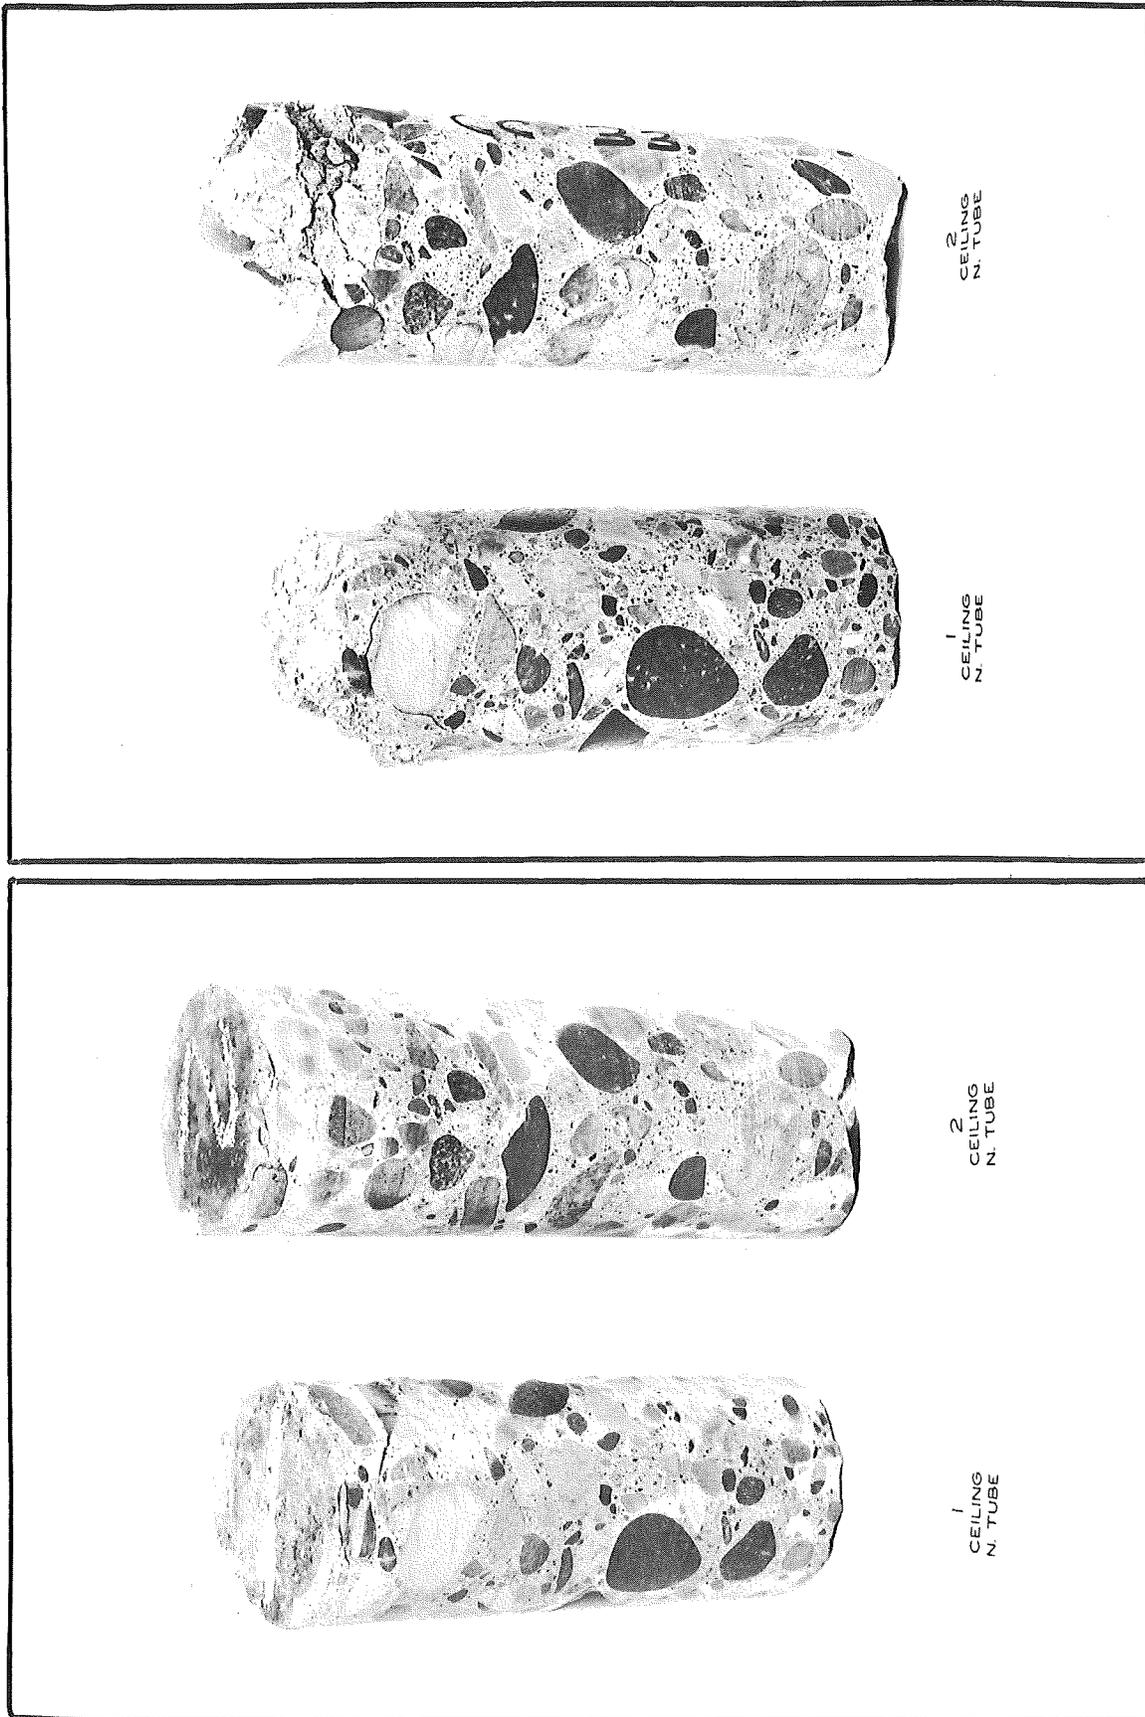
Figure 2 shows views of cores No. 1 and No. 2 before and after freeze-thaw testing. These cores were taken from the ceiling area where the heat from the fire was the most intense. In Table 1 the core measurements and the visual inspection data before and after freeze-thaw testing are recorded. The concrete near the surface from which the water of hydration was driven by the heat of the fire was particularly vulnerable to freeze-thaw destruction. It was also noted that freeze-thaw testing produced well-defined cracks across the cores at the level of the reinforcing steel. These cracks apparently developed from continuous incipient fractures caused by the thermal expansion of the reinforcing steel.

In general it was found that the portion of each core that was severely damaged by the fire had disintegrated. The remainder of the core sustained damage ranging from heavy fracturing adjacent to the disintegrated portion, to hair line cracking over the remainder of the core. The latter feature was due to freeze-thaw disruption of the old non-air-entrained concrete (poured in 1931).

From the results of freeze-thaw testing of the cores, it can be assumed that an incipient fracture-plane exists at, and runs parallel to, the plane of the reinforcing bars along the ceiling and higher wall areas of both tubes where the fire damage was severe. It can be assumed further that moisture will penetrate the damaged concrete and will eventually reach these bars where the resulting volume expansion of rust will cause the cover concrete to spall off. Thermal expansion spalling, as noted in the detailed inspection by Maintenance Division personnel in March 1971, has already exposed some steel, particularly the 1-in. square bars with shallow concrete cover in the ceiling area. The impairment of this reinforcing steel, especially the positive moment bars in the ceiling, will curtail the designed function of this structure and jeopardize its future performance. Before any extension is added to this culvert, its designed load-carrying capacity should be restored.

Figure 2. Views of concrete cores taken from the ceiling at the center and west end of the north tube before (left) and after (right) freeze-thaw testing. The right photo clearly shows the vulnerability of severely fire-damaged concrete to freeze-thaw deterioration. (Cores shown inverted).

A possible solution might be to line the tubes with either a circular or half-elliptical corrugated steel tube section and fill the remaining spandrel area with concrete which could be pumped in from the ends. If this arrangement or some suitable alternate repair would fail to provide an adequate water flow capacity, a more expensive solution involving demolition might have to be considered. This might require the complete replacement of the present double tube culvert with an equivalent such as one or two large pre-formed elliptical tubes.
