MICHIGAN
DEPARTMENT OF STATE HIGHWAYS

Subject: Study of Delayed Set in Bridge Deck Pour (S05 of 63103).
Research Project 71 TI-57. Research Report No. R-796.

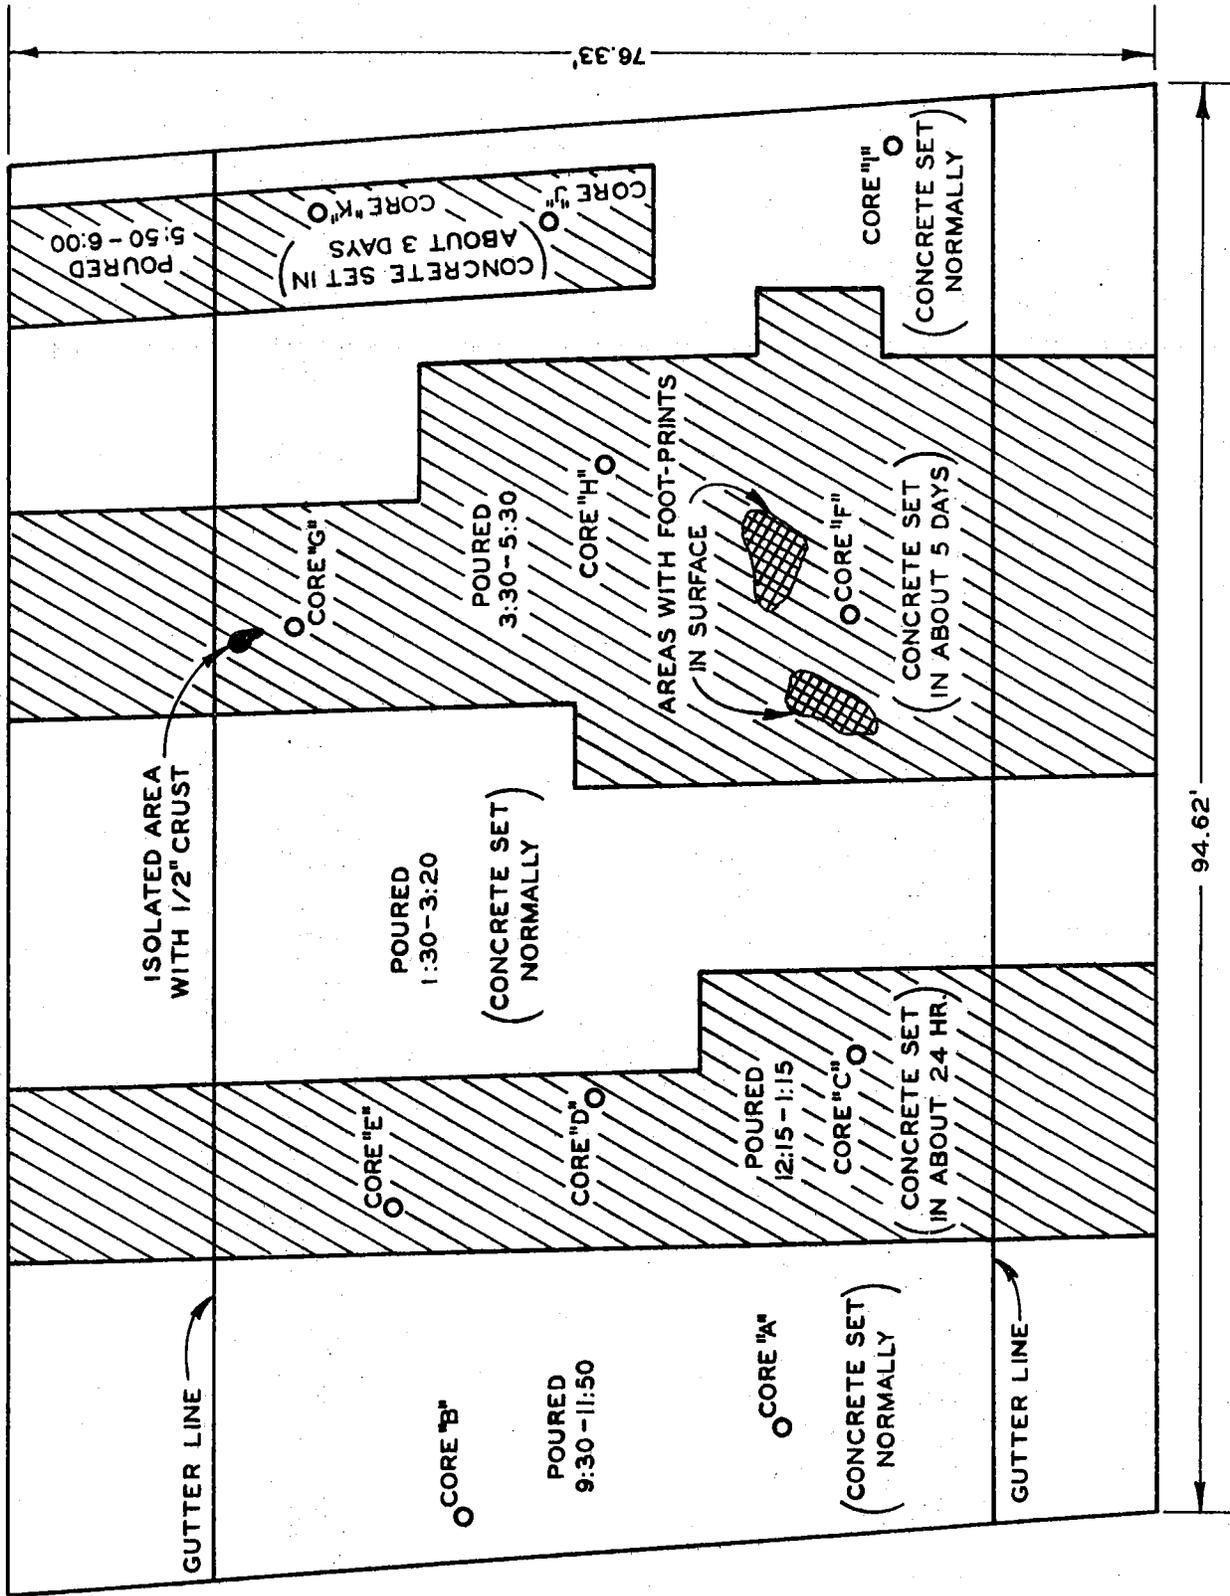
Figure 1. Pour diagram and test core location, S05 of 63103, westbound pour E (8-9-71).

The first 20 ft (45 cu yd) was reported to set up normally, but in the remaining 74.5 ft there were two large full-width areas, plus a smaller one, at the east end that were reported to have taken from 1 to 5 days to completely harden. The attached Figure 1 describes the approximate areas involved and the 4-in. core locations which were drilled on August 20, 1971.

The subject deck pour was inspected by D. L. Wickham and M. G. Brown on September 21. The concrete surface appeared to be in good condition except for footprints in the vicinity of Core F toward the south curb line. Also, there was an isolated area at the north curb line where a mortar crust of about 1/2 in. had loosened and was removed, exposing an area about 4 by 24 in. Both of these defects were in the general area that was reported to have taken 5 days to harden (Fig. 1). The strength and durability of the concrete in this particular area would appear to be good, however, as evidenced by the results on cores F, G, and H. Only a very few shrinkage cracks could be found in this area and they appeared to be mostly near the south curb line.

To summarize, the strength and durability of the delayed set concrete would appear to be good. The two isolated areas containing footprints in the east half of the pour will require some grinding to lower the bulged spots between the footprints, down to the original grade. The footprints themselves can be lightly chipped out or sandblasted, primed, and filled with epoxy mortar as described under Sections 4.14.18 and 8.16.06 of the Standard Specifications. The small isolated area of loose mortar crust at the north curb will require some chipping out and sandblasting to repair, using the same methods as the footprints. It is suggested that the few small shrinkage cracks be located by brooming off the pour area and lightly wetting-down with water. The cracks can then be marked for sealing. After the concrete surface has thoroughly dried, the crack areas may be sealed by brushing in a premixed 8.16.06 epoxy binder diluted about 3:1 by volume with toluene. This mixture will have a low viscosity for good crack sealing properties. It is also suggested that the diluted epoxy be applied in mid-afternoon when the concrete has reached a maximum temperature and has started to cool down, to promote better absorption of the sealer. A second sealer application directly over visible cracks would be advisable and this could follow the first application by 1/2 to 1 hour. We understand this structure will not be finished or open to traffic for another year, so the suggested repairs could possibly be done during warmer weather next spring. The repairs must be done before any linseed oil treatment, however.

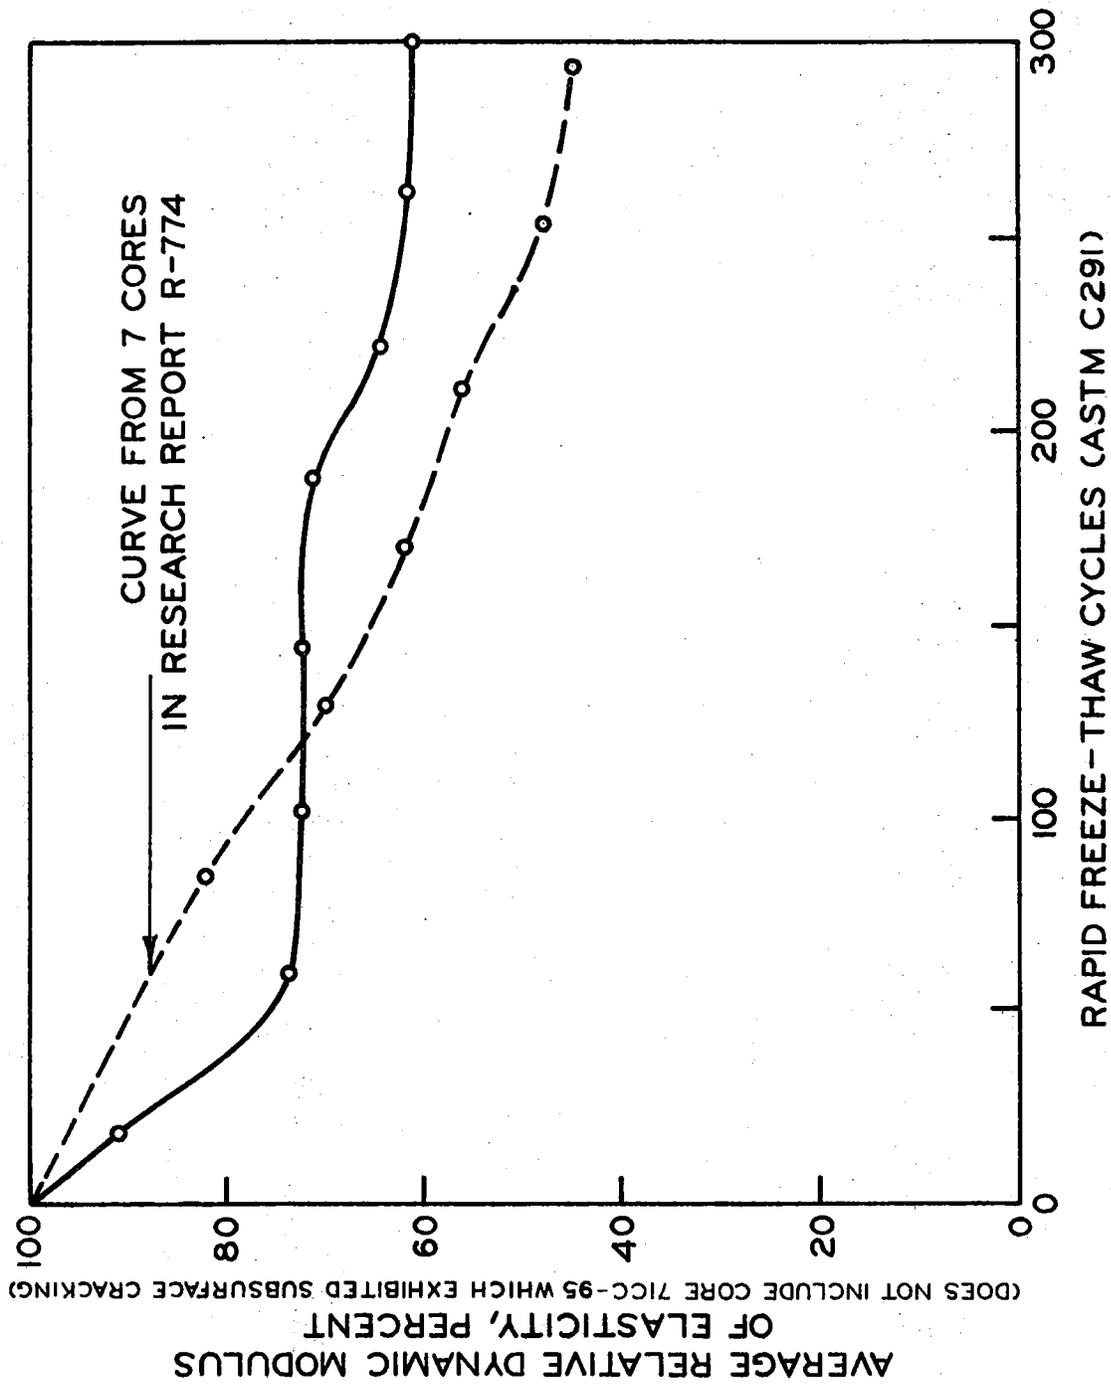
Figure 2. Drop in sonic modulus for five test cores under freeze-thaw in air-water.

The 11 cores taken on August 20 were kept in water until they were placed in the Research Laboratory moist room on August 23. The cores were examined on August 24 by H. B. LaFrance and D. L. Wickham of the Construction Division, R. L. Morris of the FHWA, and M. G. Brown of the Research Laboratory. The full-depth cores appeared to all be in good, sound condition with some scattered 1/8 to 1/4-in. voids. It was decided to select 5 of the cores for air determination and 28-day compressive strength tests. The remaining 6 cores were run through 300 cycles of rapid freeze-thaw in air-water (ASTM C291) and then broken in compression. The results of these core examinations are shown in Table 1 and Figure 2. The strength and durability, in general, proved to be quite good. Core D was found to contain a vertical crack in the top 2 in. which resulted in the low compressive strength after freeze-thaw. The drop in sonic modulus for the freeze-thaw cores shown in Figure 2 appears to be normal for air-entrained concrete deck cores. A similar curve on 7 deck cores previously tested

from another project has been included for comparison (from Research Project 71 TI-28, Research Report No. R-774). The 4-in. cores with a full-depth cut surface and exposed aggregate appear to be more vulnerable to the freeze-thaw test than 3 by 4 by 16-in. cast beams with formed faces. The sonic modulus on these standard freeze-thaw beams made from typical deck concrete would be expected to drop to about the 90 percent level in 300 cycles.
